Warranty Extension: Audio-HVAC Display Is Dim or Dark(Supersedes 04-021, *Audio-HVAC Display Is Dim or Dark*, dated February 15, 2006.)**The entire content of this bulletin has changed.)****BACKGROUND**

In some audio units, a component failure on the PCB (printed circuit board) could cause the audio display to become dark or dim and prevent the audio/HVAC panel buttons from illuminating. On vehicles with navigation systems, this condition does not affect the display, but the navigation panel buttons do not illuminate.

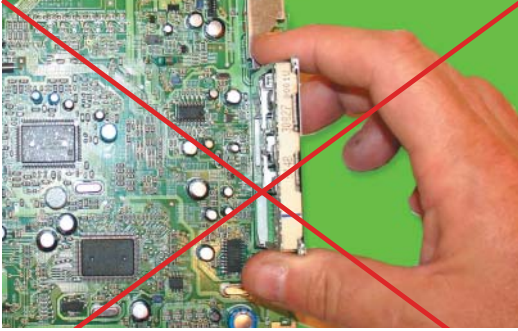
Never lift the PCB by the component parts.

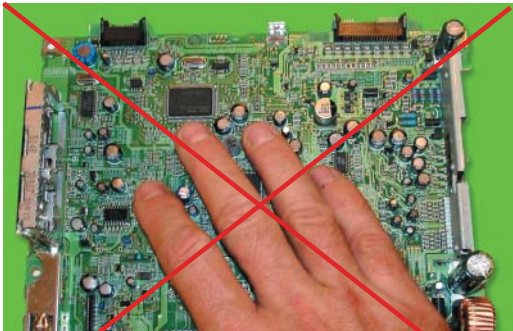
Never touch the electrical components of the PCB.

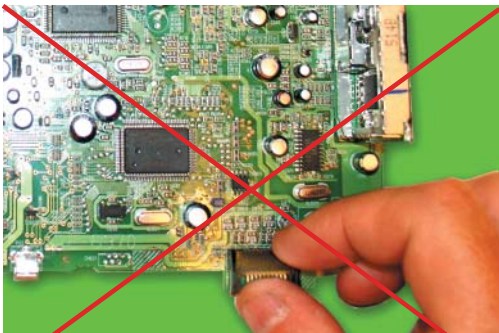
Never lift or hold the PCB by the connectors.

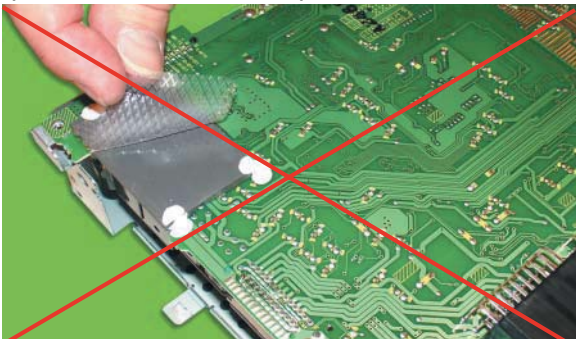
To prevent damage to the thermal pad, don't remove the protective cover until step 14.
