Applies To: **2004 TSX** – From VIN JH4CL9...4C000070 thru JH4CL9...4C040281**September 17, 2004****Safety Recall: TSX Rear Wire Harness****(Supersedes Preliminary Service Bulletin 04-026, dated September 3, 2004)****BACKGROUND**

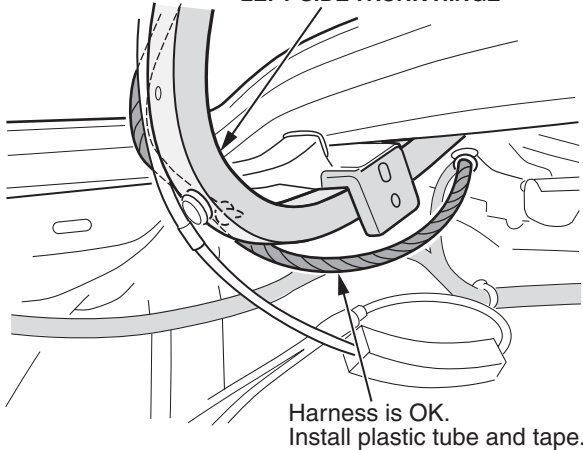
**GOOD**

1. Remove the trunk floor, the trunk rear trim panel, the left side trunk trim panel, and the left side trunk lid hinge cover:
  - Refer to pages 20-61 and 20-62 of the 2004 TSX service manual.
  - In ISIS, enter keyword **TRUNK**, and select **Interior Trim Removal/Installation - Trunk Area** and **-Trunk Lid** from the list.
2. Inspect the rear wire harness where it attaches to the left hinge of the trunk. The harness should have only a slight bend in it. It should not be twisted or damaged.
  - If the rear wire harness is not twisted or damaged, go to **REPAIR PROCEDURE A**.

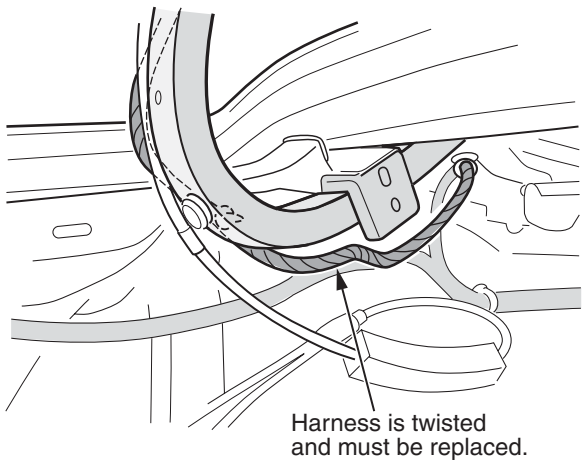
**NO GOOD**

The rear wire harness near the left side trunk hinge is not adequately protected and could be damaged when the trunk is repeatedly opened and closed. A damaged wire harness can cause a blown fuse or an open circuit, with either resulting in a loss of the backup lights, the license plate light, the left or right taillight, and/or the trunk release button function. Driving without back-up lights or driving at night without taillights can make it difficult for other drivers to see the vehicle, and a crash could occur.

- If the rear wire harness is twisted and/or damaged, go to **REPAIR PROCEDURE B**.
