Applies To: 2004 TSX – ALL

December 17, 2004

Rattle From the A-Pillar

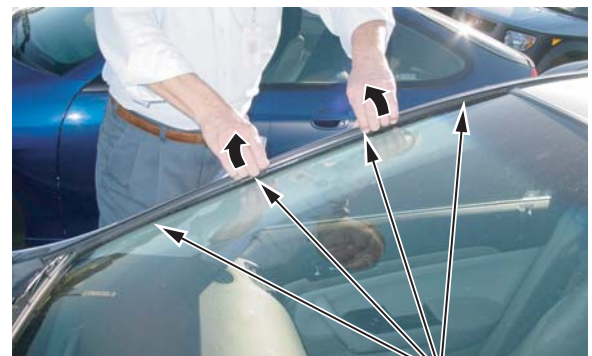
CLIPS
(Mark the
windshield here.)

1. Using a flat-tip screwdriver, gently pull the molding away from the windshield, and locate the four retaining clips.

NOTE: Mark the windshield with a tire crayon at the clip locations.
