Applies To: 2009 TSX – ALL

June 4, 2008

Fuel Fill Door Is Hard To Open

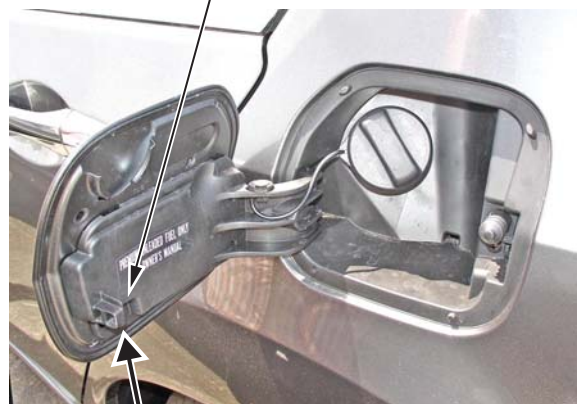
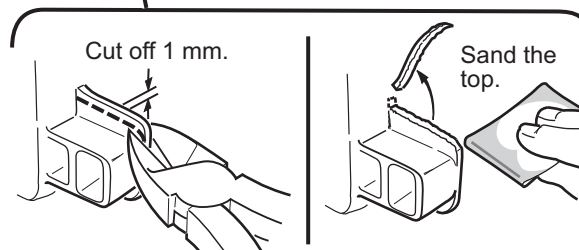
FUEL DOOR LOCK TAB

When the fuel fill door is pressed, the release latch does not disengage.

Not enough clearance in the fuel door lock tab.

1. Trim 1 mm of material from the top of the fuel door lock tab with a pair of sharp diagonal cutters.

2. Smooth the top of the tab with sandpaper or emery cloth.
