Applies To: 2009 TSX – ALL

June 4, 2008

Beverage Holder Lid Will Not Open

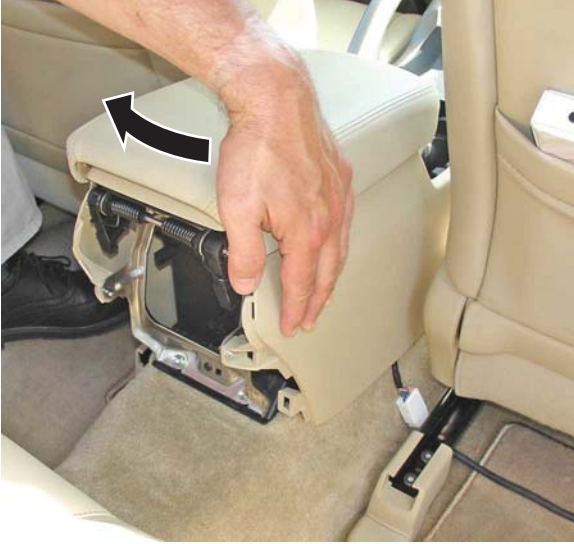
The center console is slightly out of alignment, causing the beverage holder lid to bind against the center console panel.

4. Pull the back of the center console toward the driver's side, and hold it in position while you tighten the bolts to 9.8 N·m (7.2 lb-ft).
