Vintage & Collector Car APPRAISALS

Make of Vehicle: 1964 Buick Skylark Convertible. **Engine:** Original Aluminum 300 cu. in. V-8 was recently rebuilt and bored out to 310 cu. in. with steel inserts installed.

Vehicle Identification Number: 3K1192047

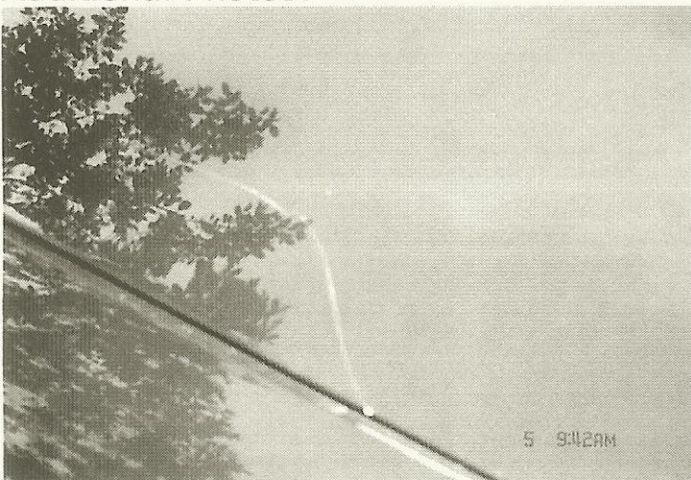
Fairly new re-paint (original color) appeared to be in excellent condition with the exception of a few scratches. See additional photos...

Scratch on passenger side of trunk lid...

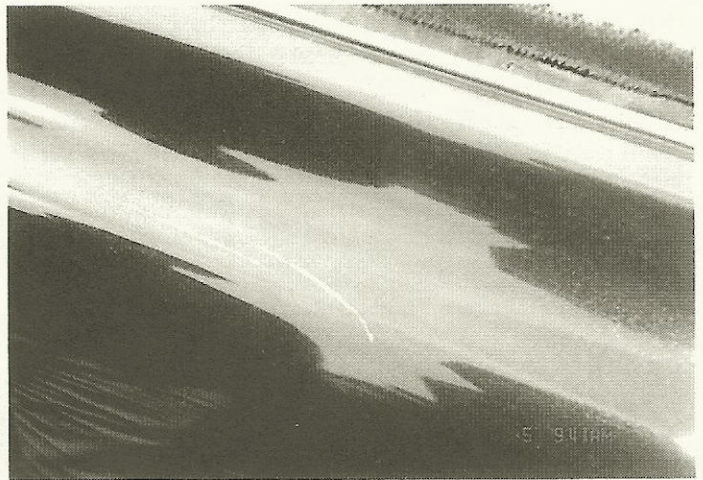
Similar scratch on passenger side door.
