Applies To: **See VEHICLES AFFECTED**

Child Seat Anchor Locating Button Is Missing

(Supersedes 05-014, dated May 17, 2005, to update the information marked with the black bar)

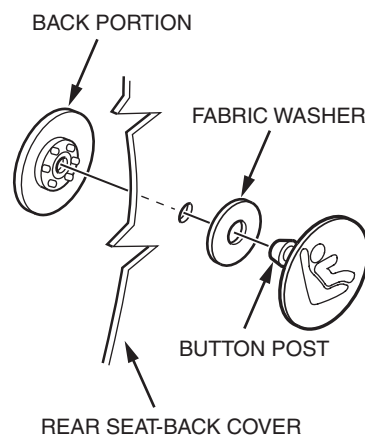
1. Remove the rear seat-back cover just enough to allow access to the opening where the button will be attached:
 - Refer to Section 20, Rear Seat-back Cover Replacement, in the appropriate service manual, or
 - Online, enter keyword **SEAT COVER**, and select the appropriate Rear Seat-back Cover Replacement procedure from the list.
2. Select the appropriate button from the Child Seat Anchor Service Set.
3. Attach the button to the rear seat-back cover:
 - Place a fabric washer over the button post.
 - Insert the post through the opening in the cover.
 - Snap the back portion onto the post.

4. Repeat steps 2 and 3 as needed for additional buttons.
5. Install the seat-back cover in the reverse order of removal.
