Driver's Seat Squeaks

(Supersedes 06-018, dated May 12, 2006, to update the information marked with the black bars)

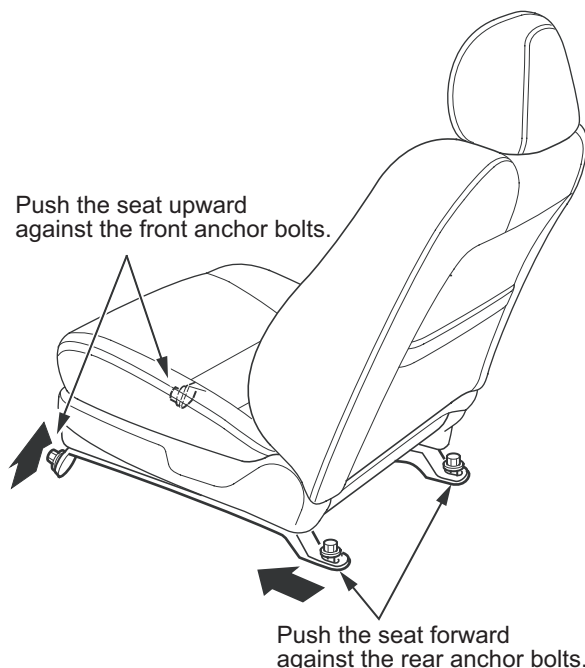
1. Remove the seat track end covers:
 - Refer to page 20-99 in the *04-06 TSX Service Manual*, or
 - Online, enter keyword **FRONT SEAT** and select **Front Seat Removal/Installation**.
2. Loosen the four seat anchor bolts.
3. Push the seat forward against the rear anchor bolts and upward against the front anchor bolts, then tighten all four bolts.

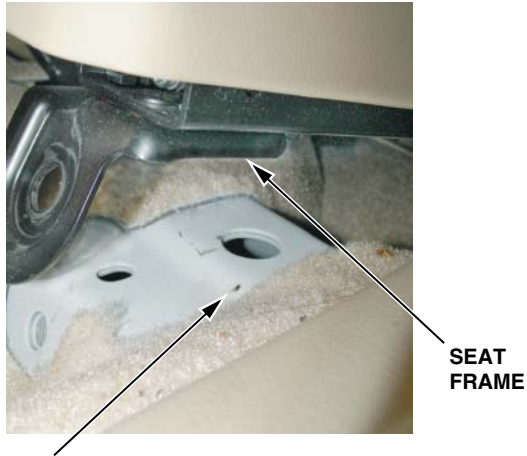
6. Locate the scratch marks made by the seat frame on both sides of the floor panel (right side is shown).

Locate the scratch mark made by the seat frame.

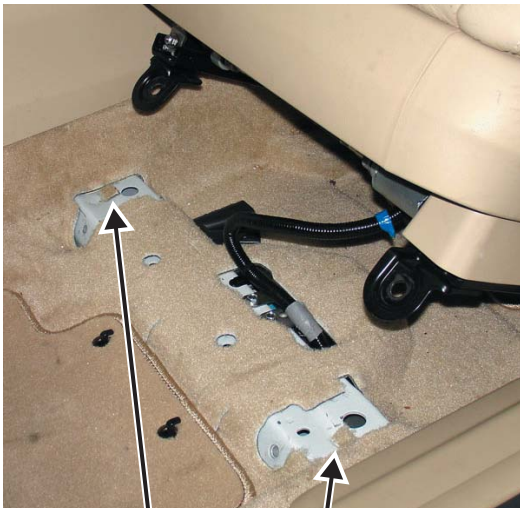
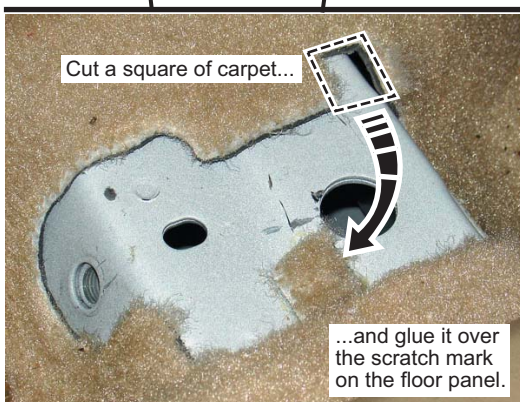
7. Cut two 15mm square pieces of carpet from underneath the driver's seat, and use weatherstrip adhesive to glue them over the marks as shown.

8. Install the seat in the reverse order of removal.
9. Torque the bolts to **34 N·m (25 lb-ft)**.
10. Reinstall the seat track end covers.
