Allied-Axis

THE PHOTO JOURNAL OF THE SECOND WORLD WAR

The A4/V2 Missile

Sherman Flail

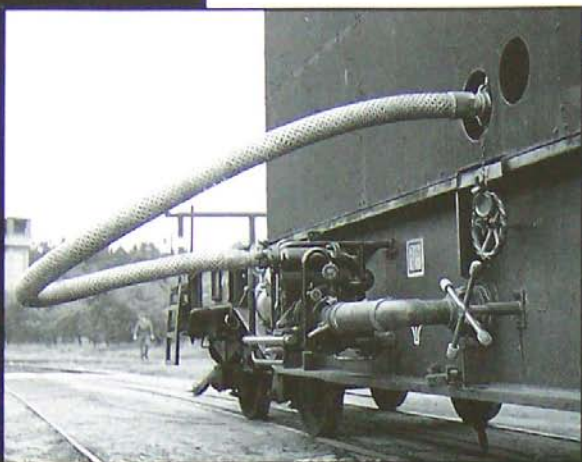
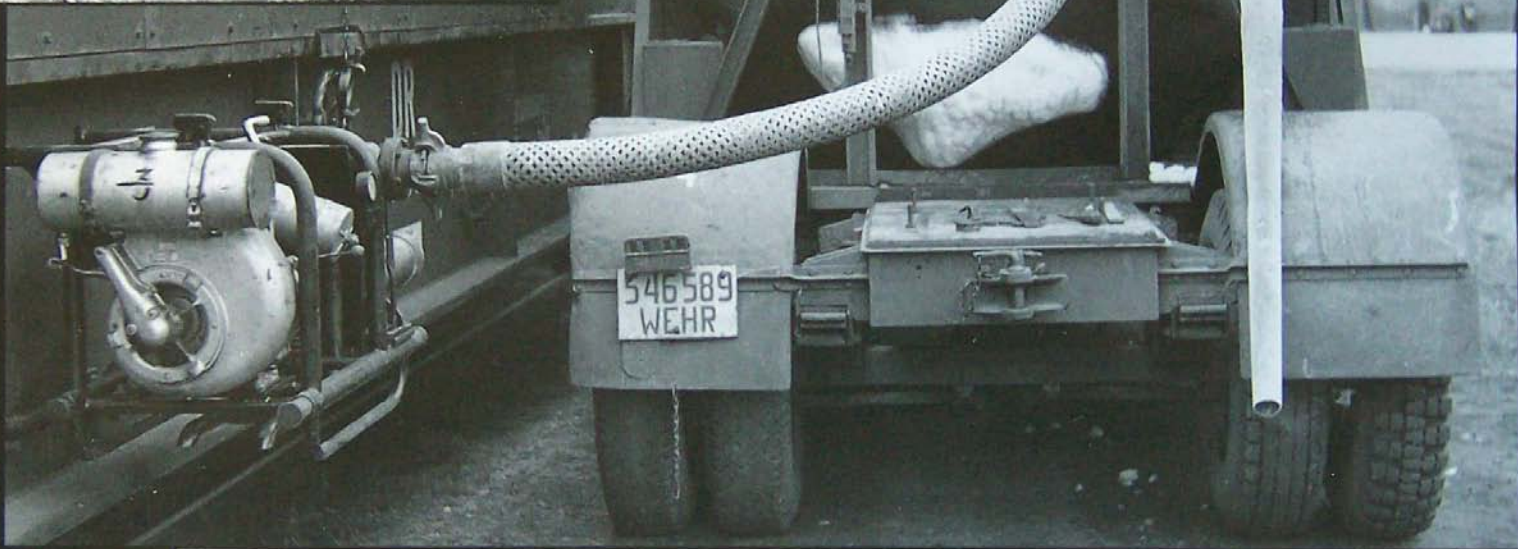
An engine-driven pump was attached to brackets on the side of the A-Stoff rail tank car and hoses were then connected to the pump and wheeled A-Stoff trailer. The pump was a simple rotary type, and was driven by a one-cylinder air-cooled gasoline engine. The straight portion of the feed pipe and all of the feed hoses to the wheeled trailer were insulated with external covers to keep the A-Stoff as cold as pos-

sible. When not in use, the hoses were disconnected and stowed on the wheeled A-Stoff trailer, and were used later to fuel the V2 missile. The pump was used when the rail tank car was only partly full; when the car was full, gravity was sufficient to fill the first few A-Stoff trailers. The pump was also slowed on the wheeled trailer to pump A-Stoff into the V2 during the launch. (IWM)

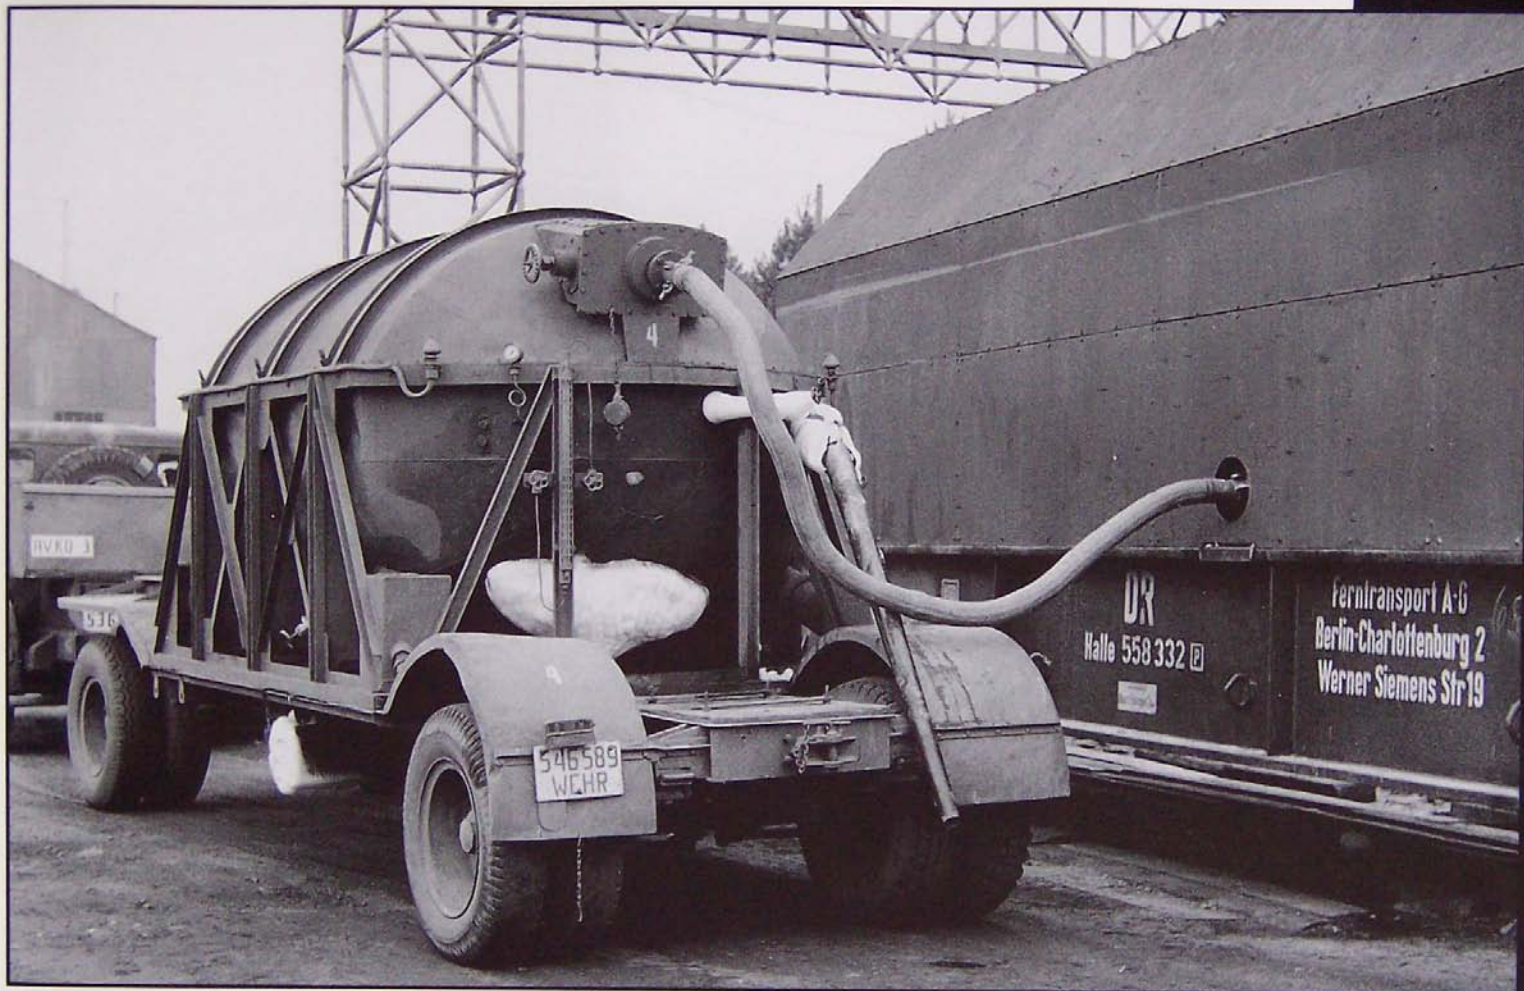
During the filling process, the extremely cold temperatures of the A-Stoff caused ice and frost to condense around the metal fittings. The A-Stoff wheeled trailer was heavily reinforced to contain the pressure in the tank. Here the engine-driven pump is used to transfer the A-Stoff to the trailer. The British Army had to spend months trying to locate all the equipment needed to fire the V2 the same way the Germans had during the war. All the trailers, trucks and support equipment had to be rounded up and

gathered at Cuxhaven to conduct "Operation Backfire." **Inset:** The pump could also be used to fill the A-Stoff rail tank car or to re-circulate the liquid oxygen, as seen here. Note the double gauge track beneath the tank car. The test facility at Cuxhaven had an extensive network of narrow gauge rail tracks to handle ammunition during firing tests. (IWM)

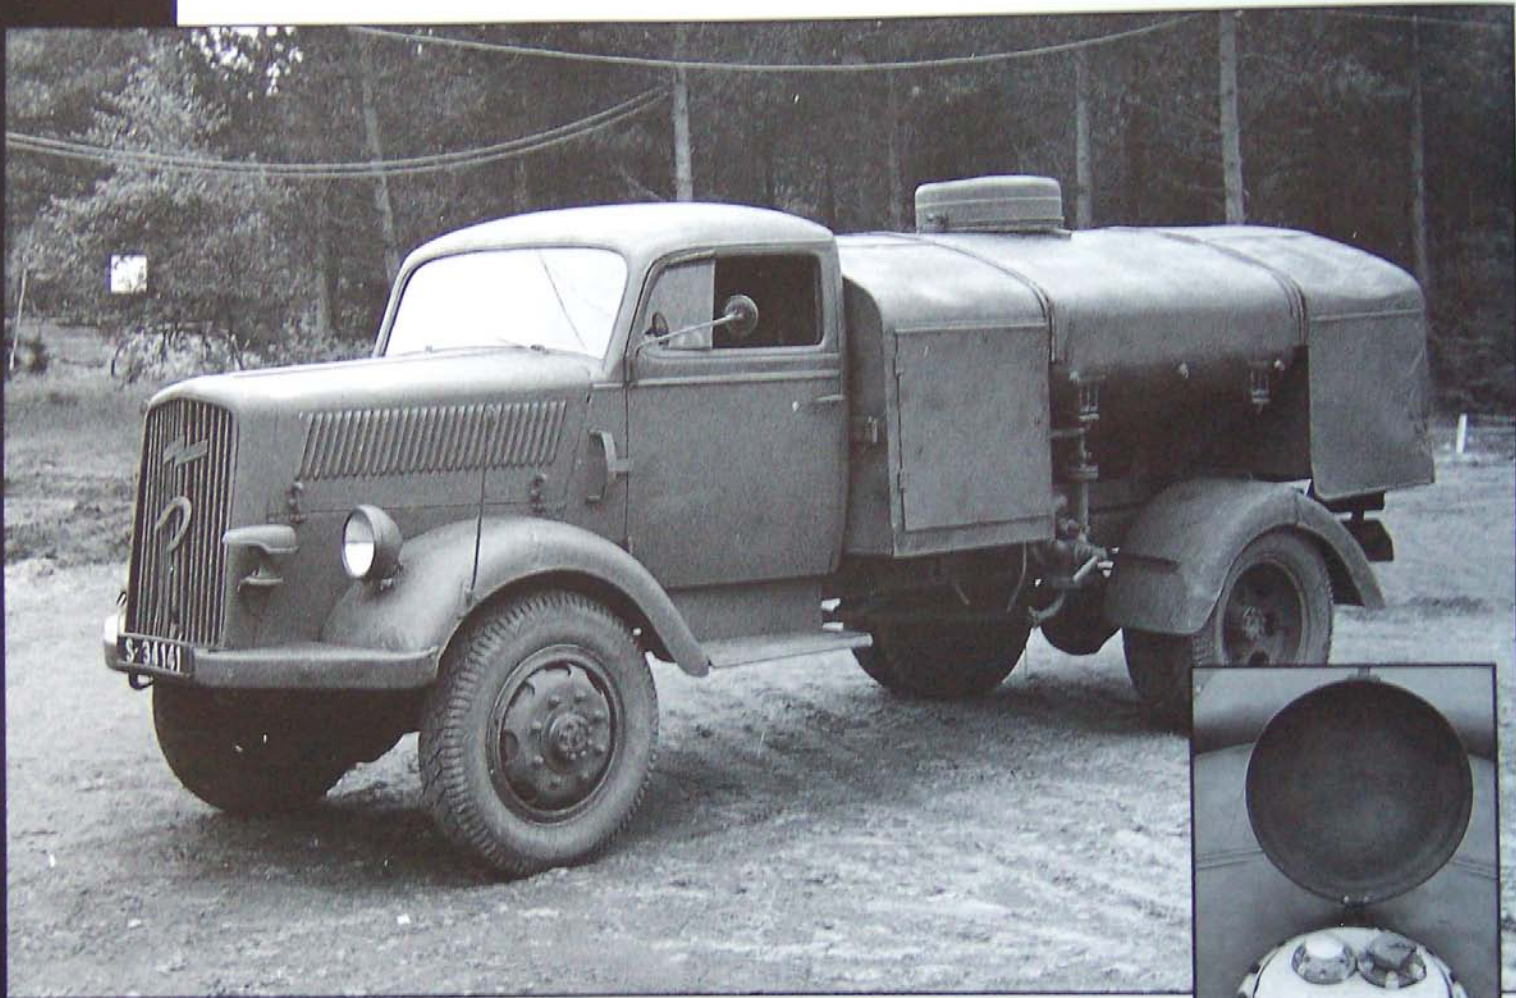
The turbine pumps for the fuel system of the V2 missile were run on T-Stoff (85% hydrogen peroxide and 15% water). T-Stoff was an extremely dangerous fuel; the 15% water was added to prevent explosions by controlling the rate of decomposition. This A-1yp (4x4) Opel "Blitz" tank truck was built to carry the T-Stoff for the rocket motor's turbine fuel pumps. T-Stoff was highly volatile and could react with almost any organic substance. When combined with a catalyst (calcium permanganate in the V2 system),

T-Stoff broke down into superheated steam and oxygen at a temperature of 500 degrees C (932 degrees F). **Inset:** Because T-Stoff was so volatile, pressure could build up in the tank. The T-Stoff tank truck had a safety pressure valve. This protected the tank by reducing internal pressure, which in turn reduced the rate at which the T-Stoff decomposed. The safety pressure valve is on the left in this view and the filling valve is on the right. Both were protected by a domed cover. (IWM)

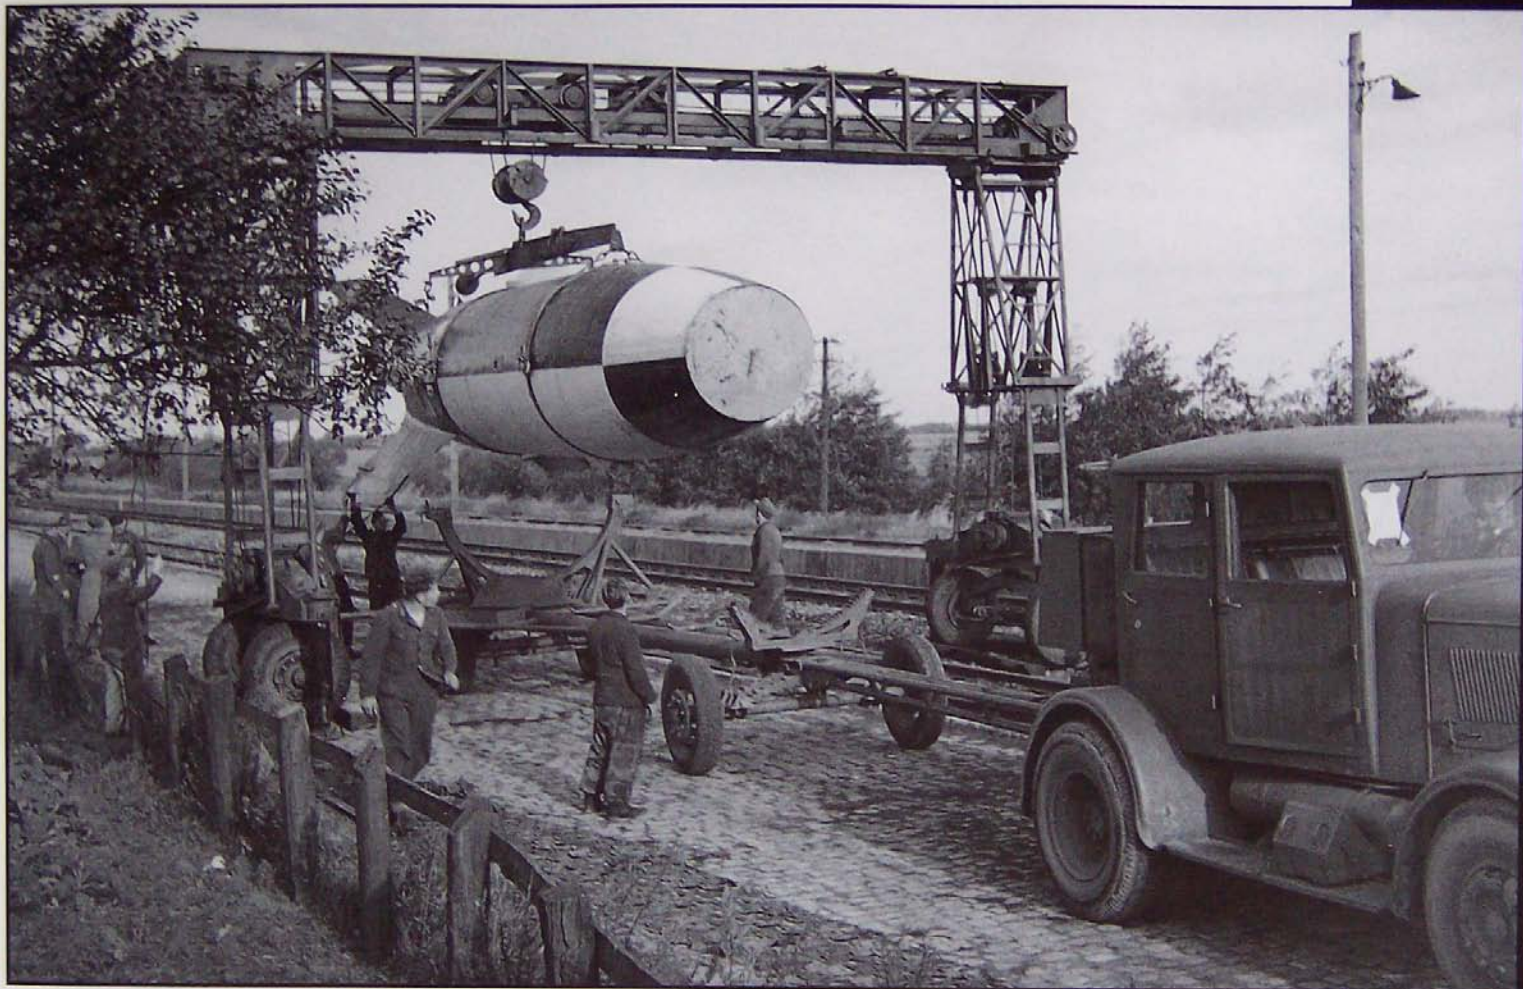
After the V2 missiles were delivered by train to the Field Store, they were transferred from the rail cars to transport trailers using a 15-ton collapsible overhead gantry crane. The crane was set up at the railhead to off-load the missiles and other equipment. The crane would then be collapsed into its travel configuration and towed to the forward launch preparation site. There it would be erected again and

used to transfer the V2s to their launch trailers. Note that at this point, the V2 missiles did not have warheads installed or fuel in the tanks. The missile airframe and motor weighed 4,485 lbs (2040 kg). The towing vehicle here was the Hanomag SS100. (IWM)

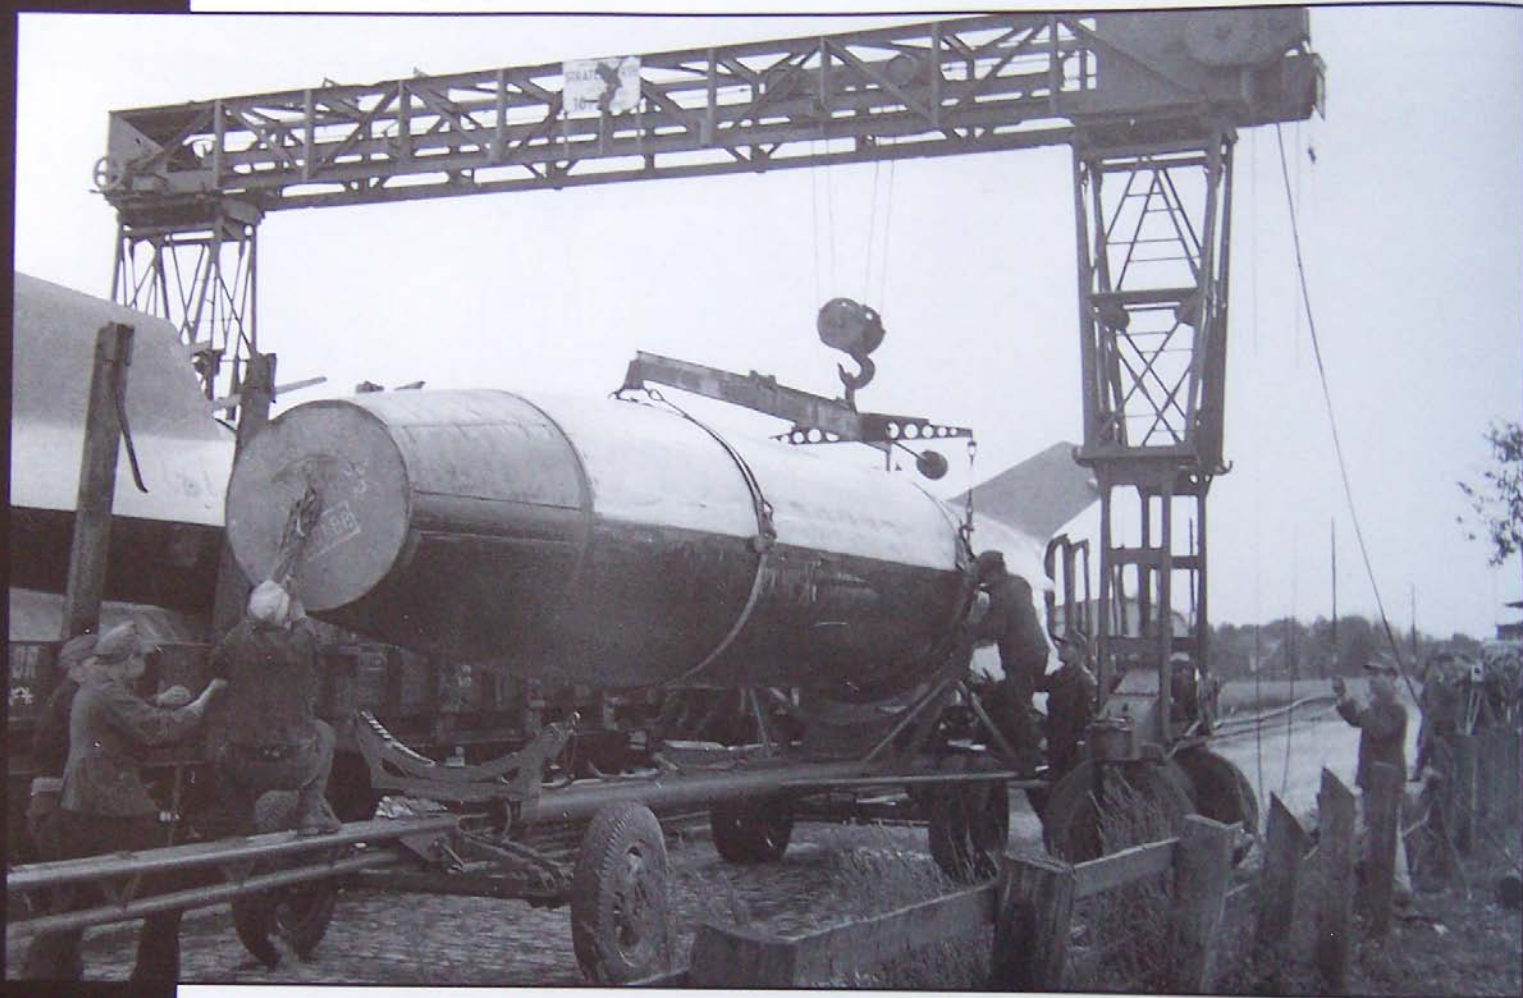
The V2 missile was transported from the railhead to the battery forward preparation site on a transport trailer called the "Vidalwagen." This was a simple A-frame tubular structure with formed supports to cradle an unloaded, unarmed V2 missile. The weight of the trailer and missile was enough that only heavy duty road tractors like the Hanomag were used to tow them. The Vidalwagen was very simple

and inexpensive to build and each battery had three Vidalwagen trailers for every launch trailer. The V2 battery would fire their first trio of missiles and then return to the forward preparation site to reload missiles onto the launch trailers. When all the missiles had been expended, the battery could then return to the Field Store and reload all the trailers and refill the support vehicles. (WM)

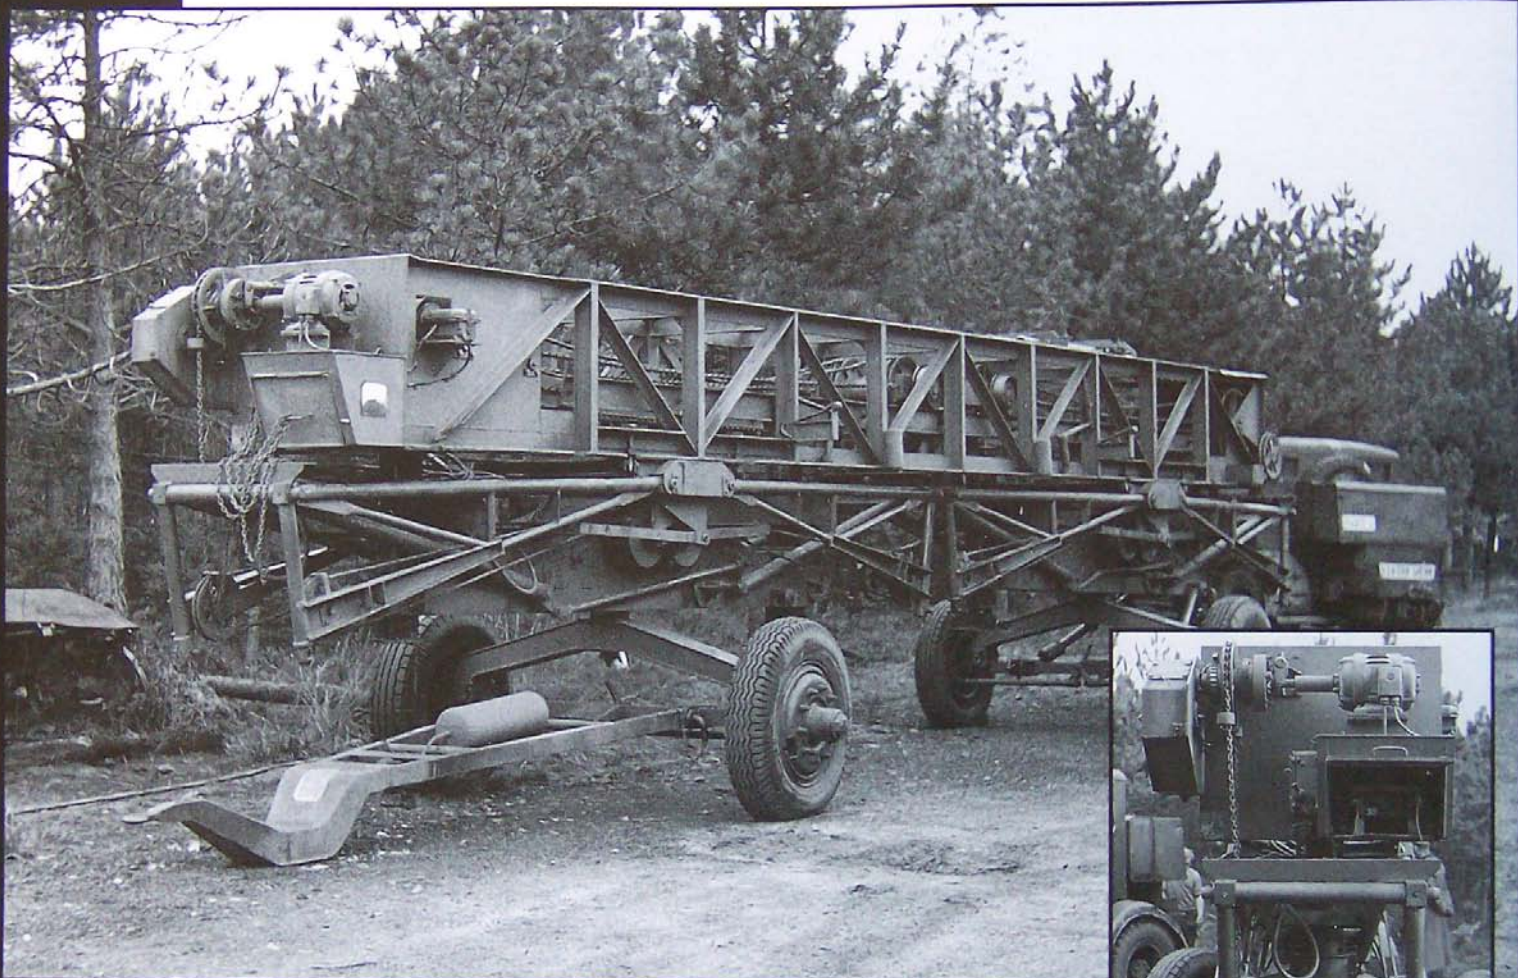
To handle the transfer of the V2 missile from one conveyance to another, the Germans adopted the 15-ton capacity collapsible overhead gantry crane already in use in Panzer Divisions to lift heavy tank turrets and other large loads. It was an ingenious design suitable for road or rail transport, and could be taken virtually anywhere a Panzer Division or V2 missile battery would have to go. It proved perfect for the V2 units' needs. The lift system allowed the crews to transfer missiles from the Vidalwagen trailers to the "Meiervagen" launching trailers. Here the Hanomag SS100 tractor had dropped the trailer at the missile forward preparation site. **Inset:** The 15-ton gantry crane had a motor drive for the winches, both

to raise and lower loads and to move them laterally. The tow bar assembly carried a compressed air bottle for the brakes. Folded down in its road configuration, the crane could be transported by road or rail within most normal clearance limits for bridges, tunnels or curves. Just inside the vertical tube struts were the cables and winches for raising and lowering the crane. (JWM)

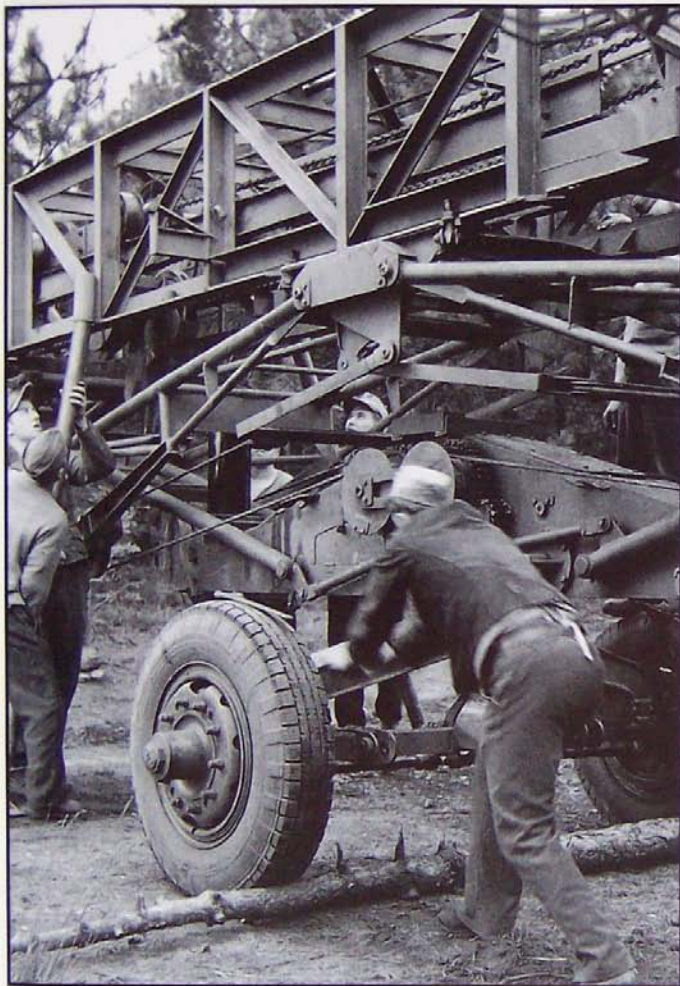
Left: Erecting the gantry crane took a number of men, as the process of unfolding the support structures had to be done manually. With the road wheels blocked against a tree trunk, the crew began the task of erecting the crane. Time was of the essence in the last months of the war, due to Allied planes, but in fact, the great difficulty in spotting a V2 being prepared for launch made this a fairly safe procedure. The complex scissors arrangement of tubes and struts had to extend and retract reliably and quickly, but also had to support the weight of the gantry overhead frame and of the load being carried. (IWM)

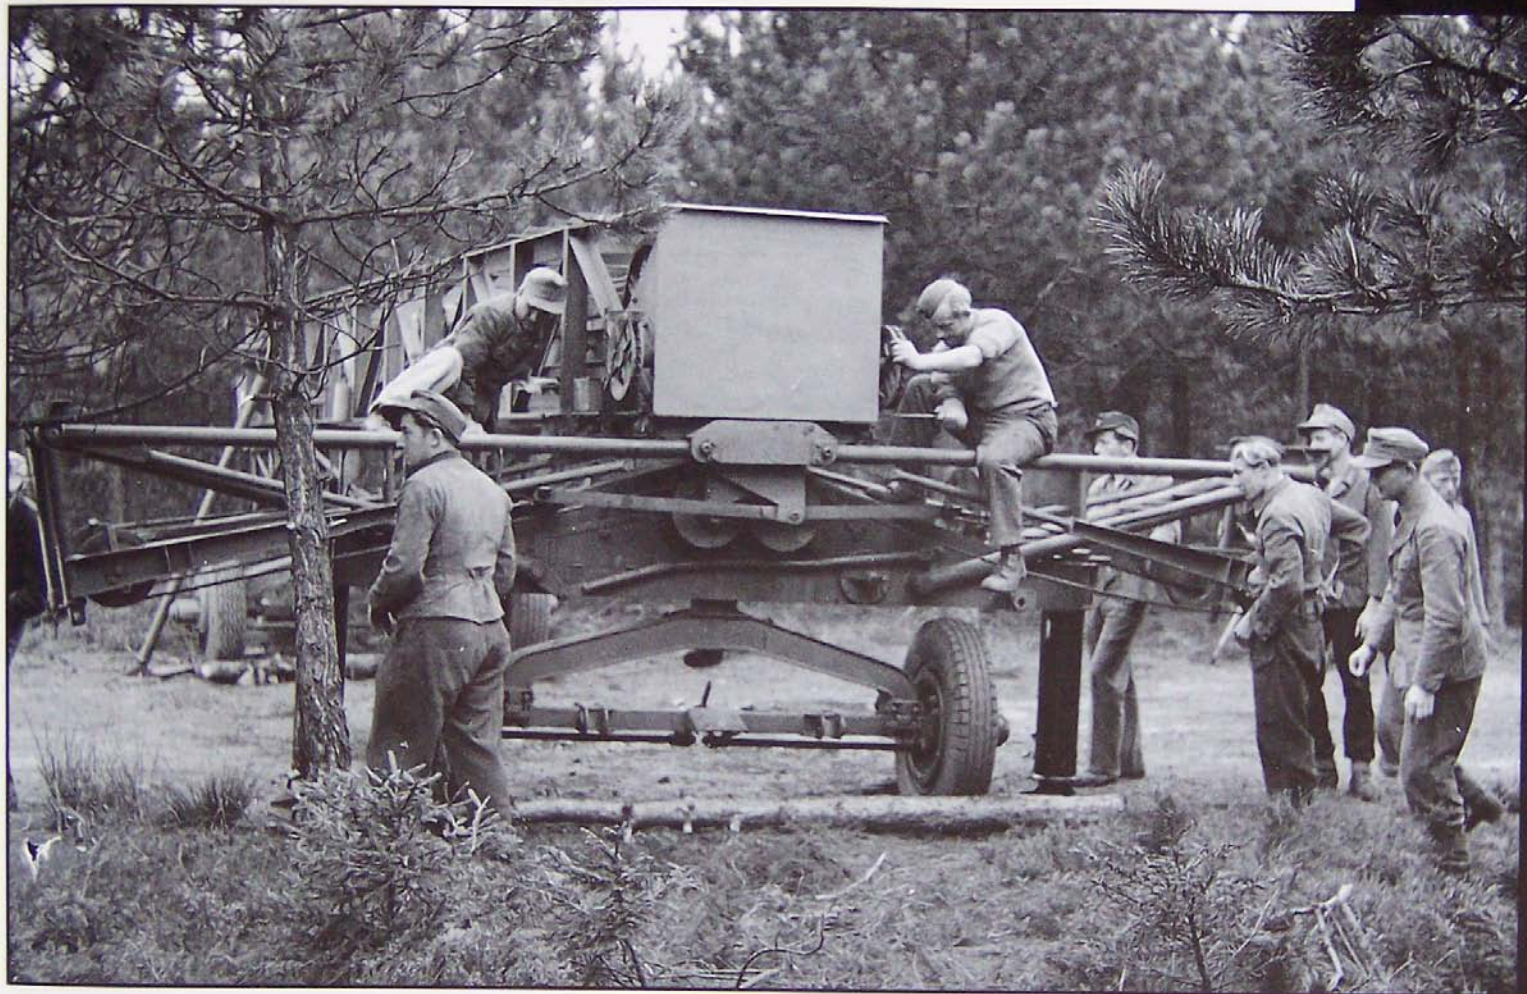
With the folded end frame turned sideways to the cross piece, the crew could then raise the crane structure. The scissors design was light weight and very strong. The cable and pulley system was the simplest way to move the scissors to raise (or lower) the entire crane. After adjusting the cables and pulley system, the crew carefully began lifting the crane, making sure the two ends were raised evenly together. The large jack struts were adjustable and were locked in place before the crew raised the gantry. Stabilizing the crane was very important, as the heavy loads could cause an unstable crane to fail. (IWM)

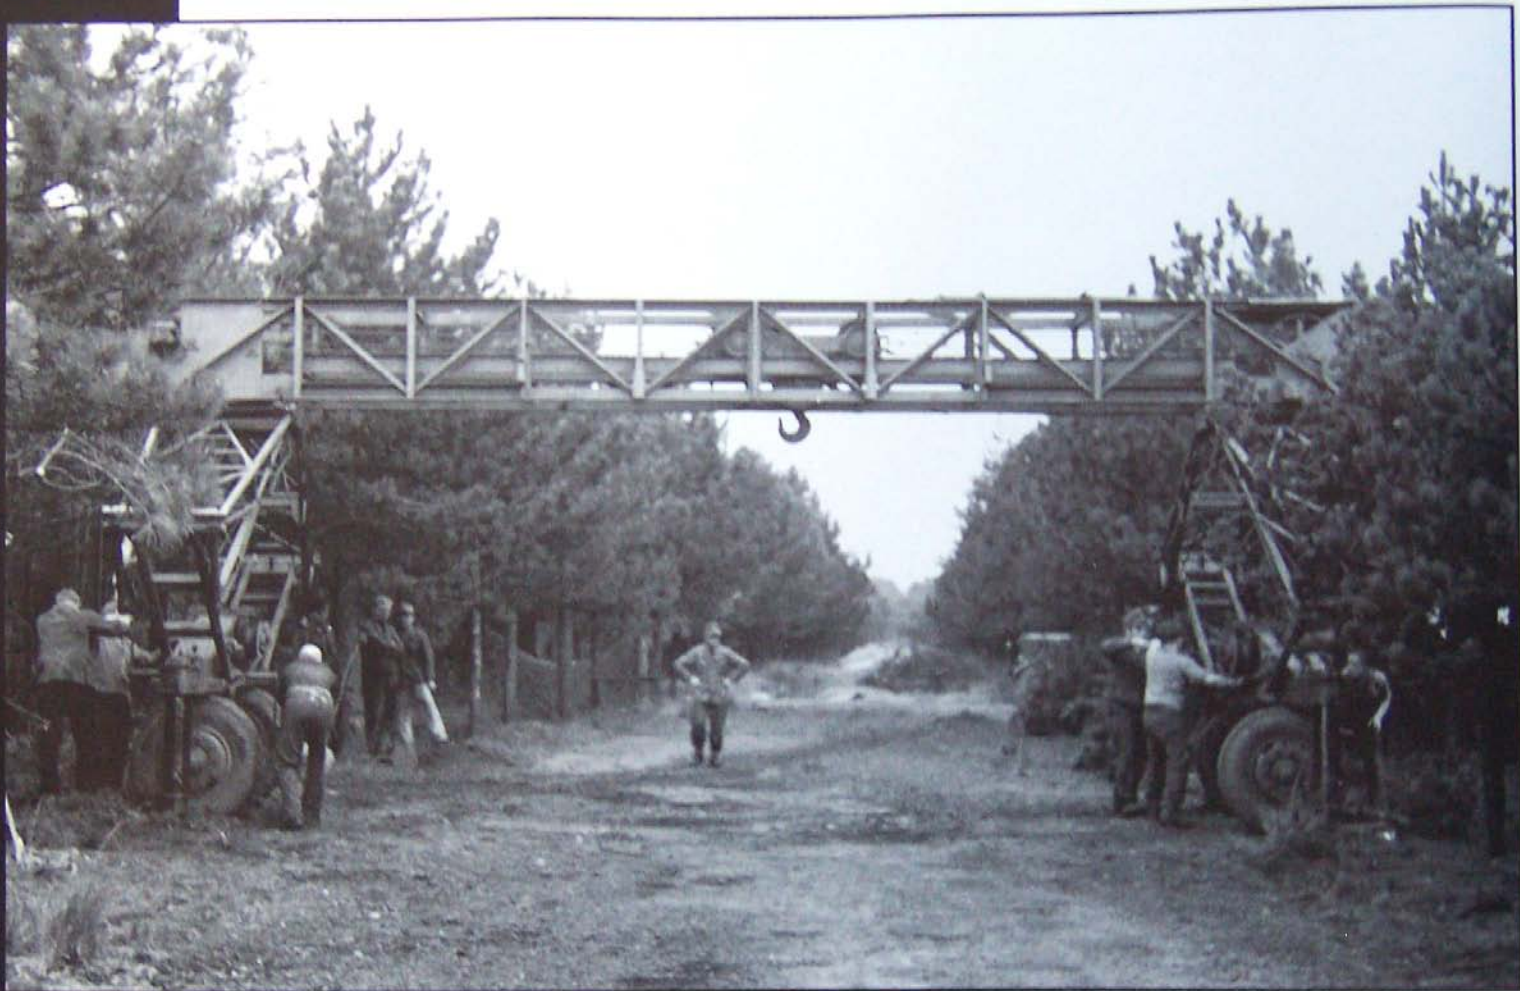
The 15-ton gantry crane was a large structure, long enough to straddle two railroad tracks to transfer loads from one train to another or to a truck or wagon parked next to the track. The motorized bogie truck and lifting hook ran transversely along the gantry, allowing loads to be moved side to side. Here, the crew had raised the gantry about half way, tightening the cables on the tower frames to lift the cross piece to its full height. Because of the size of the V2, the gantry crane needed as much ground clearance as possible. (IWM)

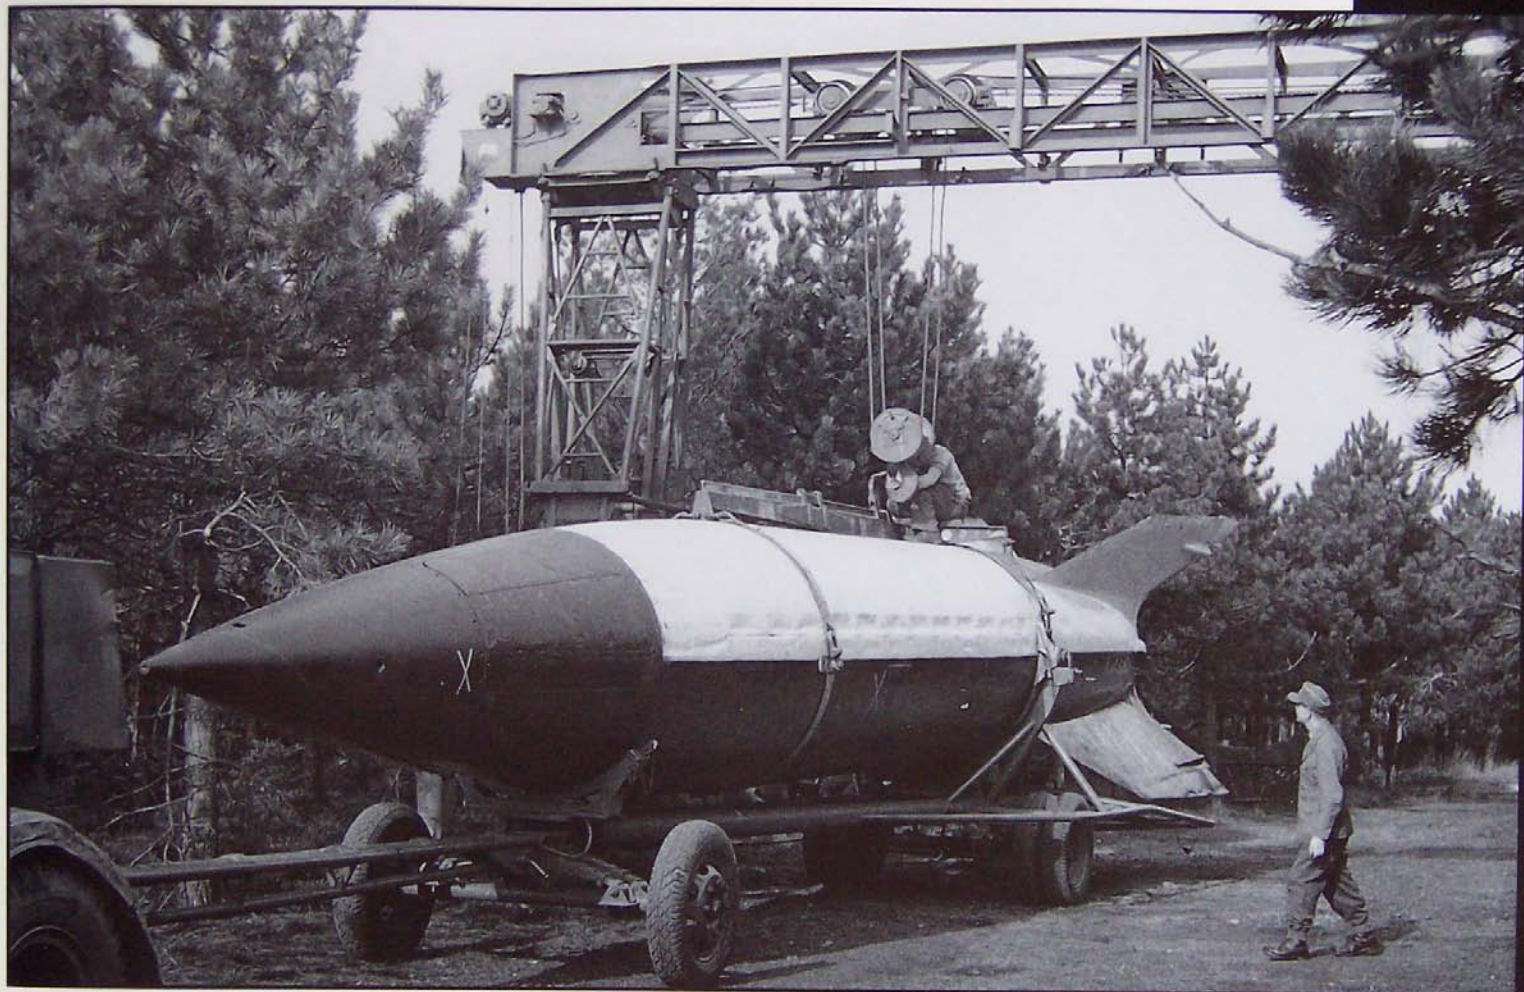
With the warhead attached, the V2 missile weighed about 6435 lbs (3015 kg), well within the working limits of this crane. When the warhead had been installed, the missile was ready to be transferred to the Meillerwagen launch trailer. The straps that had secured the missile to the Vidalwagen were fastened to a lift beam. This, in turn, was hooked to the gantry lift mechanism. When the crane was fully extended, as seen here, there was sufficient clearance to lift the V2 clear of the supports on the Vidalwagen and move it to the Meillerwagen. The size of the men here in relation to the rocket shows how large the V2 was. It was the largest tactical missile fired in combat, though some modern ICBMs are larger. (IWM)

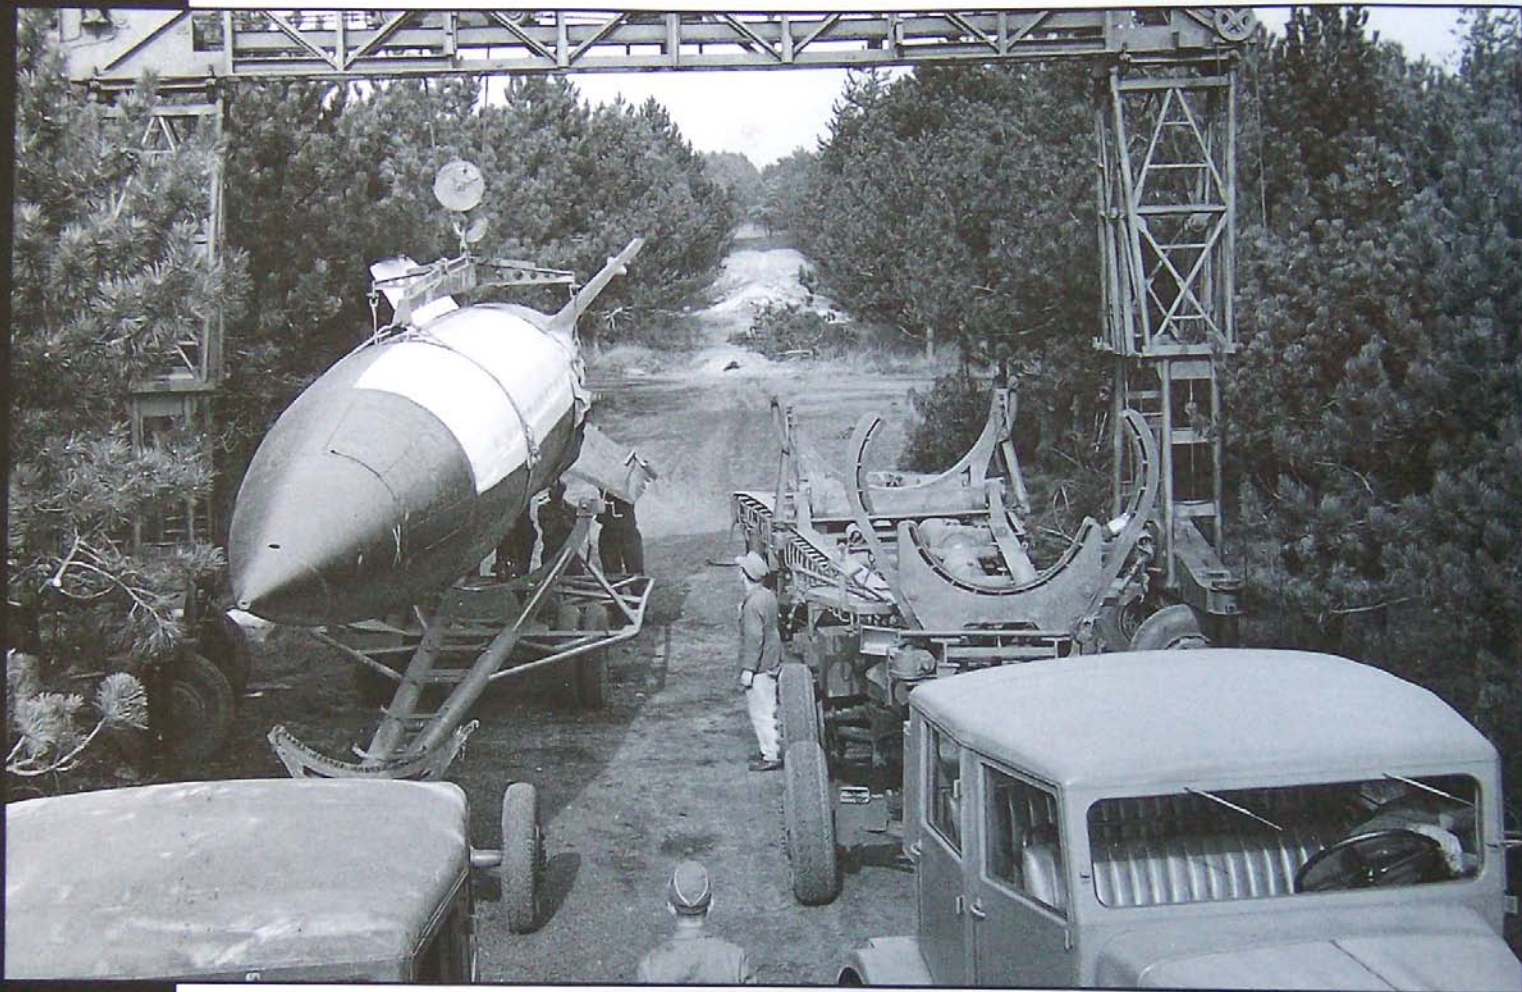
The missile was lifted from the Vidalwagen trailer (left) and moved to the other side of the gantry to be loaded onto the MeiBlerwagen. As seen here, the Vidalwagen had a simple tubular frame intended only for transporting the missile. The MeiBlerwagen was heavier and much more complex, designed to transport the missile to the launch site and then launch it. The MeiBlerwagen also supported the V2 during fueling, which could be done only at the launch site. (IWM)

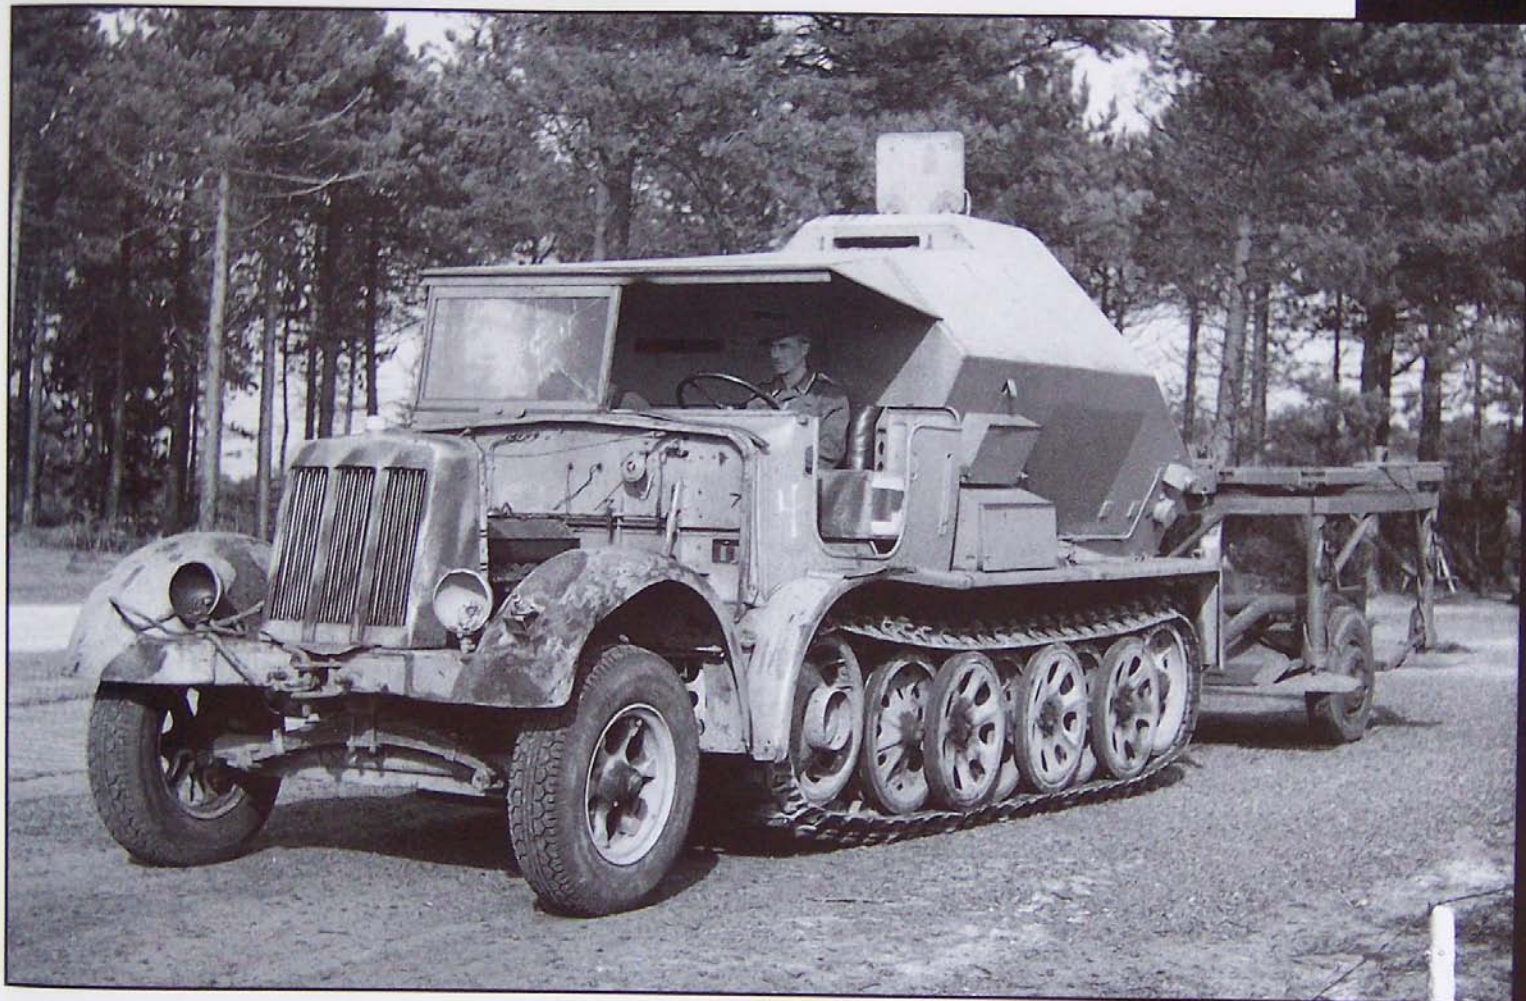
Seen from the front, this is the same vehicle from the previous photo. Note the lack of the engine section hood. The British had to scour Germany to find all these items of equipment, and some of them were much the worse for wear. The sheet metal in the front of the vehicle was not damaged by the

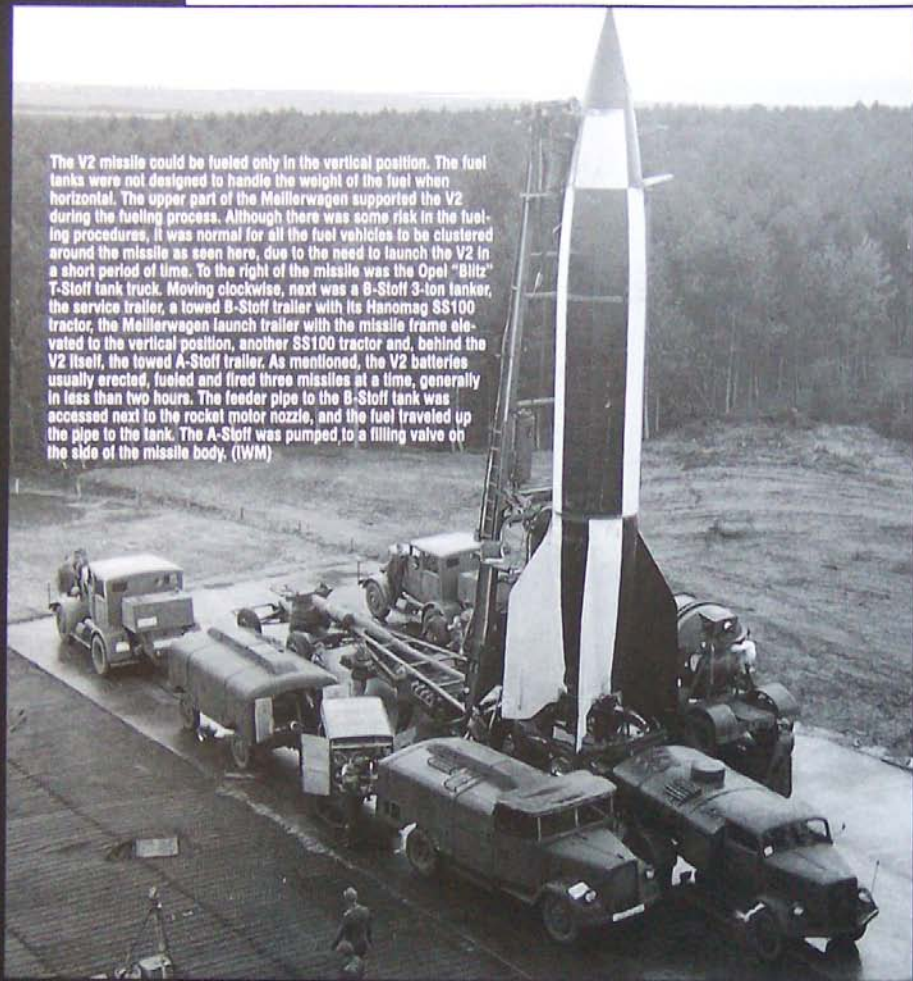
Right: Hydraulic cylinders elevated the upper part of the Meillerwagen and the V2 missile to the vertical position, until the missile was centered over the Bodenplatte firing table. Raising the missile before fueling had the additional advantage of allowing the Meillerwagen to be lighter and more reliable than it would have been lifting the full weight of the fueled missile, and was considerably less risky, as well. The A-Stoff flowed through the insulated hose, seen passing over the Meillerwagen frame. The engine-driven pump was required to lift the liquid oxygen up to the V2 lower tank. Outriggers on the Meillerwagen stabilized the trailer as the V2 was raised to the launch position. The lower part of the Meillerwagen was

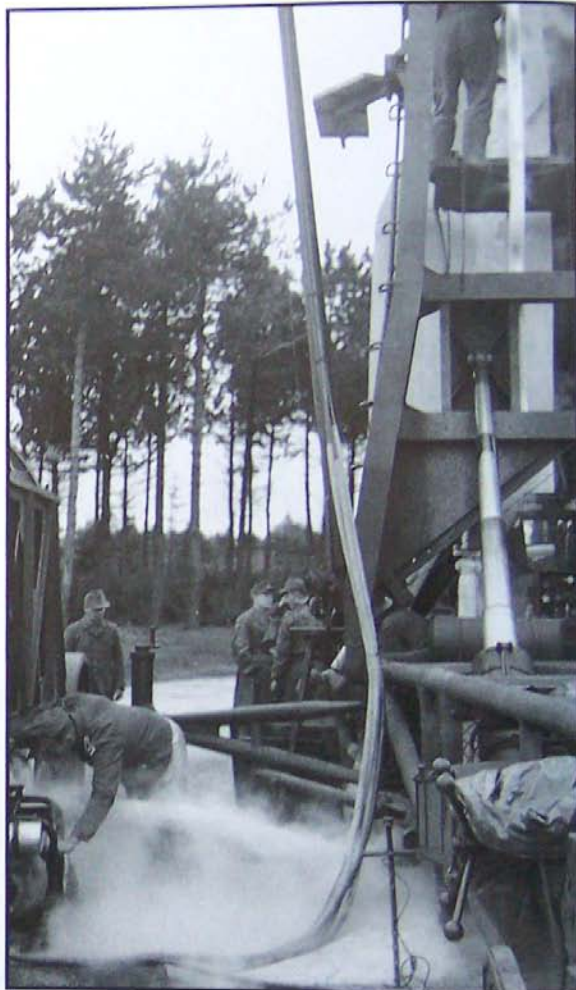
a welded tubular structure, the upper frame was largely channel and beam construction. Both were easy to build and strong for their weight. (IWM) **Opposite left:** Before igniting the rocket motor to launch the V2, all support equipment was withdrawn to a safe distance. The Meillerwagen was returned to the forward preparation site to load another missile and fuel vehicles would be sent back to be refilled. At the launch site, the firing crew entered the armored control vehicle. The control vehicle was positioned a distance away from the V2 on the firing table in case of a malfunction or accident. The launch crew could view the missile firing through the glass block vision ports and, after a successful lift-off, they

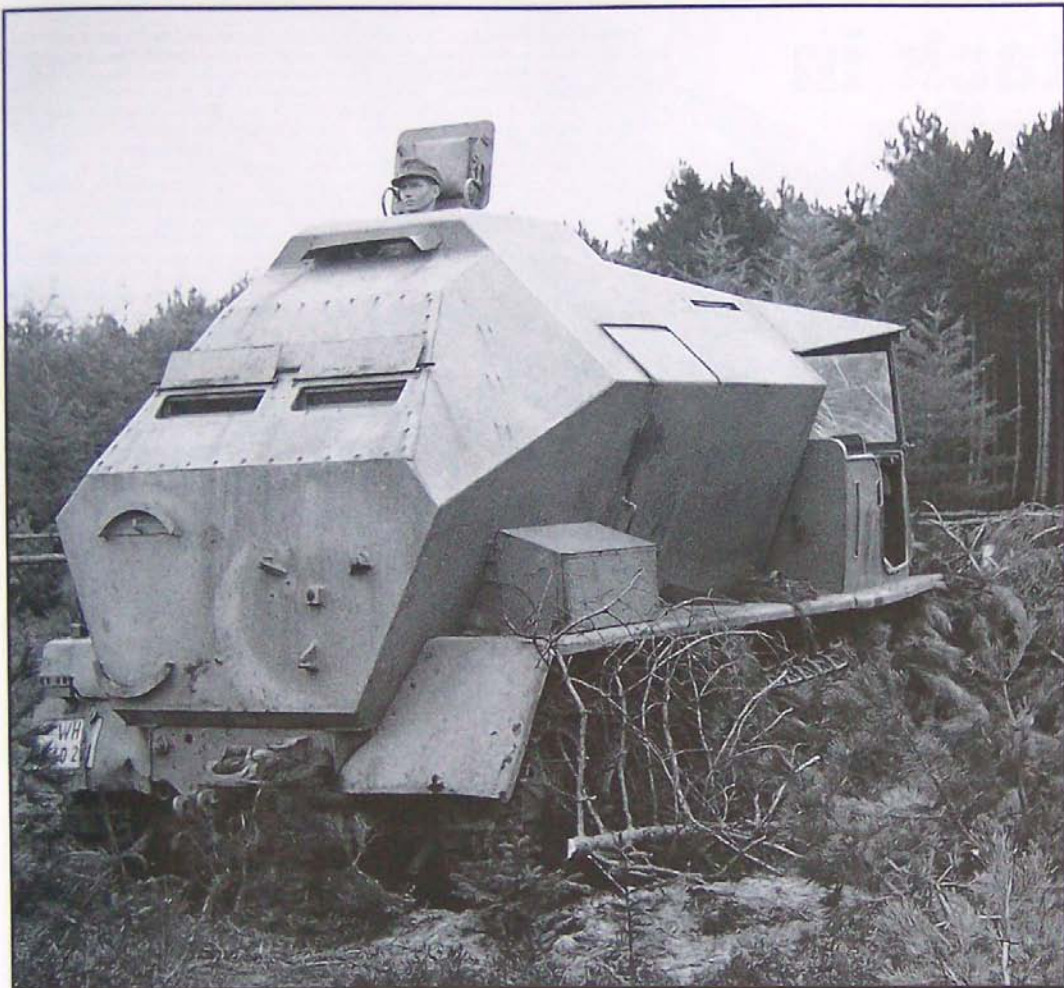
could observe through the top hatch as well. The armored superstructure was a complex design, but easily installed on the frame of the SdKfz 7 half-track. (IWM) **Right:** A successful launch, one of several conducted by the British Army during "Operation Backfire." In spite of the successful recreation of the wartime use of this sophisticated weapon, the British didn't gain as much information from their research as the United States did later on, using the German scientists who had conceived and operated the V2. Immediately after the war, Britain considered the chief architects of the V1 and V2 programs to be war criminals because of the extensive damage to civilian areas caused by these weapons. The
