Allied-Axis

THE PHOTO JOURNAL OF THE SECOND WORLD WAR

The A4/V2 Missile

Sherman Flail

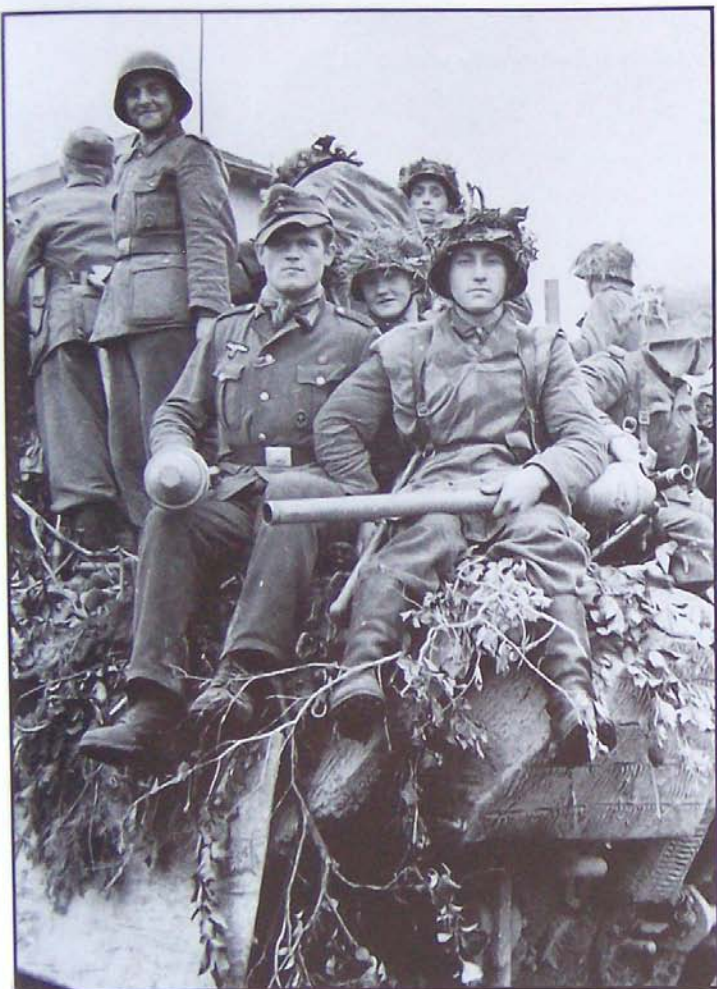
units east of the Moselle. Though driven back, the Germans were relieved when the French withdrew across the Moselle. The tactical situation forced a change in the German plans, and a smaller offensive in the Lunéville sector was proposed, with the intention of cutting off American units moving east from the Moselle. **Above:** This photo shows a Panther of Panzerbrigade 111 entering Bures on 20 September. The tank is painted in the standard mid-war three-color scheme, with the usual foliage cover. Many of the transport trucks had broken down or had been destroyed. Carrying the Panzergrenadiers on the tanks solved a number of problems, including having an infantry escort for the armor. (BA)

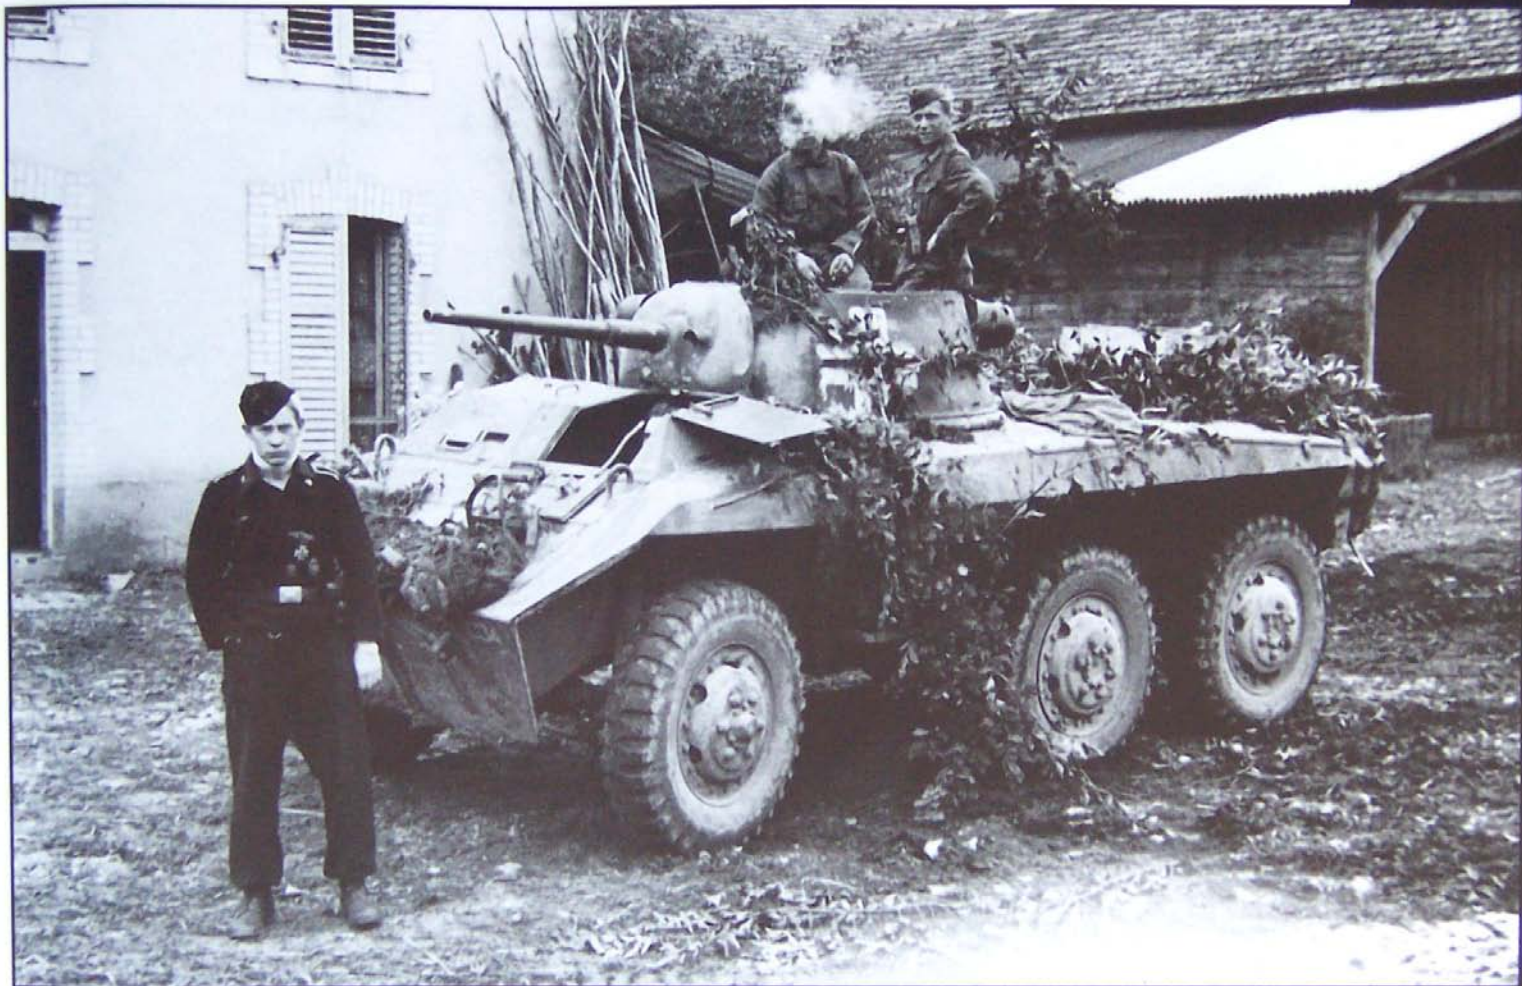
111 from Bures to move through Blanche-Eglise and seize high ground west of Juvelize. The move would start early the next day. **Above:** During the initial assault in the Lunéville area, Panzerbrigade 111 had captured a number of American vehicles from the 42nd Cavalry Squadron, including this M8 armored car. The original U.S. olive drab color scheme was quickly altered with strokes of what may be German dark yellow paint, or possibly mud. It is also possible that this color scheme was an American original. The large crosses are the mark of the new owners. Virtually all the stowage on this armored car is American, and the Germans have had to do little to put the M8 into service. (BA)

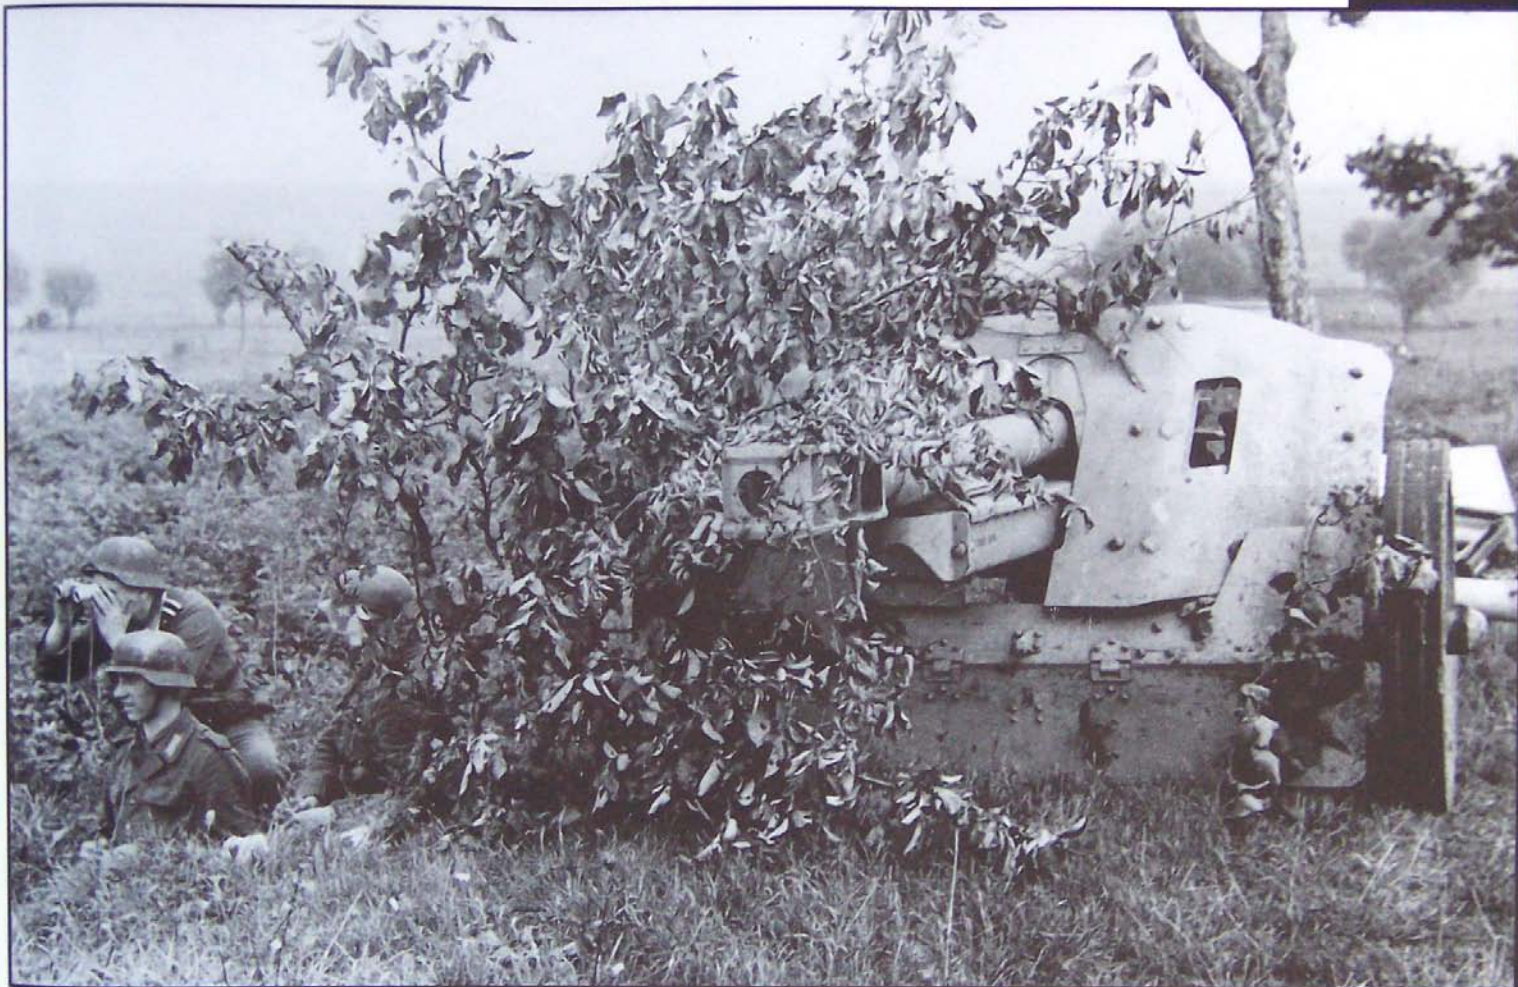
antitank performance would suffer, the PaK 40 had such a good kill margin that it was felt this less powerful variant could still knock out or disable the most common Allied tanks. Very few PaK 50 guns were issued to troops in the field and photos are quite rare. Among the few that did see service was this example seen in the Alsace campaign, September 1944. The carriage is almost exactly the same as the 5cm PaK 38. The gun itself retains the PaK 40 style breech and rear barrel with recuperator. The forward barrel was cut down and a large 3-baffle or 5-baffle muzzle brake was fitted to control recoil on this lighter mounting. (BA)

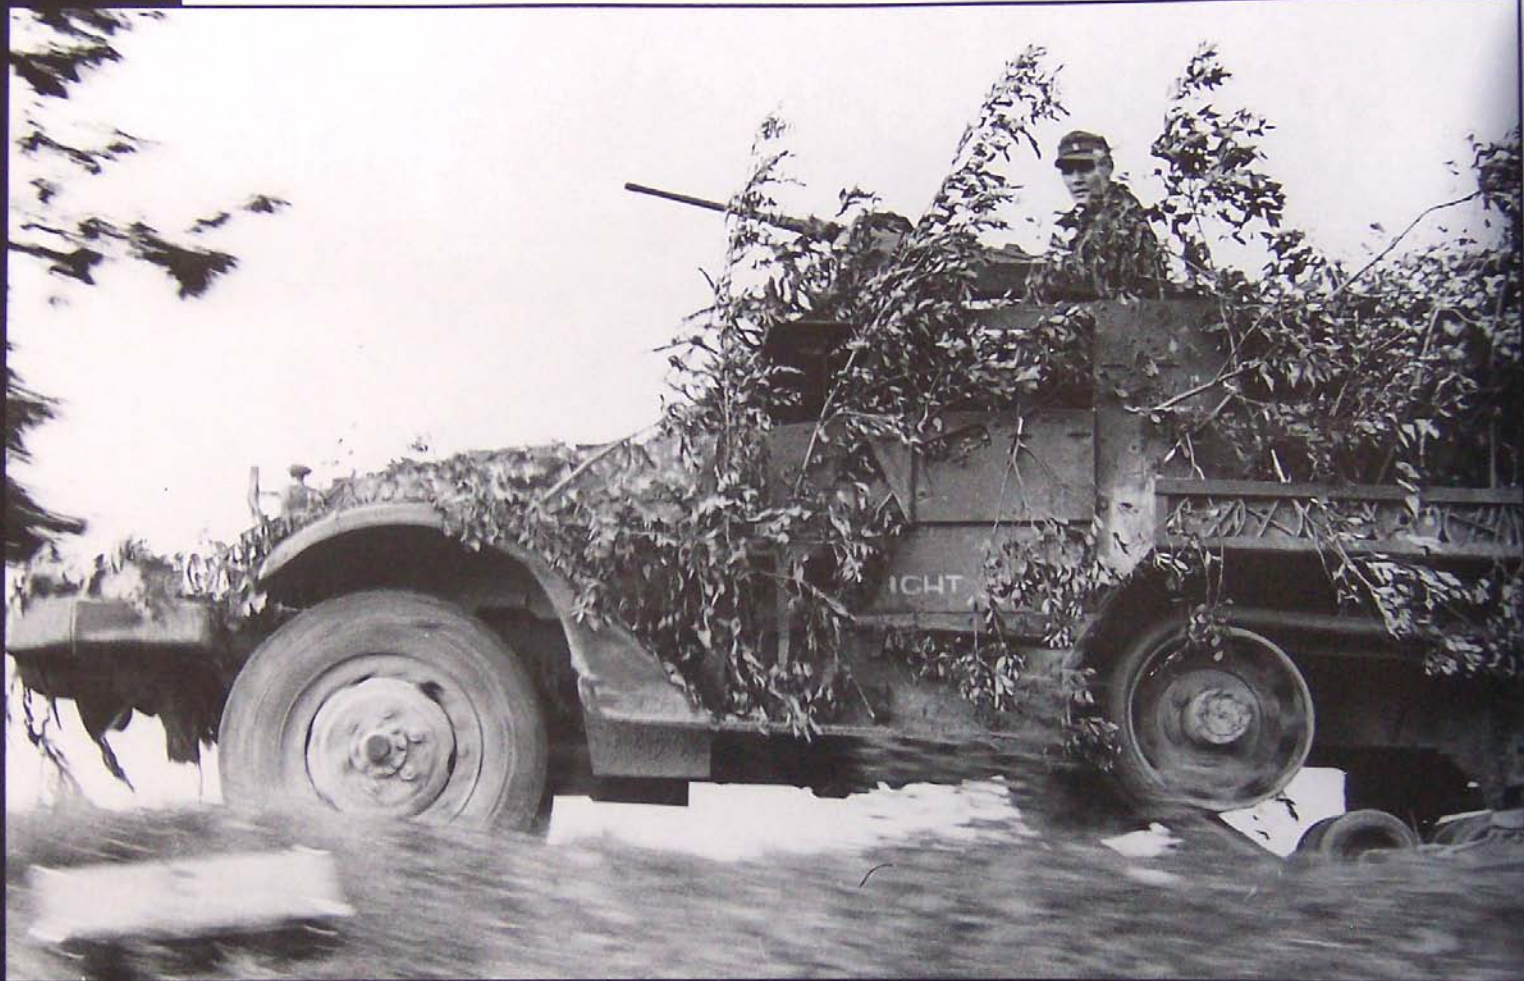
During the fighting around and in Lunéville, the advance elements of Panzerbrigade 111 captured a number of American vehicles, including this M3A1 infantry half-track. The M3 series was rugged, reliable, easy to maintain and generally capable of long periods of use without breaking down. All of these advantages endeared it also to the Germans. This example, captured during the early fighting around Lunéville, again has been well garnished with the usual foliage cover. The overall olive drab paint scheme hasn't been changed, except for the addition of a German word, part of which is hidden. This half-track has the front-mounted winch, which made it even more useful to the Germans. It could retrieve most unarmored

vehicles with little trouble. Though the M3 was much simpler than the Sdkfz 251 SPW used by the Germans, in fact its performance was fairly comparable. The Sdkfz 251's major design failing was the lack of a driven front axle. The M3's driven front wheels allowed it to negotiate terrain that even the '251 could not handle well. Cross-country performance was similar, in spite of the Sdkfz 251's sophisticated torsion bar suspension and steering differentials. The M3 also had considerably more interior room, always hard to find. Both sides seem to have had some fascination with the equipment used by the other army and both used captured vehicles and weapons as often as it was practical to do so. (BA)

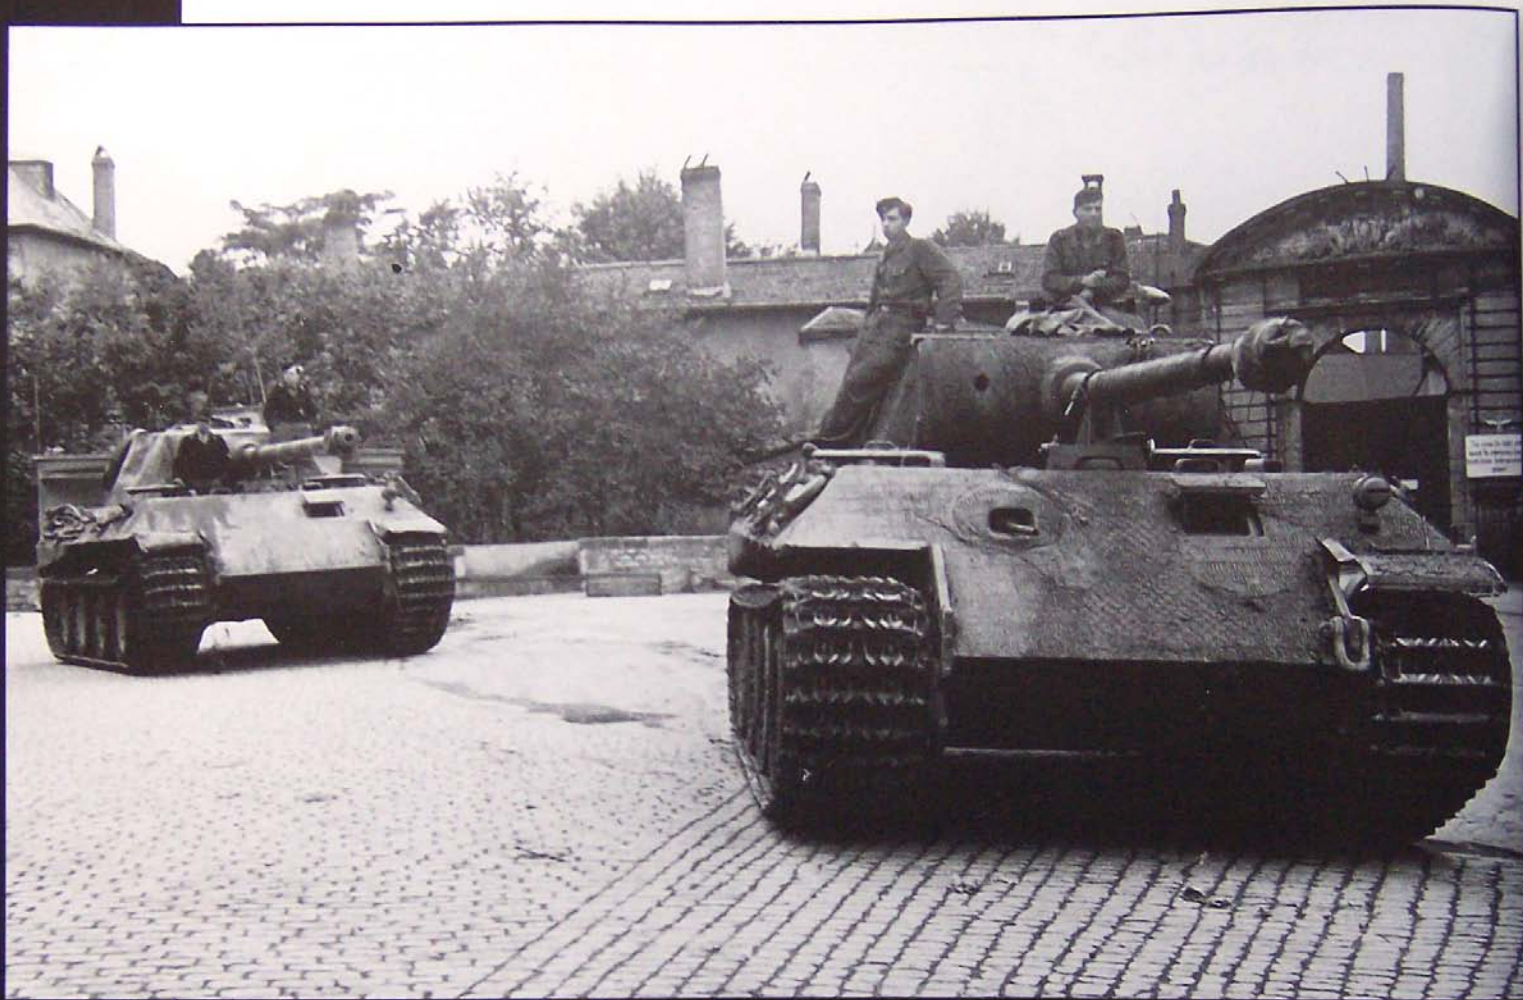
On 23 September 1944, 11. Panzer Division was moved up to reinforce 5. Panzerarmee, and moved toward Dieuze. This photo gives a good impression of the terrain in the area. Here, a column of Panther tanks advances toward Dieuze from Sarrebourg. Note the tanks are well spaced, which allowed them maneuvering room if attacked and made it difficult for the enemy to destroy all the vehicles in a column. This particular Panther is a new ausf G, and having come from a railhead, hasn't yet been festooned with the usual foliage cover. On an open road like this, the Panthers were capable of good speed and could move quickly. The camouflage scheme is the early 1944 type, dark yellow base with olive green

and red brown overspray. The lack of extra stowage, except for the bucket and milk can hanging off the rear, was not uncommon. This trip was made without two dozen Panzergranadiers packed onto the engine deck, although most of the crew rides outside the tank. There were never enough Panthers to meet the needs of the Panzer Divisions and many Panzergranadier Divisions had to make do with the smaller PzKpfw IV. A few Panthers could have more effect on the battlefield than many more of the PzKpfw IVs because their very accurate and lethal main guns could break an enemy advance and allow the Germans to regroup and even counterattack. (ECPA)

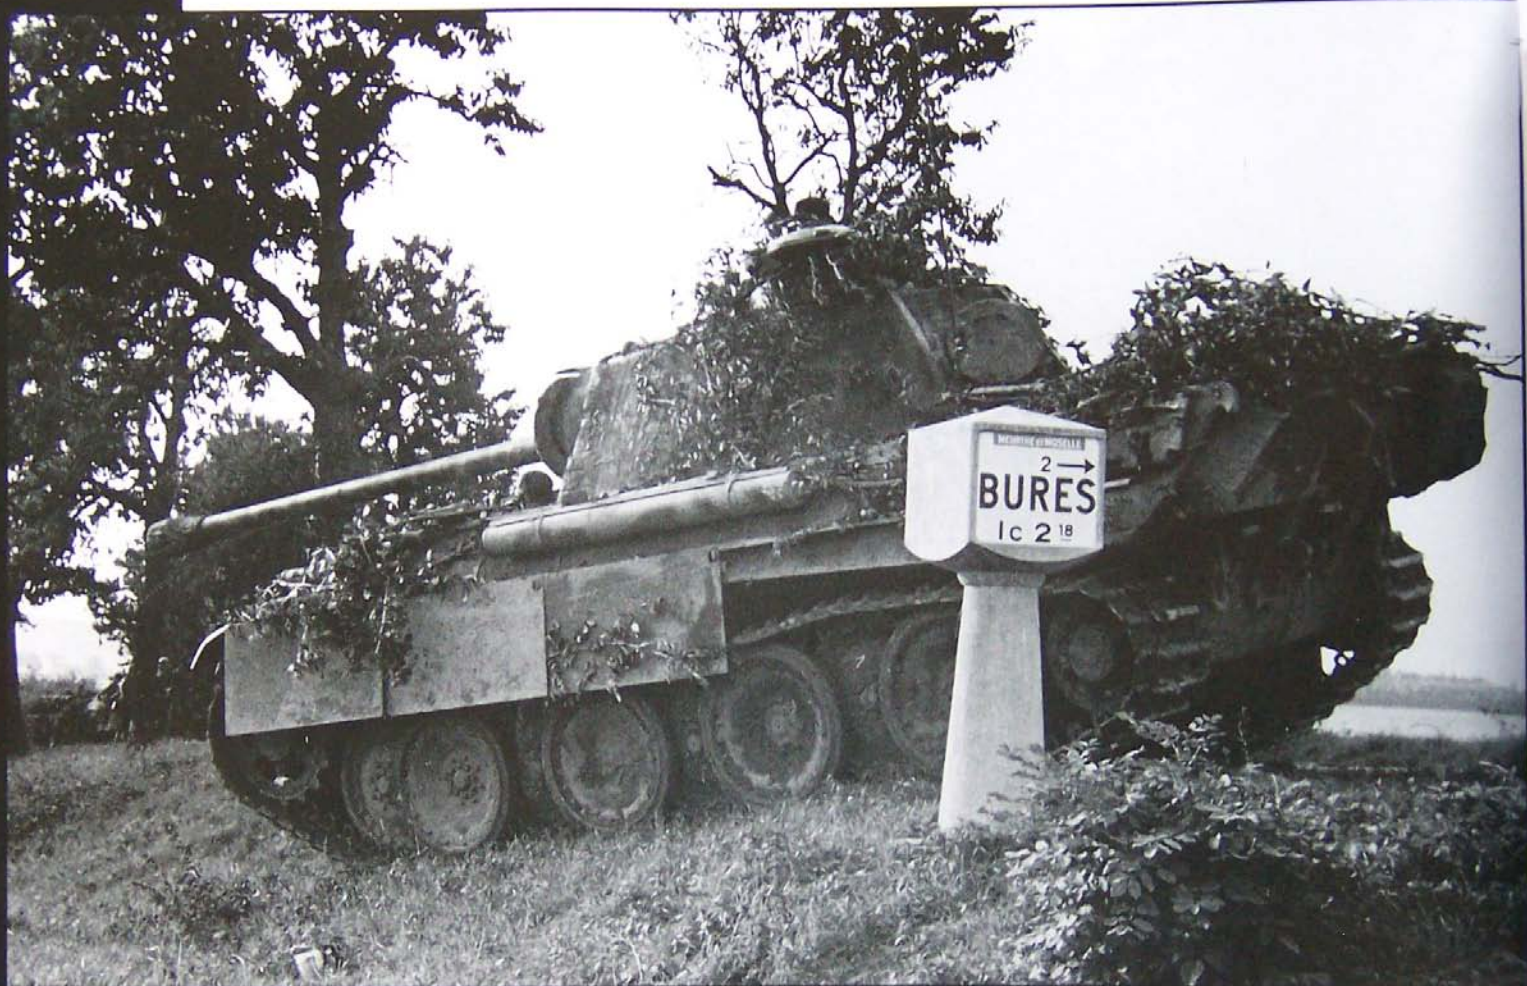
same ground, as Germans and Americans prevailed in individual actions. This is the first of two views of this particular Panther ausf G as it approached the town of Bures during the day on the 26th. Although it's likely that the photos were taken by the same photographer, the negatives for this shot reside in the Bundesarchiv in Germany, while the following one resides in the ECPArmées in Paris. The foliage, though apparently simply draped over the tank, was actually carefully applied so as not to interfere with any of the critical systems of the vehicle, or any of the entry hatches. The side skirts were removed for maintenance of the suspension and when replaced often didn't match, as shown. (BA)

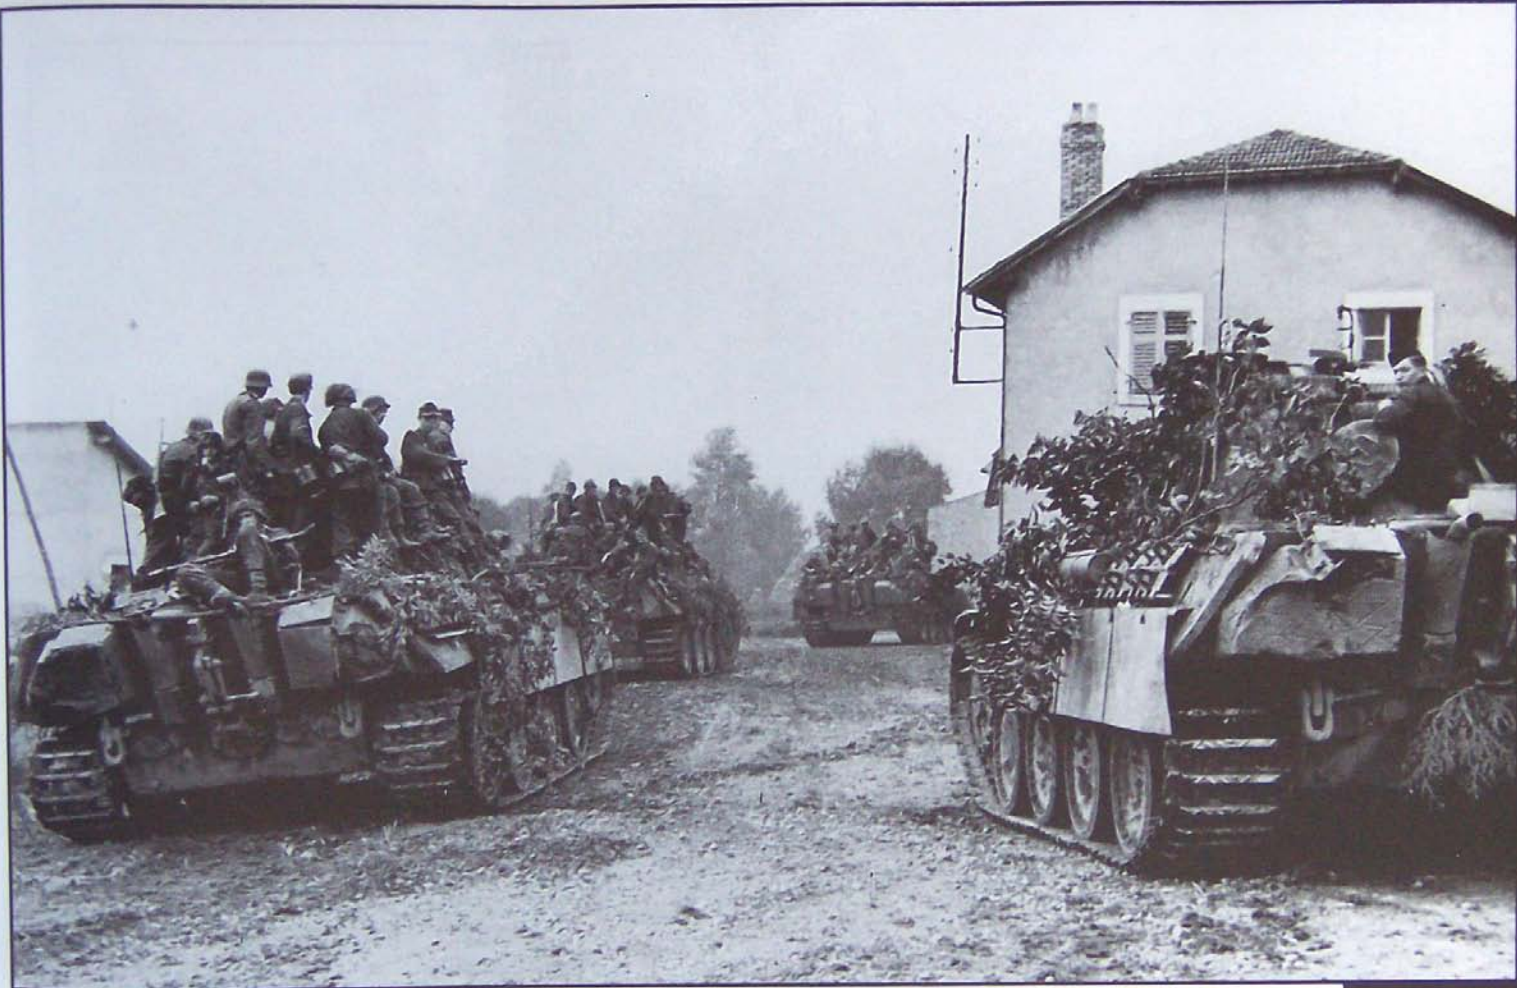
state of most of the German formations made it essential that all the attacking units perform at the highest level. This second picture of the Panther was taken shortly after the first. After the recent rains in the area, this Panther carries the usual load of mud and dirt on its suspension. The Panther's interleaved roadwheels tended to pick up large amounts of mud and dirt. The foliage on this tank has apparently been arranged to break up its distinctive shape. When foliage was placed over or around tanks hidden this way, they could be very hard to see from the air. In rear areas, the hatches were usually left open for better ventilation. (ECPA)

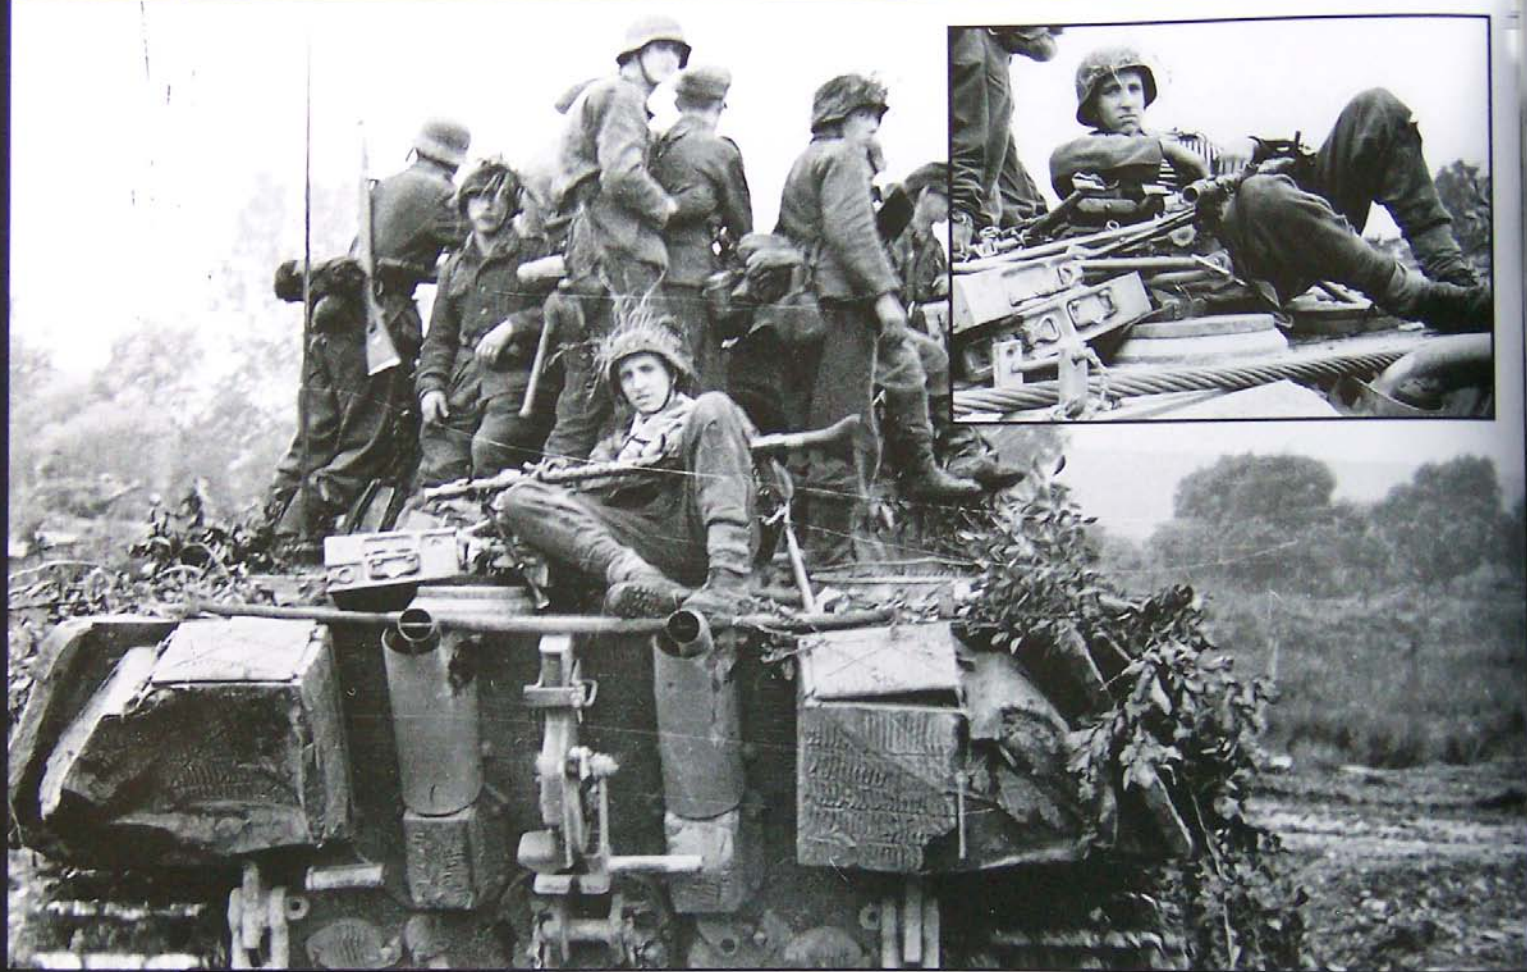
into a Kampfgruppe for the forthcoming assault on the 4th Armored positions. The tanks were again used to transport the division's Panzergrenadiers, who had no SPW halftracks for their unit. The shortage of SdKfz 250 and 251 SPWs meant that relatively few Panzergrenadiers were able to fight from these specially designed vehicles. Only a very few divisions had both regiments of Panzergrenadiers mounted in halftracks. Even in Panzer Divisions, only the first regiment had SPWs. The second regiment had to use trucks, and fight as dismounted motorized infantry. As important as the SPWs were in carrying the Panzergrenadiers to action behind armor, their role as fire support vehicles was even more valuable. (BA)

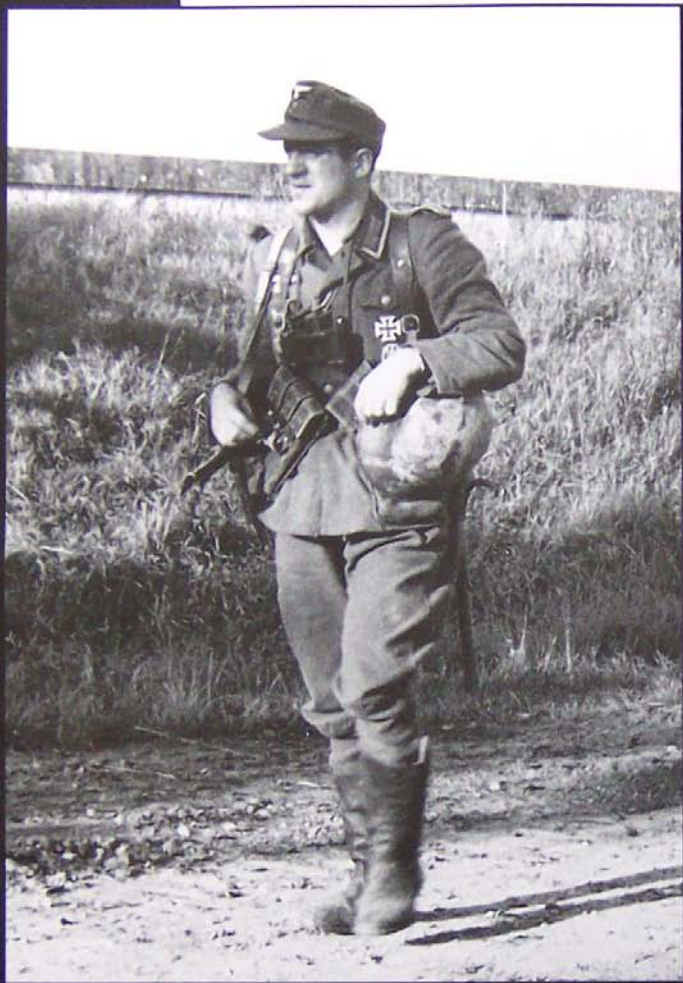
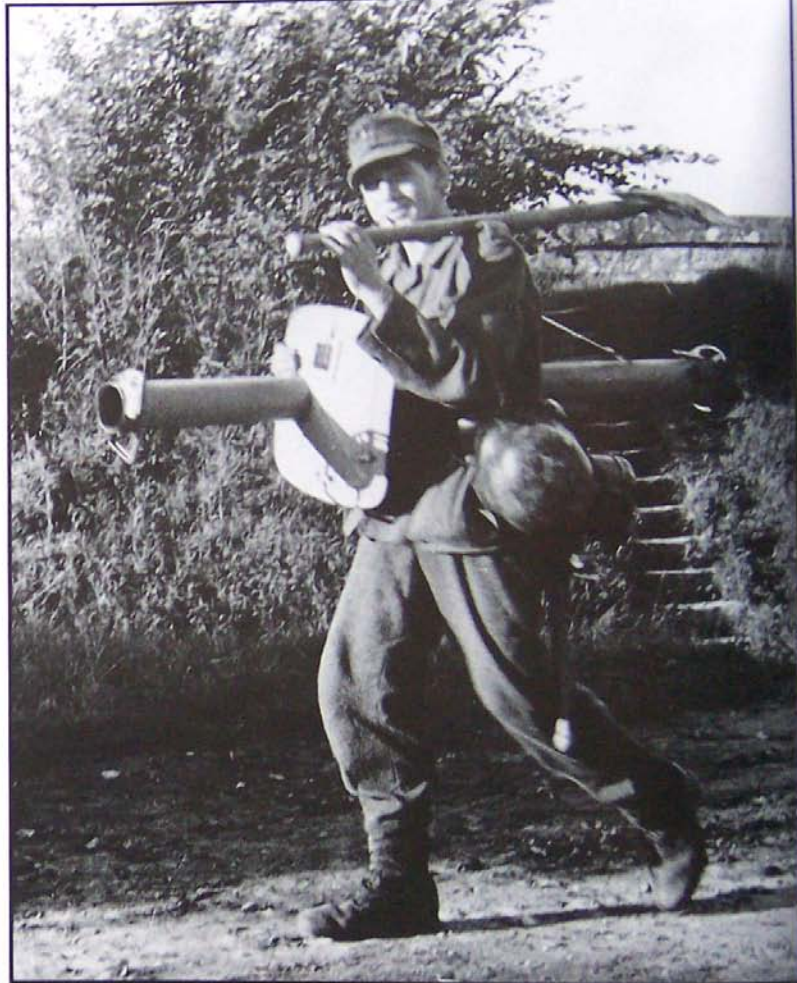
objectives in the Bathelemont plateau area. Panthers moved through Bures to join the attacking units to drive the Americans out of the Bures and Bathelemont areas. This Panther (probably of 11. Panzer Division, has the unusual "disk" style ambush camouflage pattern on the front of the turret and gun mantlet. This scheme was painted by spraying the base color of dark yellow over the secondary colors (olive green and red brown at this point in time) through a cutout stencil. This scheme has also been applied to the cupola as well. Combined with the extensive foliage seen here, this camouflage scheme would make this vehicle extremely hard to see under any sort of tree cover. (BA)

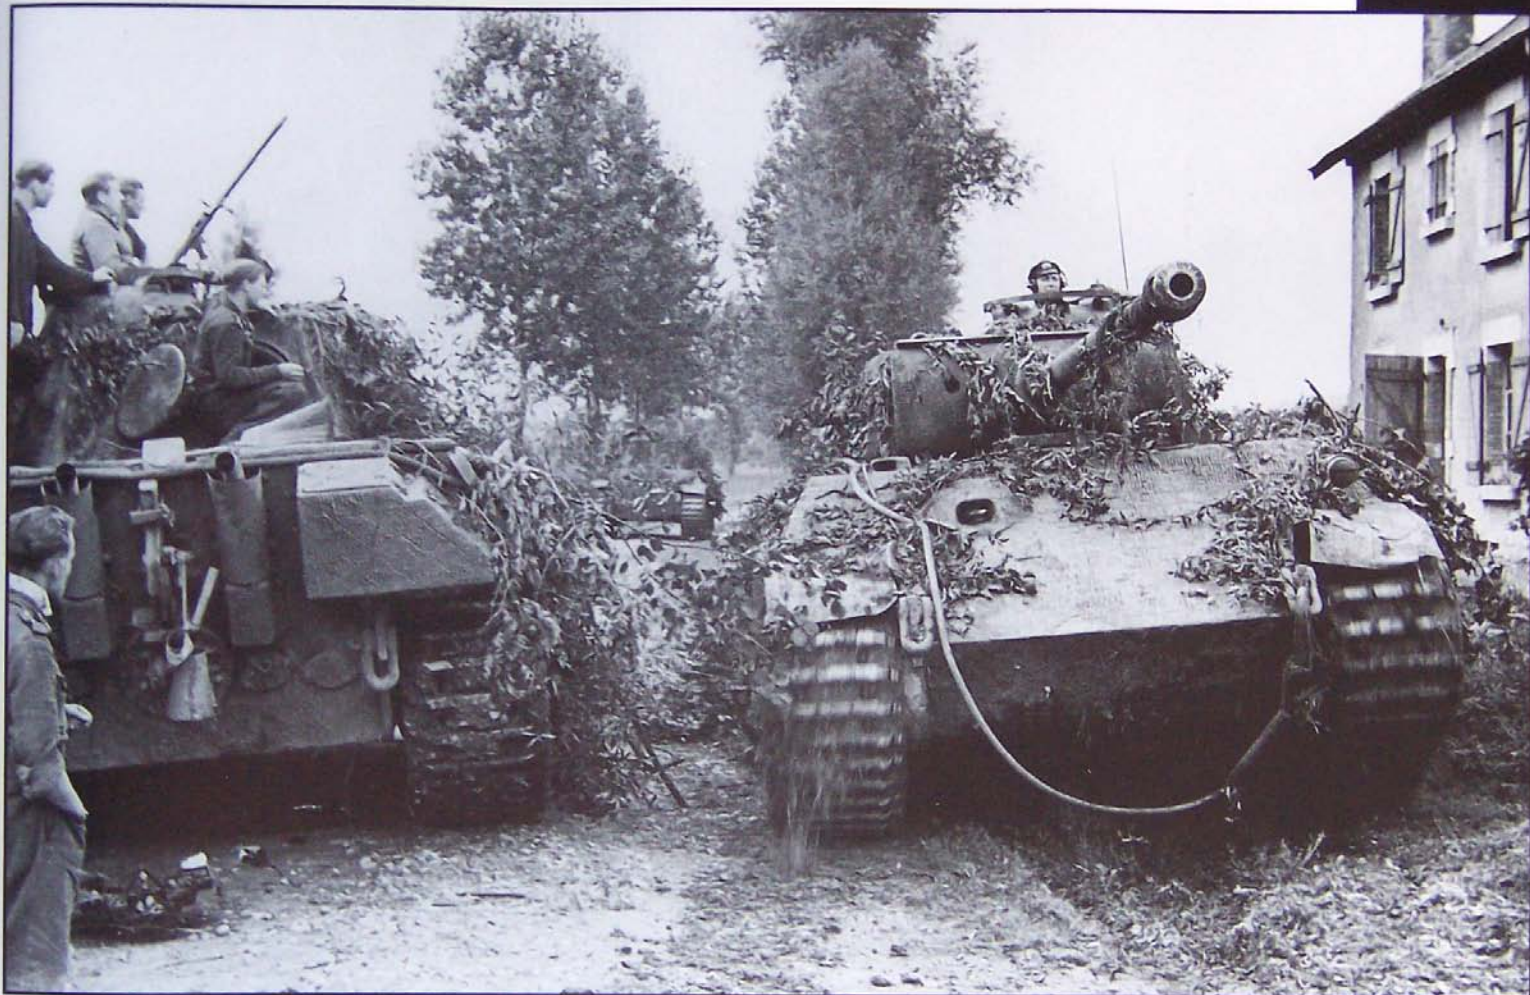
for American fighter-bombers, who did attack the town several times, burning much of it to the ground. In this second photo of these two Panthers, note the better view of the foliage placed around the Panther at the left. By running the branches from the ground up, it was possible to conceal the most distinctive parts of a tank, its suspension. This vehicle is exposed to have a better line of sight to see incoming enemy aircraft. The tank on the right appears to have a simplified form of the dotted "ambush" camouflage scheme. Though damaged, the front flip-up mudguards still have their Zimmerit coating intact. (ECPA)

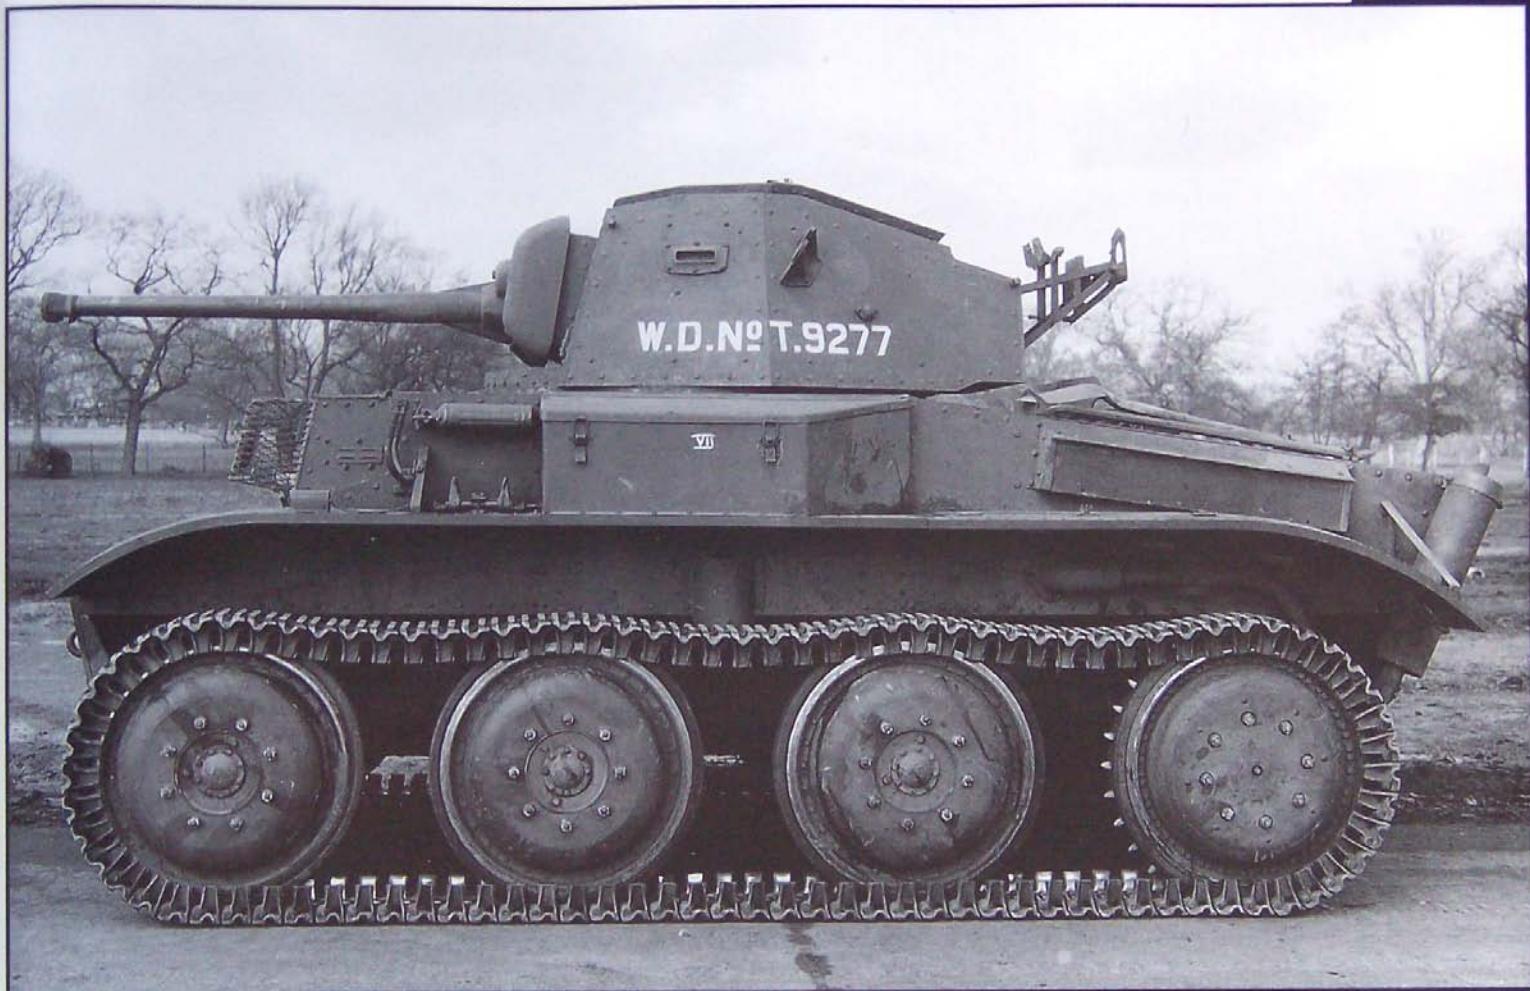
The Tetrarch broke new ground with its suspension, at least for British tanks. Four large road wheels carried the vehicle, and steering was accomplished by tilting and turning them, thus warping the tracks. Skid turns were only used in lower gears and at lower speeds. The wheels added to the side protection by virtue of their armored construction. Power was provided by a 165hp Meadows, giving the

respectable road speed of 40mph. **Above:** 9277 again during evaluation. Interesting here is that the cooling vents on the engine deck sides are closed off, indicating very cool weather (the Tetrarch was refused for use in North Africa because of inadequate cooling). Also noteworthy is the screen guard applied to the driver's position (IWM).

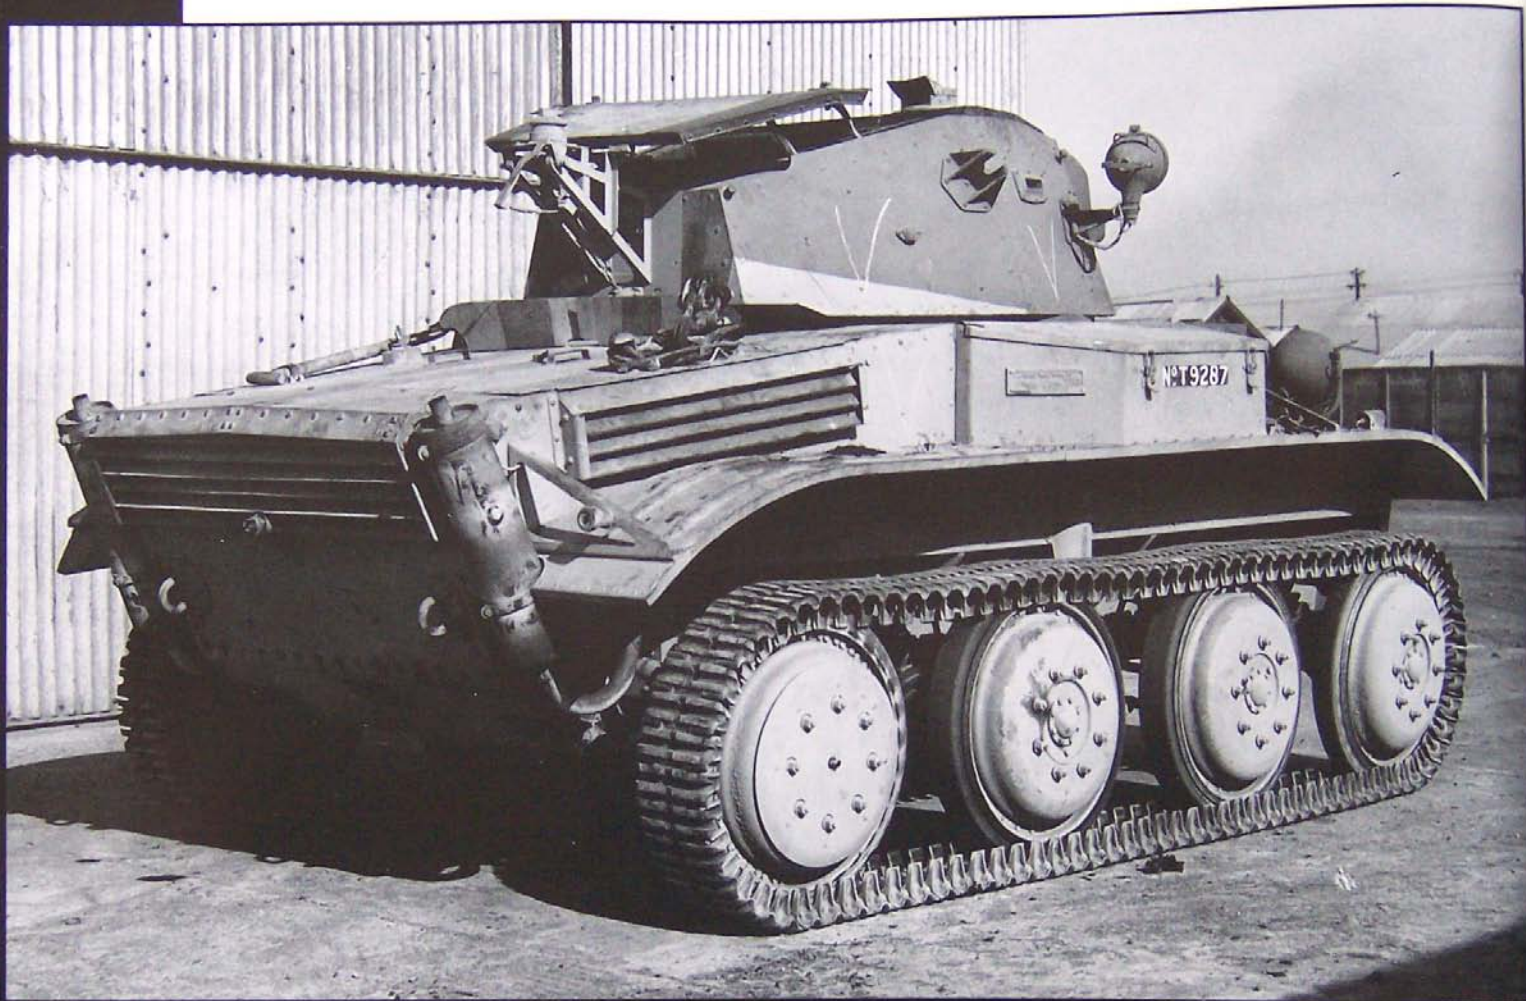
The same vehicle as the preceding photo. In this rear view the turret hatch is open and note that it raises up and then slides to the rear to rest on the back of the girder arrangement. Notice also the smoke launcher mount. The chalked "Vs" on the turret are a curious addition. Note the manufacturer's plaque on the right side stowage box. (IWM)

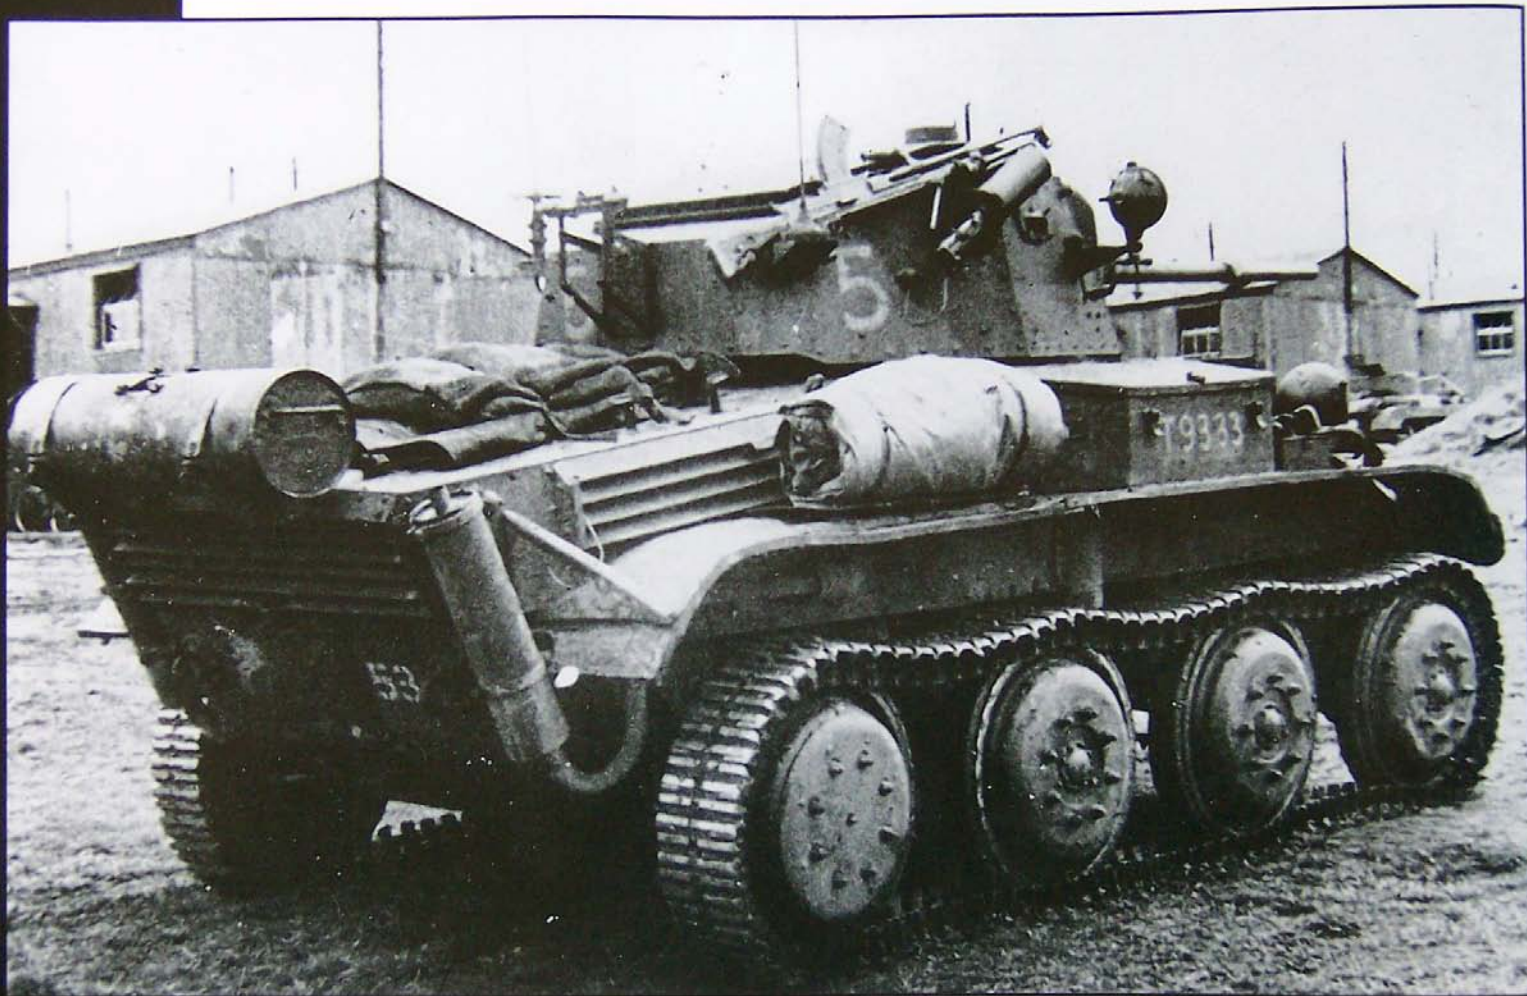
This photo and the preceding one could very well represent a portrait of a vehicle about to be loaded into its Hamilcar glider. The crew has already tied down its tarps, and the rear fuel tank and smoke launchers are fully rigged. The only airborne use of the Tetrach was in Normandy, when a squadron was deployed via Hamilcar. One of these tanks fell out of its glider on the way. Since the crew had to ride in the tank while in the air (there was no way to get in or out), they and their tank are still on the bottom of the Channel. (IWM)
