Allied-Axis

THE PHOTO JOURNAL OF THE SECOND WORLD WAR

The A4/V2 Missile

Sherman Flail

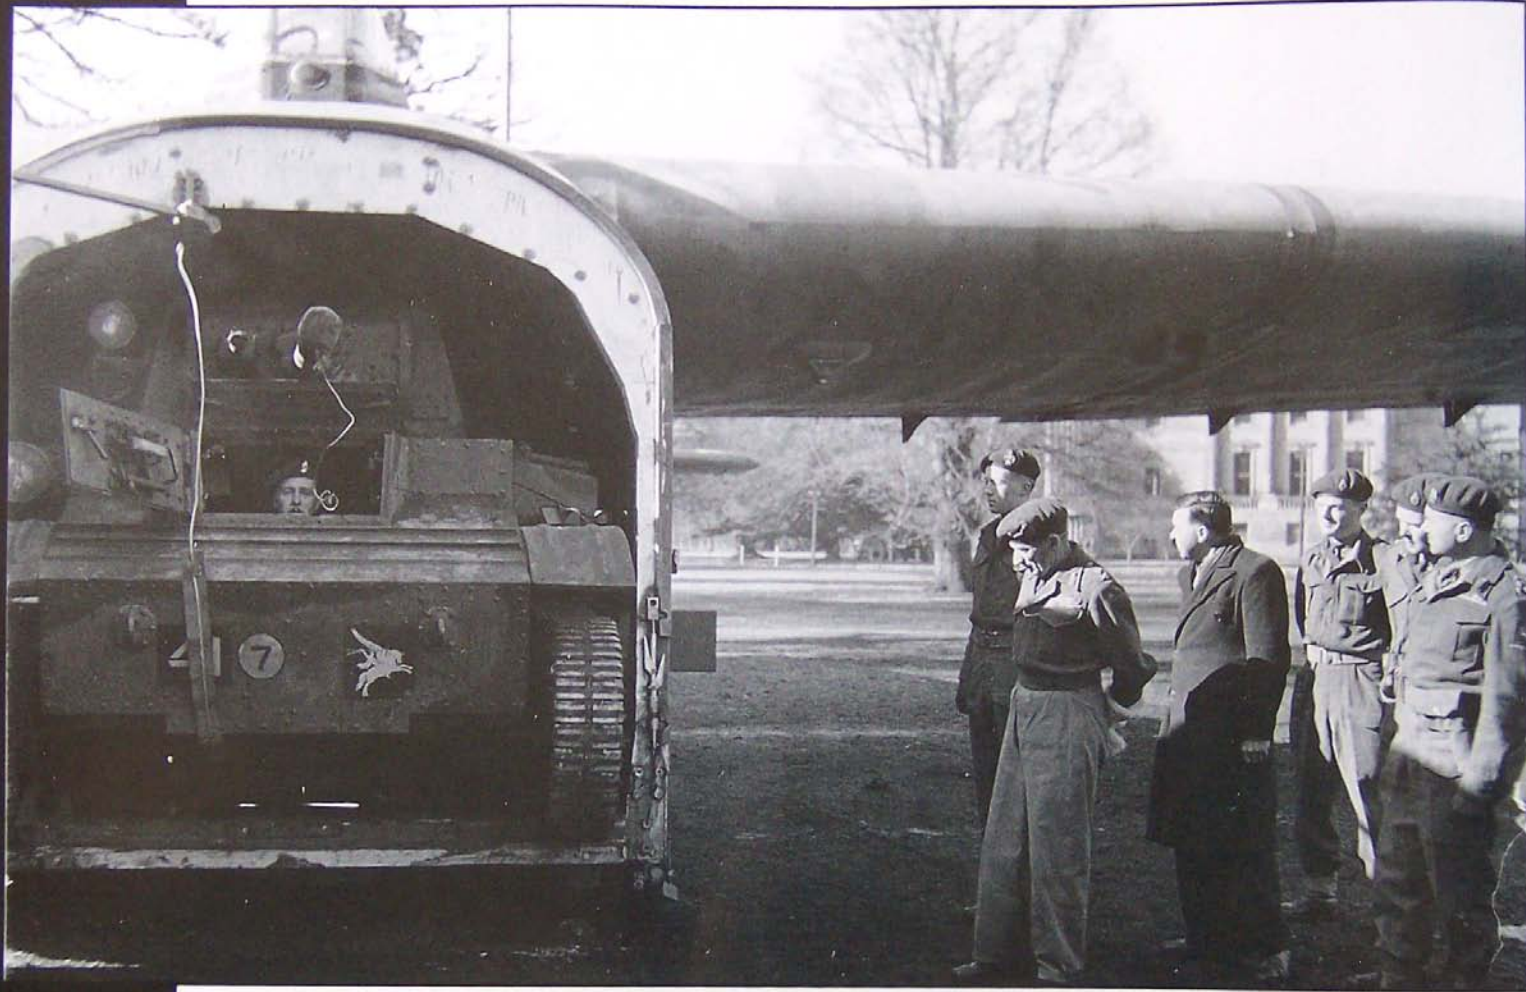
assembled, in the C-82, the twin-boomed forerunner of the C-119 Flying Boxcar. **Above:** This and the previous photo show how the vehicle was secured in the glider. The Tetrach would have been secured in a similar fashion. Note the springs on the rear tie downs. The ladder in the foreground leads up to the flight deck. The Pegasus emblem of the British airborne forces is more clearly visible on the rear of the tank in this photo. (IWM)

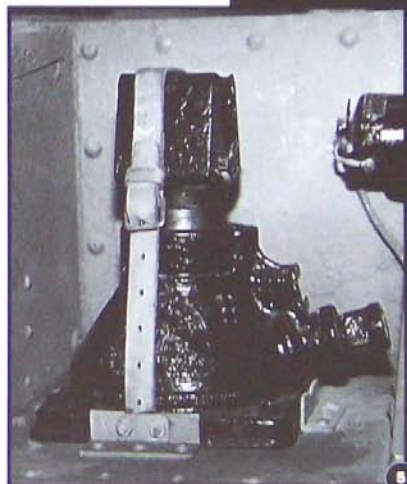
4

plate of the tank is riveted, the glacis seems to be secured with screws. **3)** A blackout light on the left side. It appears that most vehicles did not carry a light on this side and this may be a museum addition as the "blackout" portion of the light is simply paint. **4)** A more rearward view of the right side light detail, showing the attachment point and the wing for the light and the convoy light. The horn is the black cylindrical object. **5)** An excellent view of the Tetrach's jack and its mount.

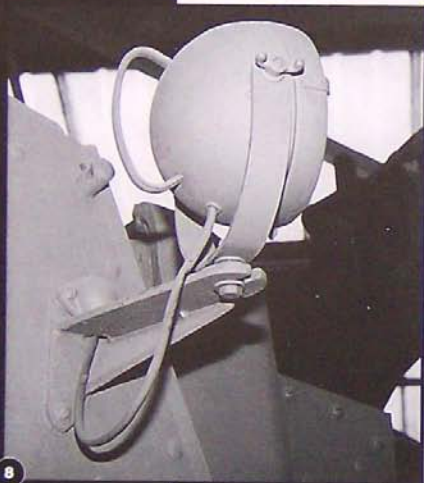
8

6) This is the left side light detail, showing the fire extinguisher and its mount. Typically, the extinguisher is unpainted brass. 7) The diminutive size of the Tetrarch (and the Locust) made an auxiliary fuel tank a necessity. These could be jettisoned. 8) The spotlight mount on the Tetrarch's turret. 9) The smoke grenade launcher on the Tetrarch turret. These were made using the breech of the Enfield rifle and indeed the opening for the magazine in front of the trigger guard is still there. 10) Antenna mount on the rear of the Tetrarch turret. The involved and elaborate arrangement of girders is the hatch rest.

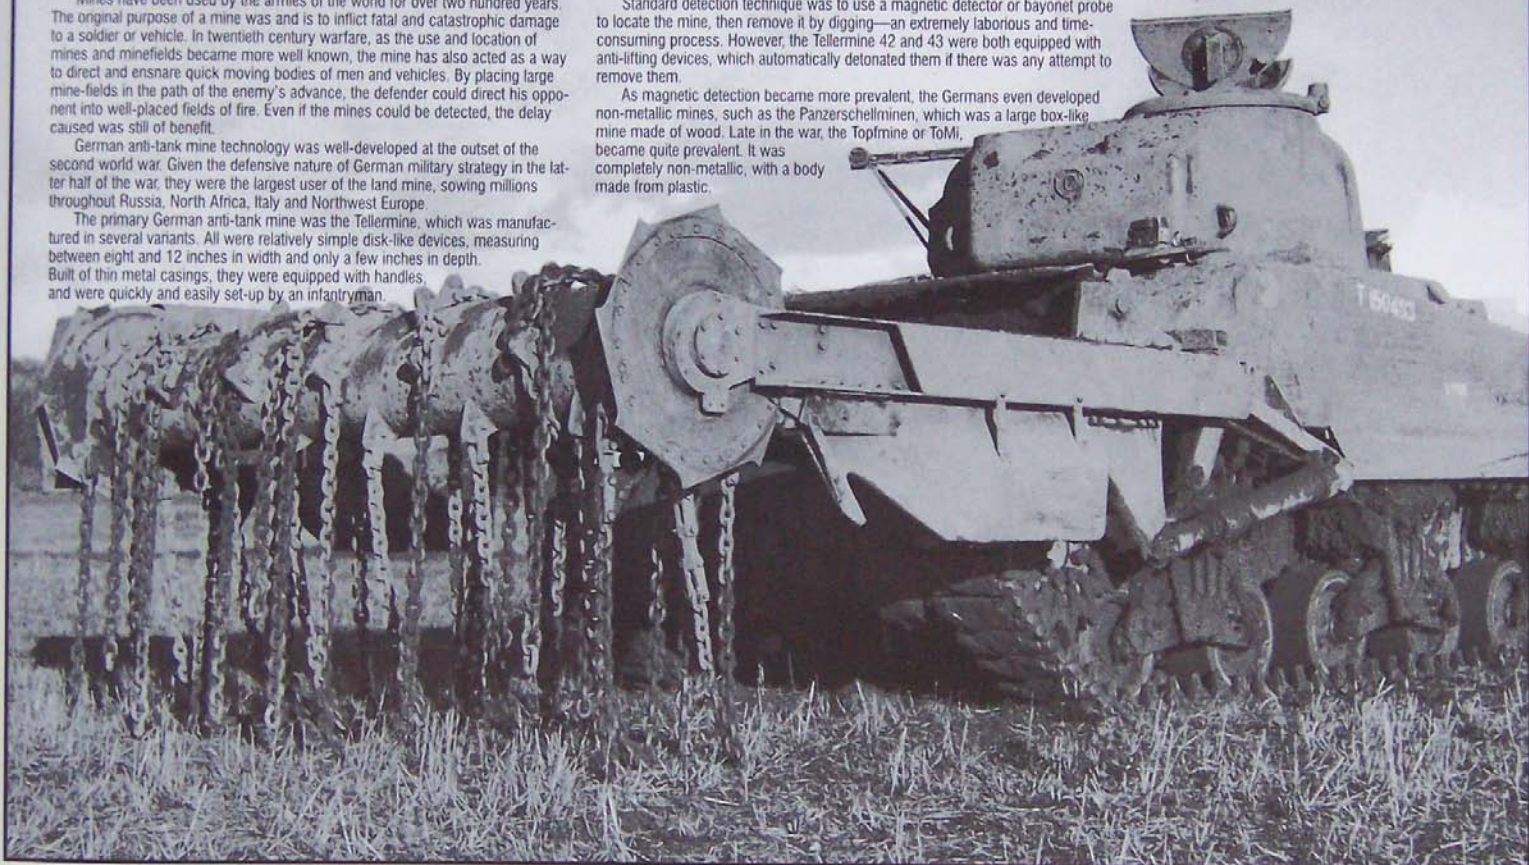
It became clear to Allied planners that the most efficient way to clear a mine field was to simply detonate as many mines as possible. Since a minefield uncovered by fire is more of a nuisance than obstacle, a way to clear mines under armor was a priority. The wide-open spaces of North Africa lead to an ever-increasing use of mines and a South African engineer officer on duty there, Major A.S.J. Du Toit, was responsible for developing the most effective means of clearing mines by use of an AFV. Above: The Crab concept was tested extensively in England prior to its deployment. At the time of its develop-

ment, the Crab was considered Top Secret. The vehicle depicted in this photo and the next is a Crab I and it was among the first produced. It carries the first style of chain, which was very simple conventional heavy-duty towing chain. This type of chain was very unstable. The ordinary chain strands had a tendency to sway from side to side. They would strike each other and the rotor, and often become entangled. More importantly for the success of the vehicle, the sway created large gaps in the clearing path. The jagged circles on the ends of the rotor were designed to sever and clear wire obstacles.

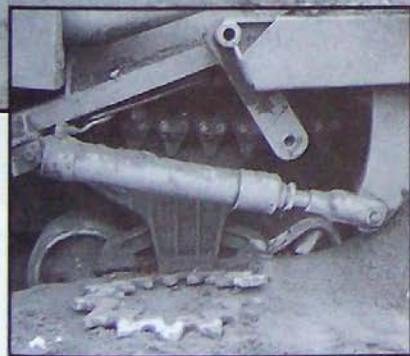
Another early Crab in action, this time during testing on the beaches near Norfolk, England. From the lack of dust it's obvious the ground is damp. Instead of a fitted mantlet cover, this tank just has a tarp draped over the front of the turret and the main gun. Notice the rocks being flung into the air. Using the Crab on sand was generally frowned upon as the resulting shallow trench dug by the flail sometimes became an obstacle itself. It must have been difficult for the driver to see and the crew is no doubt navigating by the compass provided. This vehicle has a fully armored transmission joint. **Insets:** Due to its importance in the upcoming invasion, it was eventually necessary to conduct live testing of the flail. British MkIV and MKV anti-tank mines were used for this, but a fair number of captured Tellermine were also utilized, creating a highly realistic testing scenario. Here, it appears as though the flail was traveling too fast. The mine detonated after the rotor passed over it, resulting in damage to the track and running gear of the Sherman. The outside teeth of the drive sprocket have been blown off. The original caption does not state whether the mine was a British or German type.

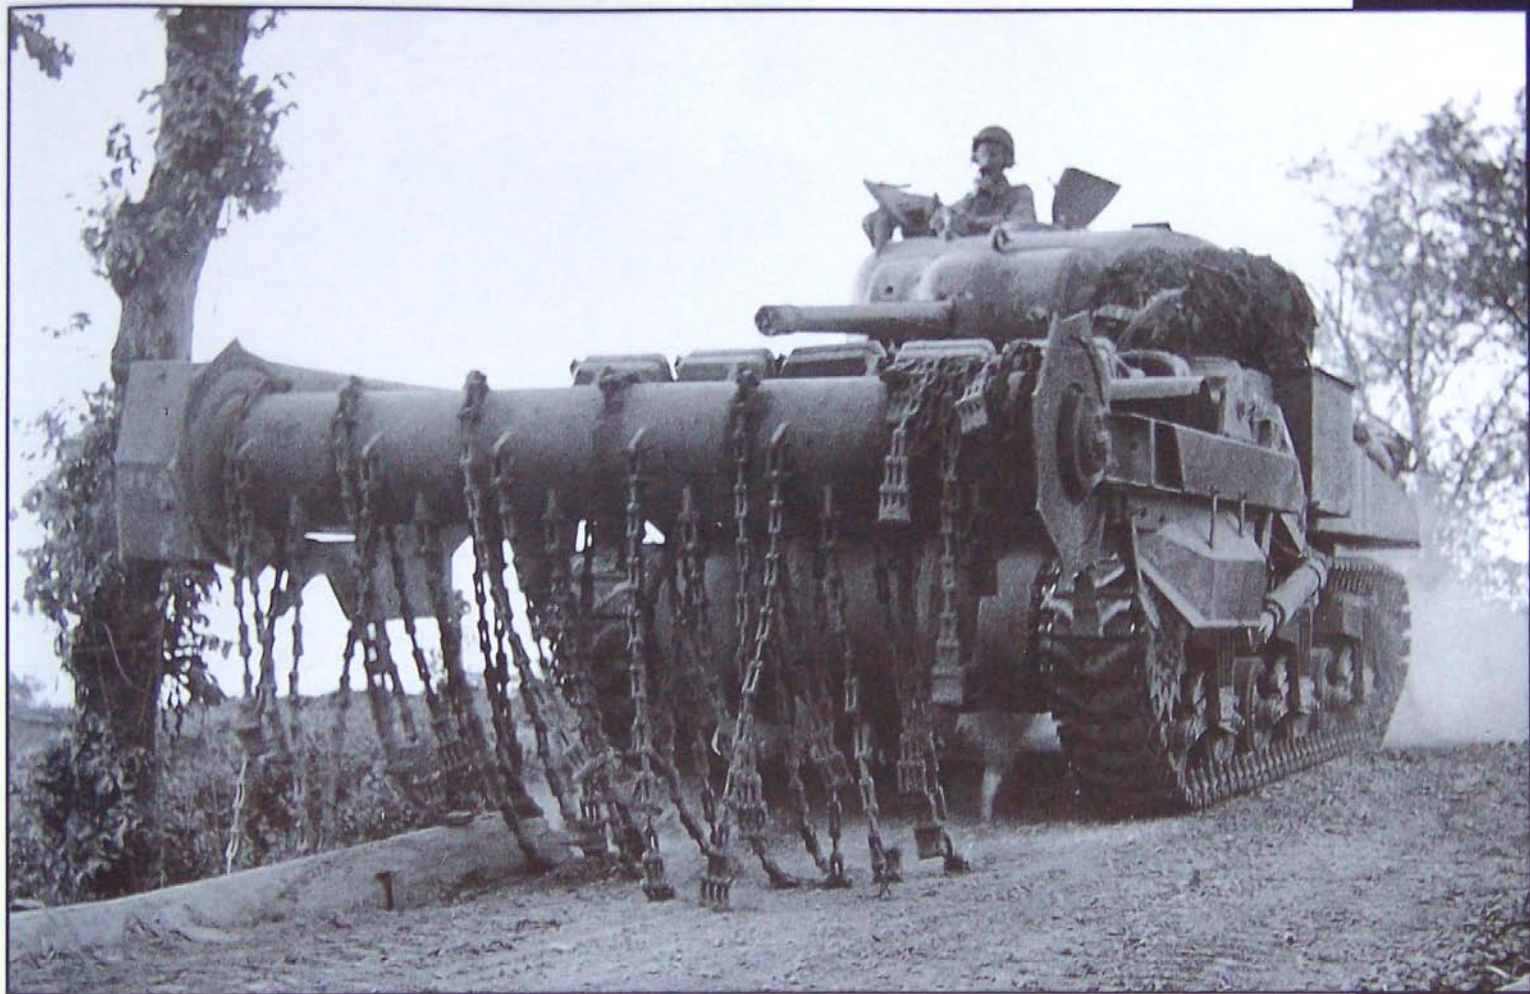
A small number of Crabs were supplied to American troops and British units were also temporarily attached specifically for mine clearing. Since Crabs were built on the long wheel-base M4A4, these were probably the only Chrysler-engined Shermans used by U.S. troops, besides the few in Southeast Asia. A few American built flails, reverting to the auxiliary engine idea and called T3, were used in the Italian campaign, but they were not a success. **Above:** Taken on July 18, 1944, this photo shows a Crab closing up to the Orne bridges to outflank Caen. Of interest here are the details of the rotor. The flail chains and their individual bolted heavy pieces of metal, getting thicker at the business end, can be

seen clearly. The serrated plates at the outer edge of the rotor are also evident. This vehicle is the classic rebuilt welded hull M4A4 with a three-piece transmission housing. It is not fitted with the protective canvas cover for the mantlet, but it does have the small canvas muzzle cover. The crew has stowed extra roadwheels among the rotor arms and oddly, have also stowed four jerrycans on the backside of the rotor. Perhaps the most interesting thing about this photo is that the tank appears to be about to drive off the road!

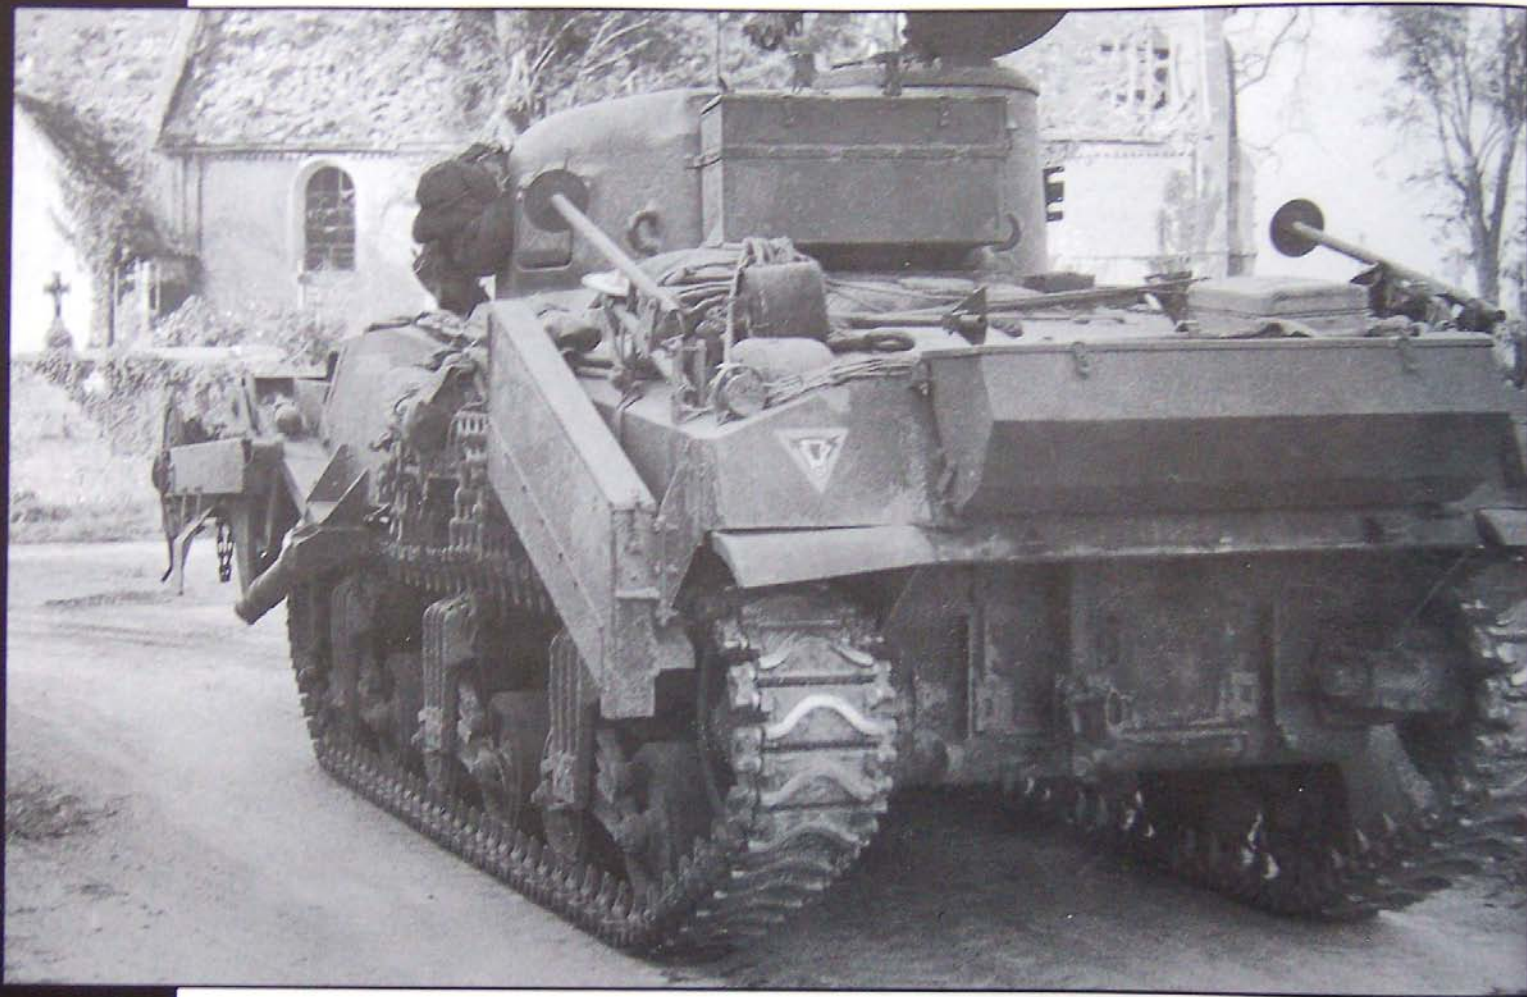
A Crab of the 79th Armoured Division, as shown by the distinctive division sign on the rear hull, is approaching the ruined church of Escoville, France. Dated July 19, 1944, this photo was taken not far from the famous "Pegasus Bridge," sight of the well-known British glider landings just prior to D-Day. This Crab has the typical British stowage bin on the hull and turret rear. Spare chains are more neatly

stowed on the hull side between the arms at the front and station keeping boxes at the rear. The large slanted bins on each side of the rear hull dropped what were described as "lighted pegs" to delineate the cleared path. The large station keeping light arms on the rear hull have been folded down for travel.

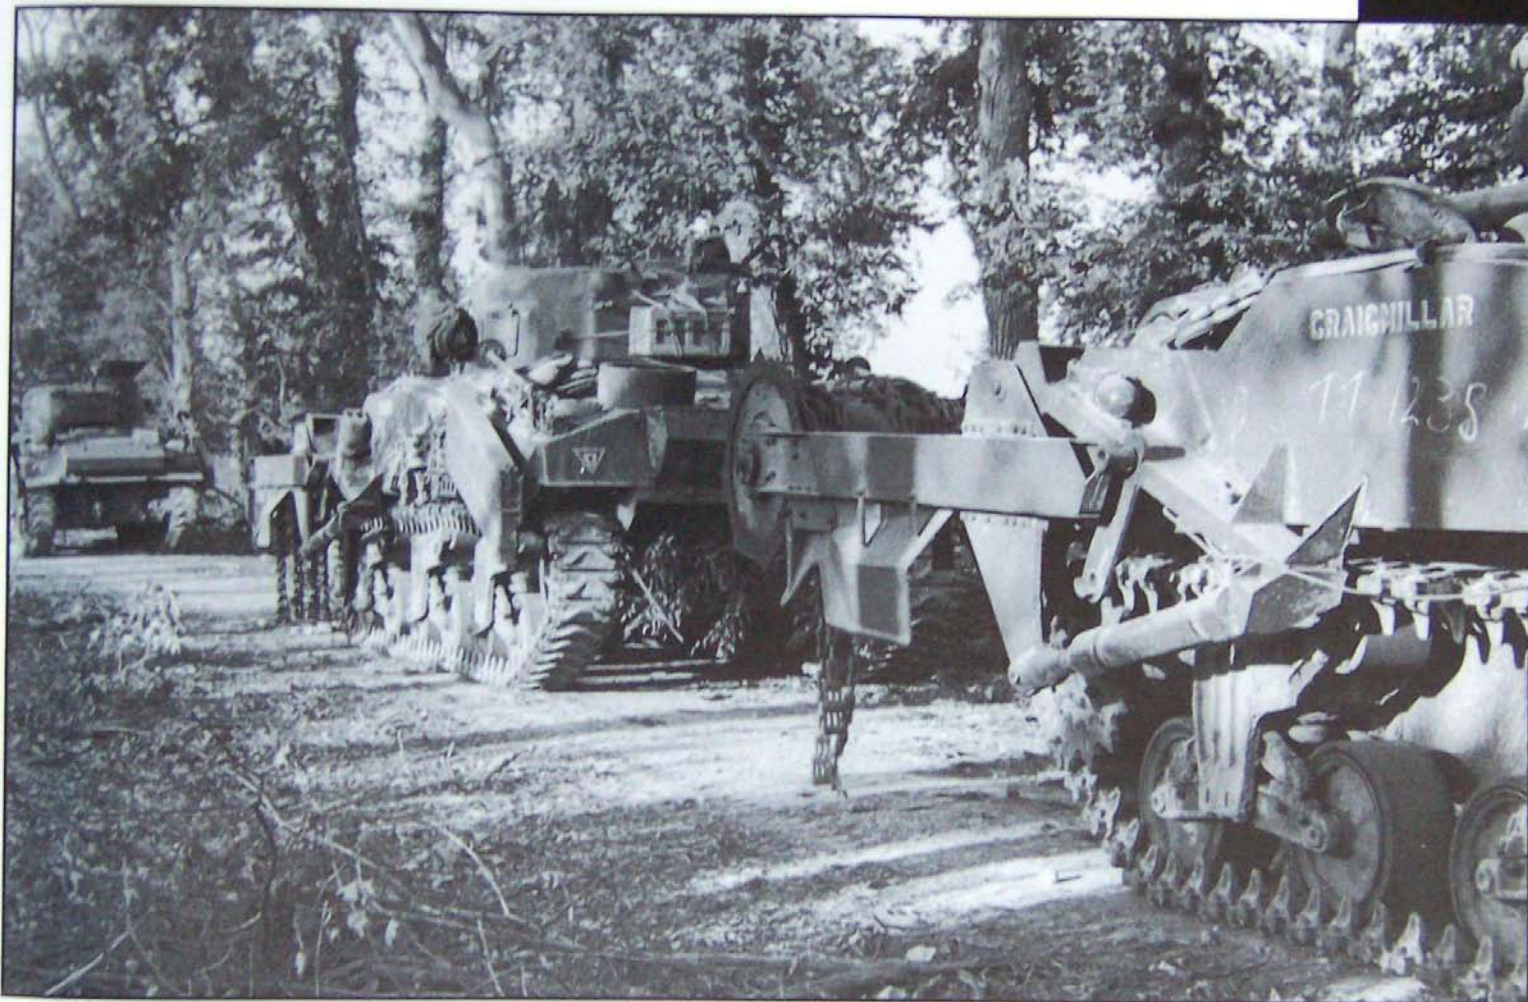
A line of Crabs, perhaps halted for 'char' as Shermans, Flails and a multitude of other vehicles pour out of Escoville. Note the welded attachments to the Hull front to facilitate the rotor mounting. Although it's rarely seen in photographs, for long road marches where little clearing was expected, the rotors were

often wrapped in canvas sheeting. All the vehicles here appear to have names in red block letters, all of which have been neatly drop shadowed in white. The nearest vehicle contains the name 'CRAIGMILLAR'.

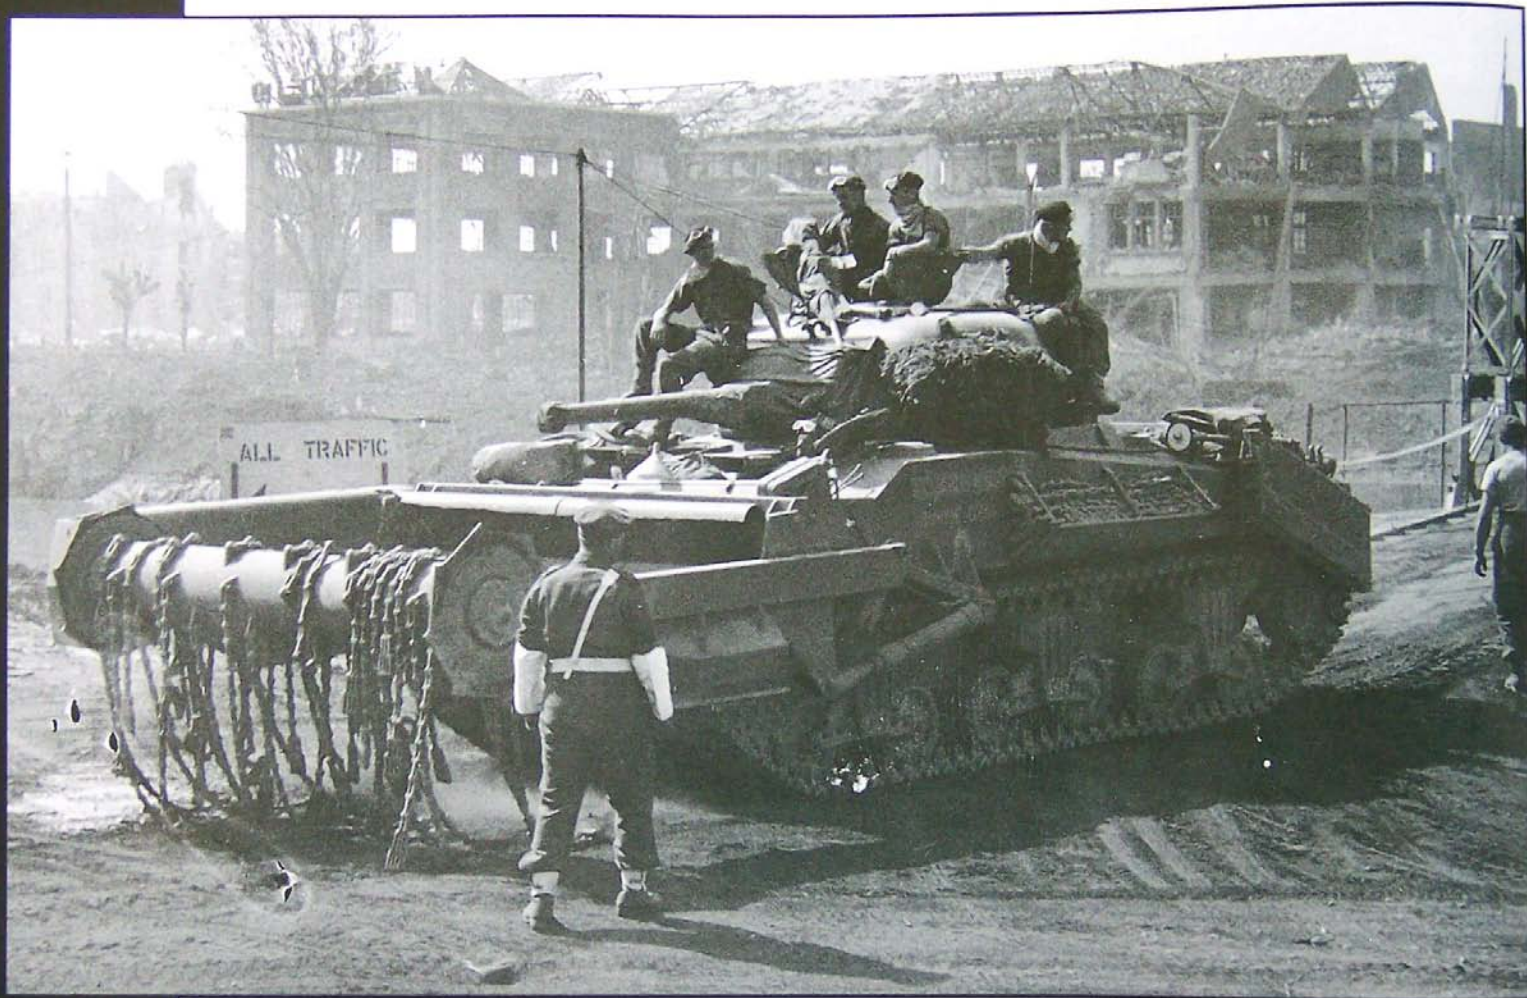
In early August, following a heavy raid by big bombers on the hinge of the German line south of Caen, tanks and artillery were moved forward for a renewed attack. Here a Crab crosses a Bailey bridge constructed over the River Orne within the town of Vaucelles, south of Caen. The whole crew, less the driver, is riding outside. Obviously there aren't many Germans in evidence. The vehicle again carries the

full protective canvas cover for the mantlet and a particularly neat arrangement has been made for the spare flail chains on the left side of the hull. It's interesting that the tank is traveling with the rotor chains dragging on the road bed.

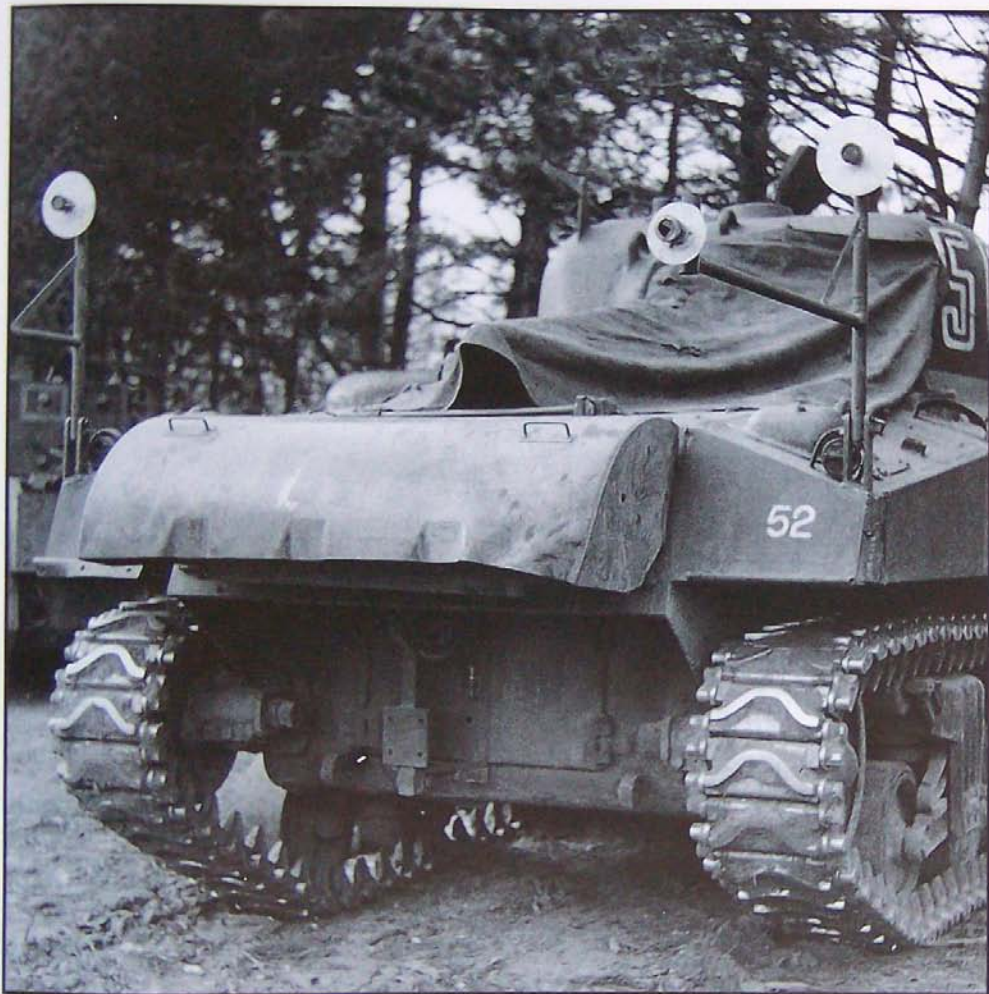
Two views of the station keeping lights on the back deck of a Crab I. These were designed to allow other vehicles to follow the Crab while it was clearing mines. The theory was that the lights, shining against a white disk, would still be visible within the cloud of dust and debris created by the action of the rotor. The light arms were hinged and could be collapsed for travel. This vehicle has been fitted with the so-called "Normandy Shroud" on the hull rear. This was a ventilation device fitted to British

Cromwell tanks. The purpose for installing it on the back of the Sherman is a mystery, as the engine vents on the M4A4 are located beneath the large rear armored overhang. Perhaps it was simply used to provide extra weatherproofing for the rear stowage box. This photo provides a good view of the moveable mechanism used for attaching a towing clevis mount installed vertically across the left-side engine-access door. The clevis is not installed here, but compare it with the Crab on page 74

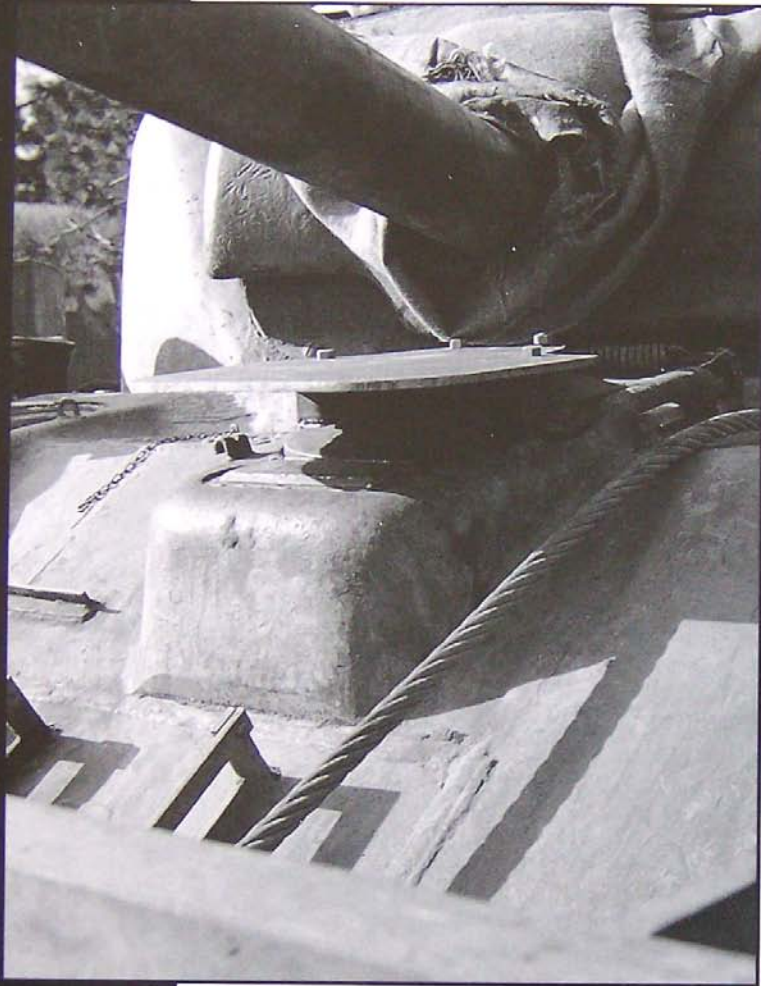
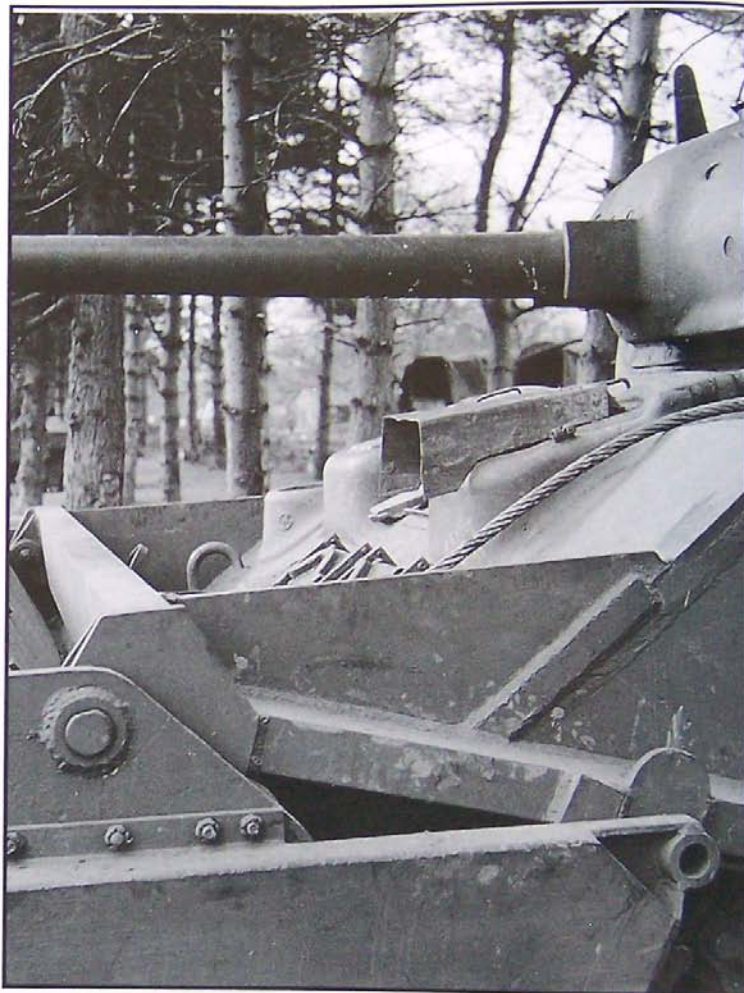
Two different views of unit-made shields installed over the driver's periscope. This was, undoubtedly, to prevent it from being buried under the detritus of the rotor's operation. The left-hand tank is a well-worn vehicle, as evidenced by the tattered condition of the canvas mantlet cover. The right hand photo shows the various fittings welded on the hull of the left side of a Crab to support the flail arms. Obviously, it was no light-weight arrangement. A pin stowed on the beam just behind the pivot point was inserted

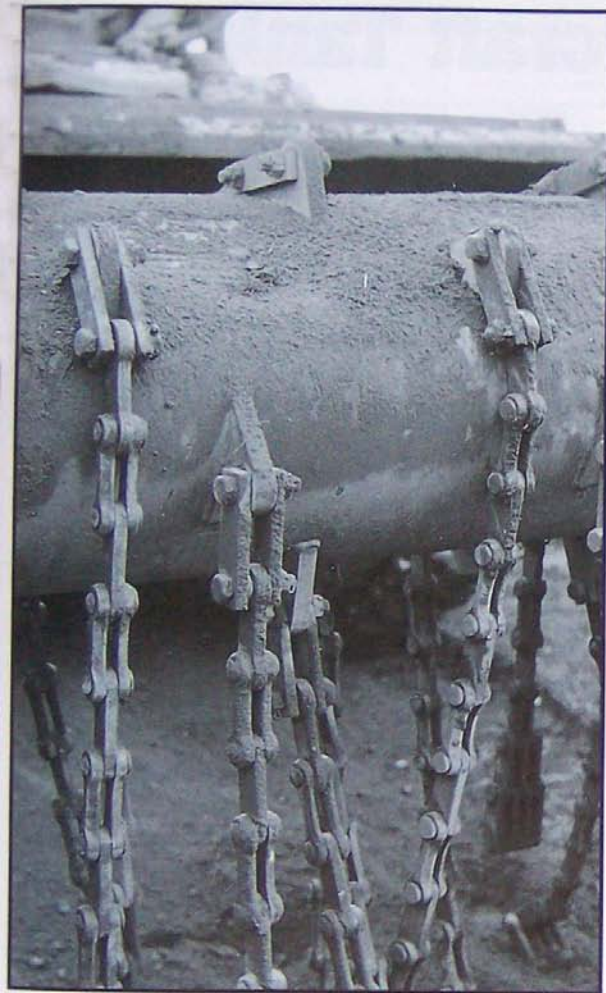
Left: An excellent close-up of the flail chains. The chains are secured with 2 flat pieces of steel. These, in turn, are secured to the rotor with bolts and locking nuts. This made it quite easy to replace broken or damaged chains. The chain links are composed of rounded end flat steel stock, alternating one, then two links. The links are permanently secured with steel rivets. Hanging just behind the rotor, one of the widened end links can be seen. These were composed of four links across to widen the contact area of the chain. **Right:** Two marks of the Crab were developed. The first, seen in all the previous photos, had

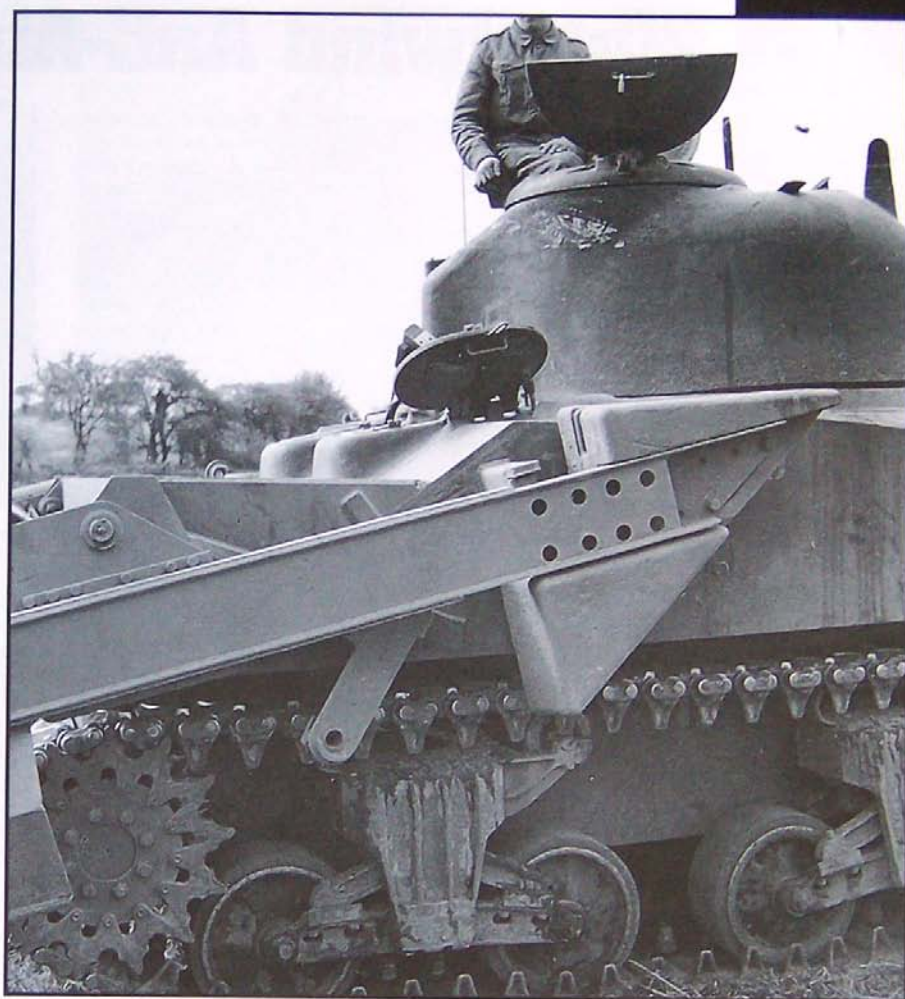
hydraulic rams on each arm so that the arms could be raised for transit. The arms were lowered to horizontal for flailing. The problem with this was that when lowered, the arms were fixed at the horizontal; the rotor could not follow uneven terrain. In the Mark II (or just "Crab II"), the left ram was replaced by a weight and the arms were allowed to float at a consistent height of 4 feet 3 inches, thus allowing the rotor to more closely follow rolling terrain and clearing a more consistent path. Although photos of the Mark I are more common, both were fielded in Europe.

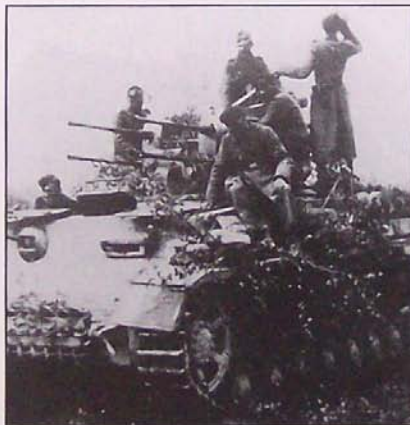
One of the three field modified Pzkw IV of SS Pz.Rgt. 12, seen in France 1944. Photo Buchner.

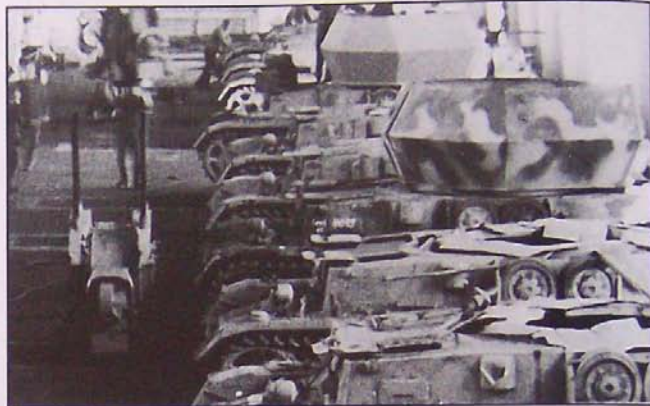
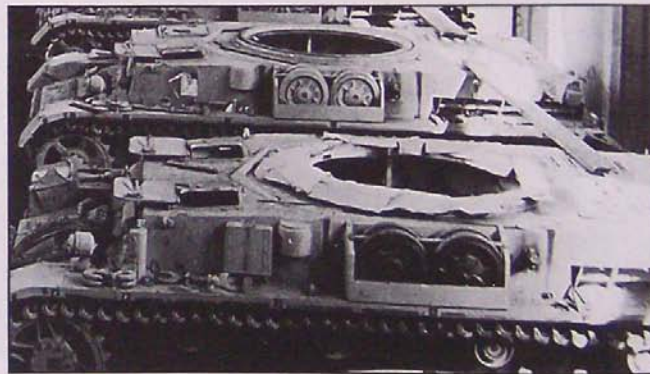
Above and below: The large assembly hall of Ostbau in Sagan. More than 10 Wirbelwind in various stages of production wait for completion. It is evident that different versions of the Pzkw IV were used. In the foreground of the lower photo, two late Ausf. H can be seen; the hulls farther in the back are possibly Ausf. G or early H. Note that early style drive sprockets were used. The empty brackets for the side skirts are visible, too. The hull with the number 4015 is already fitted with a turret. The typical Ostbau camouflage was also applied. The 2 cm Flakvierling 38 (Panzerabwehrung) waits for installation. Photos v. Seherr-Thoss.

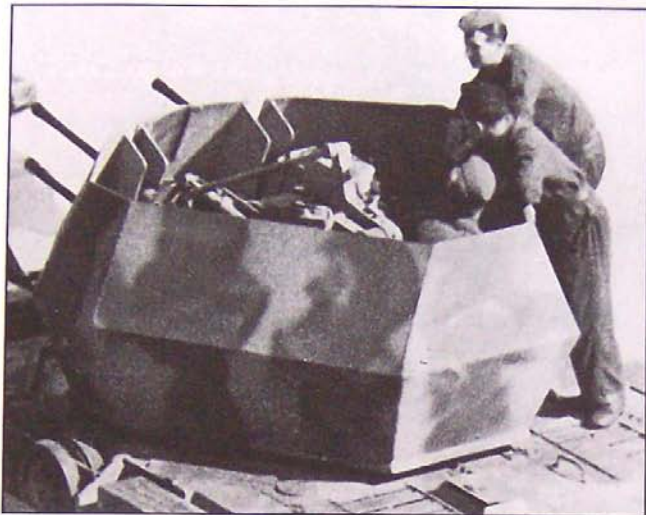
Another view inside the turret of a Wirbelwind prior to shipment to the front. It appears to be rather empty, as no further equipment is visible. Photo v. Seherr-Thoss.

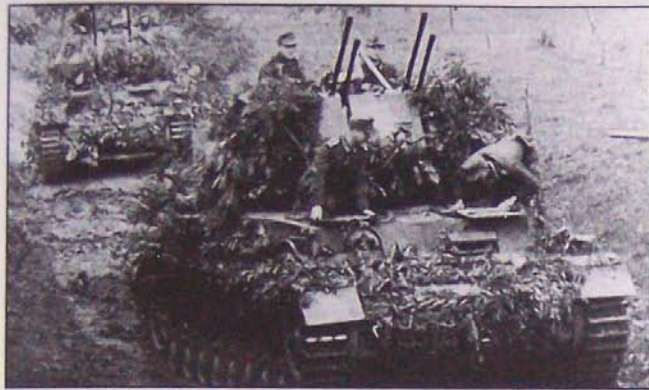
This group of Wirbelwind of an unidentified unit move through Bulgaria in late summer 1944. Again, foliage was used to further camouflage the vehicles. This vehicle, based on an Ausf. G, as evidenced by the separate 30 mm armour welded to the upper hull front. Photo R. Michulec.

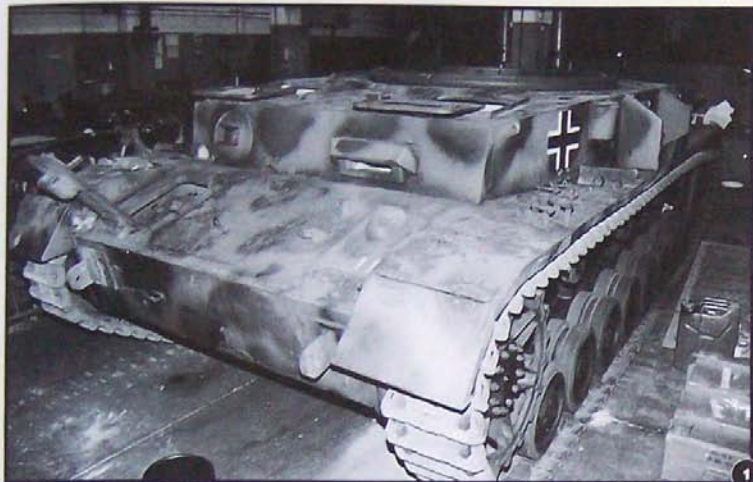
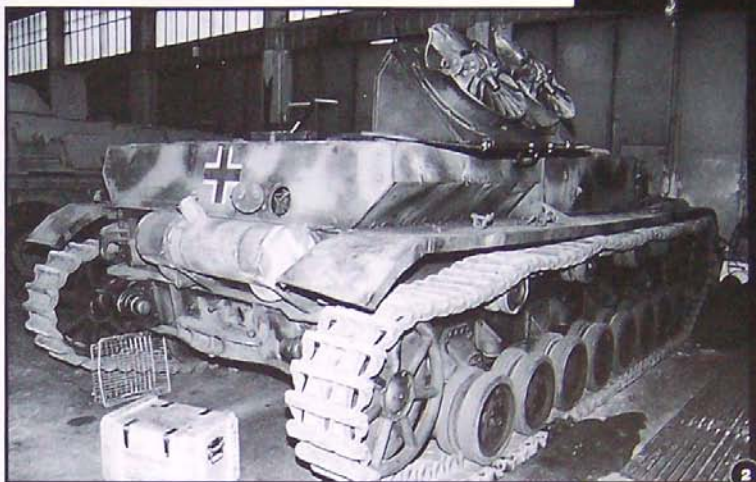
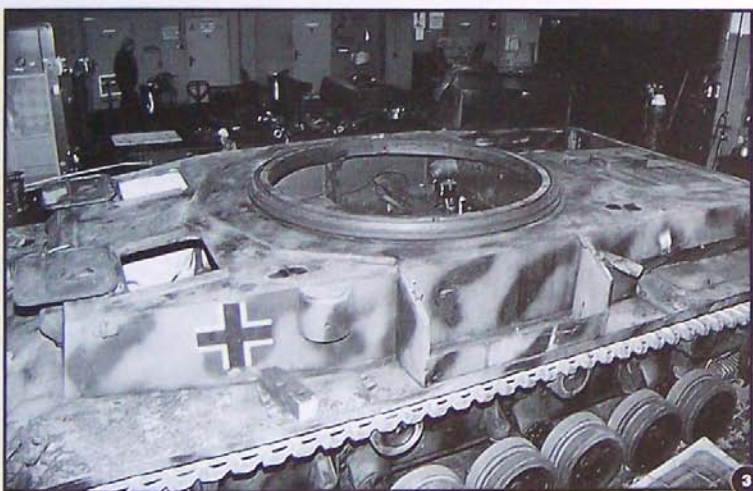
1) The hull of the Wirbelwind in Meppen during restoration shows its turret removed. Originally a late Ausf. H, the towing devices were modified in the U.S. to fit with modern tank towing bars. 2) The overall state of the vehicle is very good, the engine is still intact. 3) This photo allows a view onto the hull's top. The turret ring is evident. 4) The maintenance hatch of the right steering brake is open here.

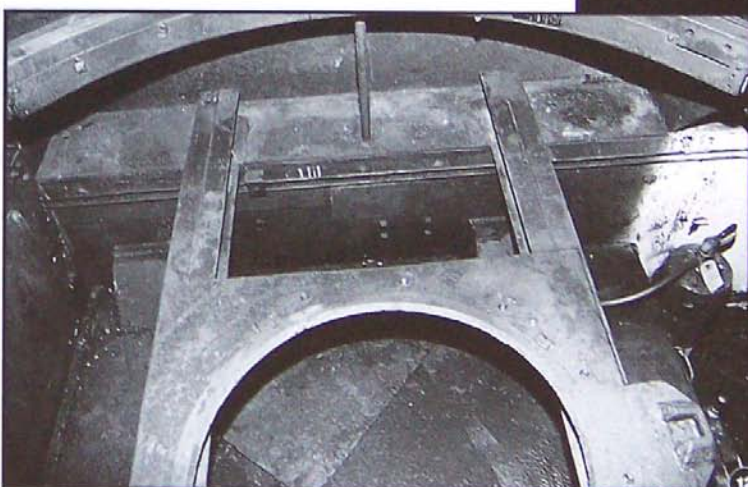
12

9) This tiny arrangement connects the gun with the turret, thus enabling side traverse. This detail will be shown on another photo. 10) A fine view onto the turret ring. The simple gun carriage is visible, too. 11) This close-up shows details of the turret ring. 12) The carriage arrangement was welded onto the hull sides.

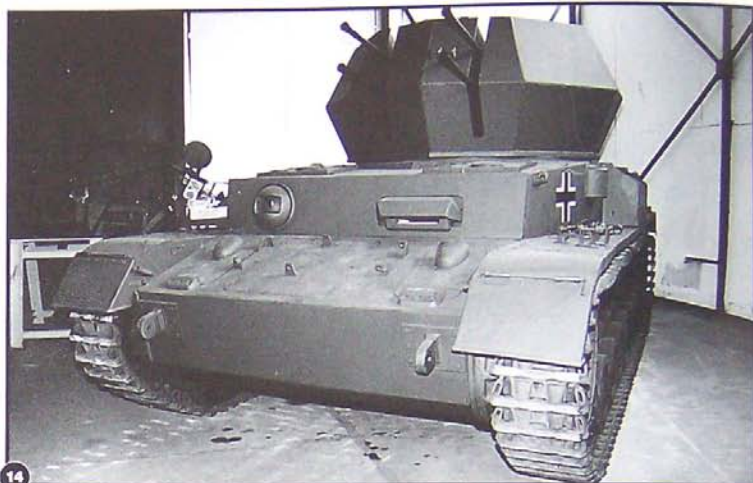
14

13) This view to the left rear of the fighting compartment shows the carriage and the fuel pump 14) The Wirbelwind after its first restoration in Meppen. 15) The turret shows two holes burnt in, this was necessary because no tool was available to lift it. 16) This close-up shows the four gun barrels. Note the weld seams.

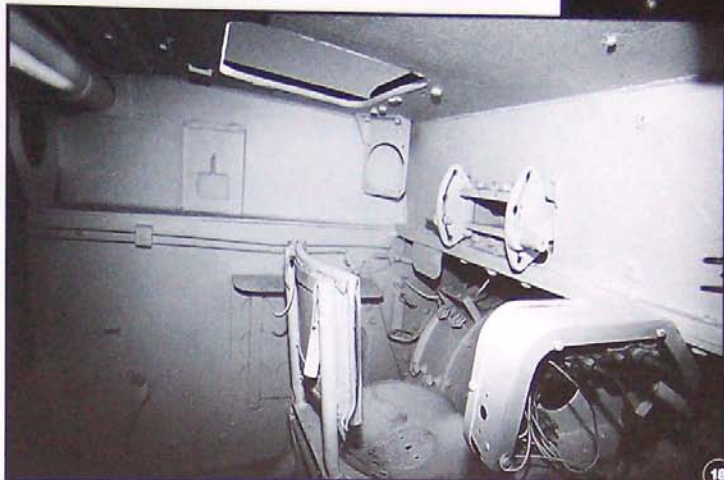
18

17) Again the welding seams are visible here. 18) The driver's position. 19) The tube conducts cooling air to the cardan shaft. 20) A view between the bottom plate above the fuel tanks and the gun carriage. Note the covered shafts of the two fuel filler caps.

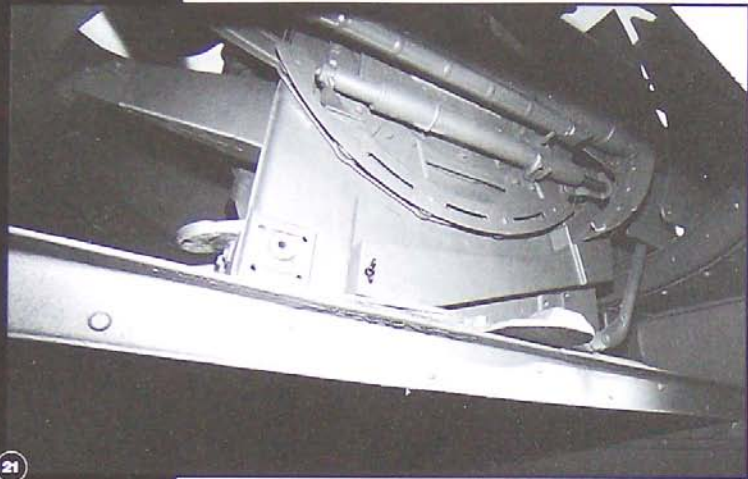
21

21) The turret turned to 9 o'clock, this view shows the gun mounted onto the carriage. 22) A round bottom plate was attached to the quadruple gun, possibly the bottom of the gun was shut after the war. The slip ring is missing at the Rendsburg vehicle. 23) The Ottawa Wirbelwind still shows the slip ring plus electric conduits. The bottom of the gun is open. Photo P Kwok. 24) This view above the gun mount shows the intercom joining box (Kst.Pz. Nr. 5c), which was fitted below the gunner's position. Photo P Kwok.

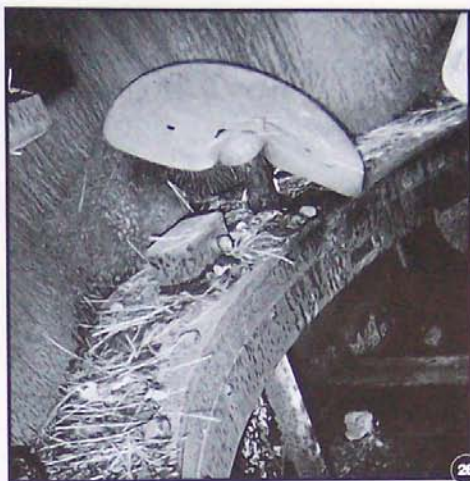
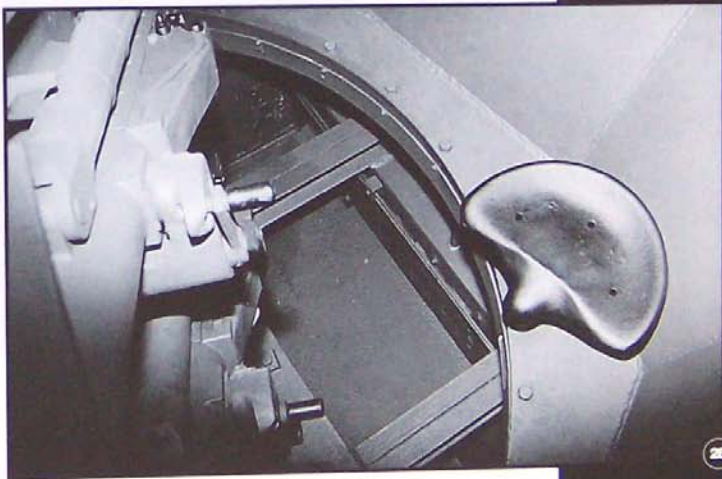
25) This interesting photo shows the coupling of gun/gunner's seat and turret. The arm carrying the seat fits into a simple arrangement. 26) This is the position of the left loader. Below the seat the intercom extension (Kst Pz. Nr. 21) was attached. Photo P Kwok. 27) The ready-to-fire ammo was stored in trays, eight magazines were stored here. 28) Another view of the left loader's seat.

Side traverse of the turret housing was not done by engaging the large gear drive incorporated in the turret ring. Instead, a simple assembly was developed to do this. The arm which carried the gunner's seat was linked into a device on the base plate. This was a truly ingenious solution, so any movement of the gun was transmitted to the turret. Due to the heavy weight of the turret, the gun's side traverse gear was reinforced. The loader's seats were mounted laterally on the turret base. Footrests were attached to the weapon's base plate. To the rear of each seat, a rack with eight magazines as stand-by ammunition, was mounted.

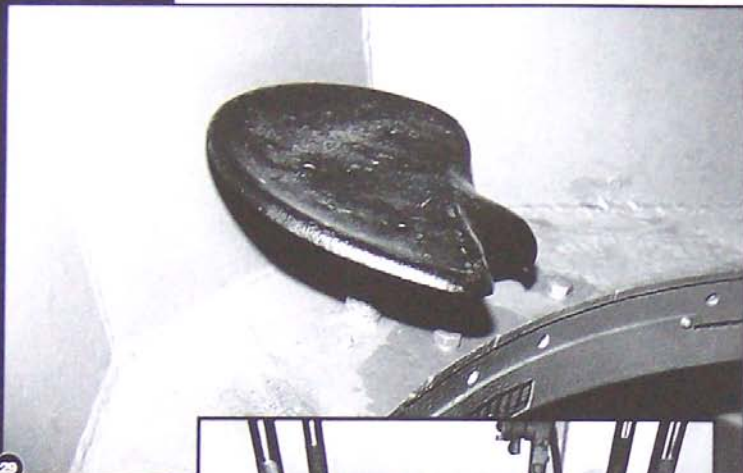
29

29) Close-up of the loader's seat. The intercom extension is missing here. 30) A close up of the quadruple gun. 31) The gun elevation was carried through by steel cables. 32) The equilibration spring is visible here.

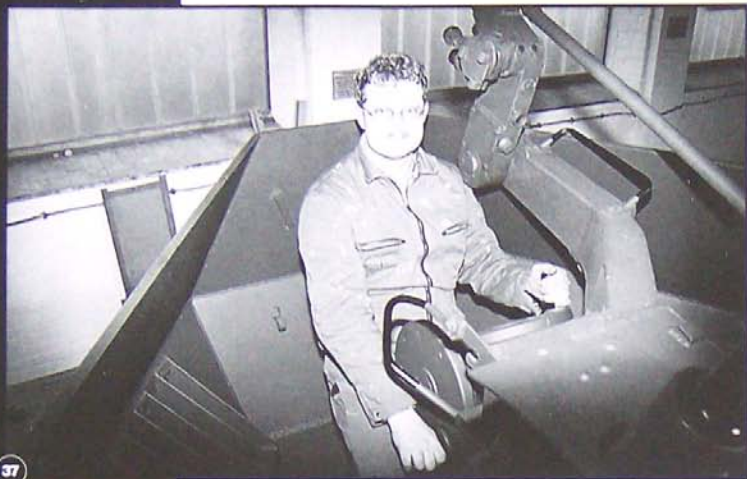
37

37) The author gives an impression of the gunner's position. It is obvious that his head was not protected. Additional foldable armor plates were developed, but not introduced. 38 - 40) The gun sight, the Schwebekreisvisier 38. 41) The spare barrel container.
