# Allied-Axis

THE PHOTO JOURNAL OF THE SECOND WORLD WAR

**German  
SIG 33/1  
Grille SPG**

**Kleines Kettenkrafttrad  
WWII Dodge 3/4-ton trucks  
DUKW Amphibious truck**

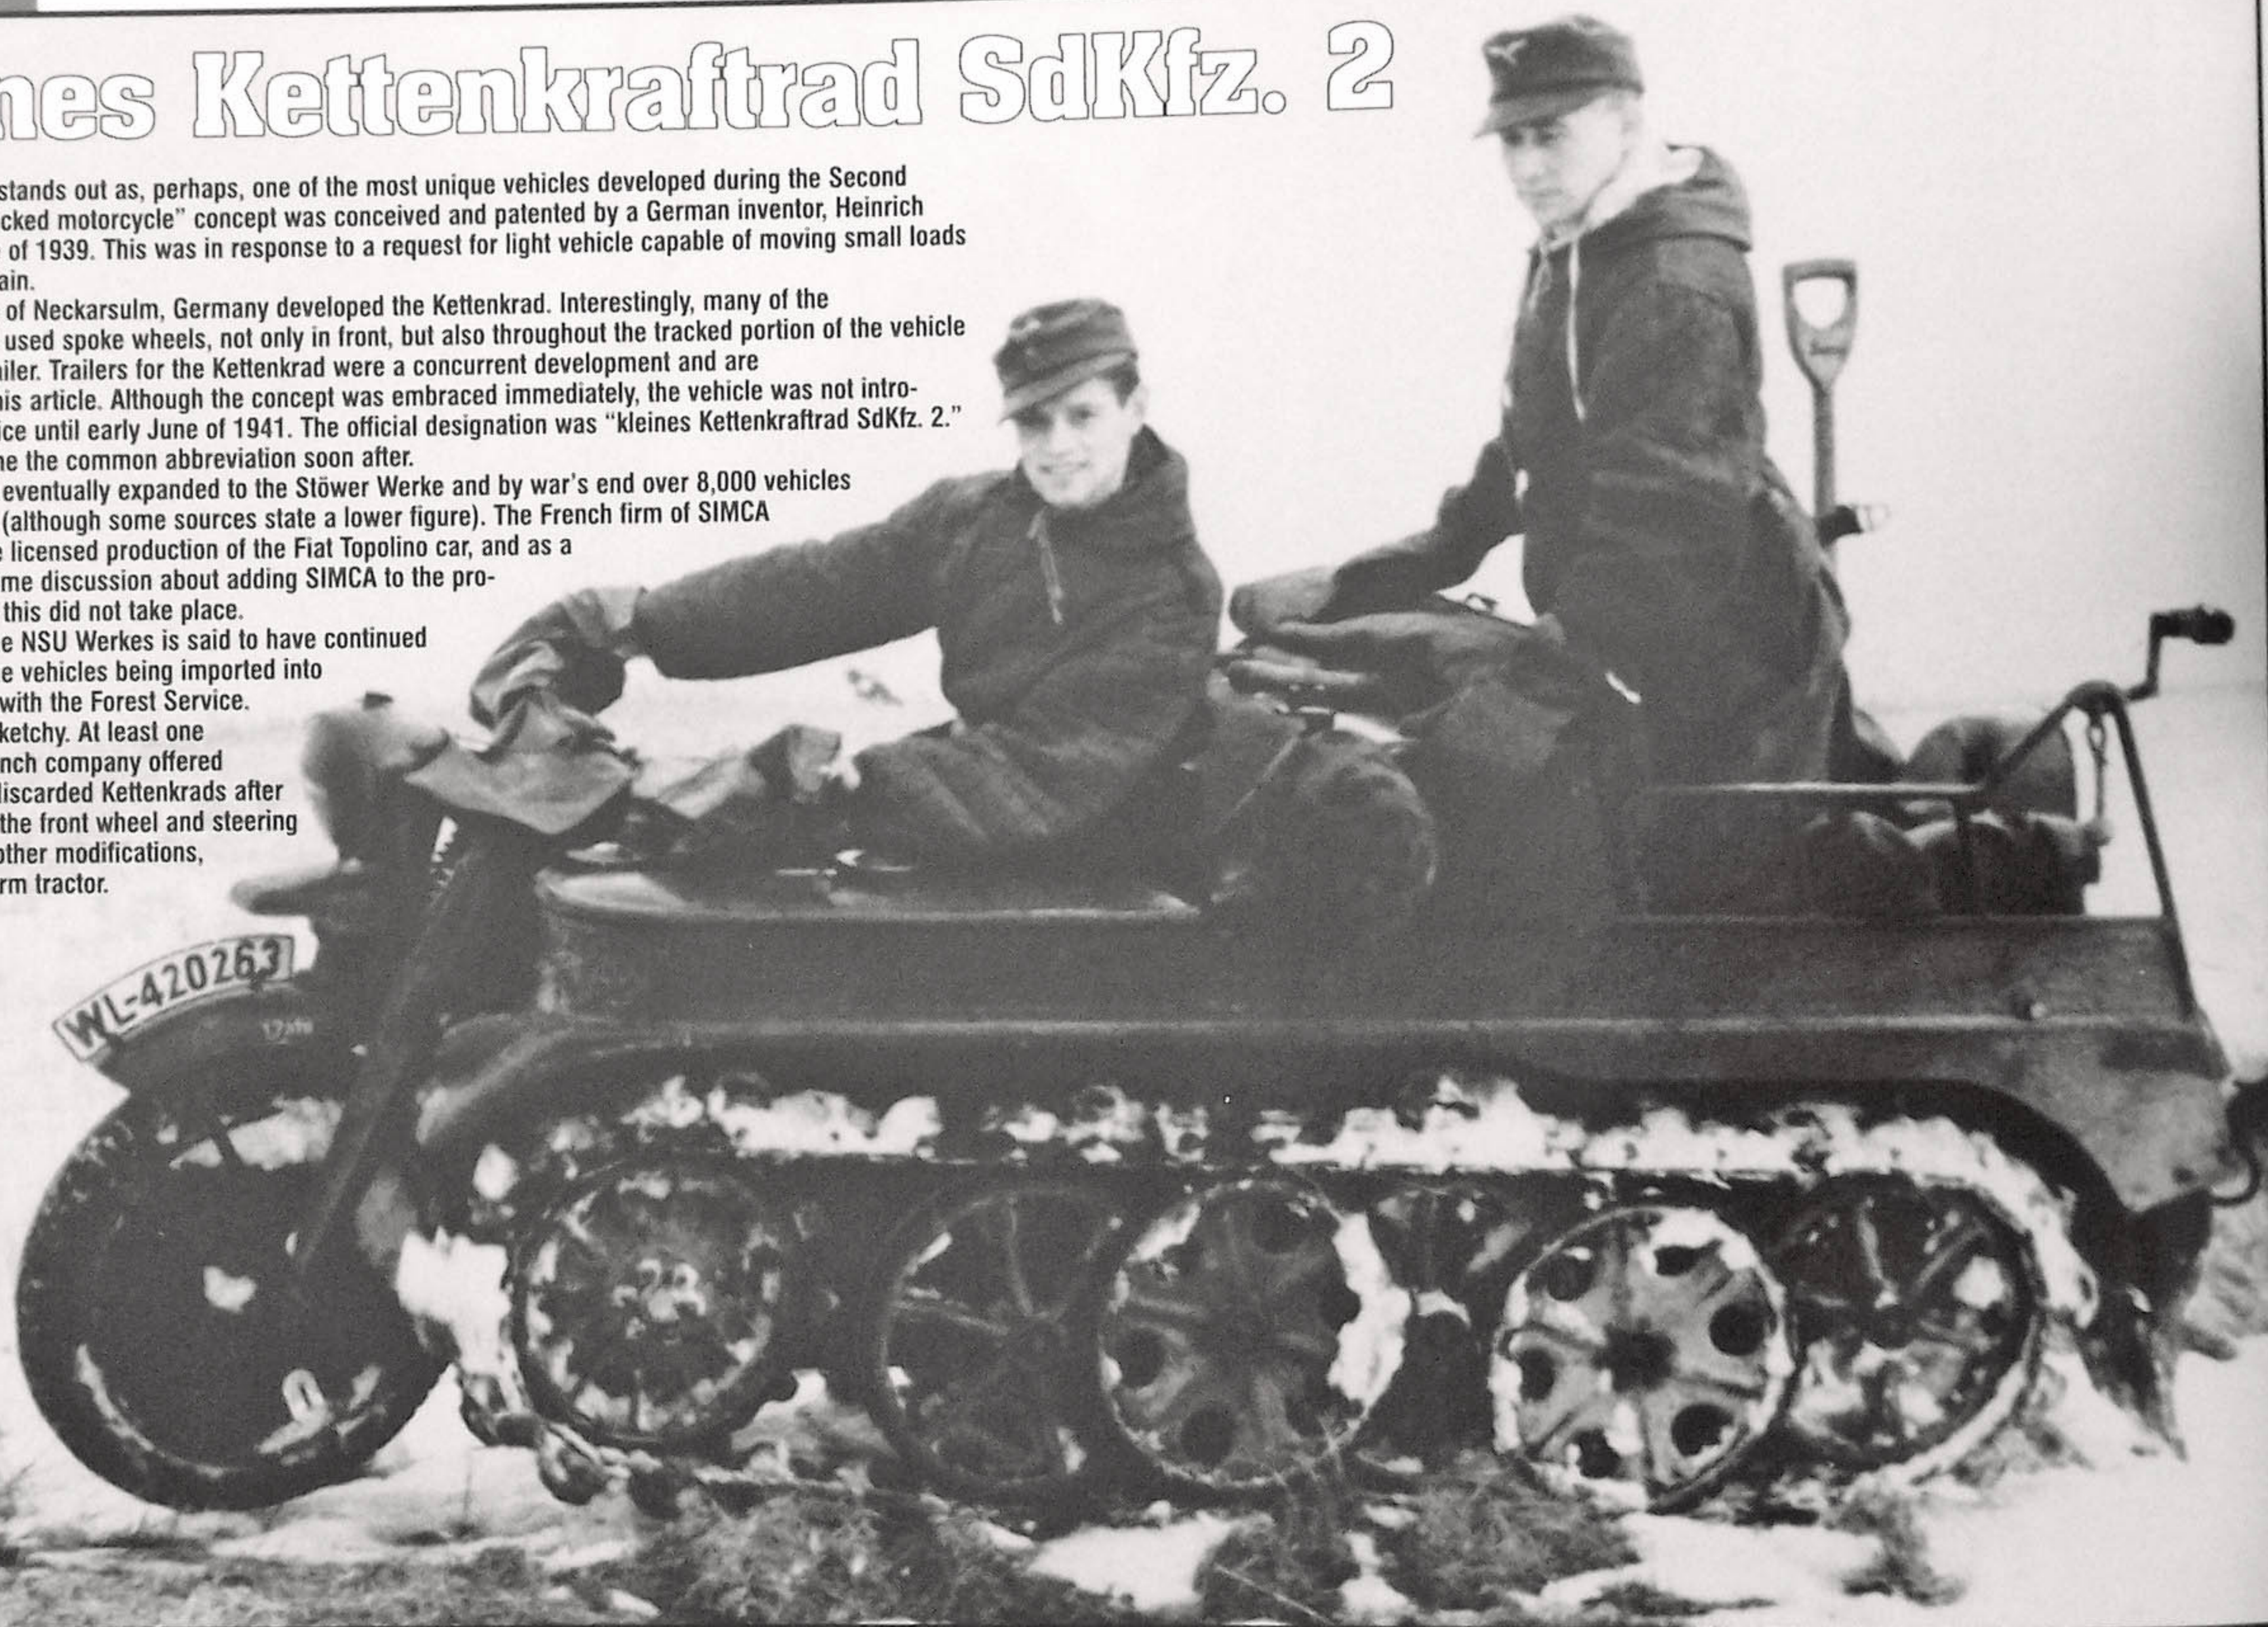
Borgward series and NSU (only) produced about 50 of these vehicles by war's end. **Above:** these two happy gents take their new Kettenkrad for a spin in the Russian countryside. This shot gives an excellent impression of the interleaving suspension and tracks. The license plate indicates Luftwaffe and the quilted cotton winter uniform further indicates that they are members of a Fallschirmjäger unit. This uniform was specifically issued to these units and was grayish-green on one side and white on the other. Their Kettenkrad still retains the foul weather cover mounted on the front of the handlebars. The driver utilizes the cold-weather gauntlets designed for motorcycle riders. (BA)

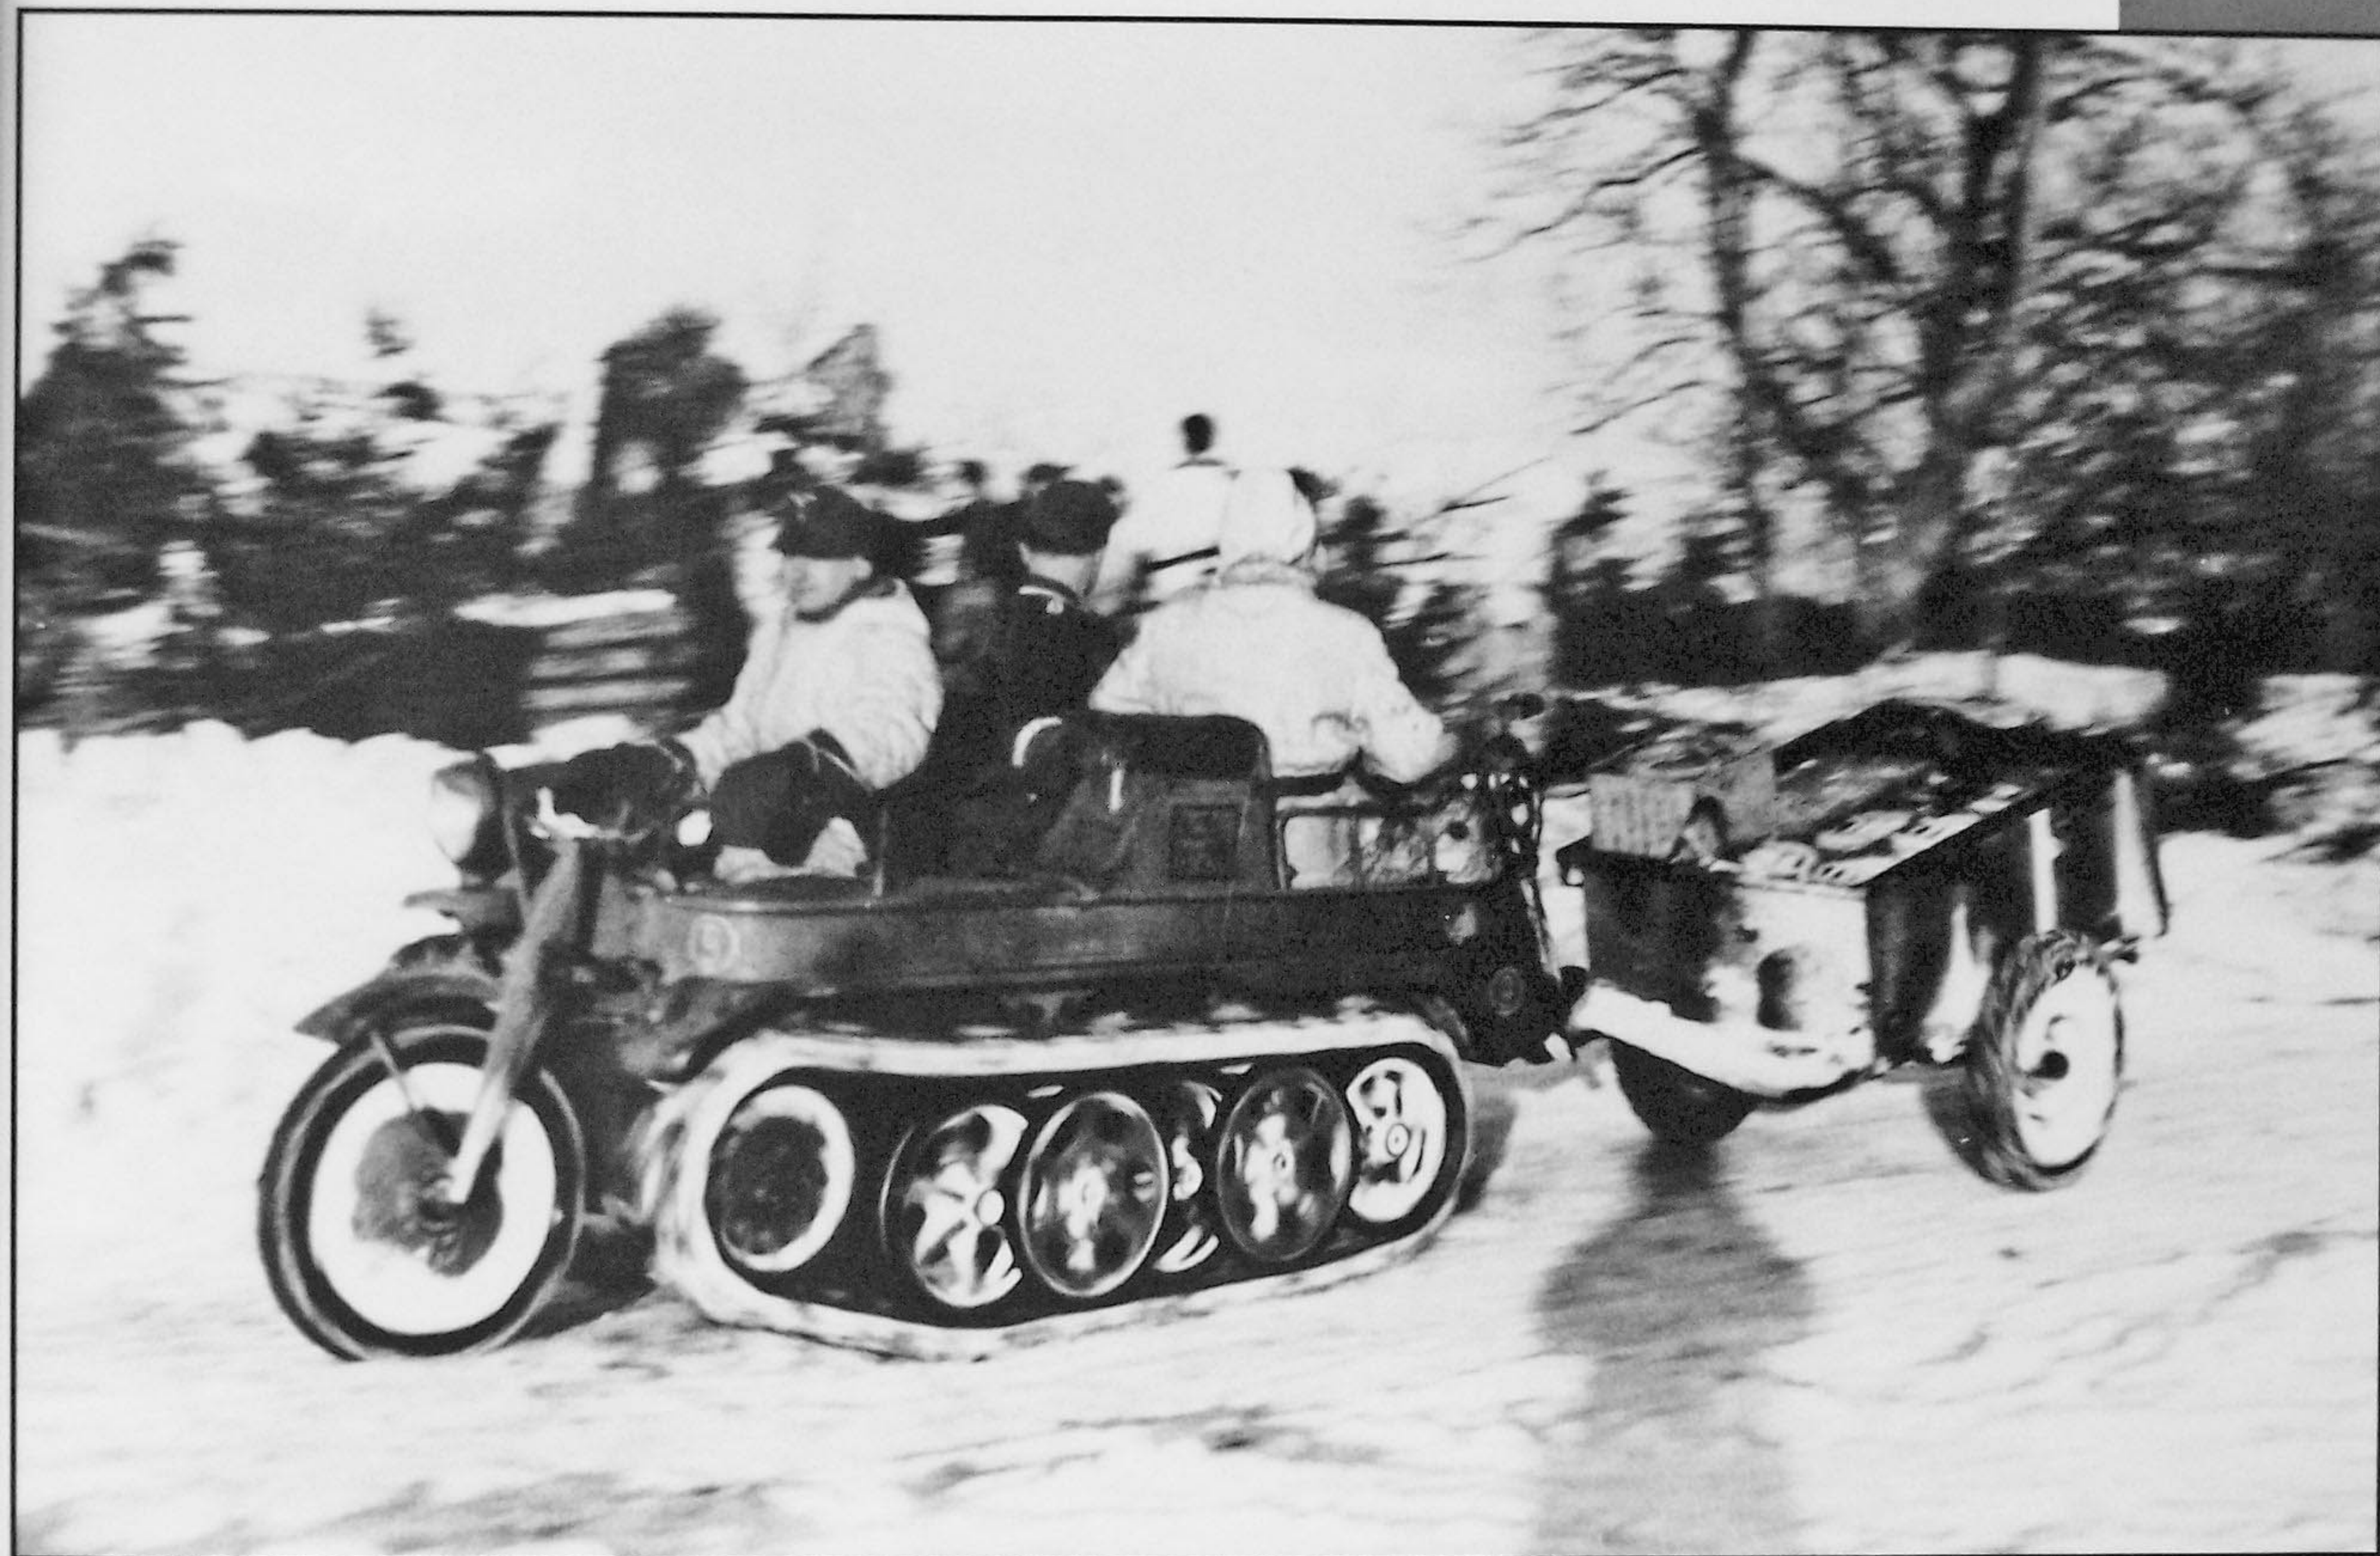
Another Luftwaffe vehicle. This may be an anti-aircraft unit as evidenced by the Flak 18 set-up in the background. Here, the vehicle is picking up some speed. When traveling this fast, the Kettenkrad's tracks barely touch the tops of the roadwheels. Although markings were usually sparse on the Kettenkrad, this vehicle contains three. The numeral 5 appears in a circle on both the front and rear of the vehicle, as well as the standard loading/shipping label. This label was commonly stenciled on the sides of soft skins and other vehicles. It contained pertinent information for both the shipping and use of the vehicle. The first line would contain the SdKfz. number and in this case reads, "Sd. Kfz 2." The

next line reads, "Leergewicht 1235 Kg" (all weights were metric). This denotes the weight of the vehicle while empty (approximately 2,717 pounds). The third line reads, "Nutzlast 325 Kg." This denoted the useful load capacity (approximately 715 pounds). The fourth line reads, "Anhängelast 450 Kg" and this indicates the towing capacity (approximately 990 pounds). Often the stencil included a final line that read, "Verl. Kl." This was normally followed by a blank space and was meant to indicate any additional equipment provided with the vehicle. Occasionally, these stencils contained no numbers. Figures would be chalked in as the vehicle made its way along the logistics chain. (BA)

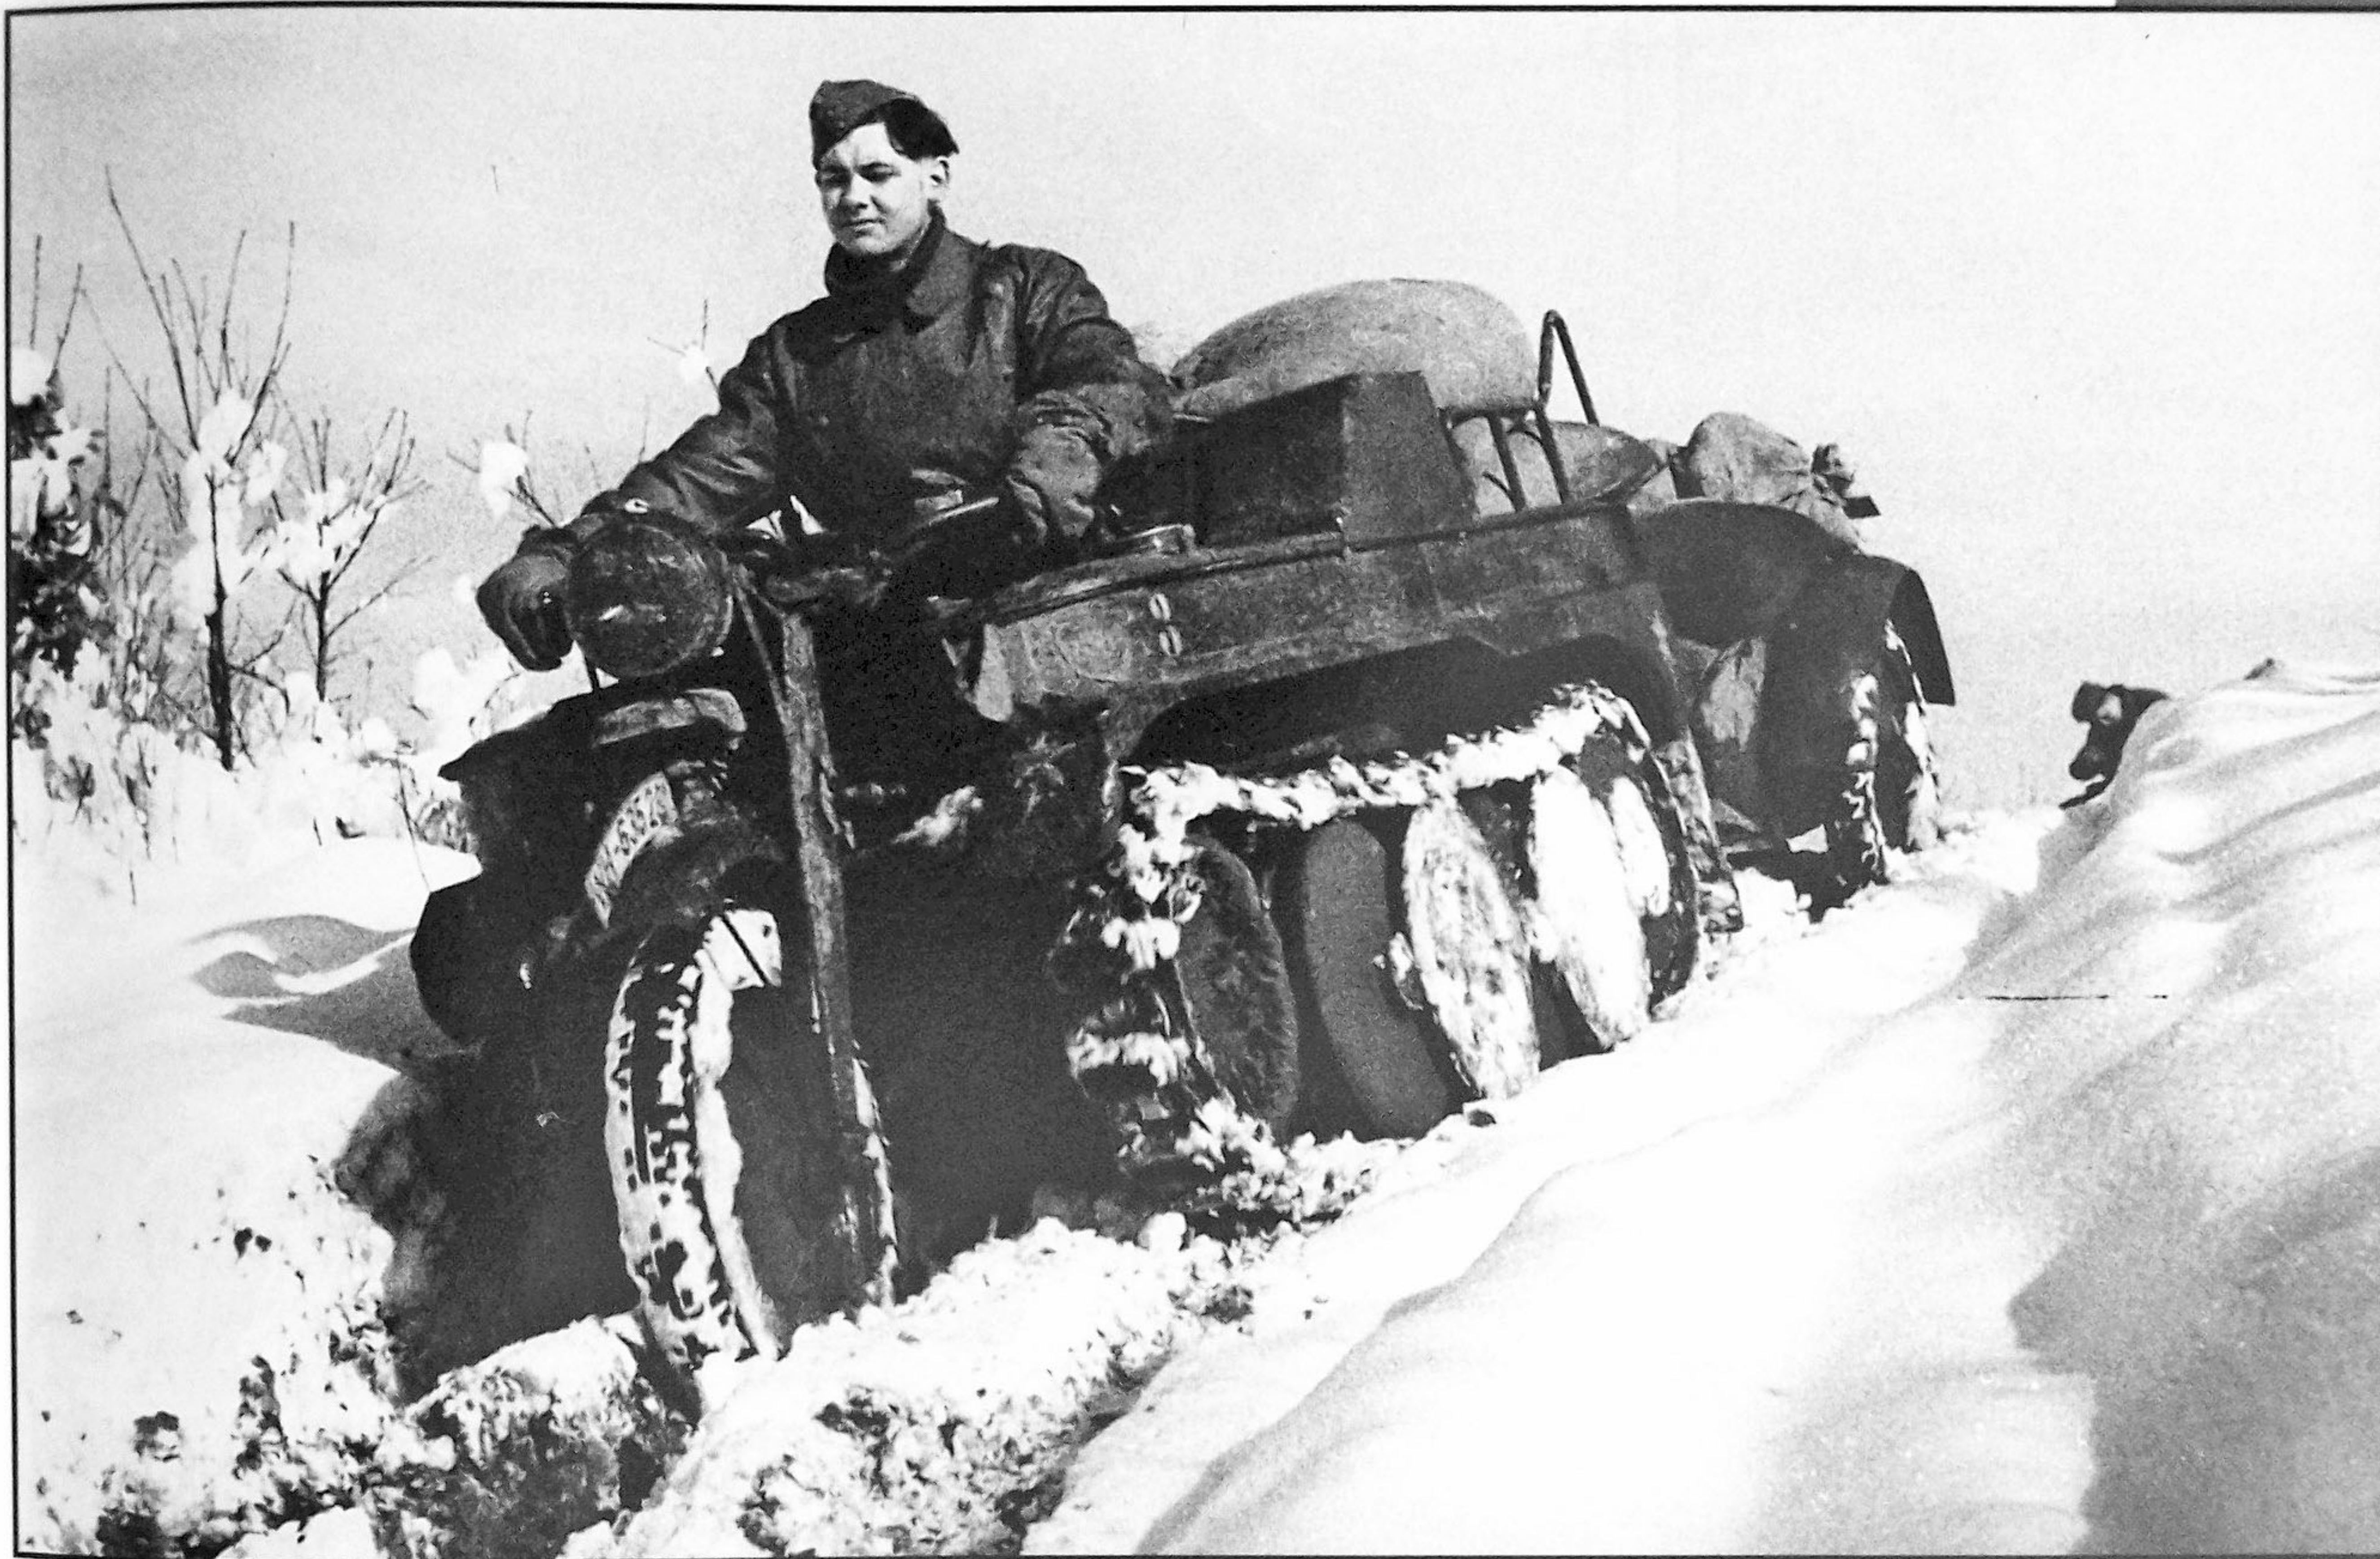
True to its intended role, the Kettenkrad was popular among troops serving in hilly or mountainous terrain. This vehicle is serving with a Fallschirmjäger unit in Italy during the spring of 1944. Because of its wide use, the Kettenkrad often took quite a beating from the troops. This vehicle is missing its headlight assembly as well as several of its rubber track pads. The folded metal brackets located to each side of the steering column are tow hooks. The hook portion on both has broken off. This appears to be a problem with many early Kettenkrads. Later vehicles had more robust, cast tow hooks located on the

front of the superstructure. Among the trailers used with the Kettenkrad, this specialized version of the standard Infanteriekarre If.8. trailer was extremely popular. The standard cart could be fitted with a curved yoke for towing, a t-shaped bar for hand pulling, or a double-bar arrangement for use with a horse. This particular trailer is loaded with mortar rounds. This photo provides a good view of the brake assembly of the trailer, which was the primary difference between it and the standard cart. Brakes were a true necessity for a trailer loaded with anything close to its rated capacity. (BA)
