# Allied-Axis

THE PHOTO JOURNAL OF THE SECOND WORLD WAR

**German  
SIG 33/1  
Grille SPG**

**Kleines Kettenkrafttrad  
WWII Dodge 3/4-ton trucks  
DUKW Amphibious truck**

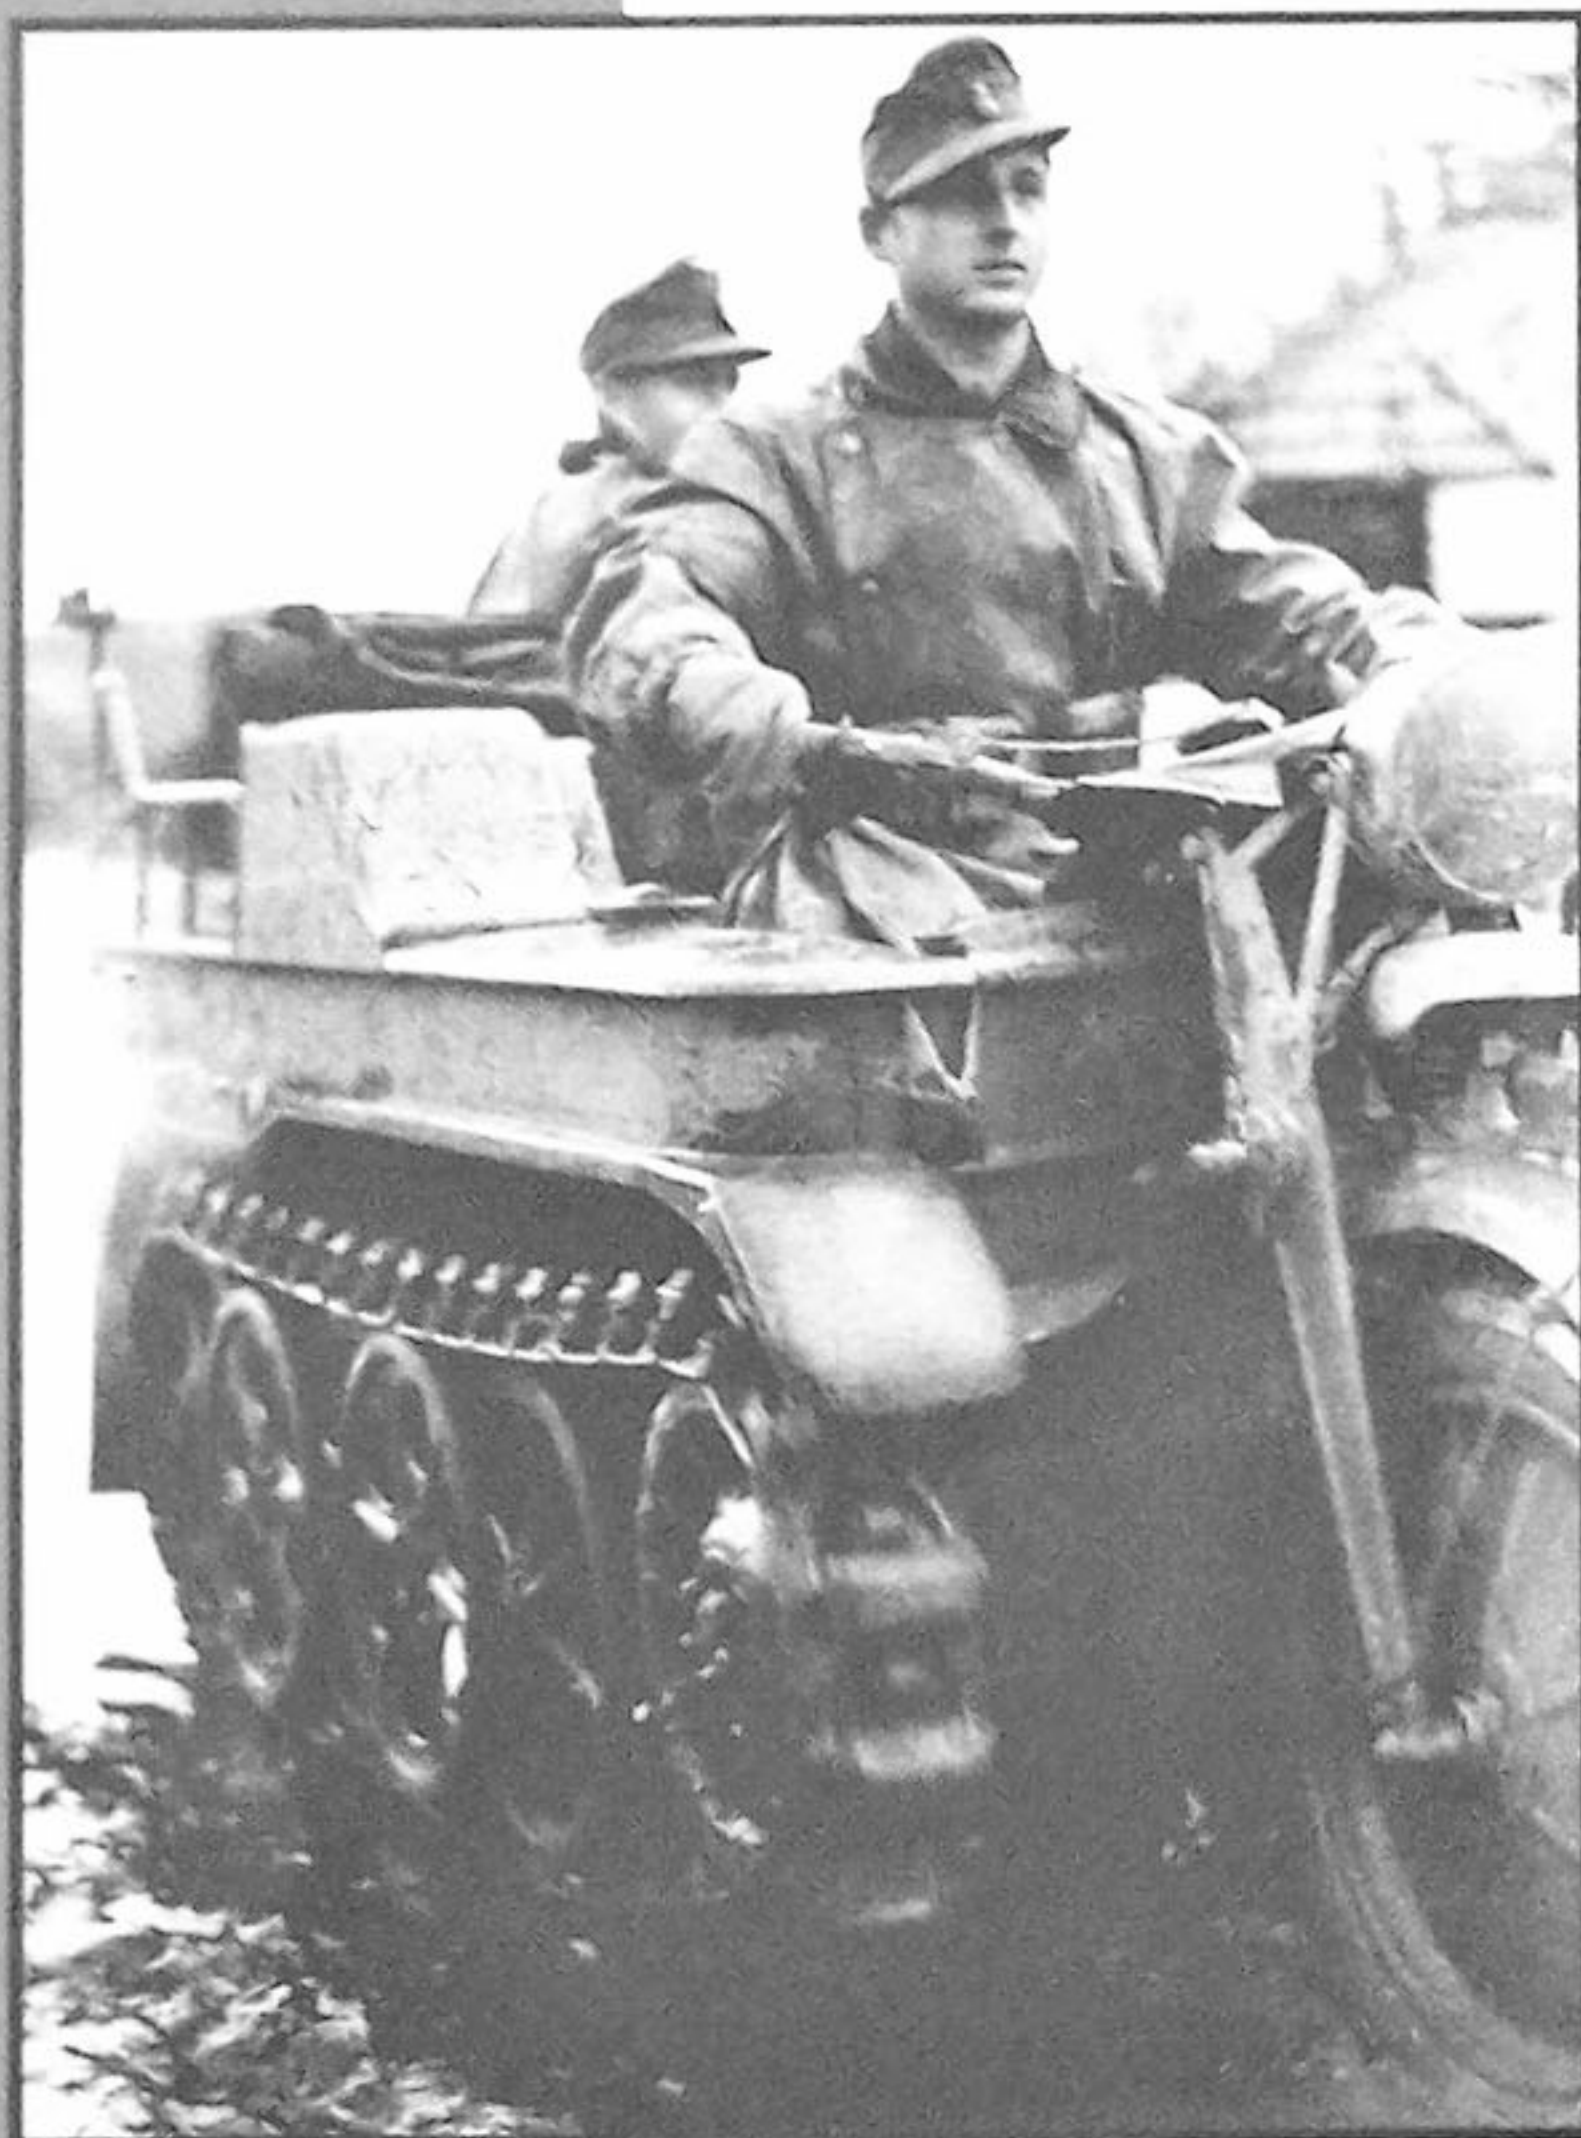
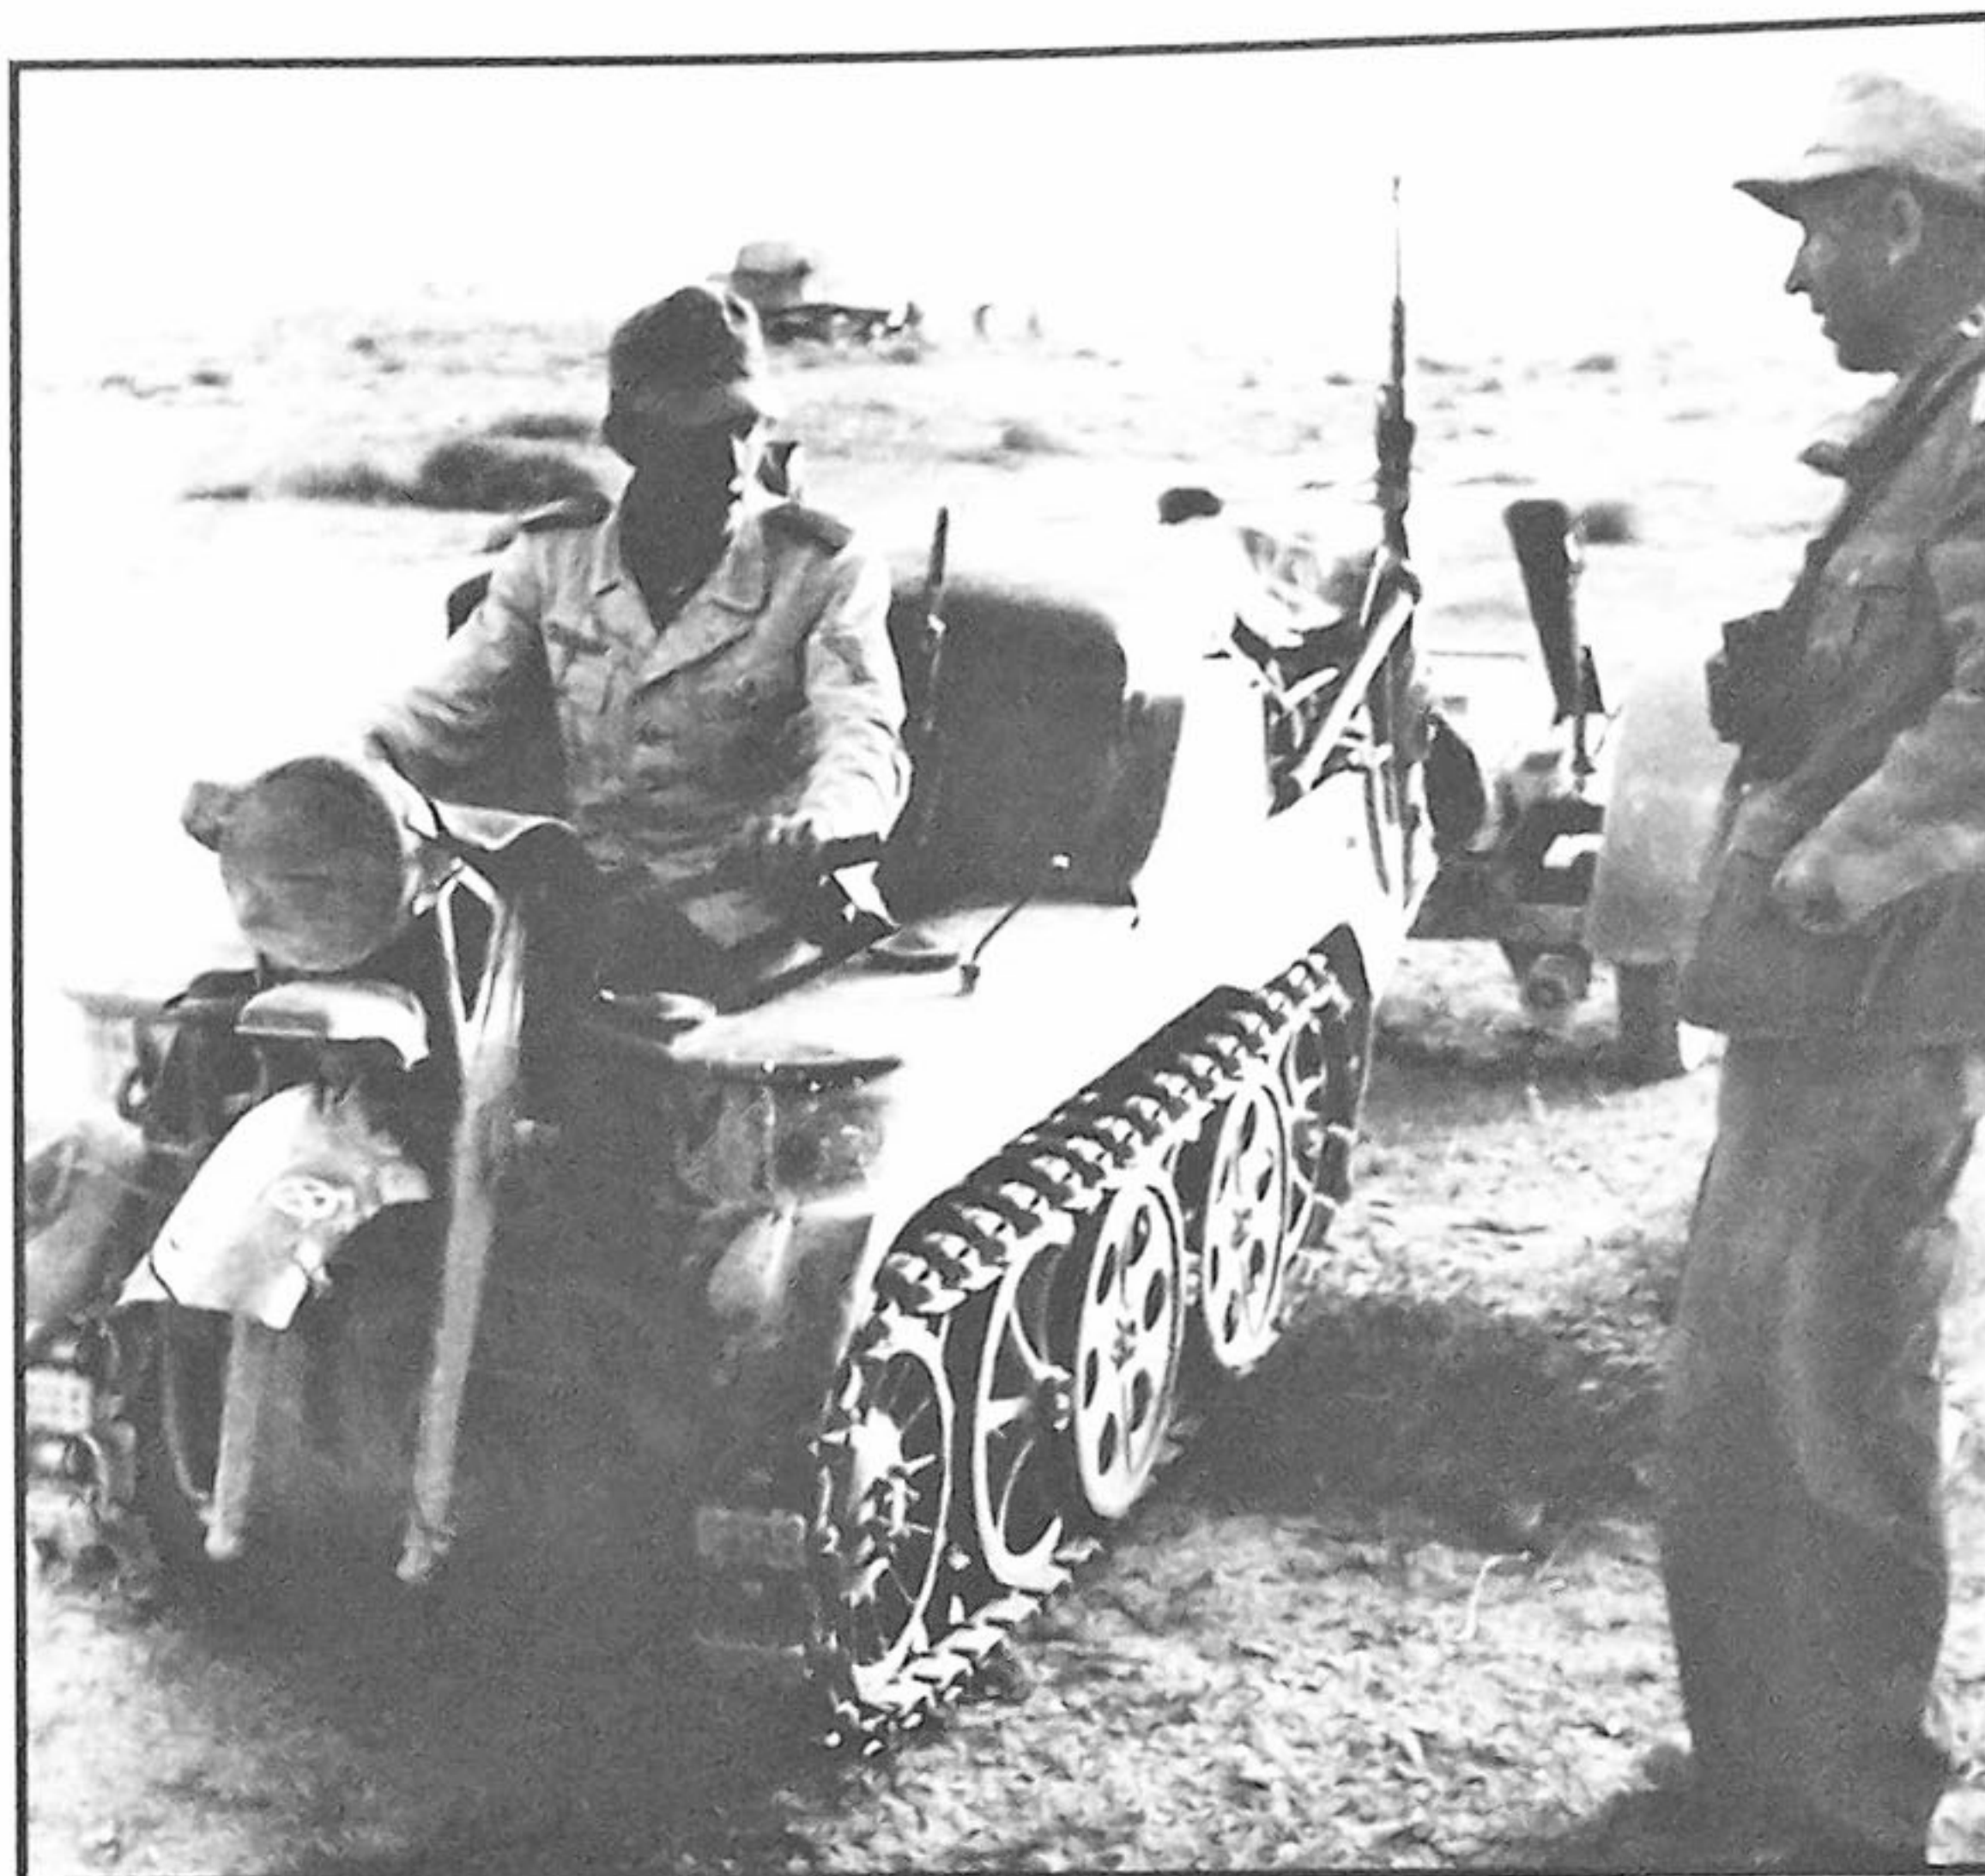
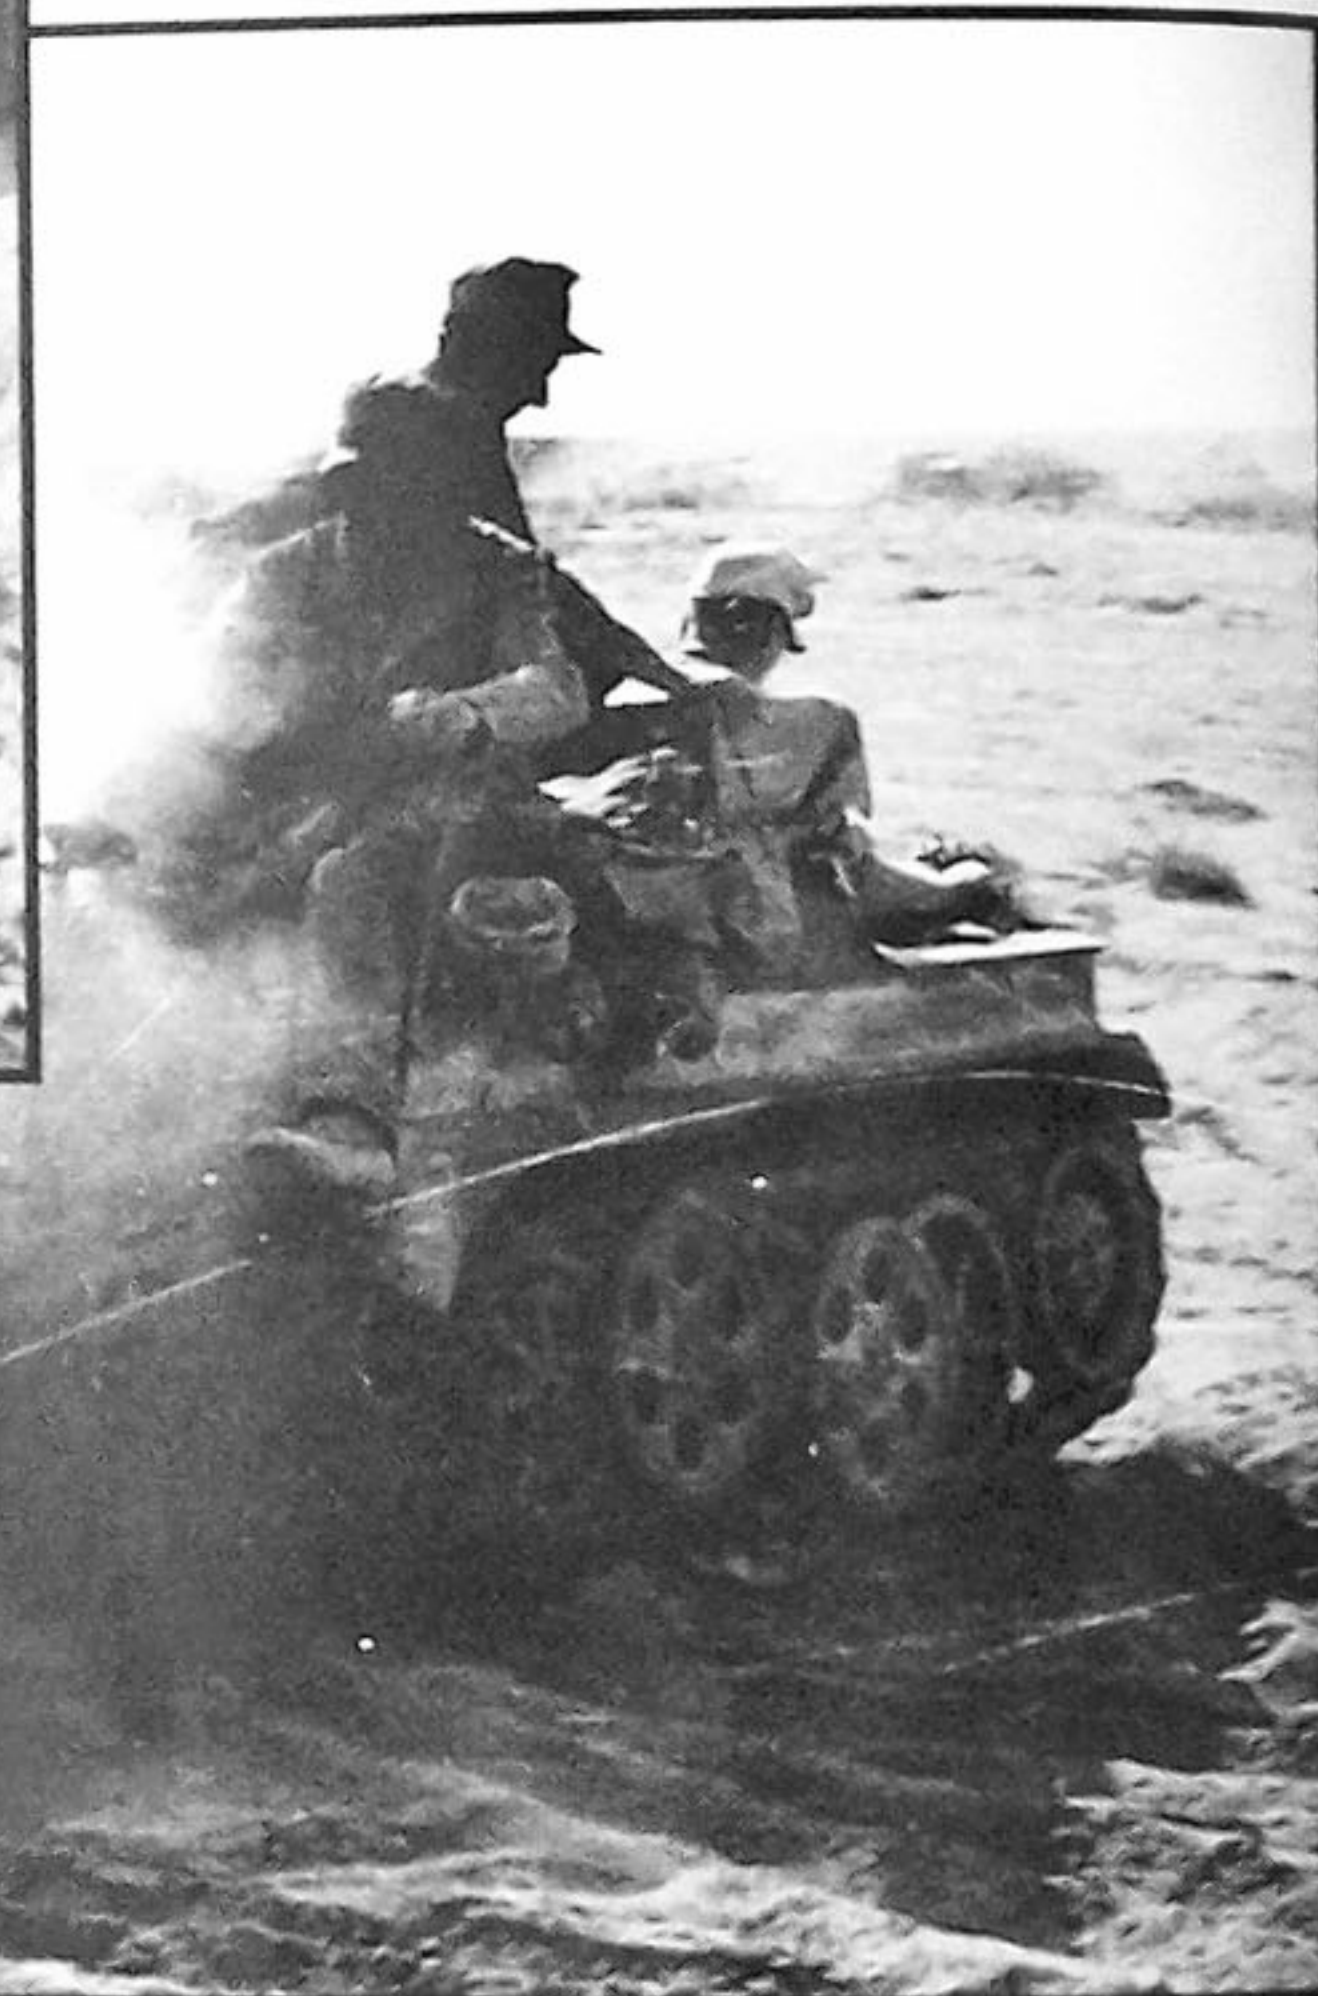
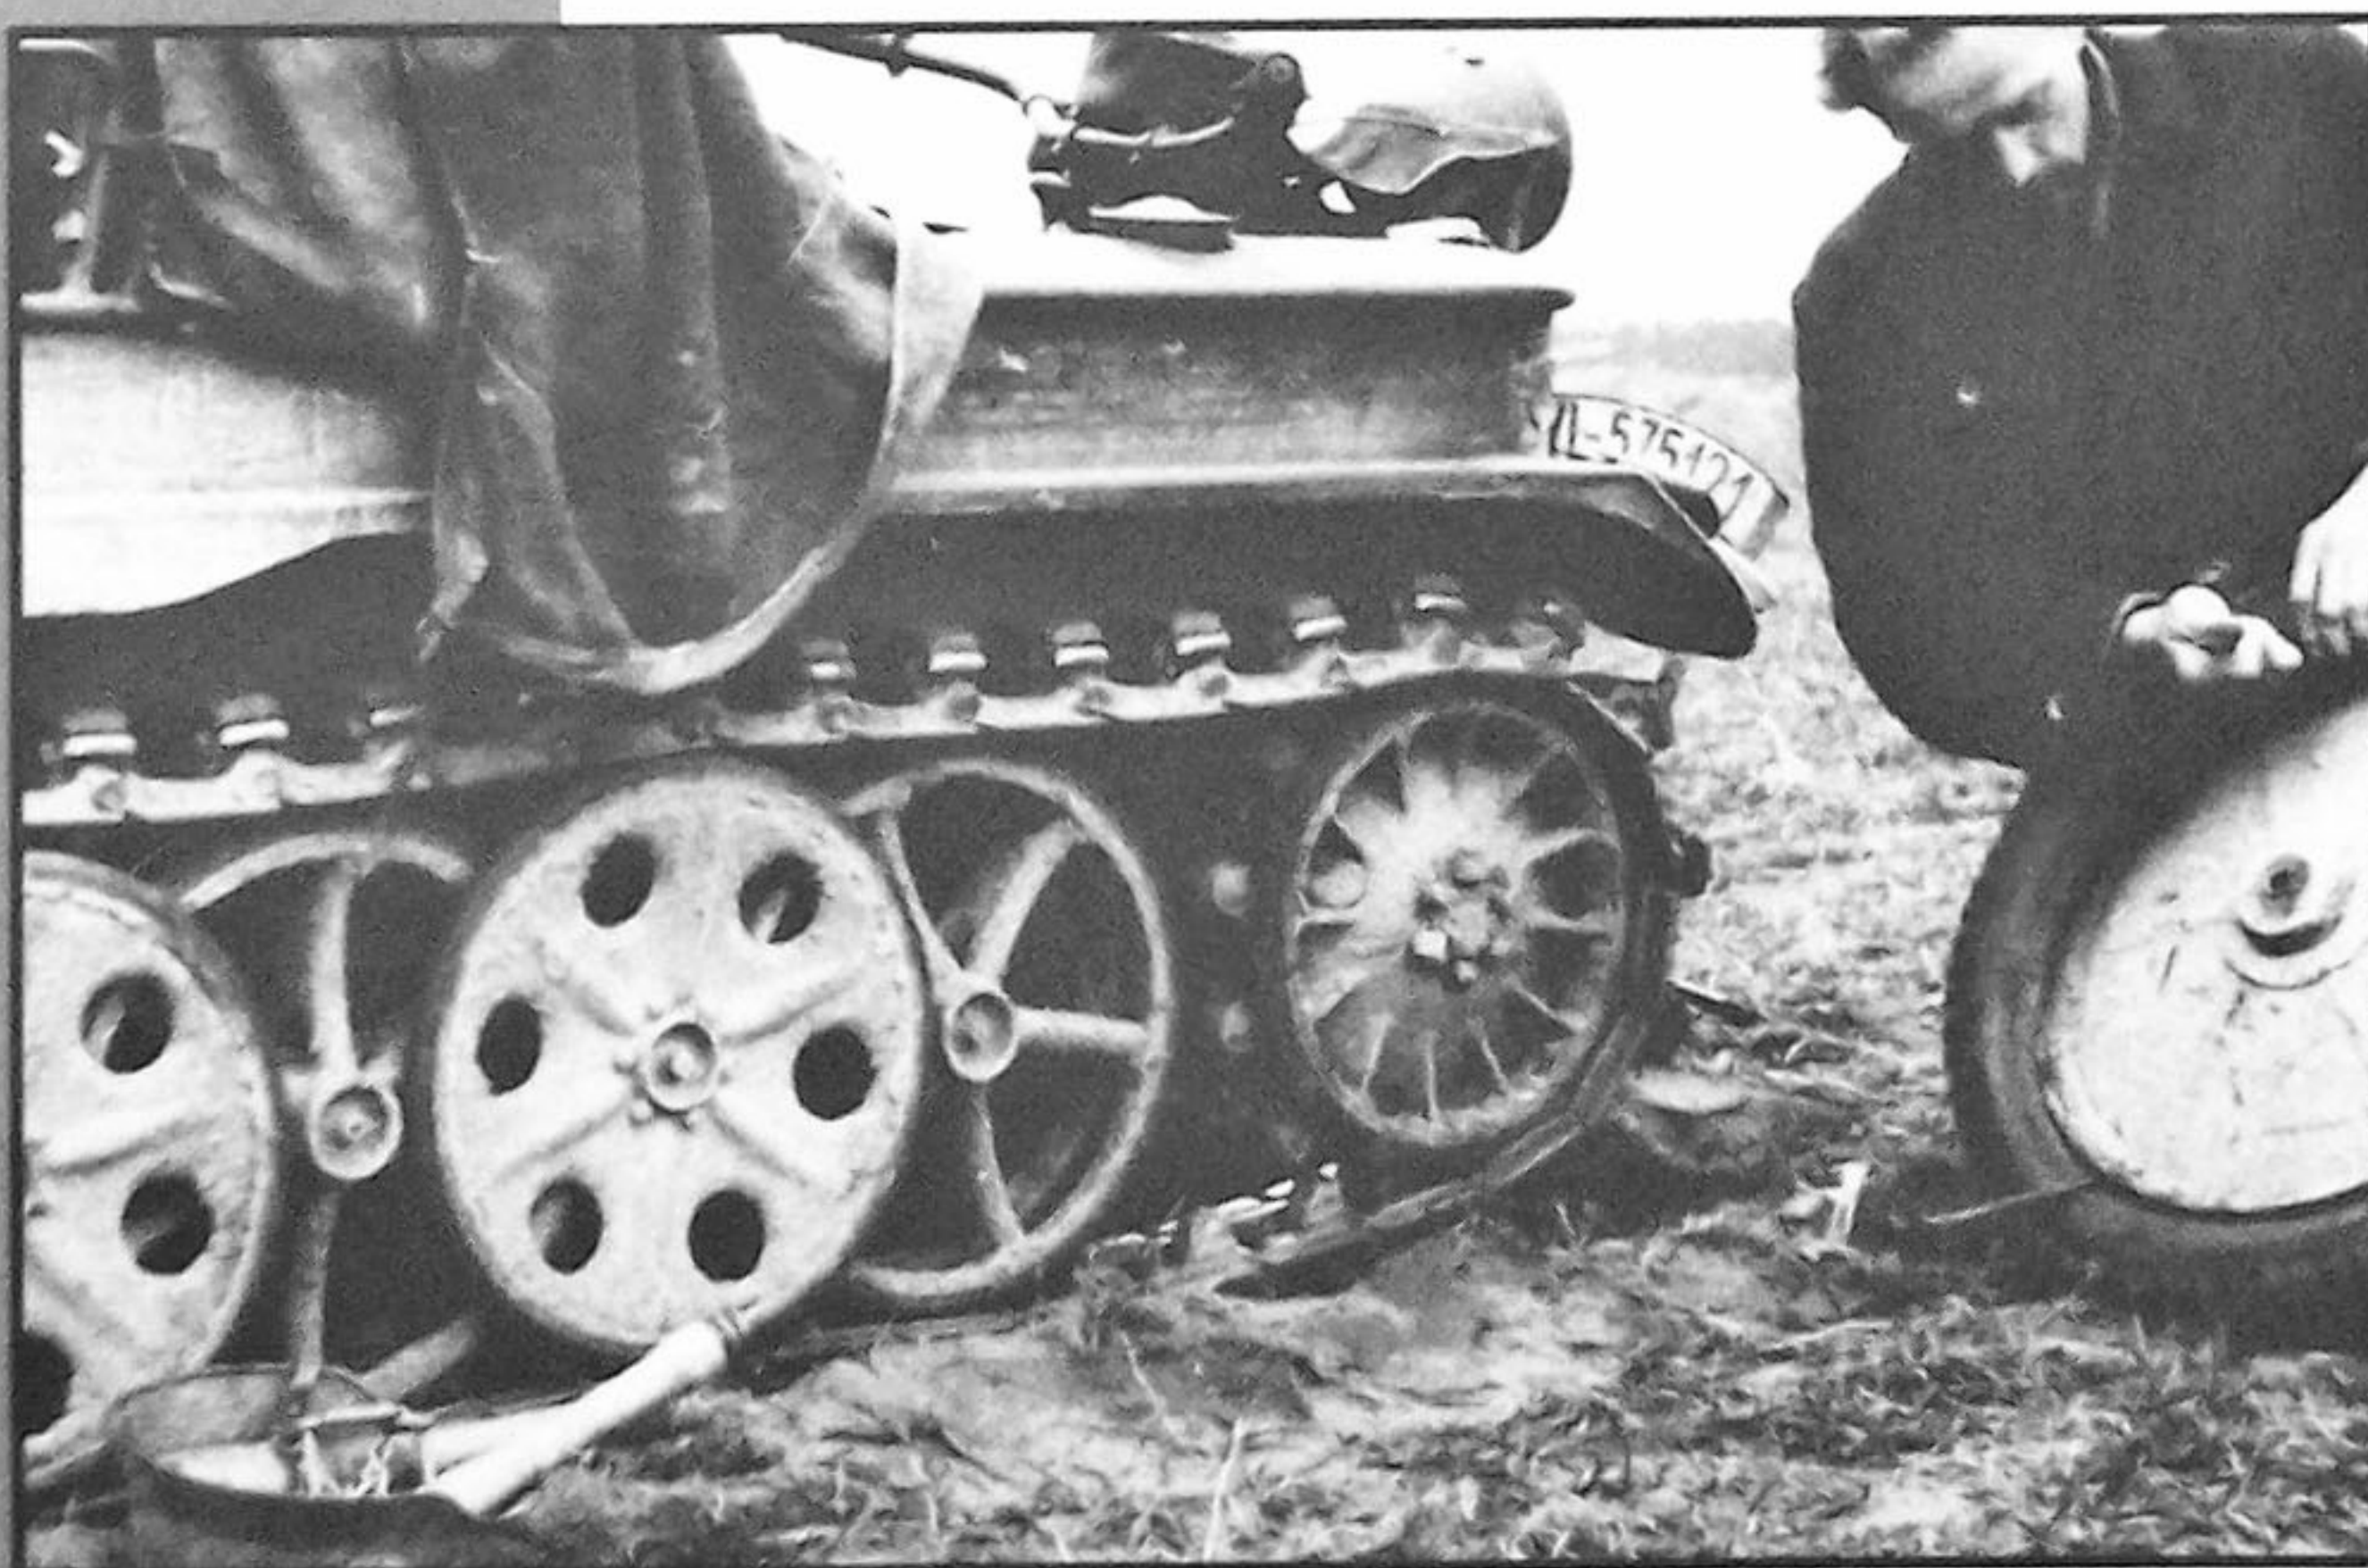
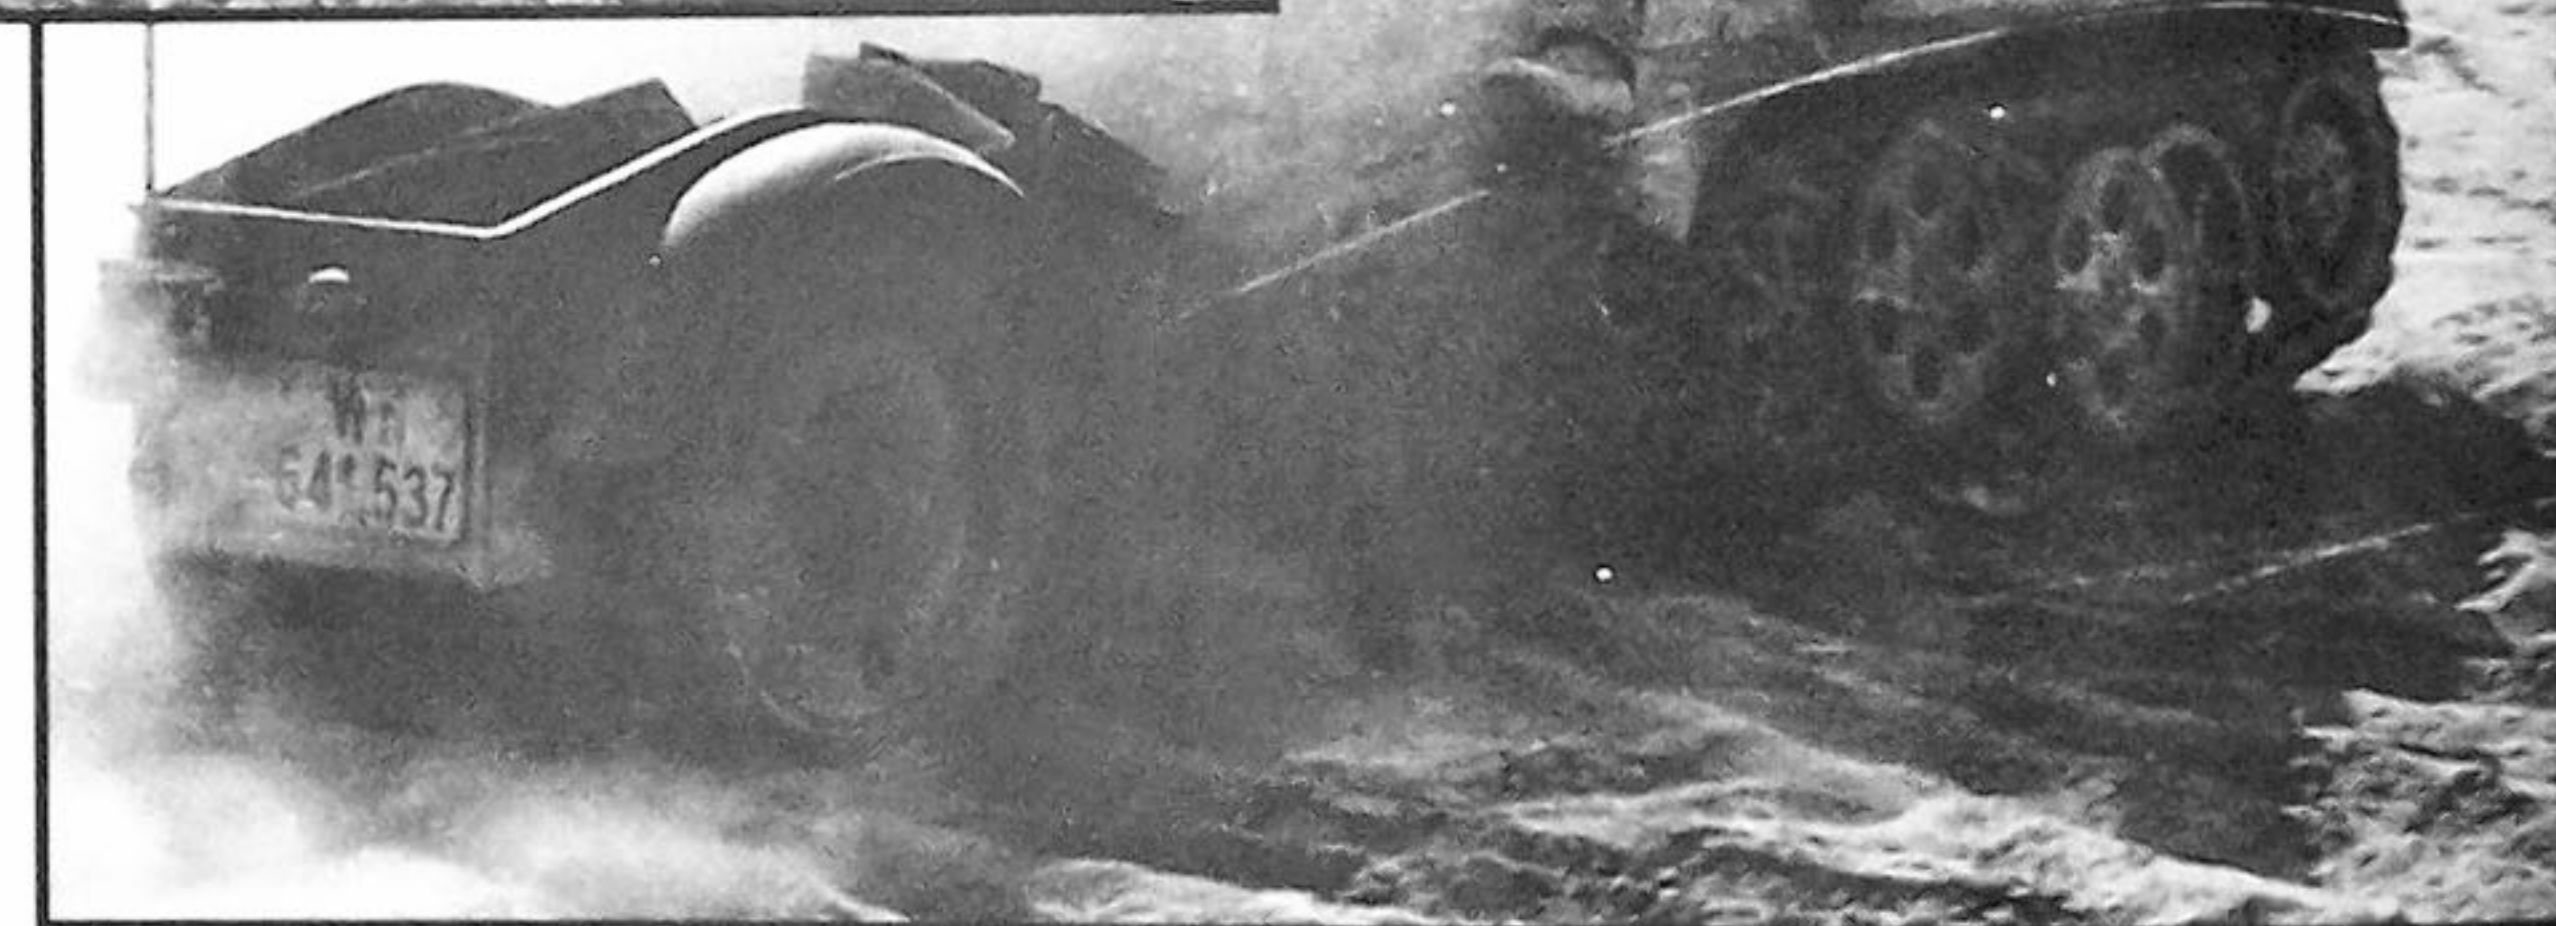
**Above left:** this shot is from the same general sequence as the previous photo. Also note the lack of front marker lights on this Kettenkrad. (BA) **Above center:** this Kettenkrad is serving with a Kradschützen unit in the Deutsche Afrika Korps. It was possible to operate the Kettenkrad in this condition as the steering brakes were actuated as soon as the forks were moved more than 5cm from the center position. The front wheel actually only steered the vehicle in gentle turns. Every square centimeter of rubber track pad has worn away on this vehicle, revealing the metal bases. It is surprising that the tracks still function in this condition. Even though the inner track link sleeves were sealed, maintenance could still be a bear on these types of tracks. Each link contained over twenty parts. This vehicle tows what appears to be a modified trailer from a 2cm-flak gun. (BA) **Above right:** this is a good example of why the track pads were worn off in the previous photo. The super fine sand thrown up by every movement was not healthy for any machine. (BA) **Left:** changing a tire was much simpler and was just like changing any standard motorcycle or bicycle tire of the time. The wheel was quite simple and it consisted of two pieces of pressed steel welded together. The center hub was more complex and consisted of an inner and outer axle and a central shaft that housed a bearing race for each side of the wheel. (BA)

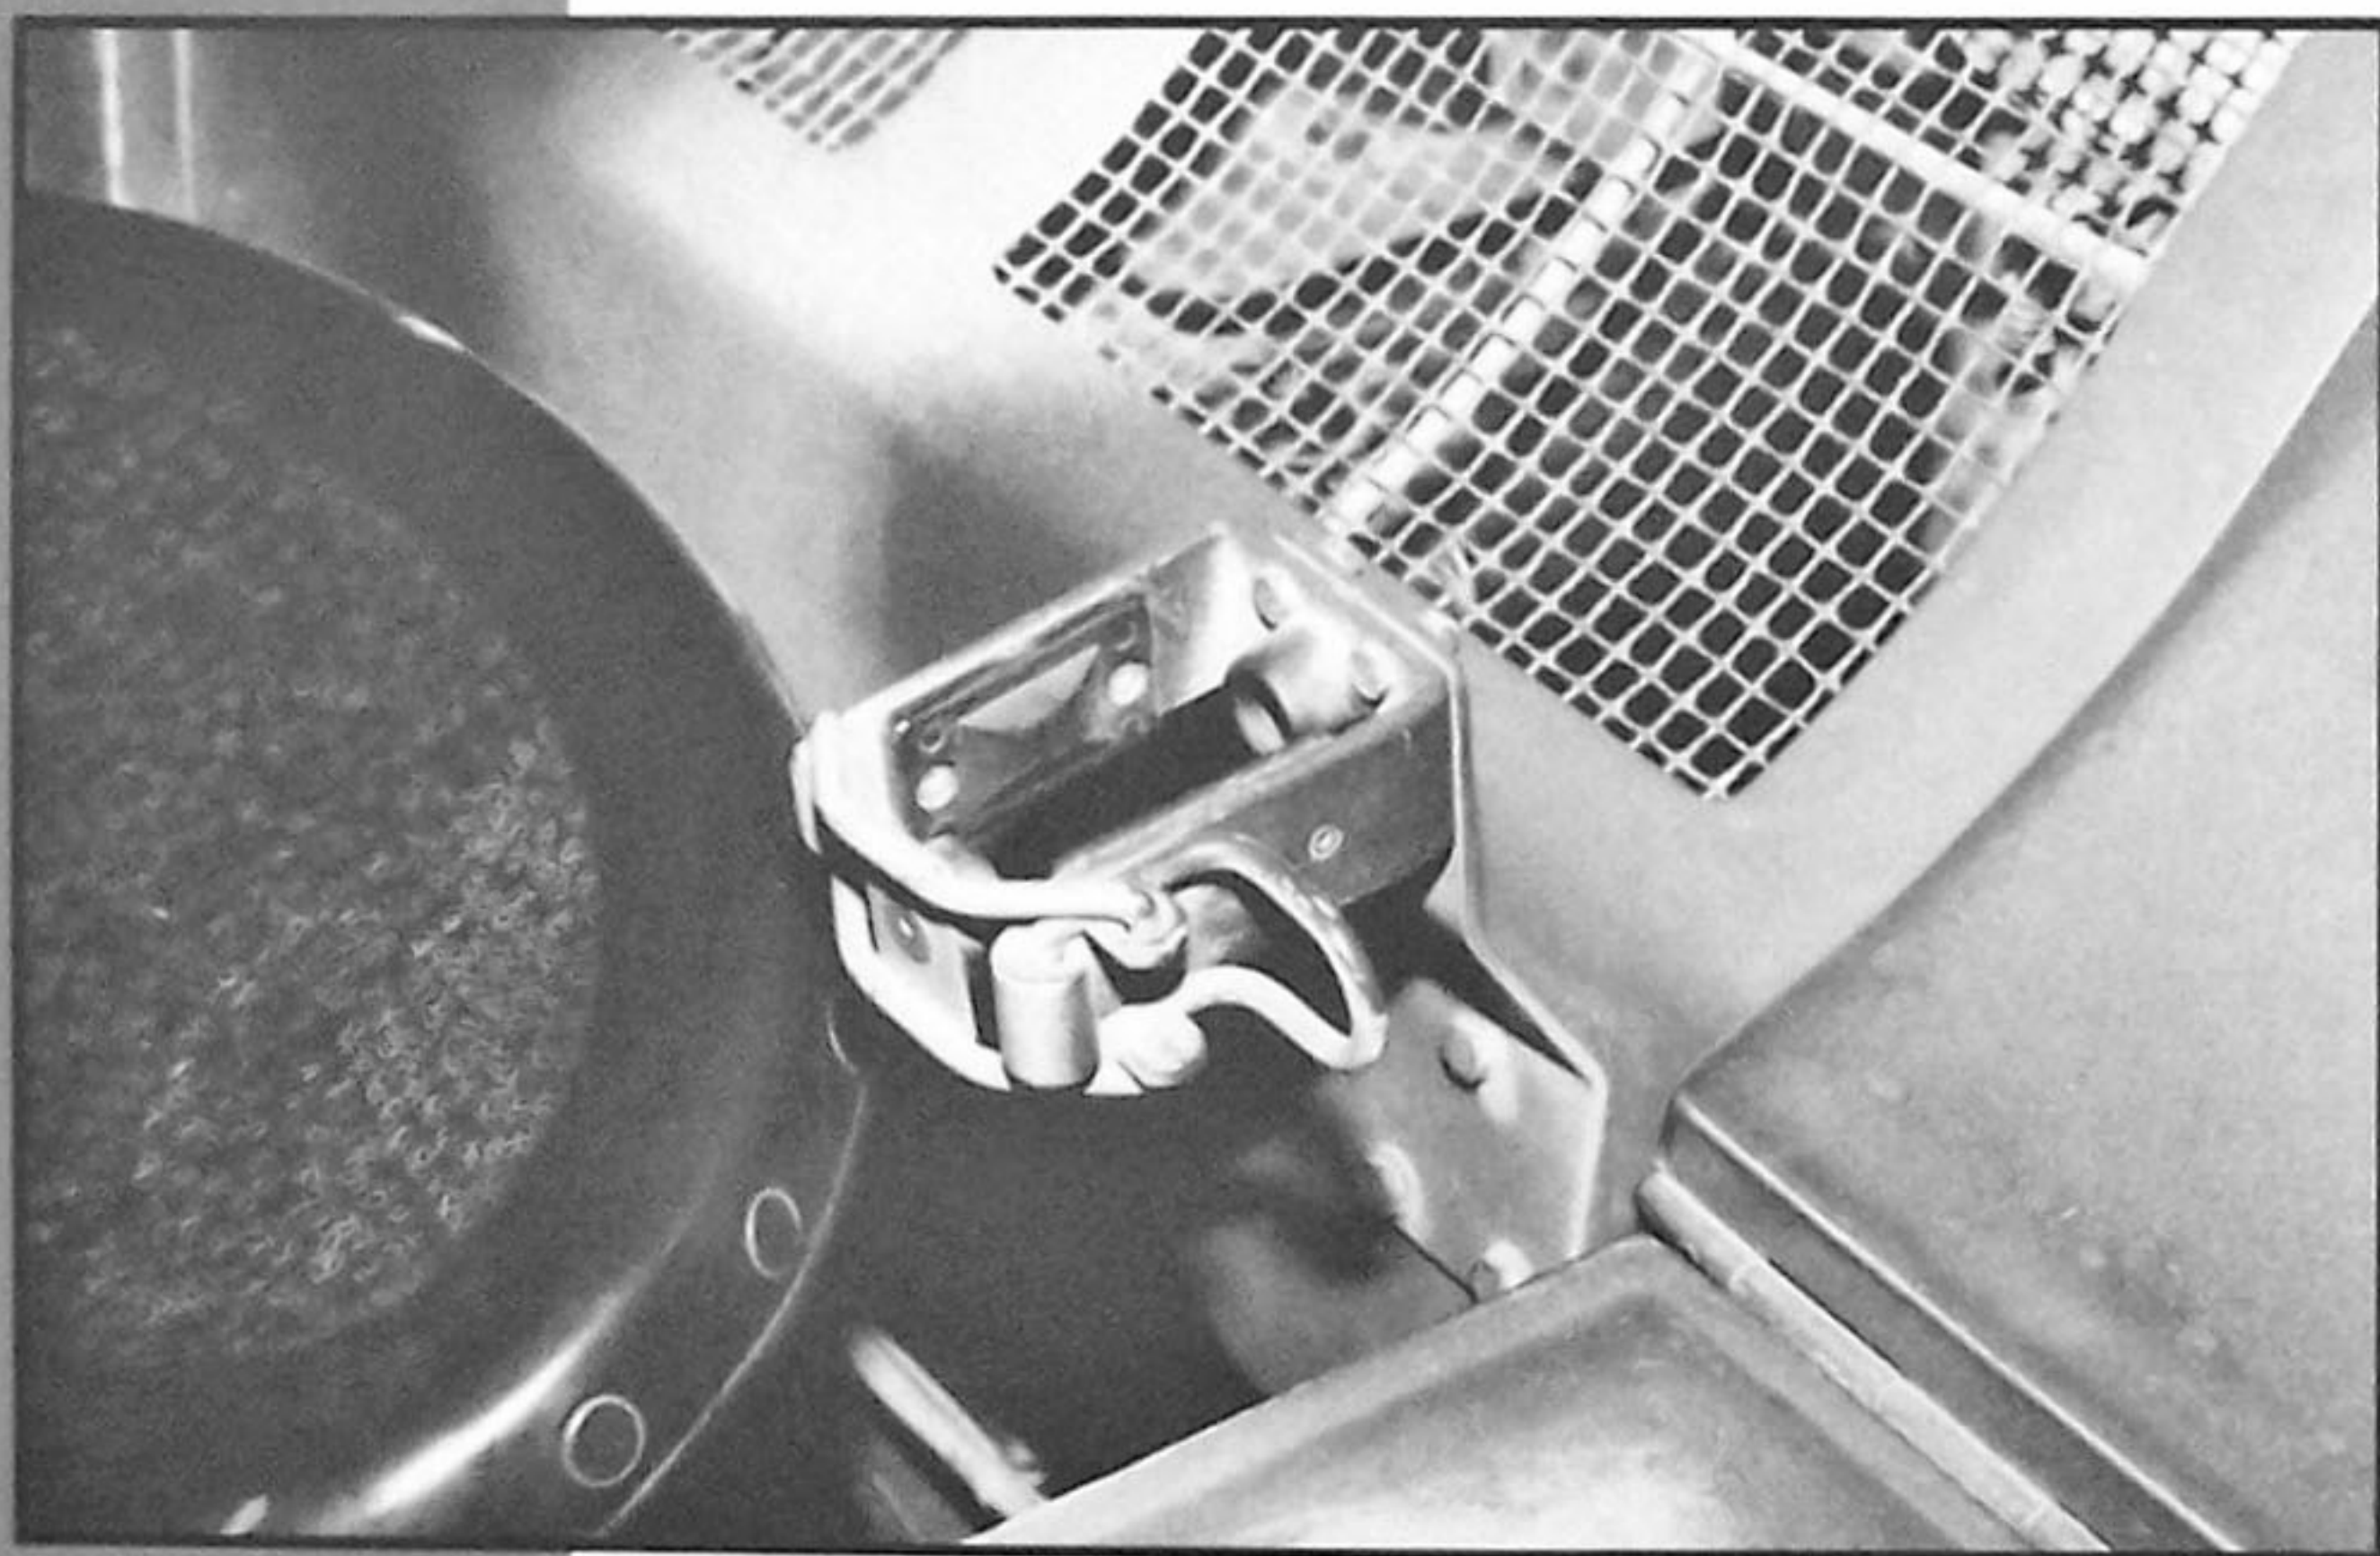
**Top left:** a closer view of the top of the steering column, showing the damping knob and the cast portion of the assembly. **Top right:** this is a replacement canvas cover for the top of the steering column. Note how it fastens to brackets on each side of the headlight. These brackets can be clearly seen in the photo on the lower right of the previous page. This particular cover is newly made and is missing the small hole in the upper right side for the light cable to feed through. **Above left:** two rifle racks are installed in the driver's area of this Kettenkrad. The clasp seen here corresponded to an oval sleeve on

the floor of the vehicle. Two similar racks are installed on the rear of the Kettenkrad. Early vehicles were missing these details. This shot also provides a close-up view of the standard motorcycle saddle installed for the driver. **Above right:** this post and bracket was used to install another canvas cover over the driver's compartment. It was also a handy place to hang equipment from. The mesh for the engine compartment can also be seen here.
