# Allied-Axis

THE PHOTO JOURNAL OF THE SECOND WORLD WAR

**German  
SIG 33/1  
Grille SPG**

**Kleines Kettenkrafttrad  
WWII Dodge 3/4-ton trucks  
DUKW Amphibious truck**

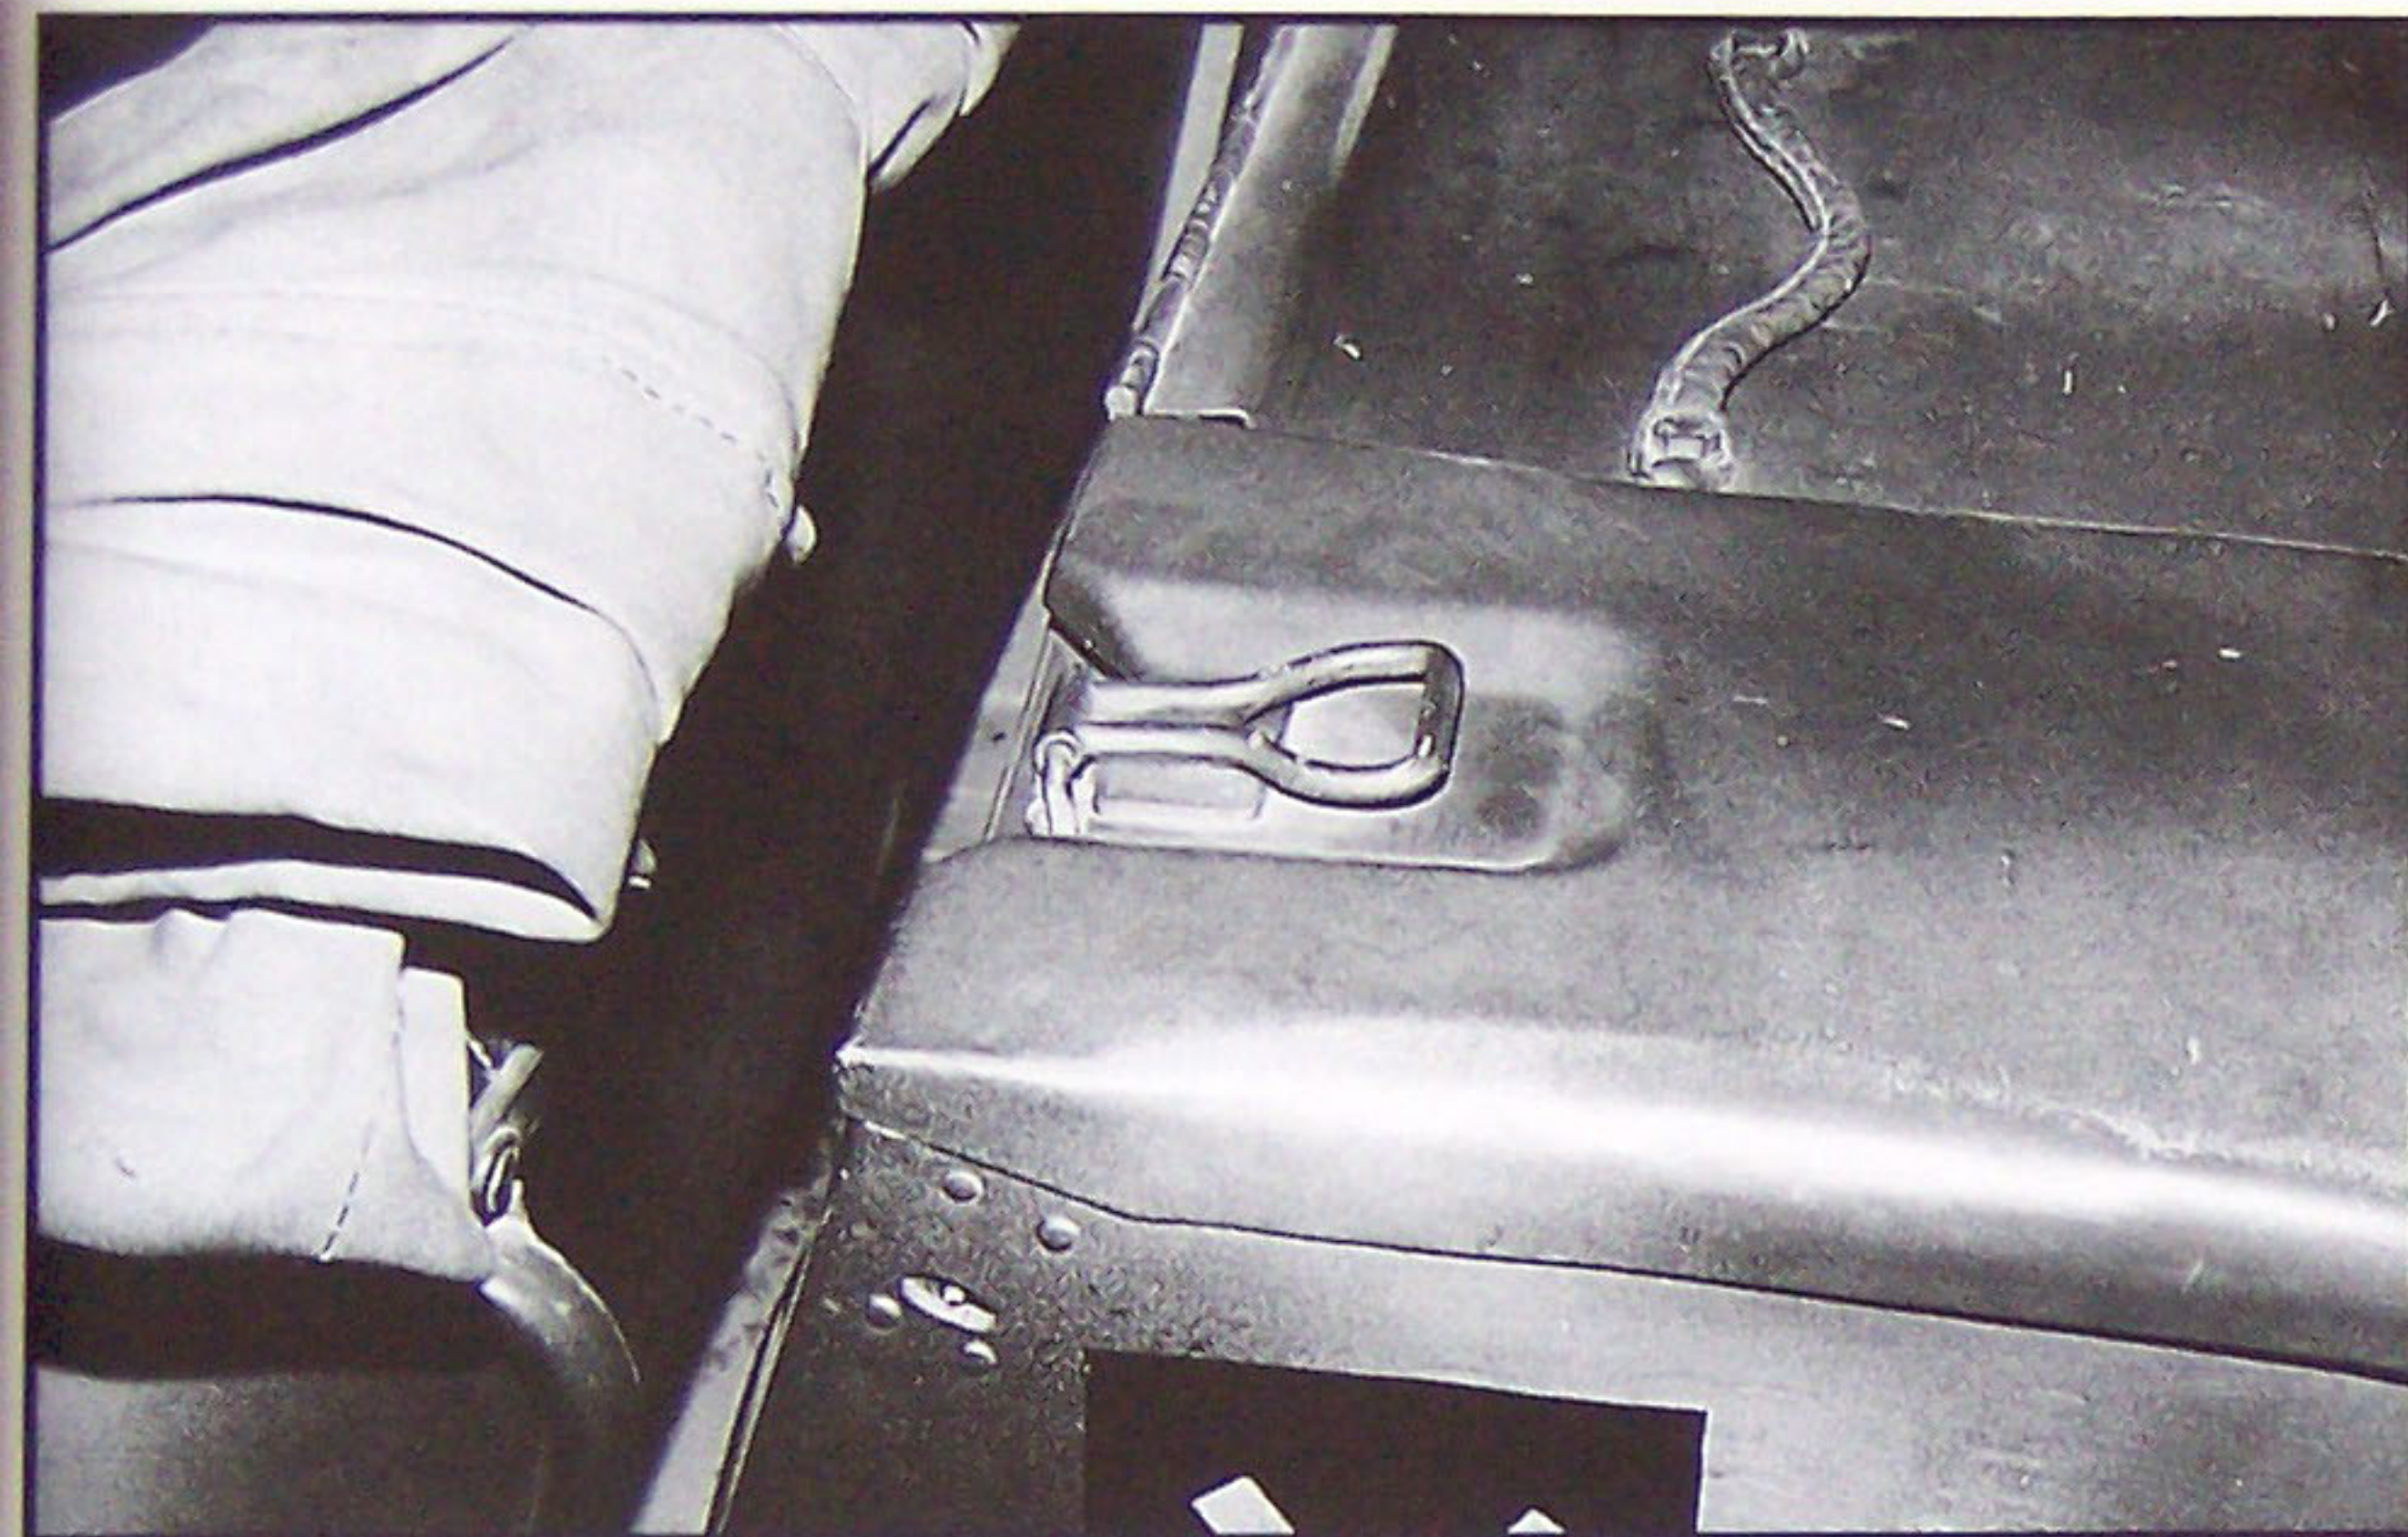
**Top left:** this is one of two clasps used to secure the engine access door. The canvas cover for the passenger area can be seen at left. **Top right:** the left side front marker light and its cord. The bottom attachment point for the steering column cover is also seen, as well as the very top of the front cast towing bracket. **Above left:** provision for a shovel was not part of the factory equipment of the Kettenkrad, but it is highly possible that it could have been done at the unit level workshops. This is another contemporary, restored vehicle. **Above right:** the back end of the Münster Kettenkrad. Both the seat bottom and the panels beneath it were removable for access to the engine and cooling system.

The in-line 4-cylinder Opel engine faced towards the rear of the vehicle and the housing for the radiator is just beneath the seat cushion. The driver could regulate the amount of air reaching the housing via the small door seen below the license plate. This door was controlled via a cable and a small lever on the left side of the driver's compartment. This shot affords a good view of the rear trailer light socket. Also note the small rectangular objects at the very bottom corner of the rear compartment. These are the rear taillights. There appears to be some variation in the shape of the center housing from vehicle to vehicle (disregard the rear marker light).

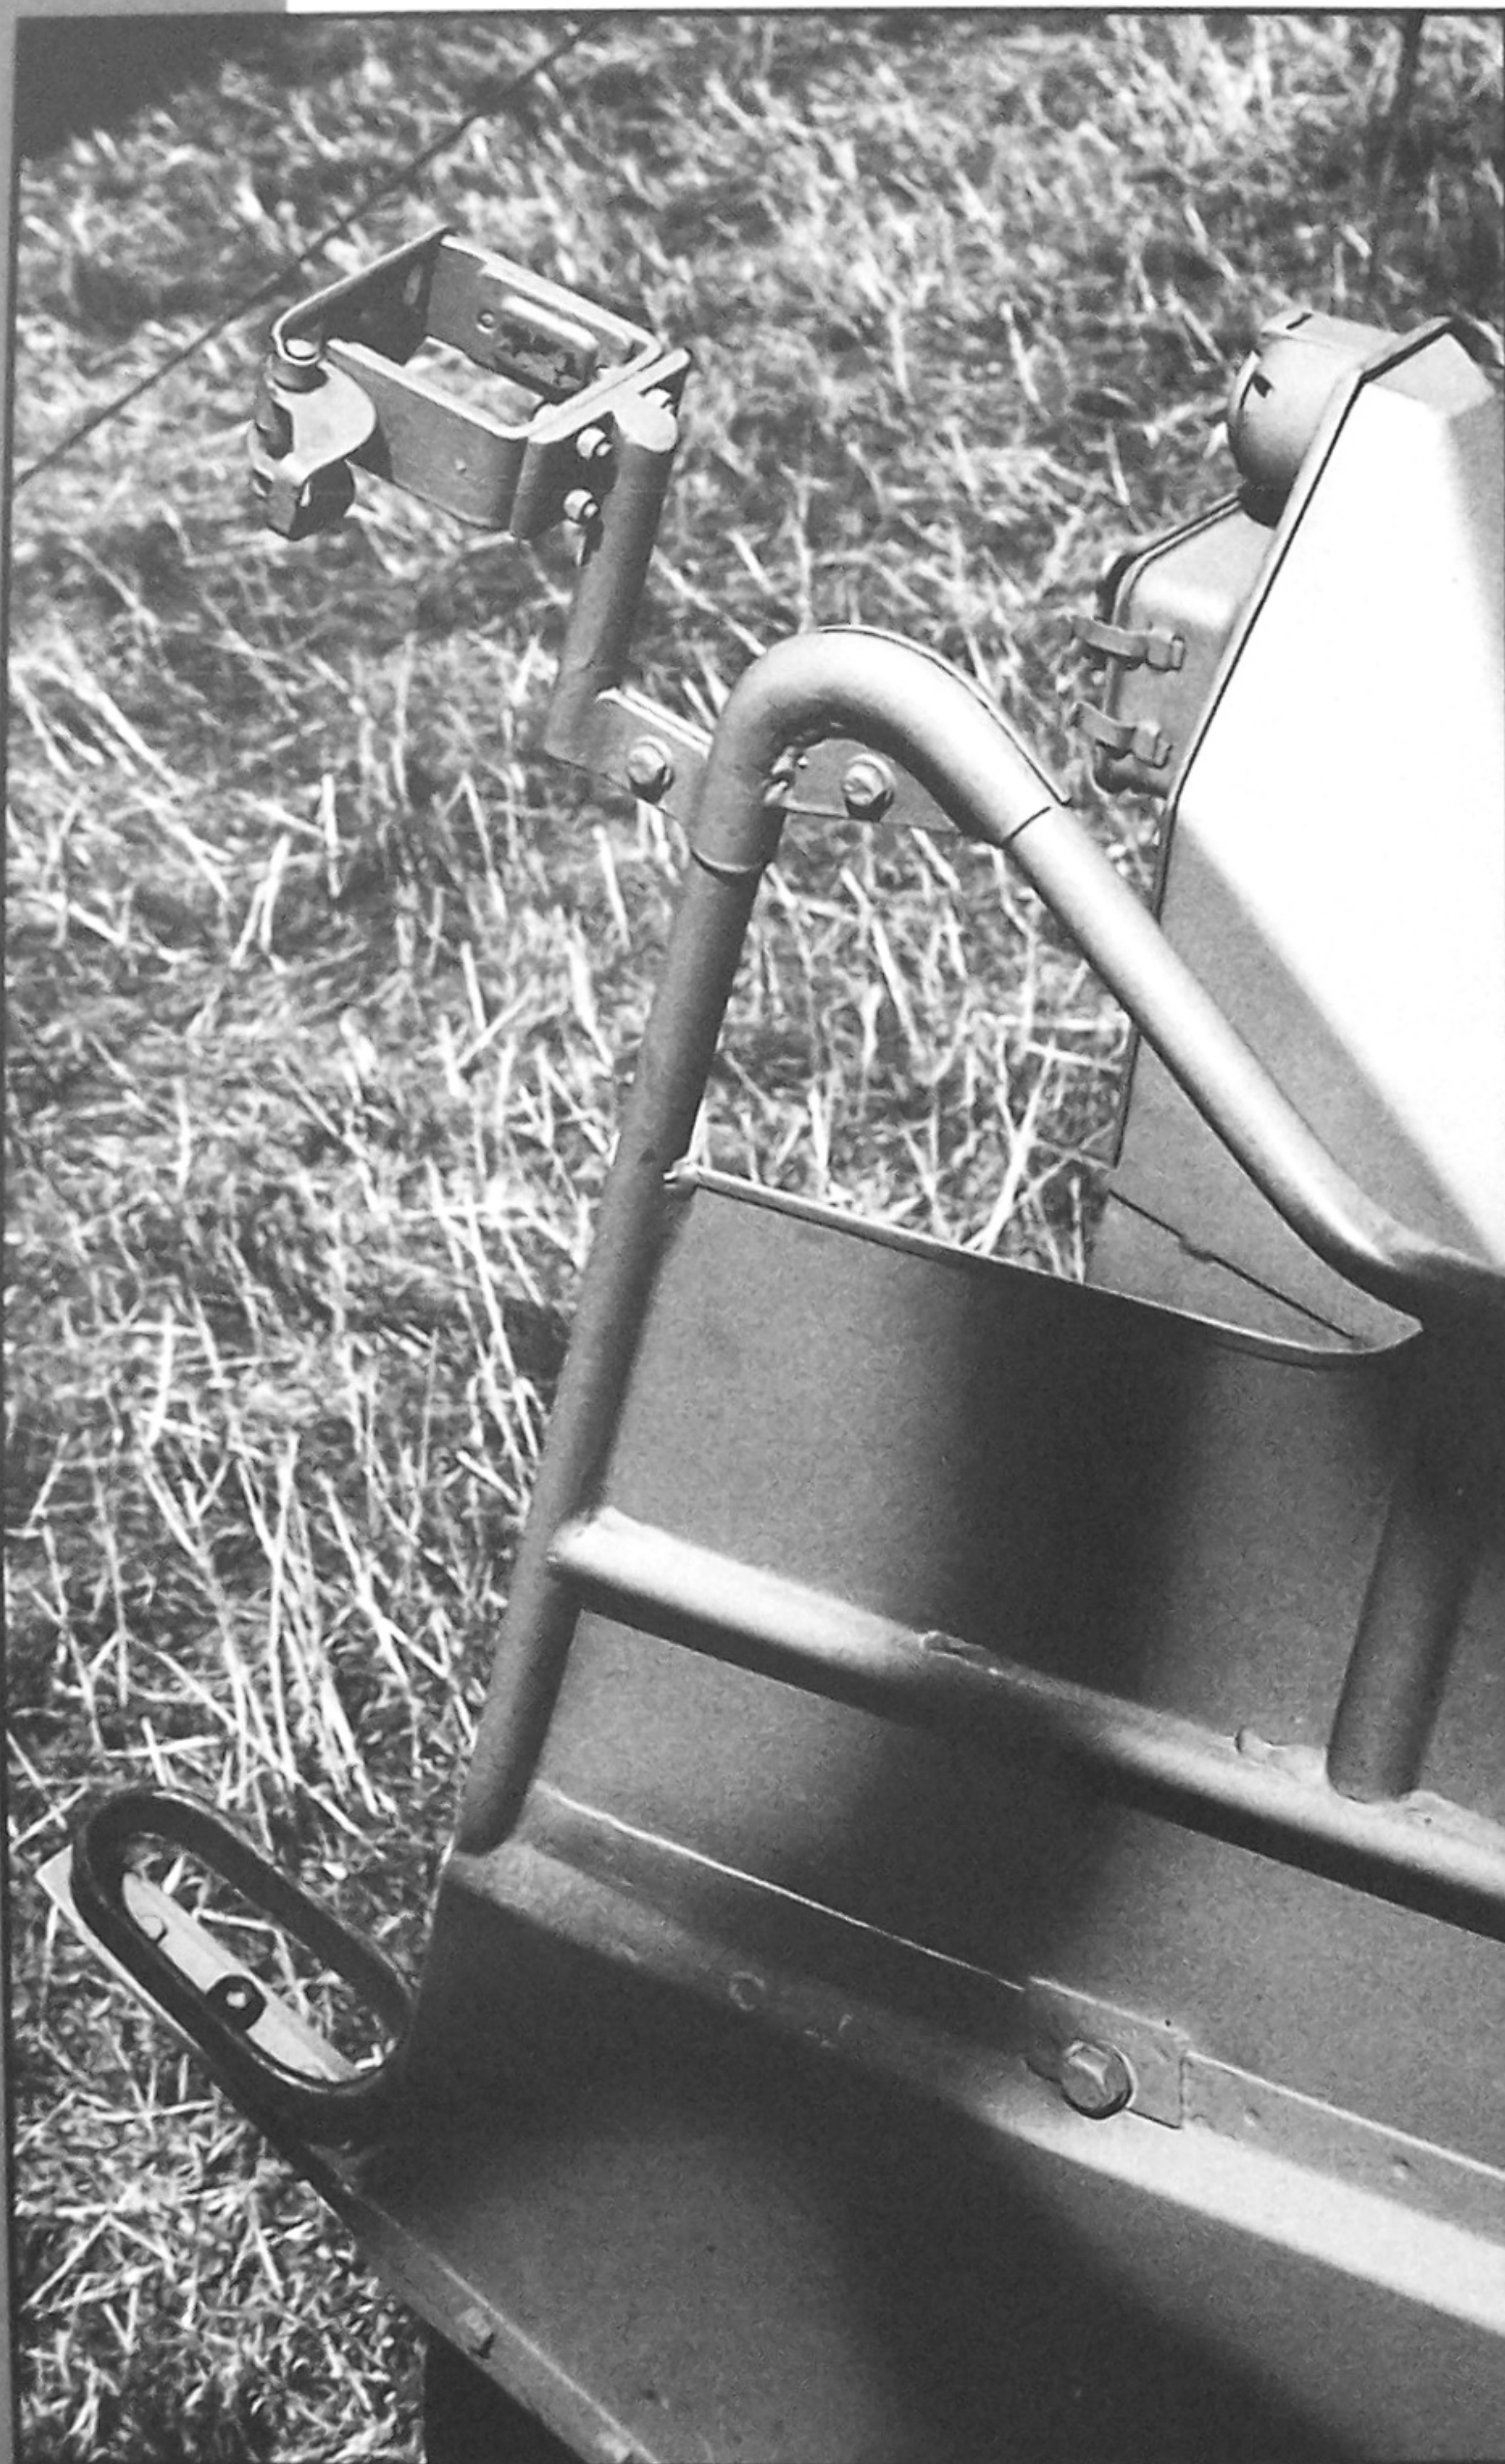
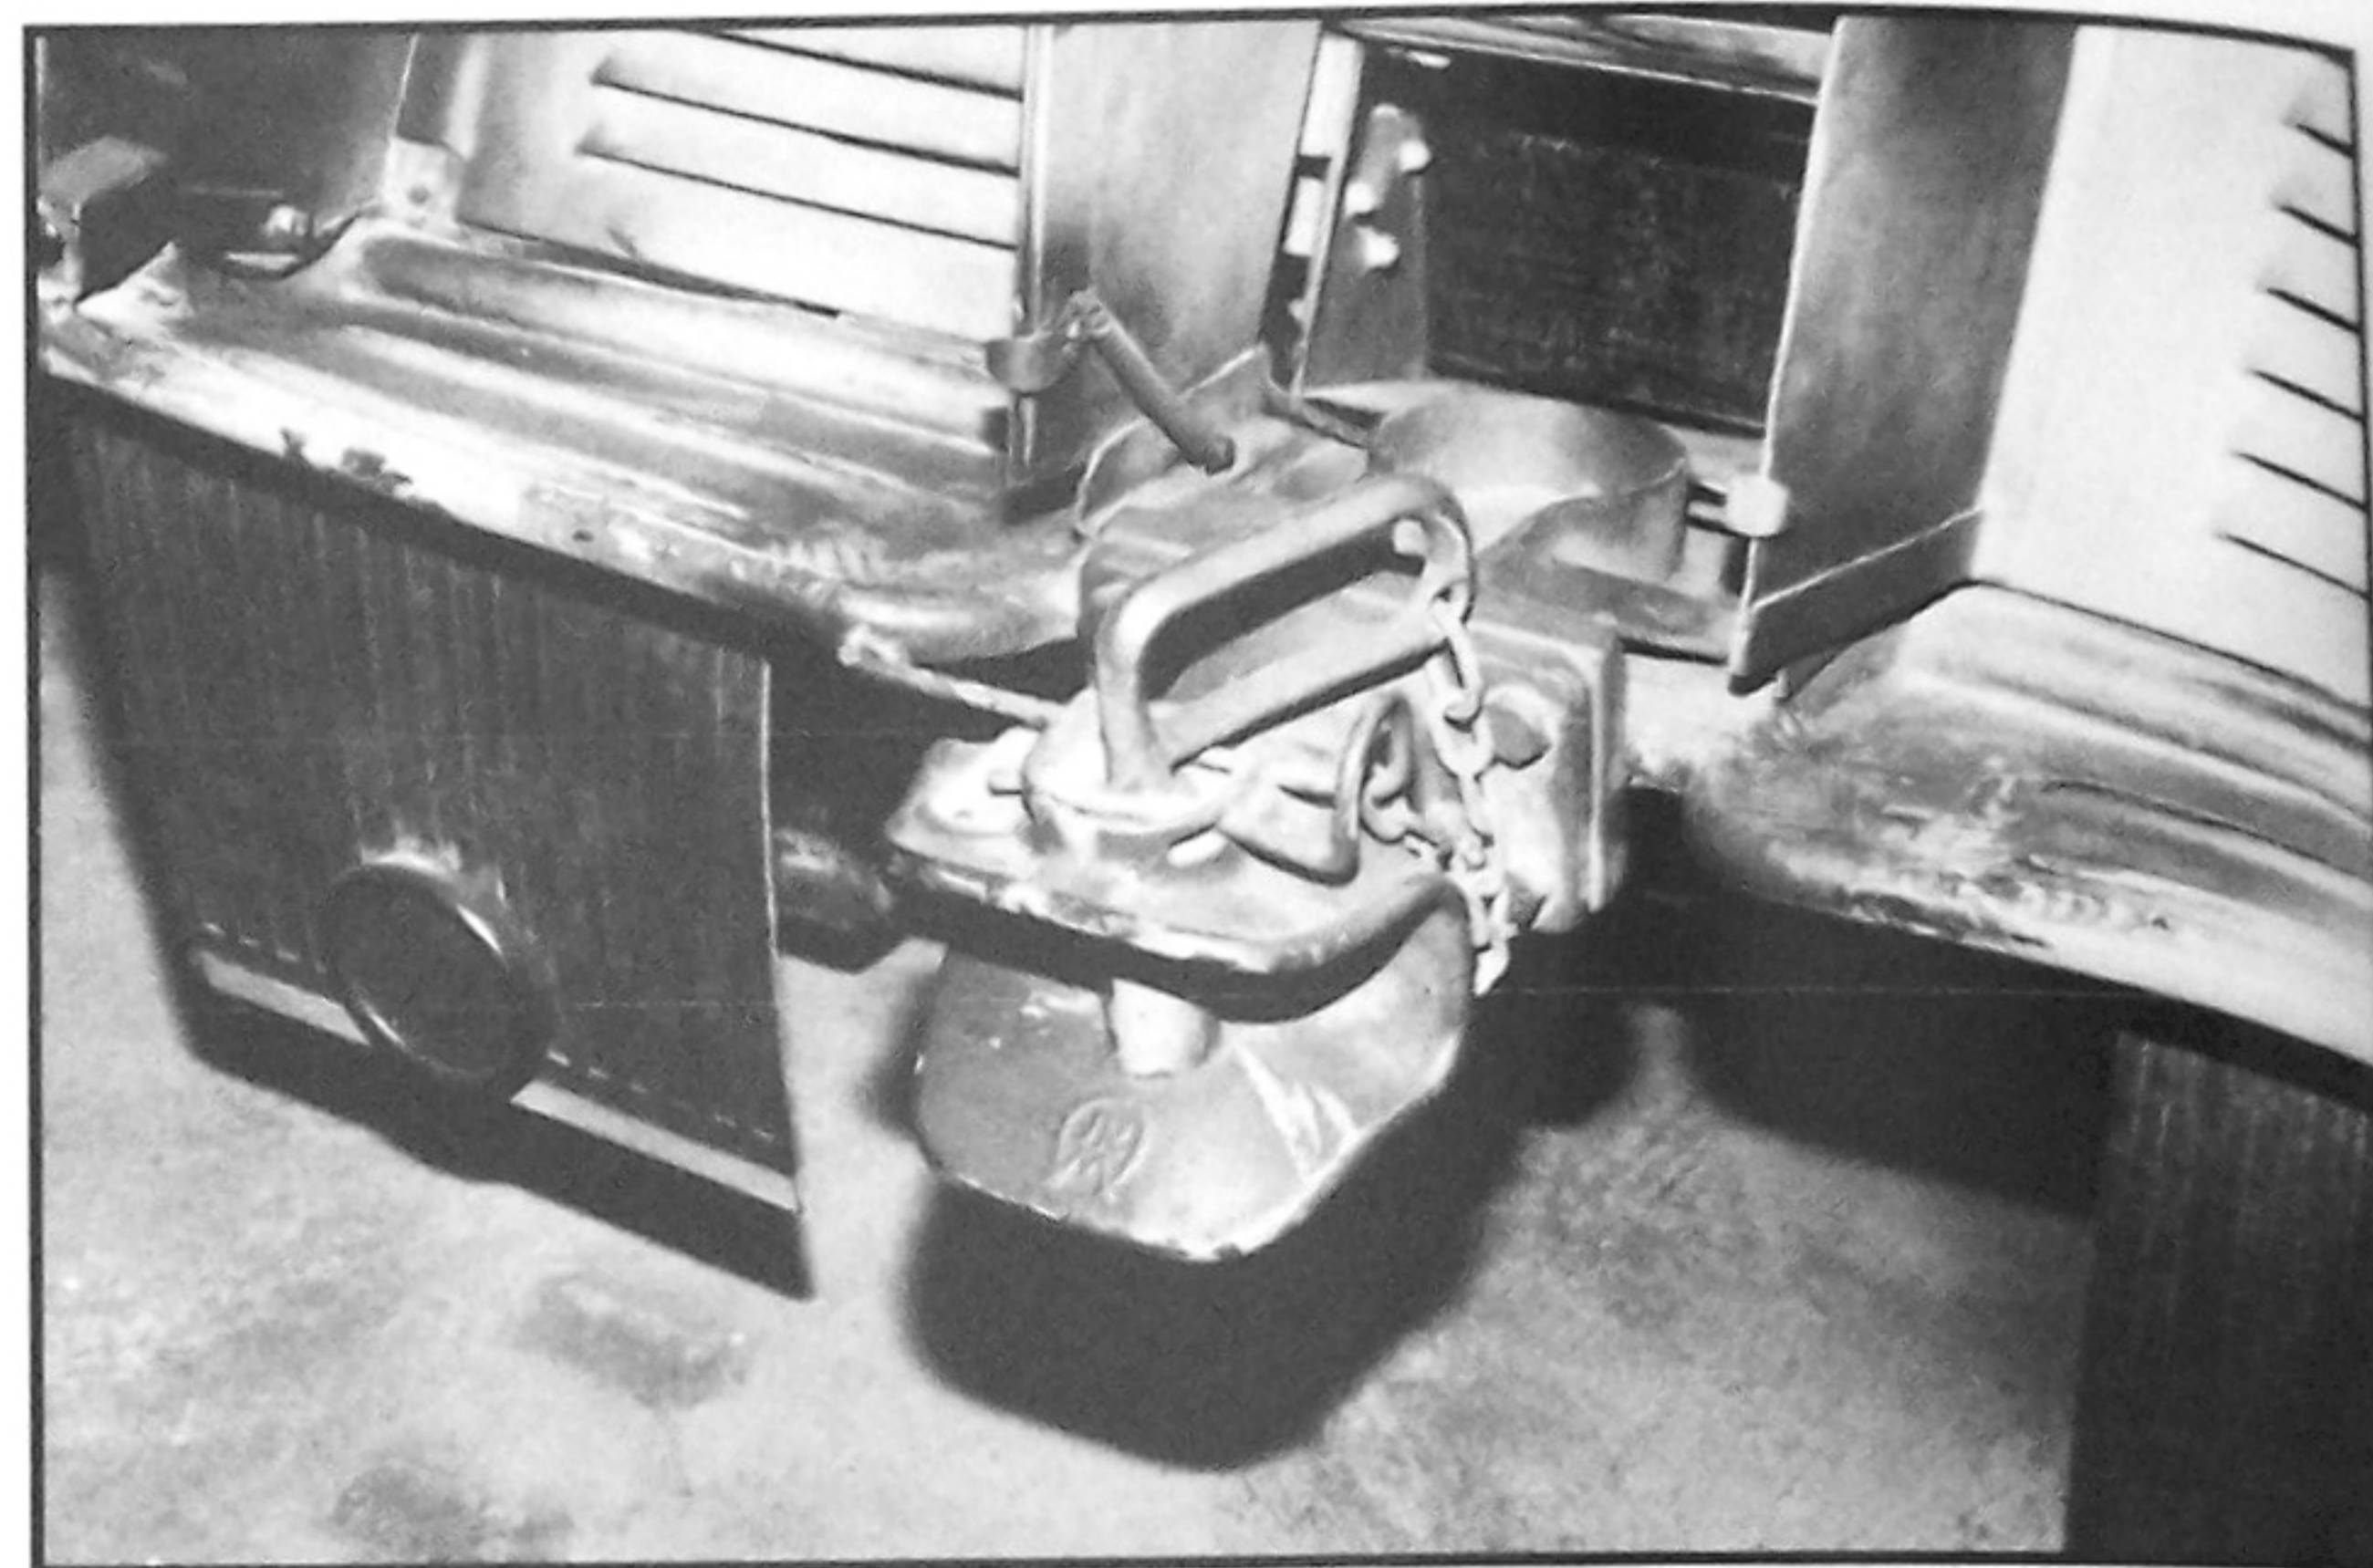
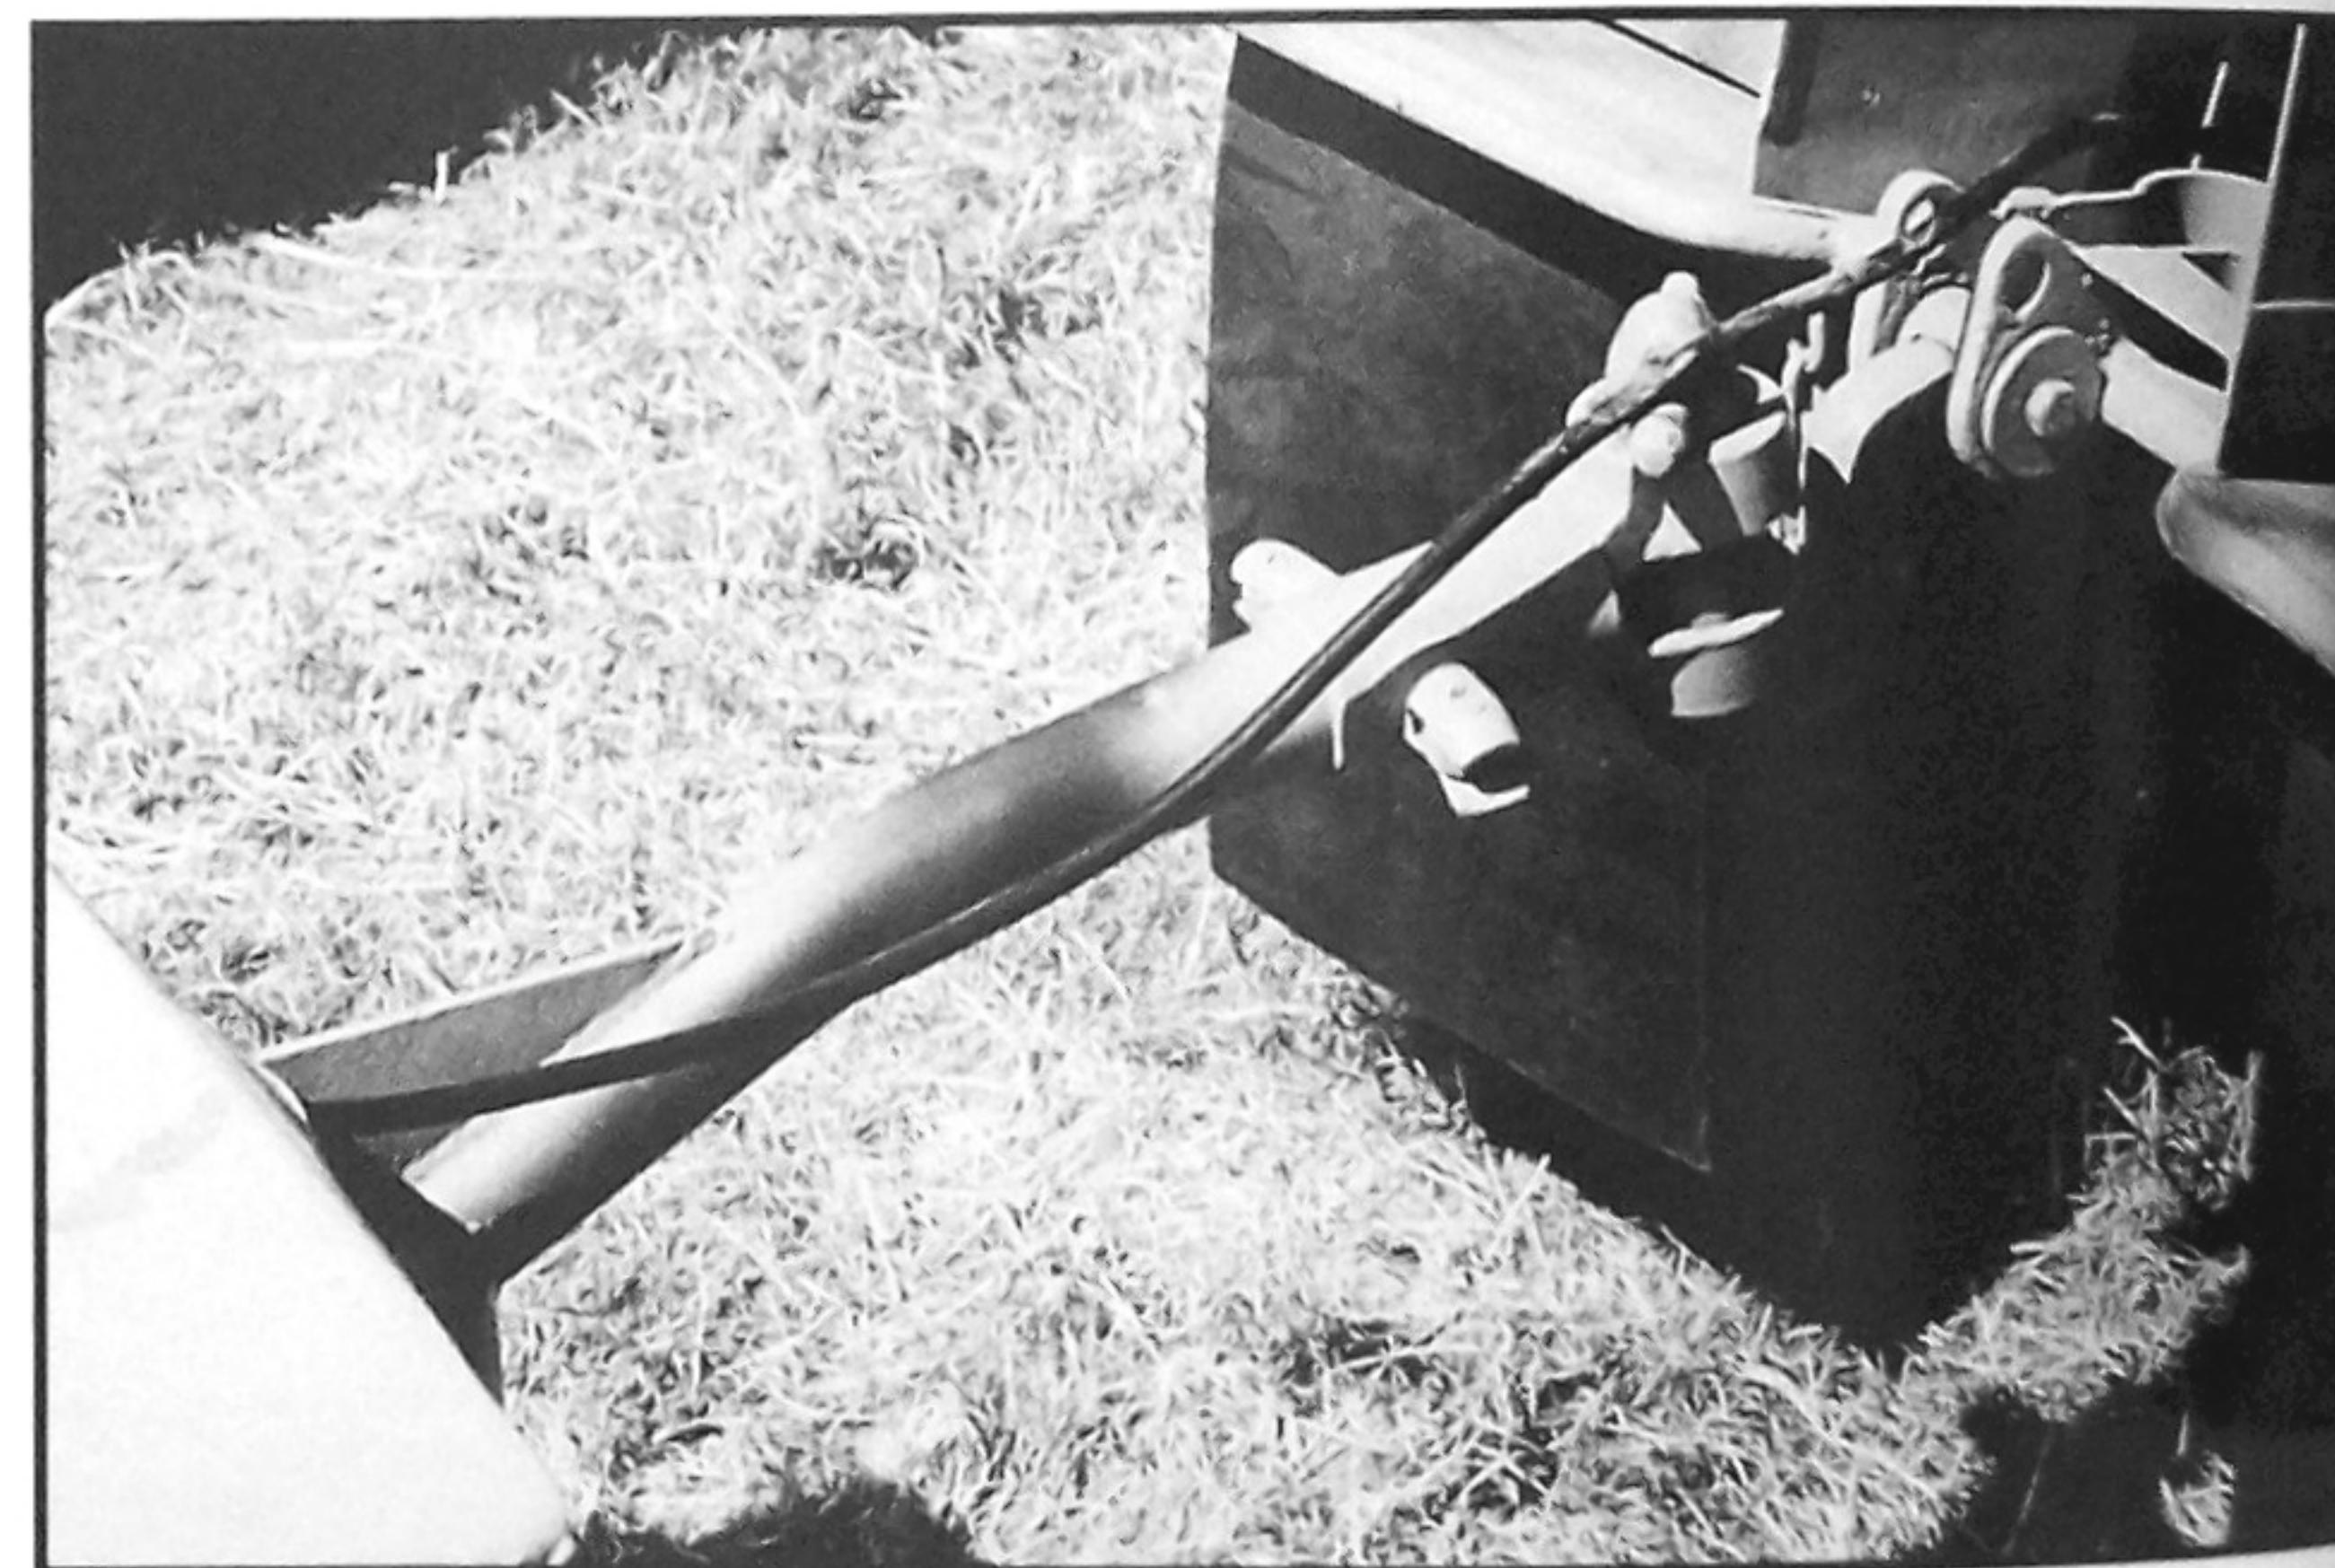
**Above left:** the rear rifle rack on the Beltring vehicle. This shot provides another view of the center housing. This vehicle has the correct rear marker light installed. **Top right:** the rear tow hook of the Münster vehicle is the heavier type developed for towing the 10.5cm LG 40 recoilless gun used by Fallschirmjäger units. **Above right:** this is the more common type of tow hook installed on Kettenkrads. The pintle itself is very similar to those seen on other German light vehicles, such as the Demag D7. The hinged base, however, was uniquely designed for the Kettenkard. This allowed it to cross obstacles of significant depth without "jack-knifing" the trailer. Here, the boom of the Sd.Ah 1 trailer is installed.

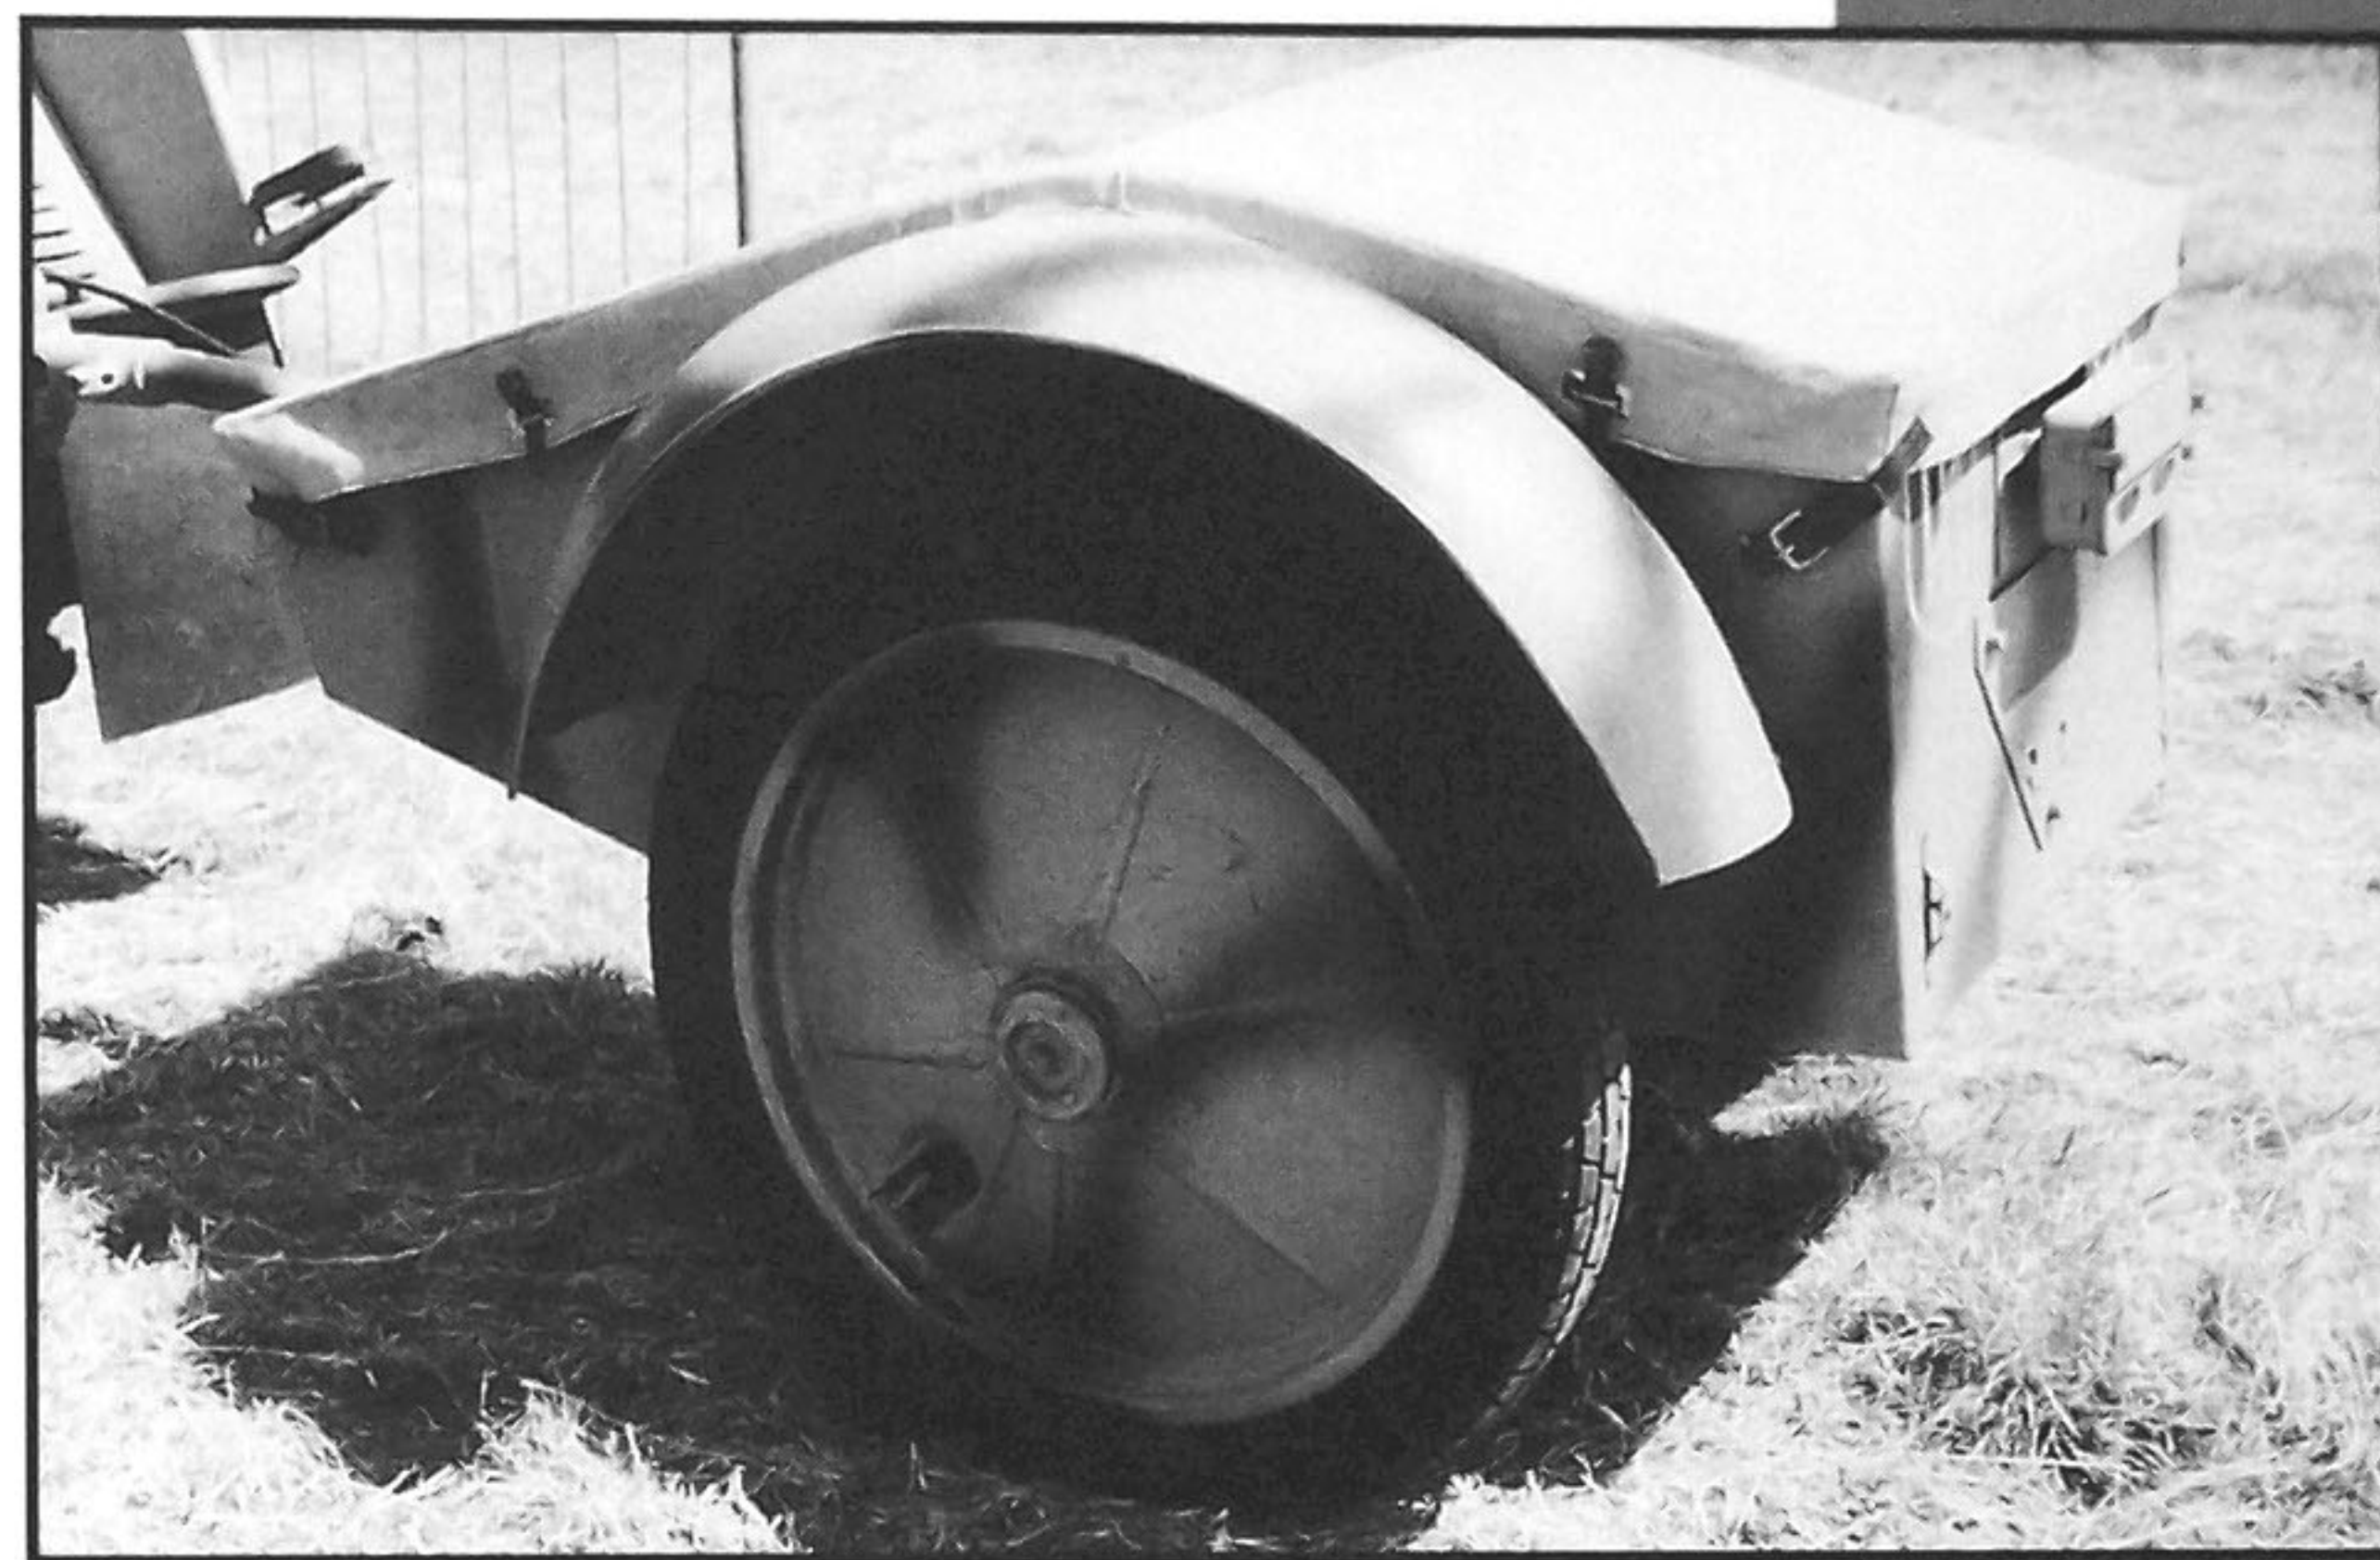
There were six different trailers designed during the war exclusively for the Kettenkrad. The first was designed with the prototype and never reached production status. The second, seen here, was the most numerous and was a derivation of the earlier prototype with a longer hitch pole and solid disk wheels. This trailer had the designation of Sd.Ah. 1 (sonderanhänger: "special trailer"). The third type was designed specially for use with Gebirgsjäger units and was a modification of the standard infantry cart (see previous photo). The fourth type was designed at the request of the Luftwaffe for a heavier trailer for Fallschirmjäger units. This trailer was of heavy, tubular construction and utilized four small, broad rubber tires. The fifth type was nearly identical to the second type, but it was equipped with special fittings to store communications cable and was used in conjunction with the Kettenkrad SdKfz. 2/1. This

trailer had the designation of Sd.Ah. 1/1. The final type, was another modification of the Sd.Ah. 1. It was modified to include a partition across its width and mounts for two large spools of communications wire. This trailer had the designation of Sd.Ah. 1/2 and was used in conjunction with the SdKfz. 2/2. **This page:** four additional views of the Sd.Ah. 1. A canvas tarp was provided to protect the interior of the trailer, which was of all steel construction. Several trailers could be linked together and the base plate for the auxiliary hitch can be seen in the photo above left. The cord seen above right could be plugged into the socket in the middle of the rear partition.
