# Allied-Axis

THE PHOTO JOURNAL OF THE SECOND WORLD WAR

**German  
SIG 33/1  
Grille SPG**

**Kleines Kettenkrafttrad  
WWII Dodge 3/4-ton trucks  
DUKW Amphibious truck**

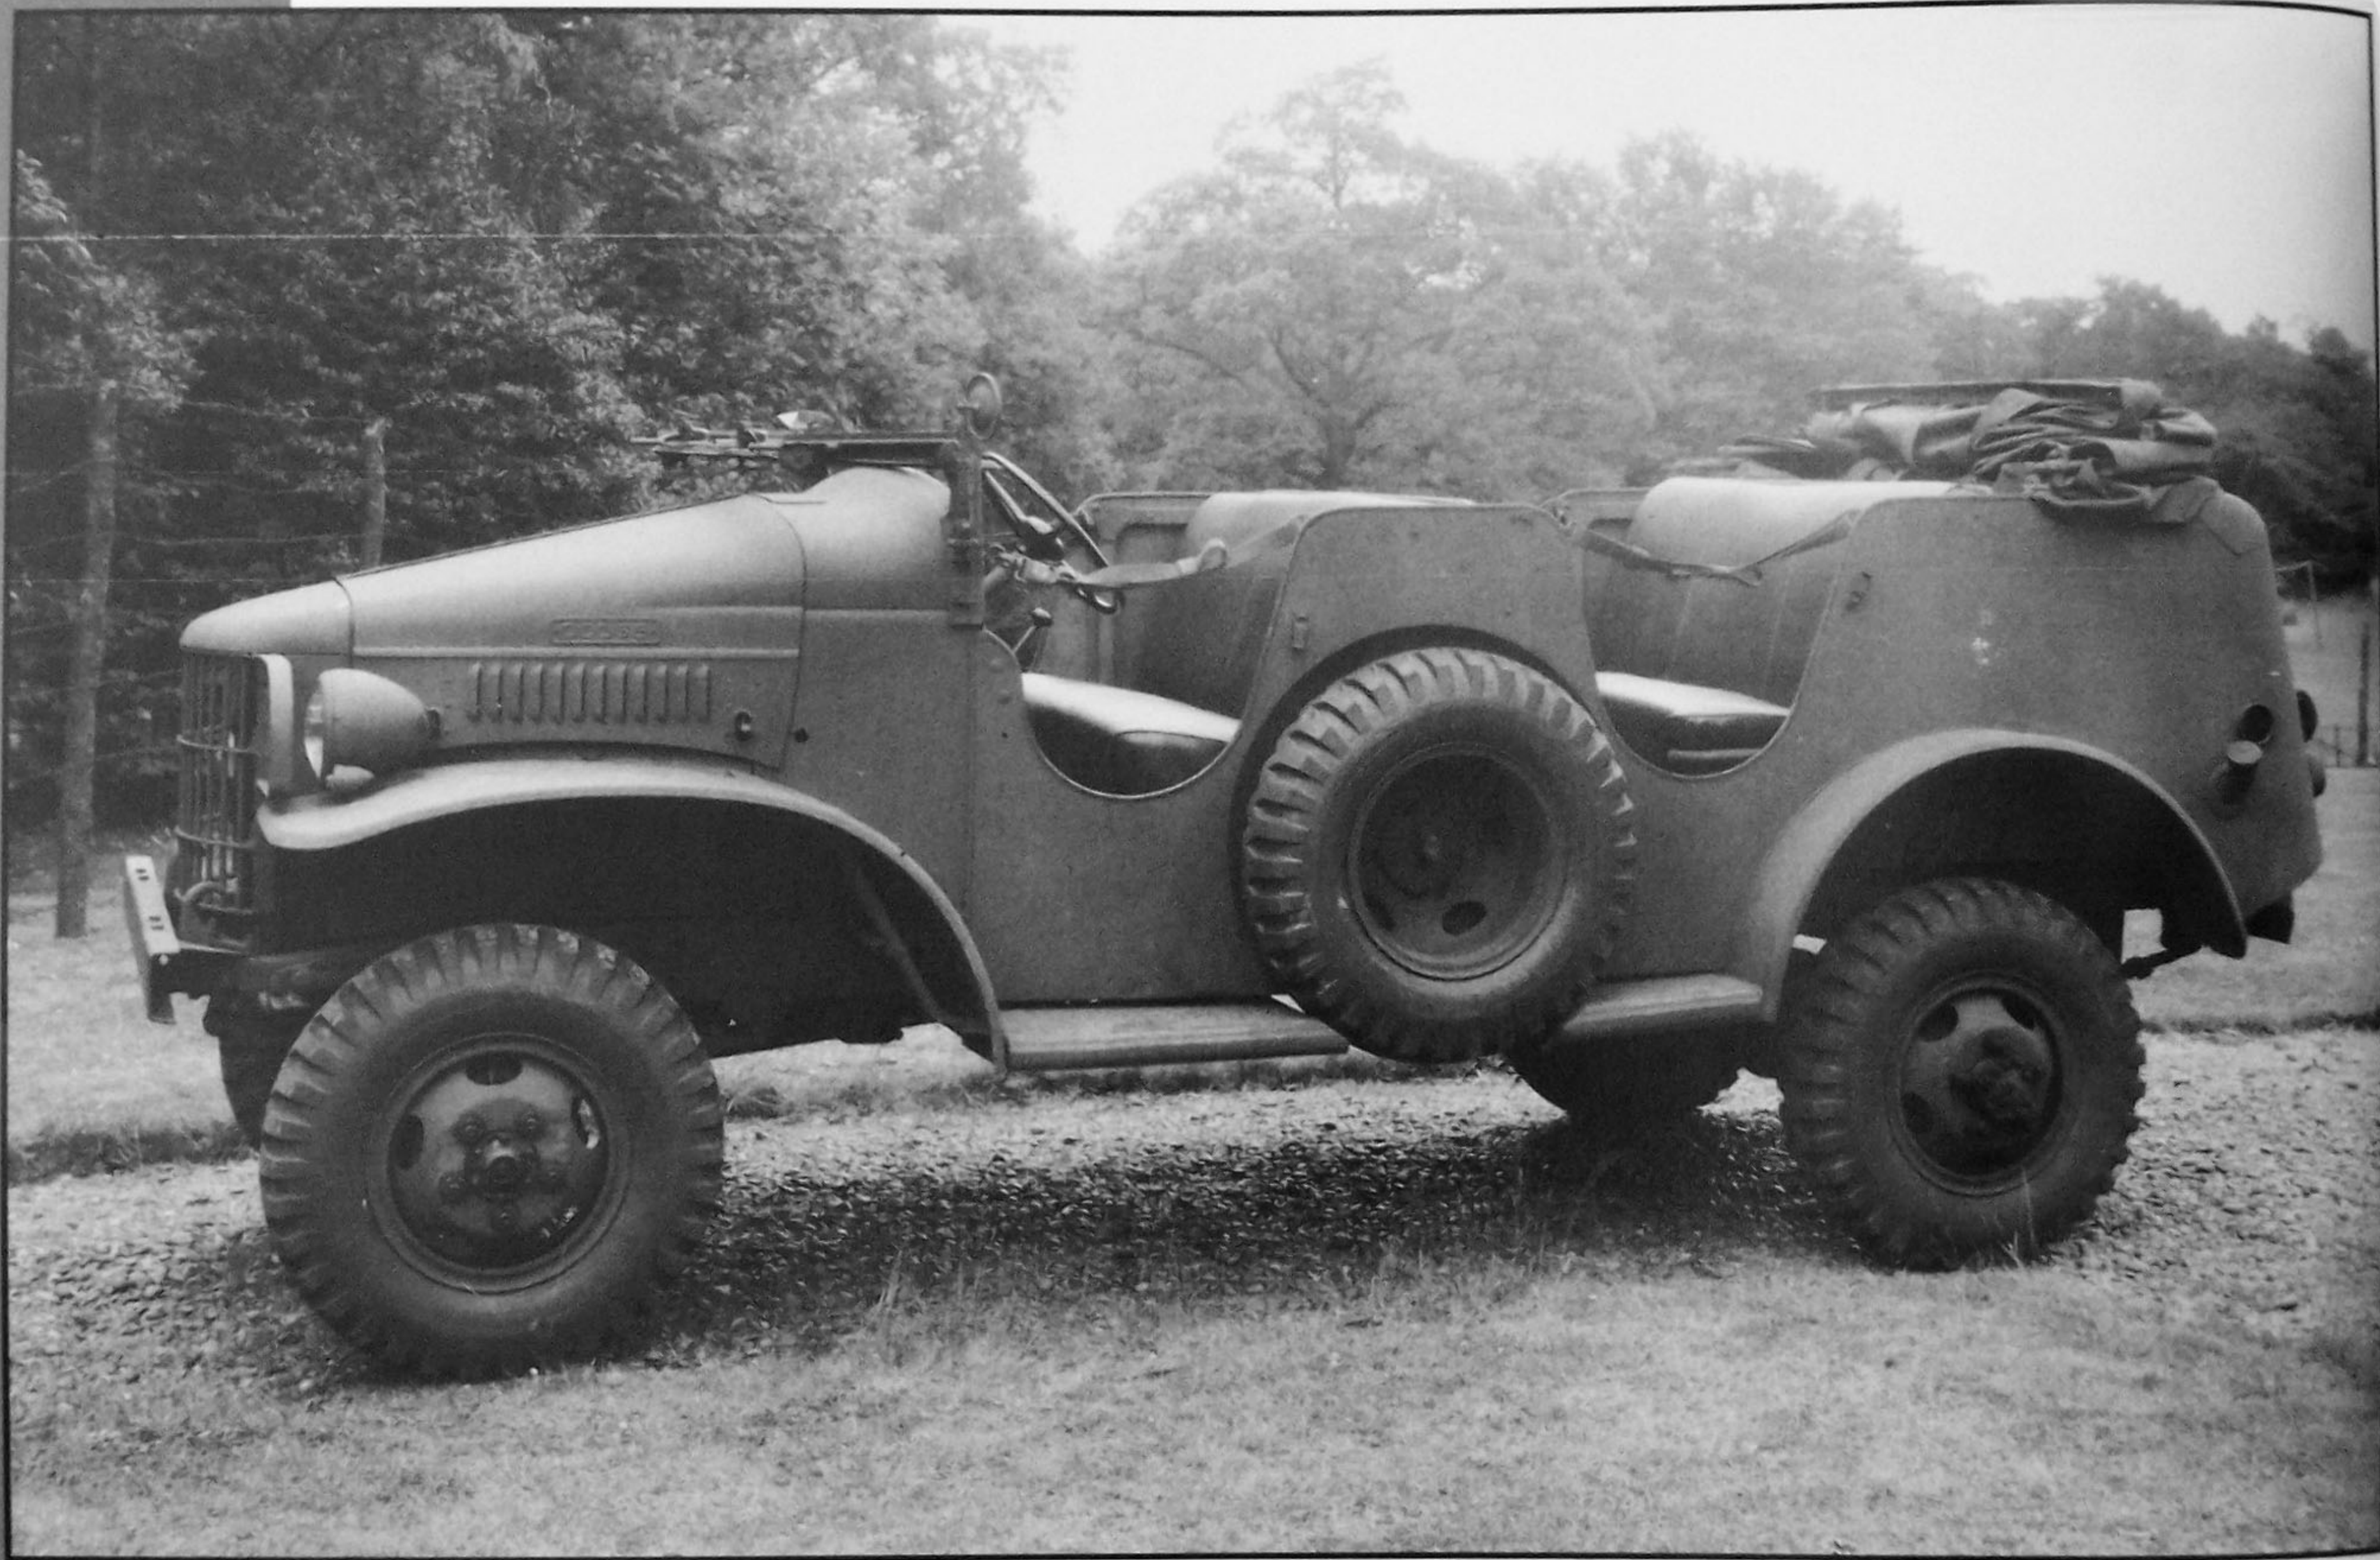
The Canadian division of Chrysler also produced a variant of the basic hard cab 1/2-ton weapons carrier. This was the Dodge T212-D8A, 8 CWT. This vehicle contained minor modifications to enable it to mesh with the Commonwealth logistics system, such as British 9.25 x 16 wheels and tires. It also had a slightly smaller engine. The D8 saw service with Commonwealth units in North Africa and Italy. The 1/2-ton series was to eventually encompass over 77,000 trucks. The series saw widespread use by the U.S. military during its training phase in 1940-1941. During this time, the Army continually evaluated the various models and eventually concluded that the truck was too light for the needs of an army fully

geared for world conflict. **Above:** the command car with the canvas top folded and stowed. The WC 23 was the final refinement of the command car design and it utilized the larger 230 cubic inch 6-cylinder engine also used in the 3/4-ton series. All WC 23 command cars were outfitted to take a radio and a large box on the left side of the truck held a 12-volt battery with an antenna base was located directly above it. Model WC 25 was permanently fitted with a radio. The WC 24 was identical to the WC23, but with a winch. This photograph provides an excellent view of the 1/2-ton's distinctive curved steel radiator guard (IWM).

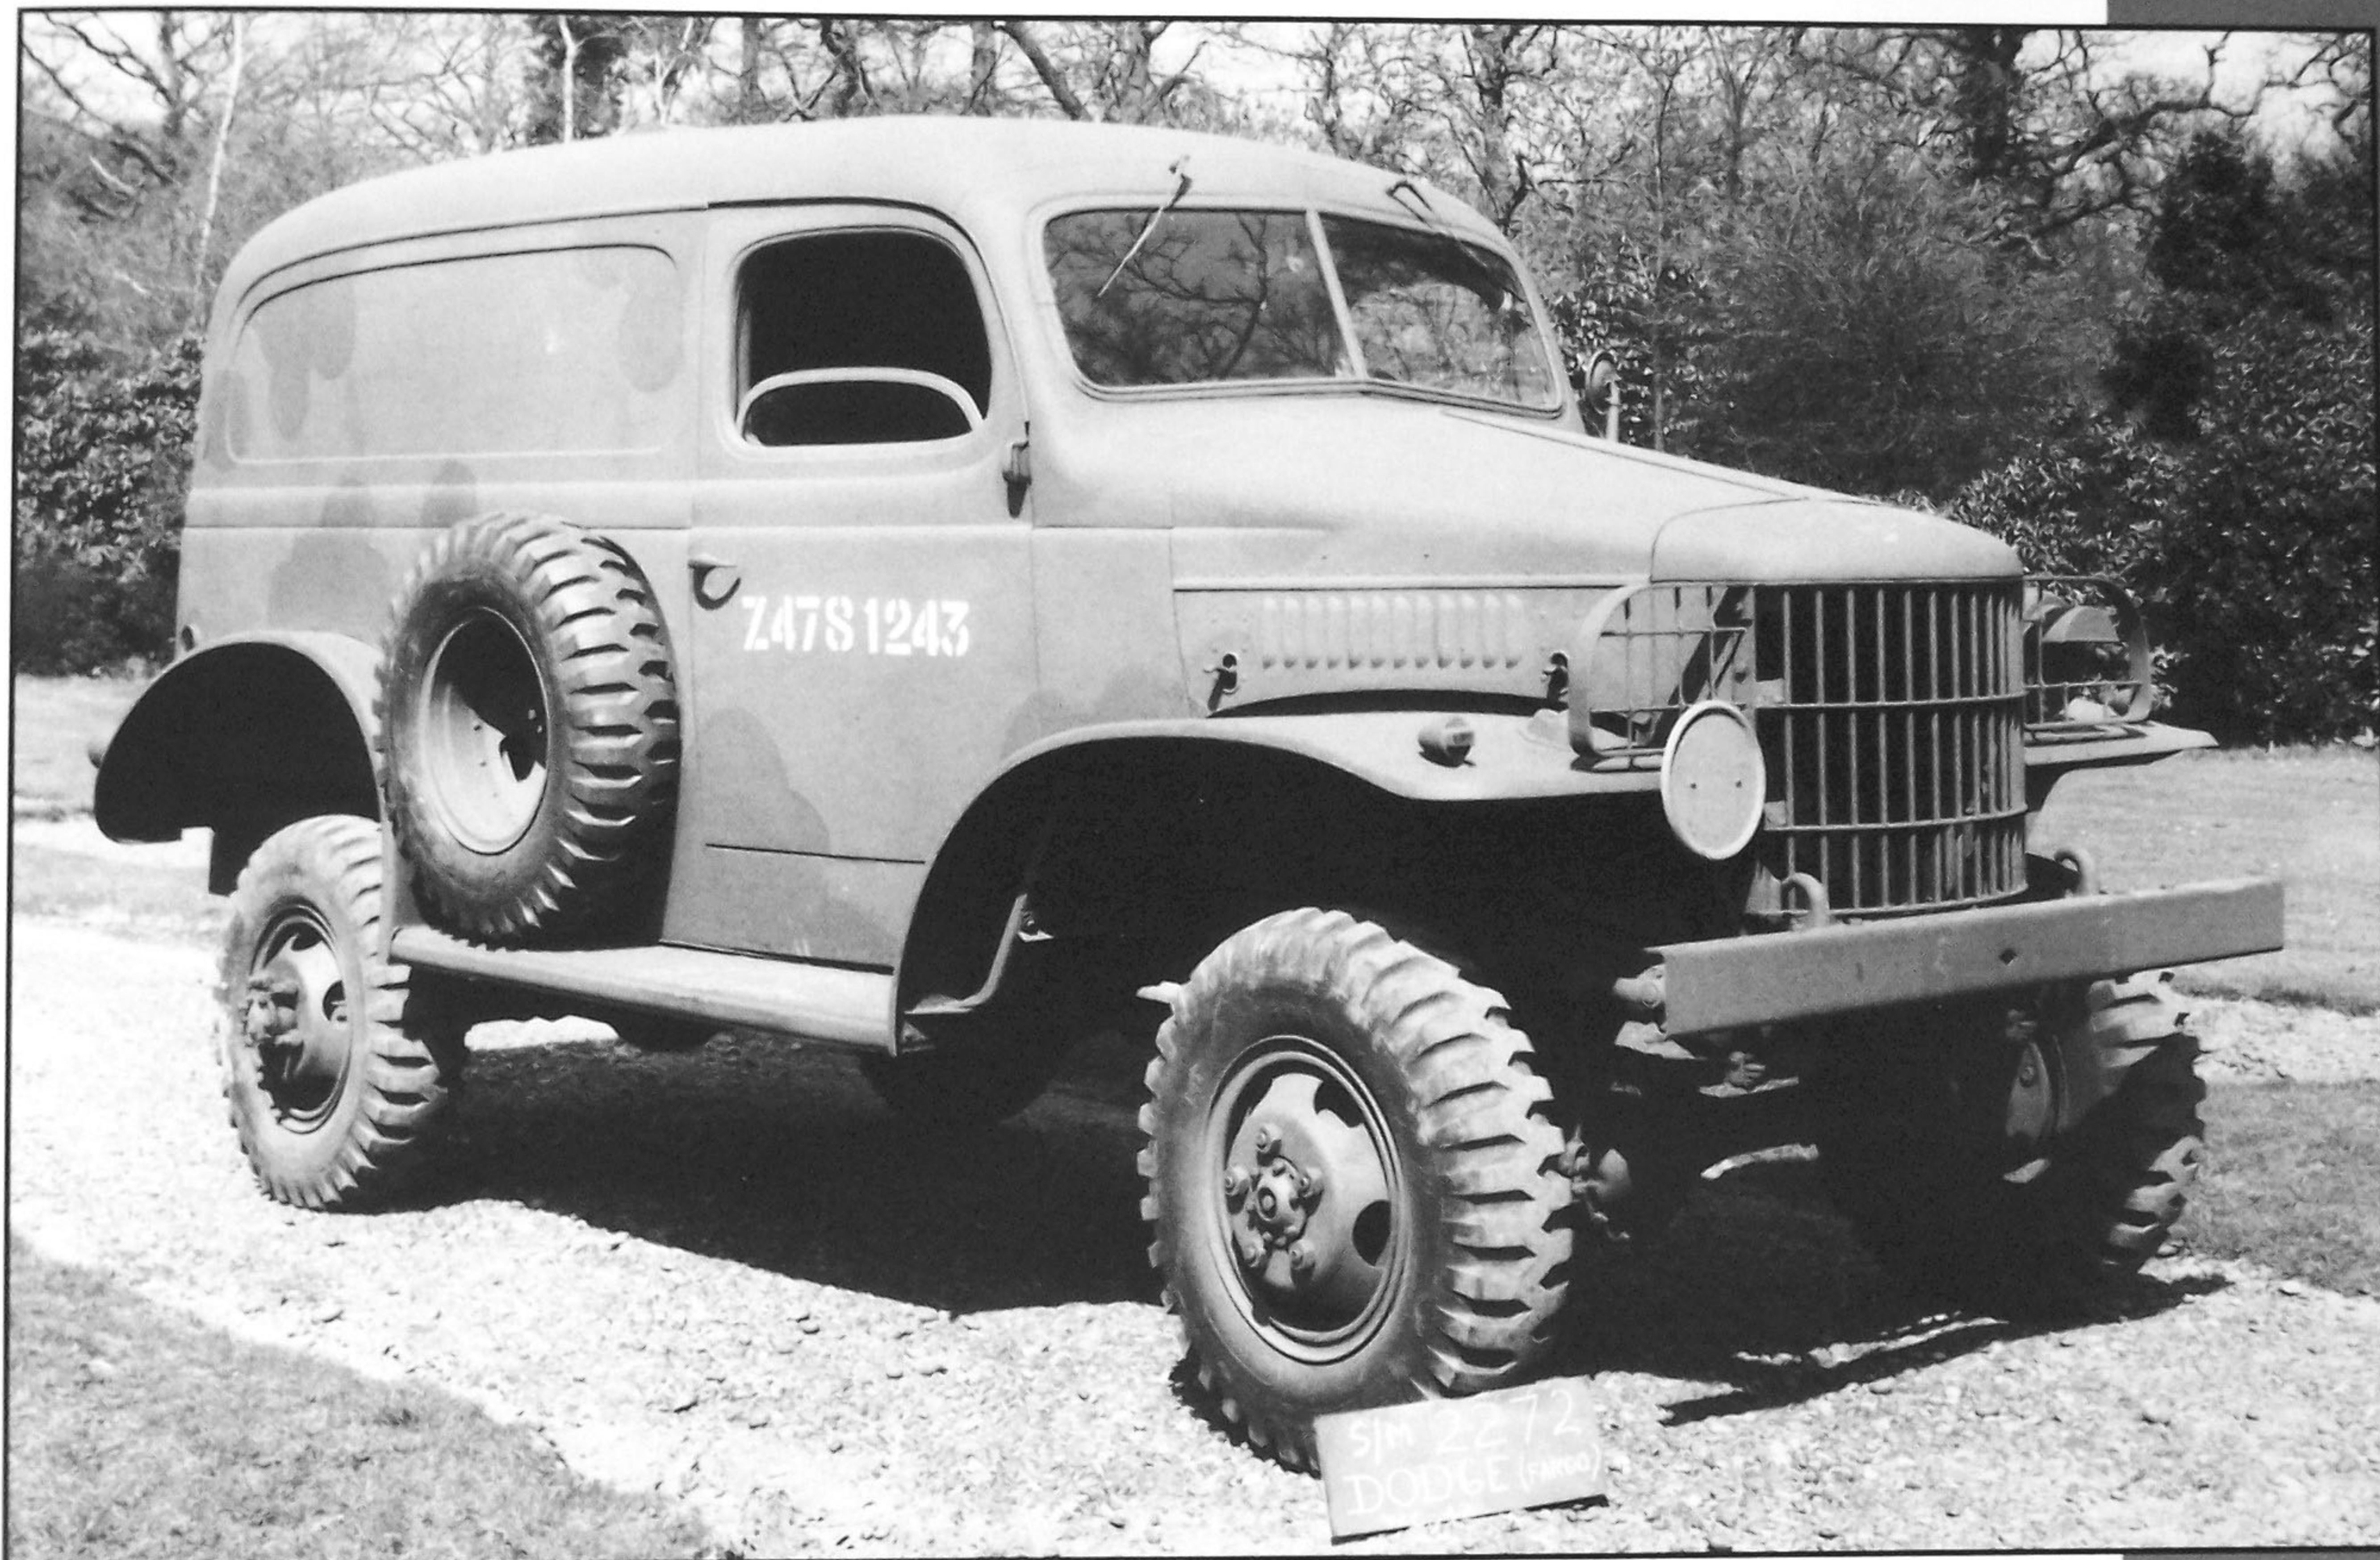
Although sturdy, many of the components of the 1/2-ton were still based on those found on civilian trucks. The frame, for example, was almost completely straight and lacking the vertical rigidity of "dropped" frames. The wheels were also weak, as they were nearly identical to standard civilian truck rims. Some 1/2-ton trucks remained in service throughout the war, being declared "limited standard" for the last time in 1947. A similar 1/2-ton truck was also produced by International Harvester specifically for the Marine Corps. By early 1942, the Army was asking Chrysler to develop a new and heavier vehicle. **Above:** the WC 42 panel truck during evaluation by the British. This last variant of the panel truck

was designed with help from the British. They were looking for a vehicle that could be outfitted with heavy radio sets and used as a communications vehicle. The WC 42 used the same sheet metal body as the earlier WC 11 and 19 versions, but it was specifically fitted with additional batteries. Three 12-volt batteries were installed in racks on the rear floor as well as additional seats and storage areas. This vehicle is already sporting a fresh, regulation British camouflage scheme and registration number. The "Z" prefix denotes a truck of under 1-ton in weight. Interestingly, WC 42s seen in the field used the "M" prefix, denoting cars or light utilities (IWM).

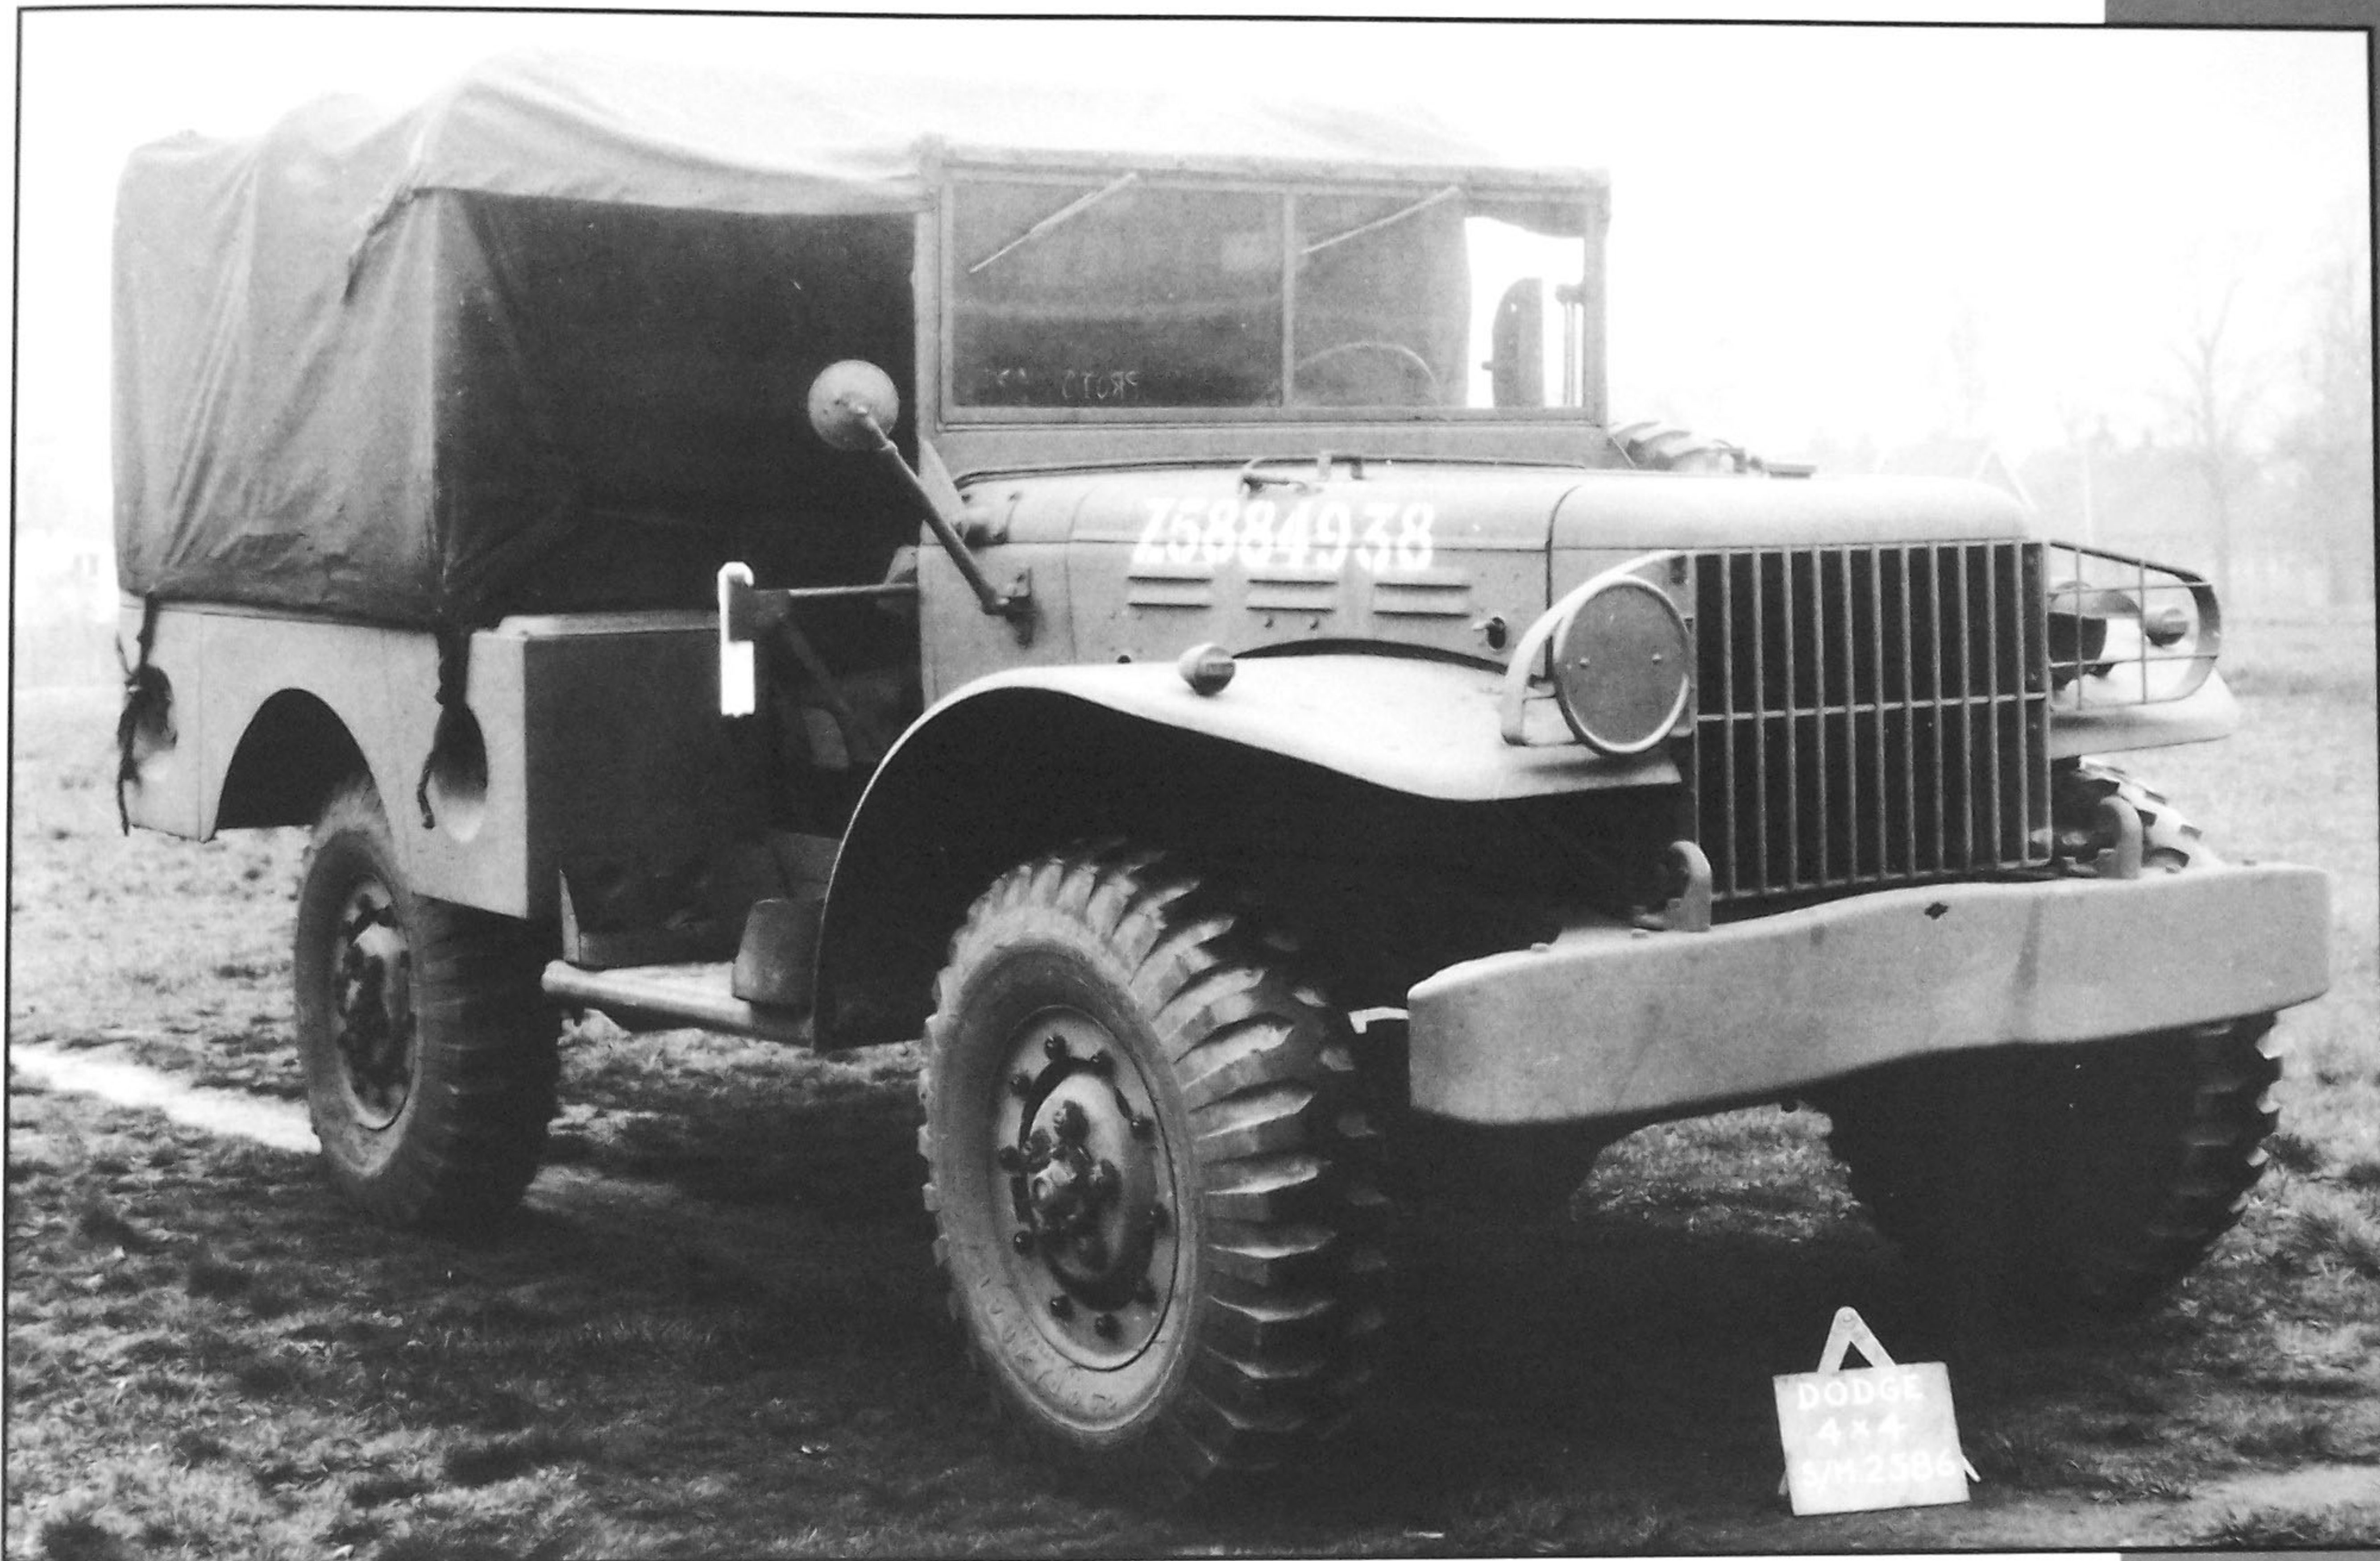
By 1941, it was clear that the existing 1/2-ton series would be inadequate for the needs of the quickly expanding U.S. Army. The army again turned to the Chrysler Corp. and work began to redesign an efficient tactical vehicle to meet the army's demanding standards. This was to be the first Dodge truck designed completely and specifically for the U.S. Army and the redesign was from the ground up. When design work did commence, it was centered around the weapons carrier version and in some respects this work was also tied into the development of a new tank destroyer vehicle, later known as the M6. The new truck frame was constructed of heavy gauge steel channel that was "double dropped" at the axle

positions for greater strength. The term refers to the frame curving down at the points prior to the axle positions. This also served to reduce the overall height of the vehicle, lowering the center of gravity and maintaining a sufficient chassis to ground clearance. The axles and other drive train components were also redesigned to a heavier and more durable standard. The front and rear springs were 1 3/4 inches wide and were 39 and 52 inches long respectively. **Above:** this and the following two photos are British evaluation shots of the WC 51 taken in late 1942. Although impressed with the capabilities of the Dodge, with their requirement for right hand drive vehicles, it was not accepted into widespread service (IWM).

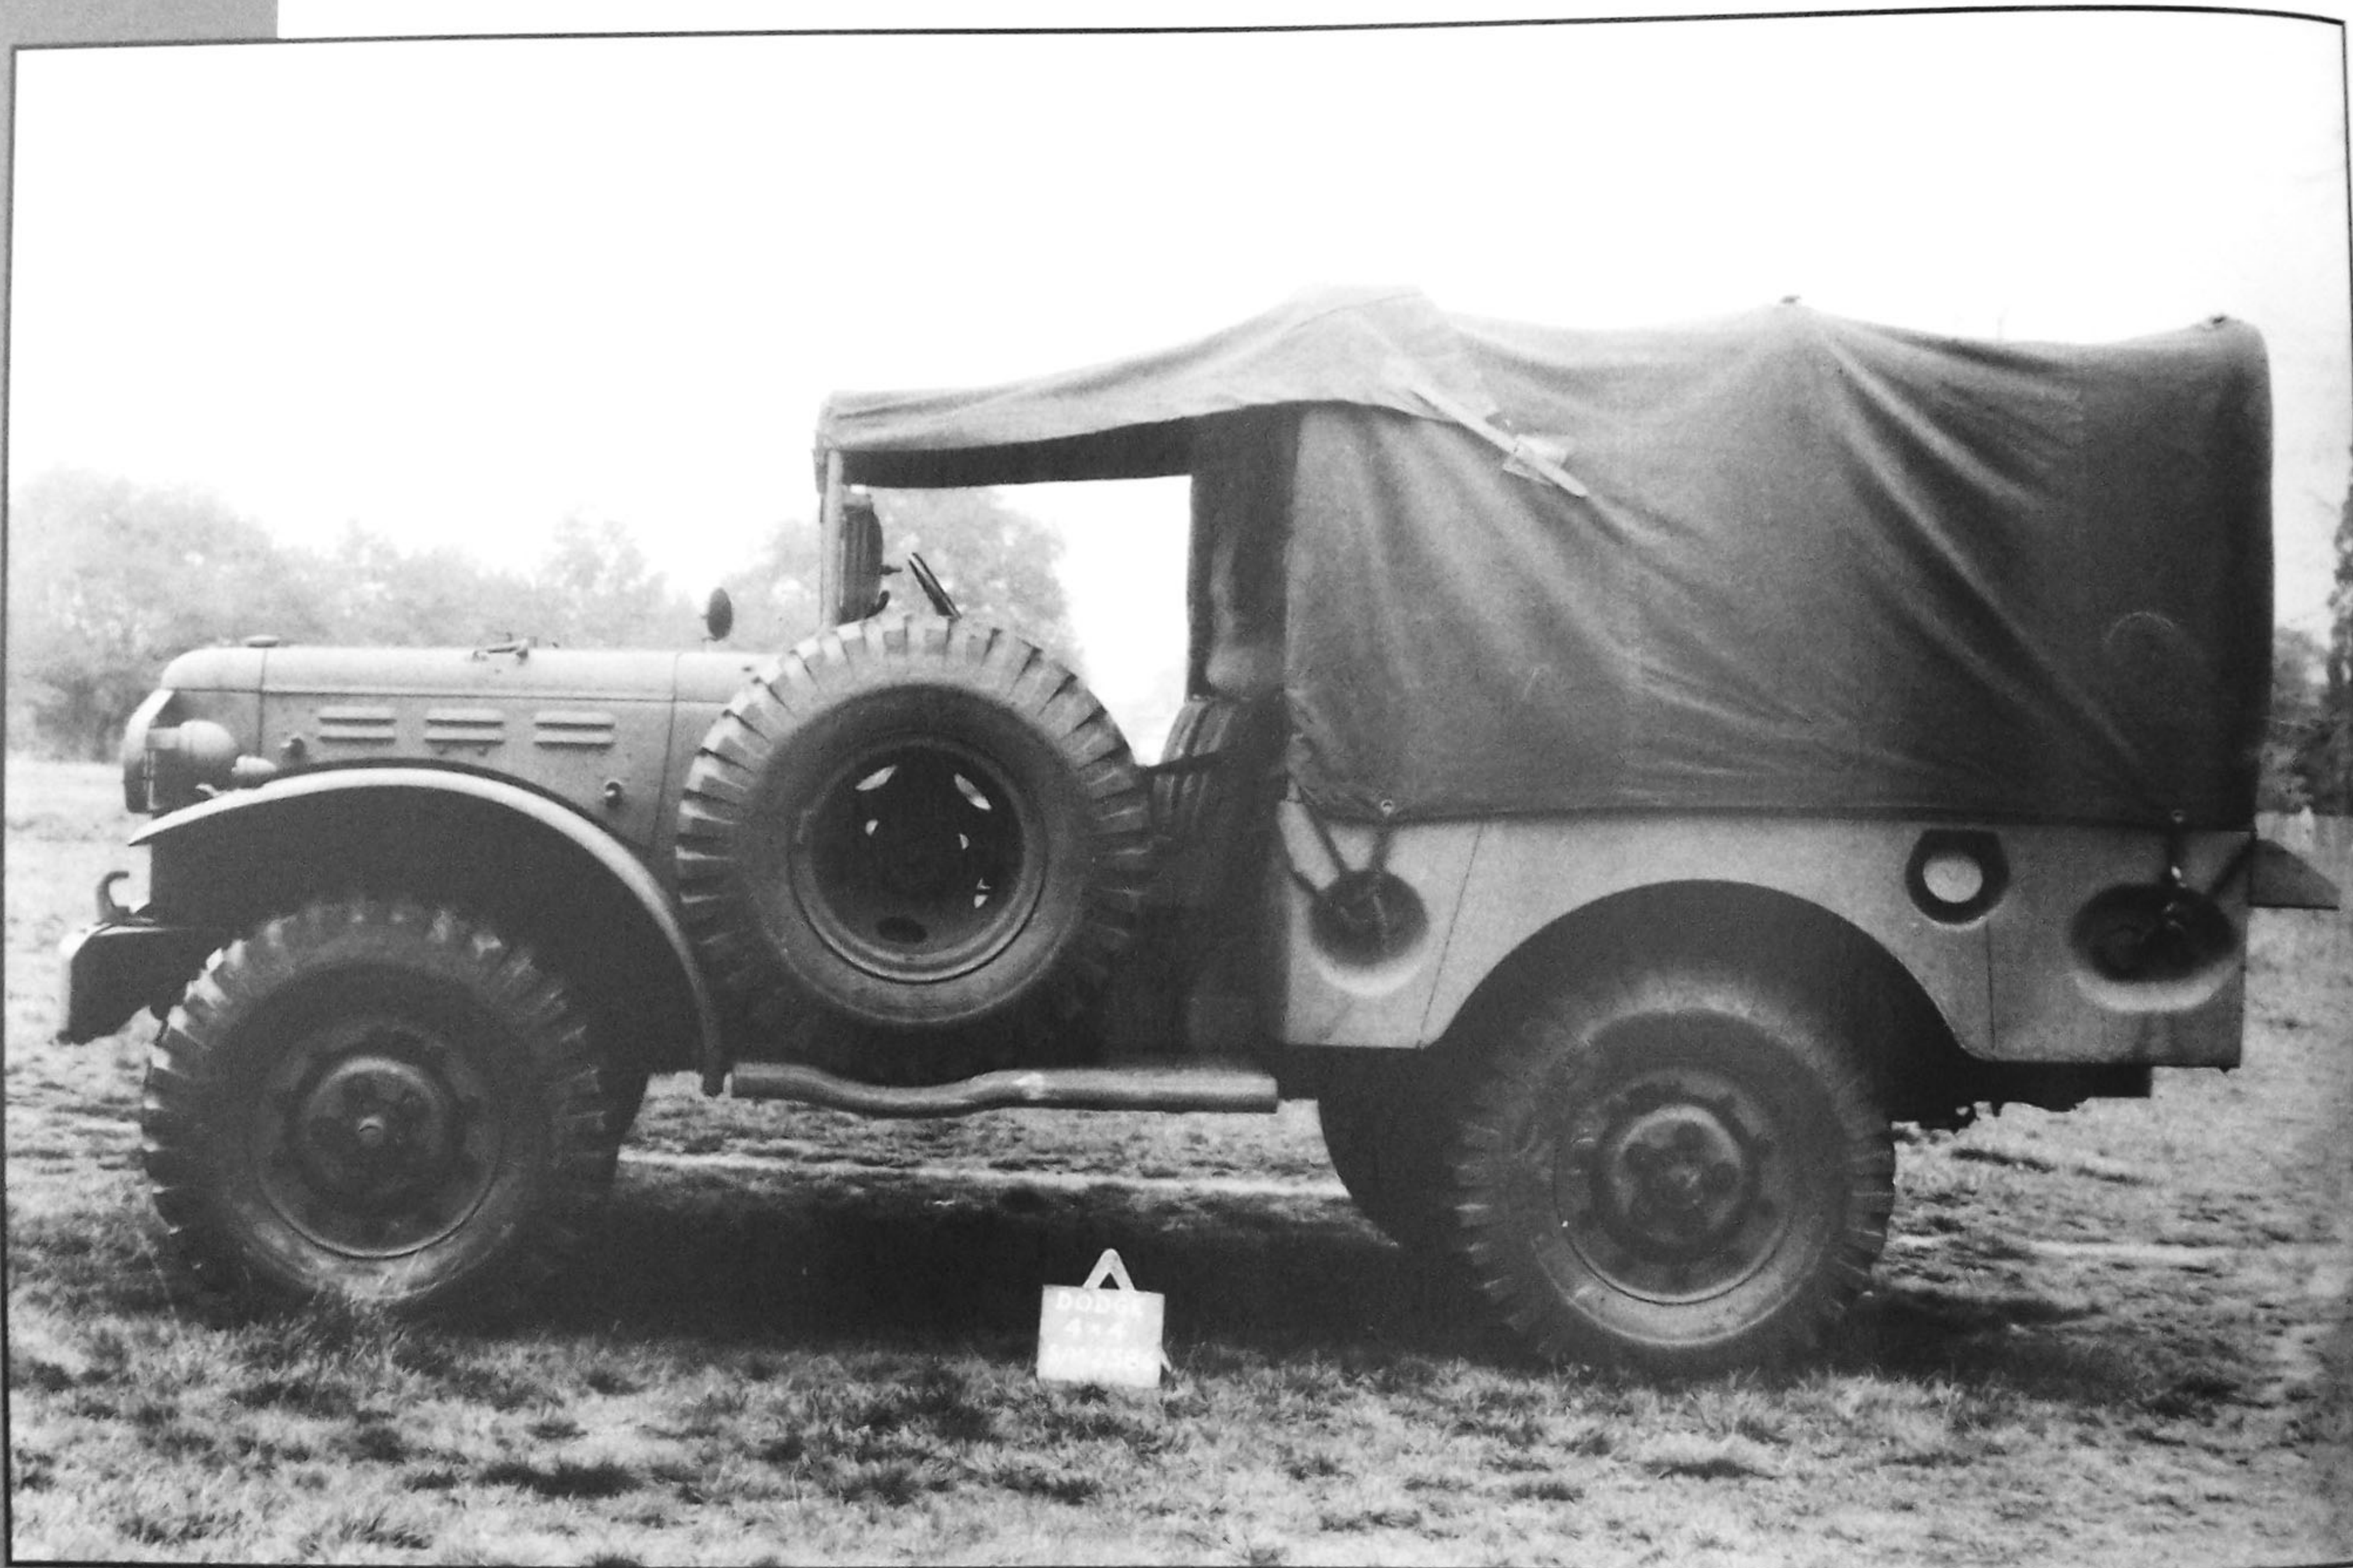
The power plant of the WC 51 was the same one used in late versions of the 1/2-ton trucks, the Dodge L-head 6-cylinder, in line engine. This engine could displace 230.2 cubic inches and was capable of generating 54.5 bhp at 1,600 RPM and 92 bhp at the engine's maximum RPM of 3,200. A four-speed transmission was used with a single speed transfer case. Power was transmitted by a short drive shaft to the transfer case and then to the front and rear axles. The vehicle could be driven in either two or four wheel drive. In fourth gear, the vehicle could reach the respectable speed of 55 mph on hard surfaces. The bodywork was also completely redesigned. The curved grill of the 1/2-ton gave way to a flat, simplified

version of the steel grate. The front coachwork was much simpler and lower in profile. For ease of maintenance, the radiator cap now protruded through the top of the radiator housing. The rear cargo area, which was quite narrow on the 1/2-ton, was expanded and lengthened. The bed was capable of carrying ten troops or up to 1,200 pounds of cargo. Chrysler Corp.'s final engineering designation for the new vehicle was T214 and this was applied to the entire "WC" series of 3/4-ton vehicles. Production began in 1942 at the Chrysler Corporation's Dodge Brothers factory on Mound Road outside of Detroit, Michigan (present day Warren, Michigan). **Above:** an excellent profile portrait of the WC 51 (IWM).

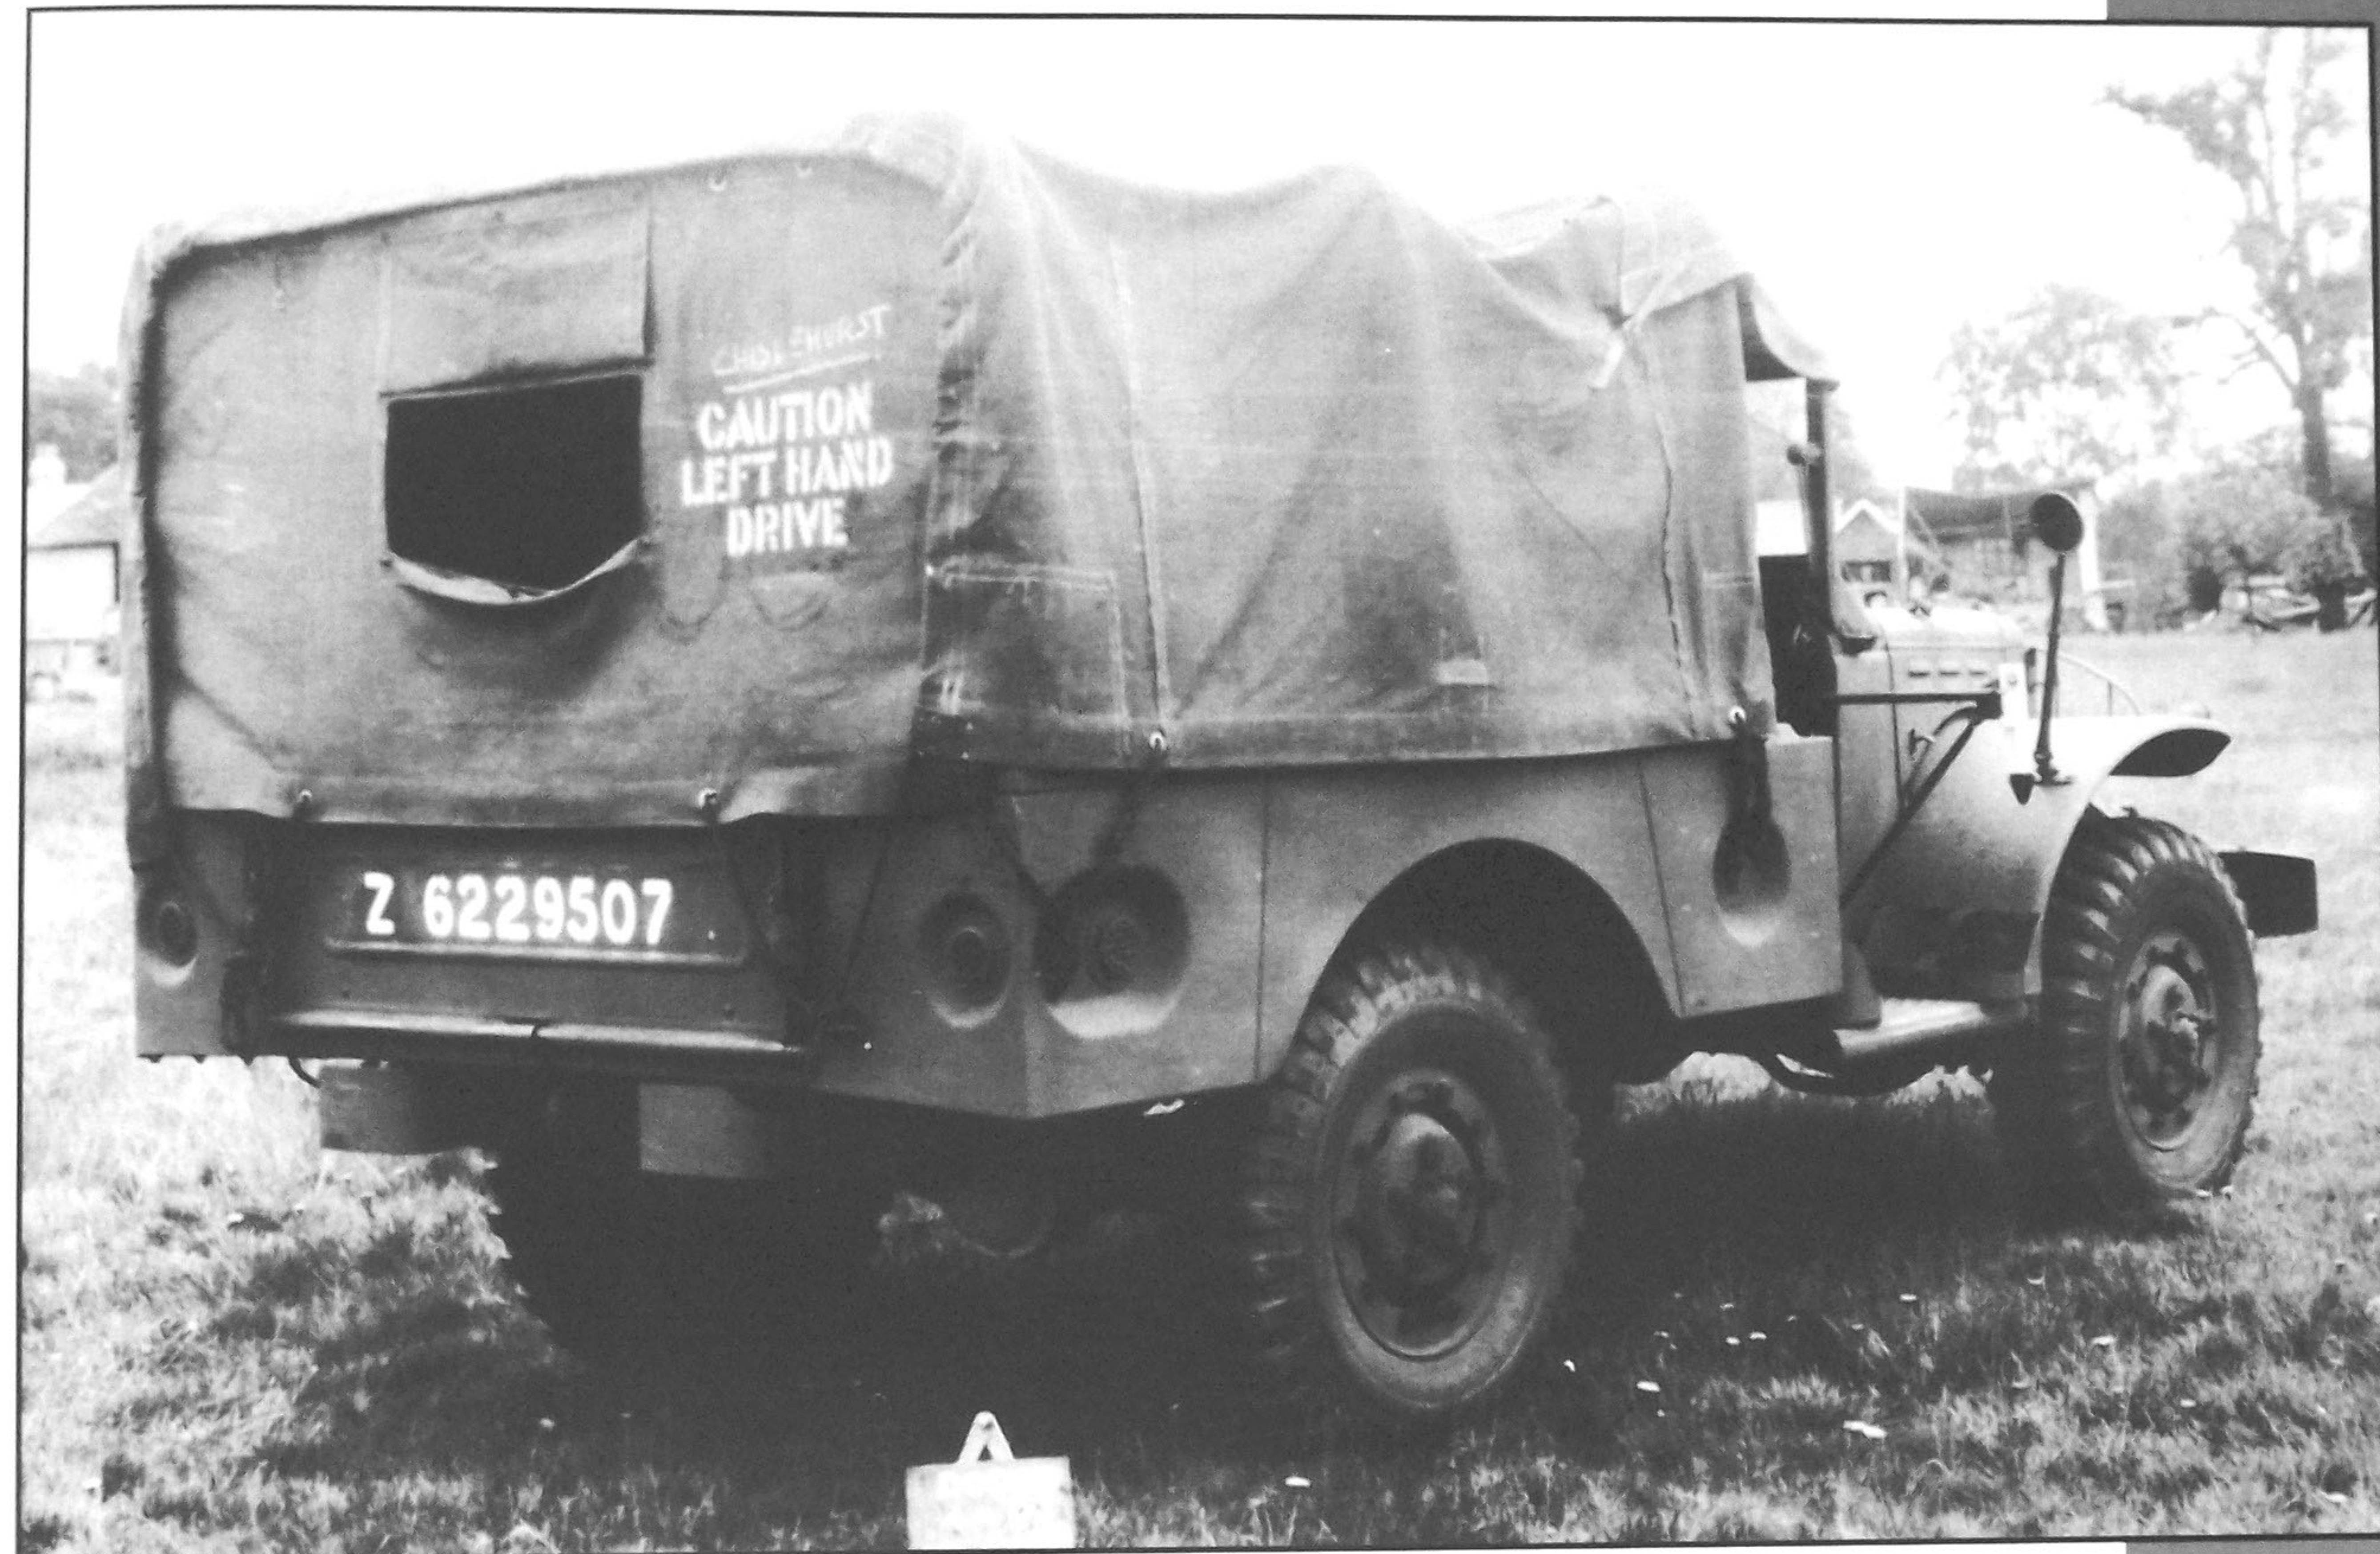
While the weapons carrier received the model code of WC 51, those vehicles with a winch installed had the model code WC 52. As mentioned, some of the design features of the cargo bed were influenced by the need to create the M6 Gun Motor Carriage. This vehicle mounted the 37mm gun behind an armored shield. The weapon faced to the rear and rounds were stowed in bins built into the sides of the cargo bed. The M6 was found to be only minimally effective when it first entered service in North Africa in 1942. Although the M6 was still issued at the time of the Normandy landings, in June of 1944, it was a brave soul that would use it to challenge any of the late war German tanks. In spite of this, a

conversion kit for the WC 52 was still listed in army ordinance manuals in May of 1945. Most M6s were later converted back into weapons carriers or into ambulances (see later in this section). The Chrysler Corp.'s model code for the M6 was WC 55. The weapons carrier was also produced by Chrysler Corp.'s Canadian subsidiary. Its designation was D3/4APT-T 236. U.S. Army registration numbers for the WC 51 ran from W-252293 to W-254792, W-259135 to W-289212, 291910 to 291992, 293685 to 294209 and 2110000 to 2125113. WC 52 registration numbers ran from W-245845 to W-246394, W-289213 to W-291384, 291993 to 292512, 2160419 to 2179292 and 2180276 to 2199555.
