# Allied-Axis

THE PHOTO JOURNAL OF THE SECOND WORLD WAR

**German  
SIG 33/1  
Grille SPG**

**Kleines Kettenkrafttrad  
WWII Dodge 3/4-ton trucks  
DUKW Amphibious truck**

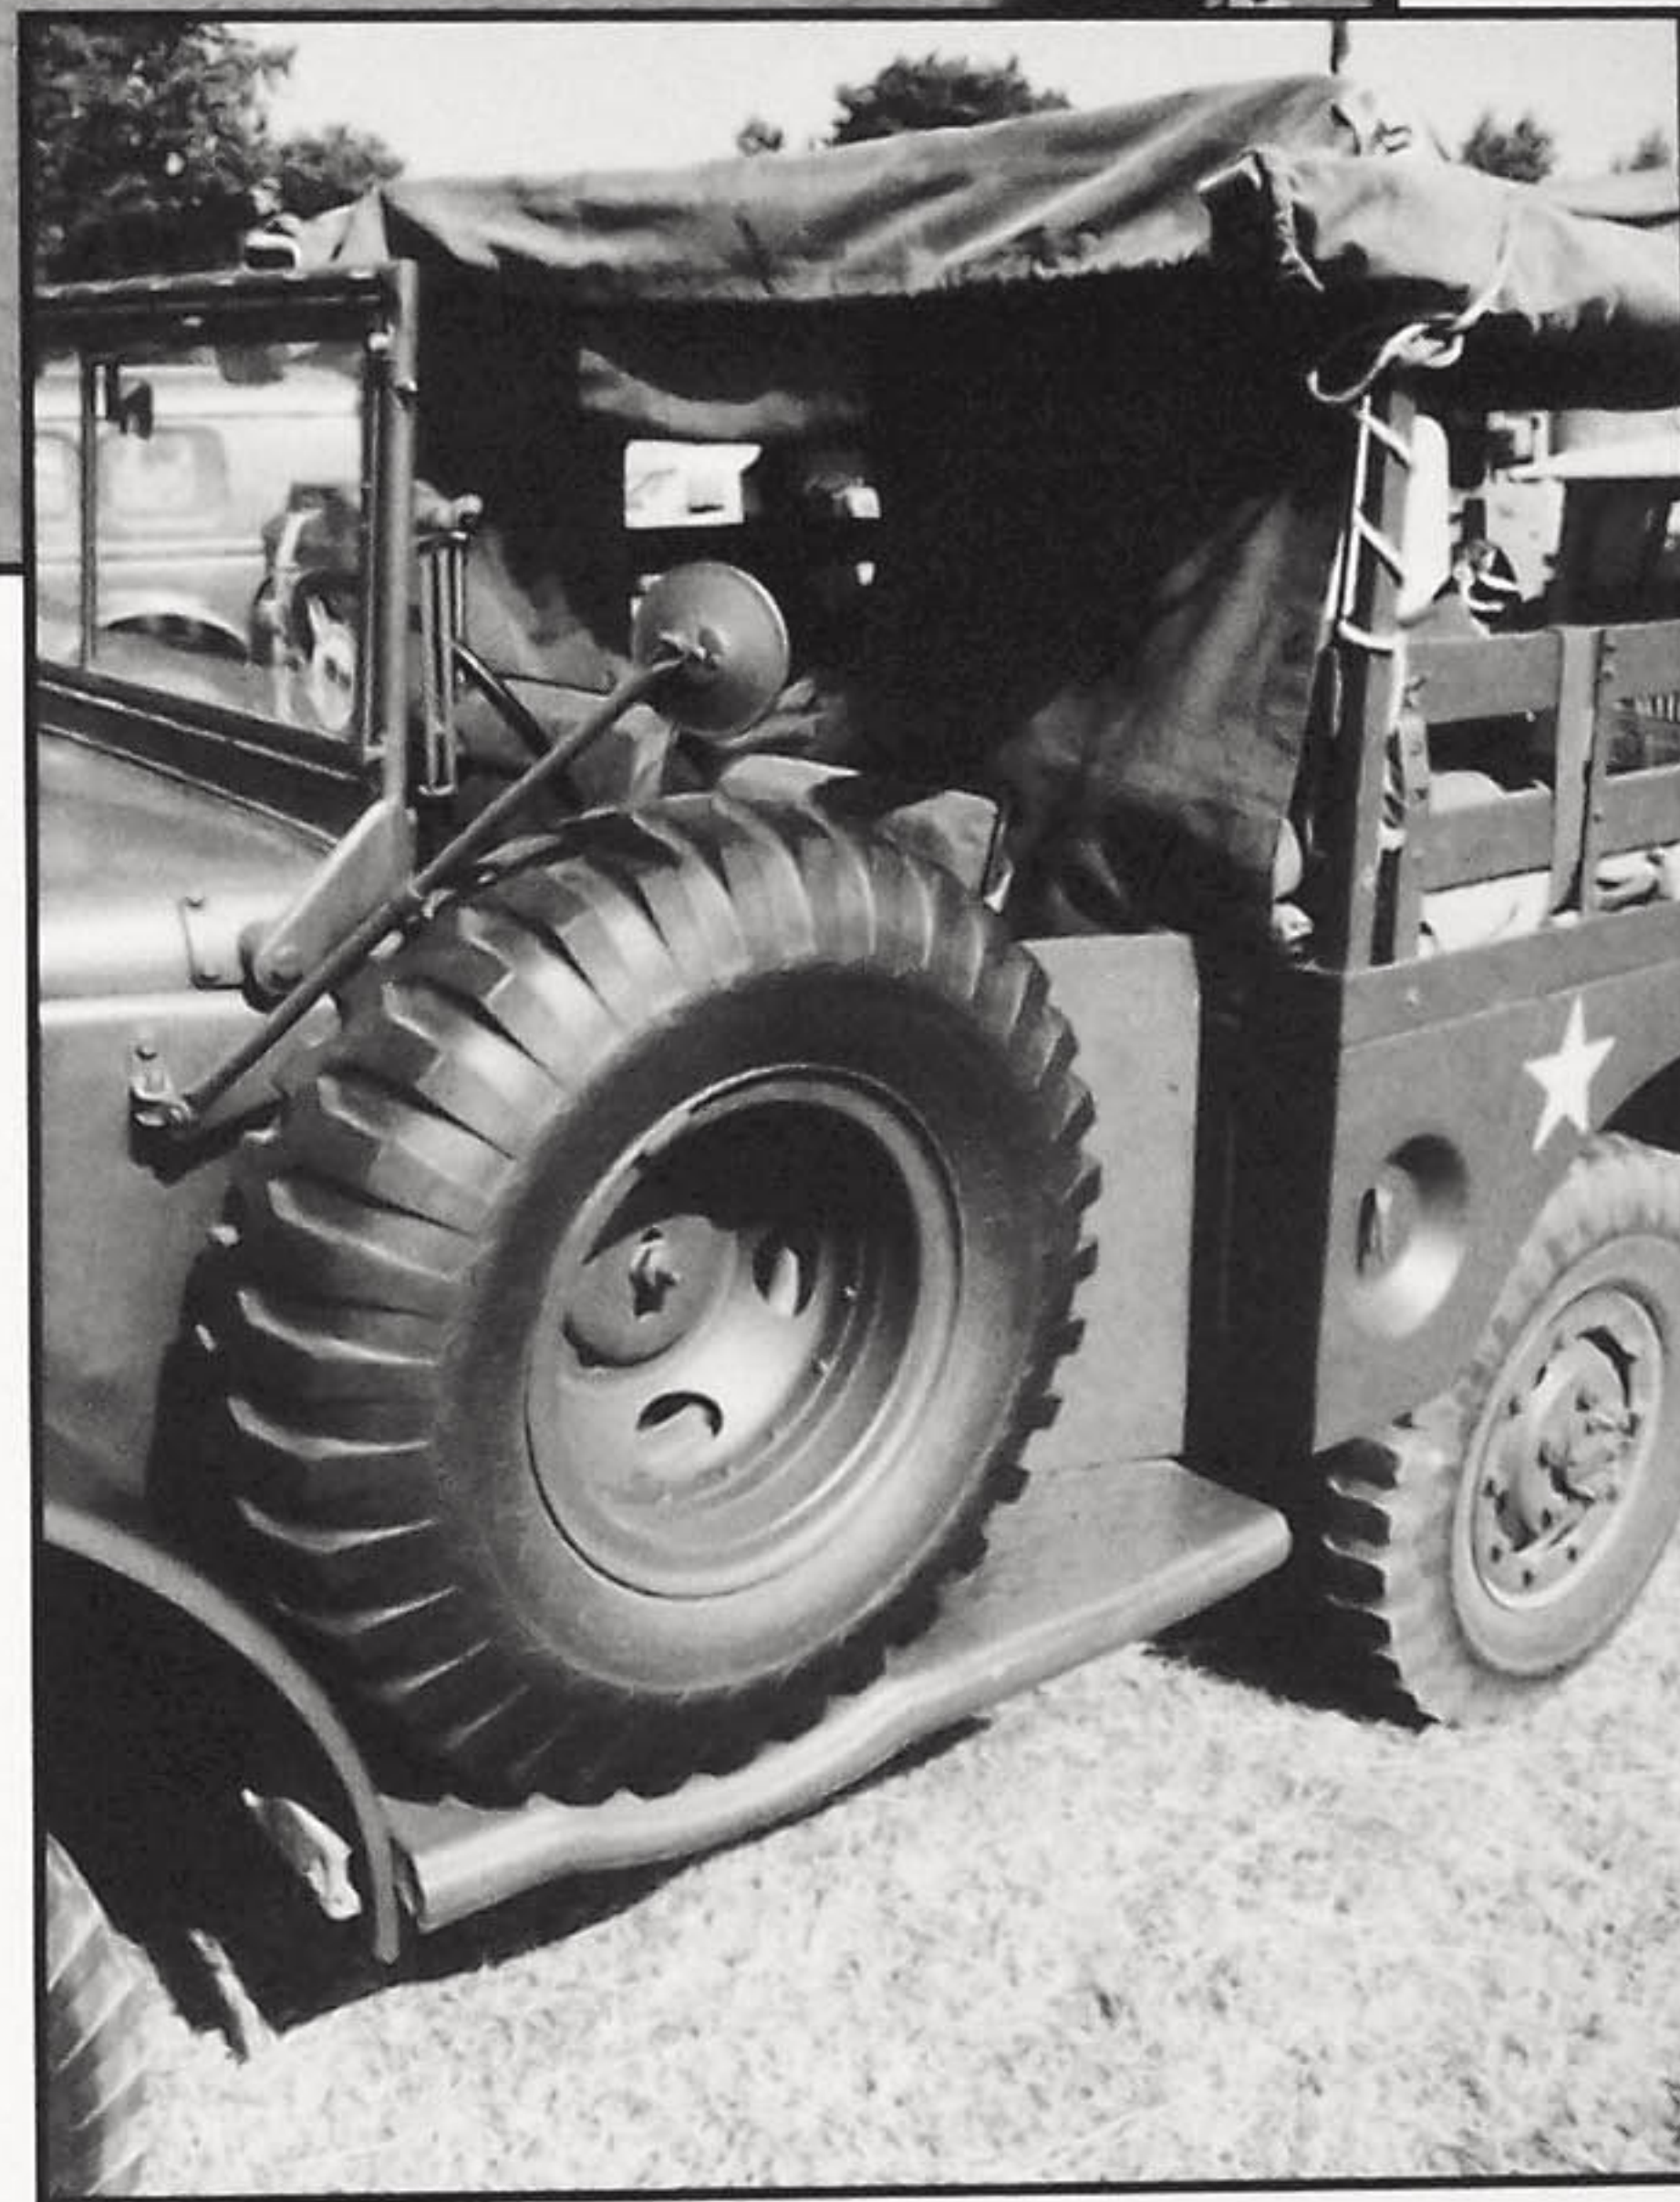
**Top left and right:** these two close-up shots of the rear tarp show how the front section is attached to the rear with reinforced leather patches and straps. **Above left and right:** Because of the location of the spare tire, the driver had to exit the vehicle on the right side. This could present a problem if the driver was forced to exit in a hurry. Further compounding this was the location of the two gas can racks on the right side running board. Later in the production run, a modification was made to locate the rear

most rack to the top of the bodywork as shown here. This gave a bit more clearance for entry and exit. The tool rack was also relocated in front of this location as seen in the photo at upper left. The circular object attached to the front of the can is a collapsible canvas water container. These and the following photos are all of contemporary, restored vehicles.

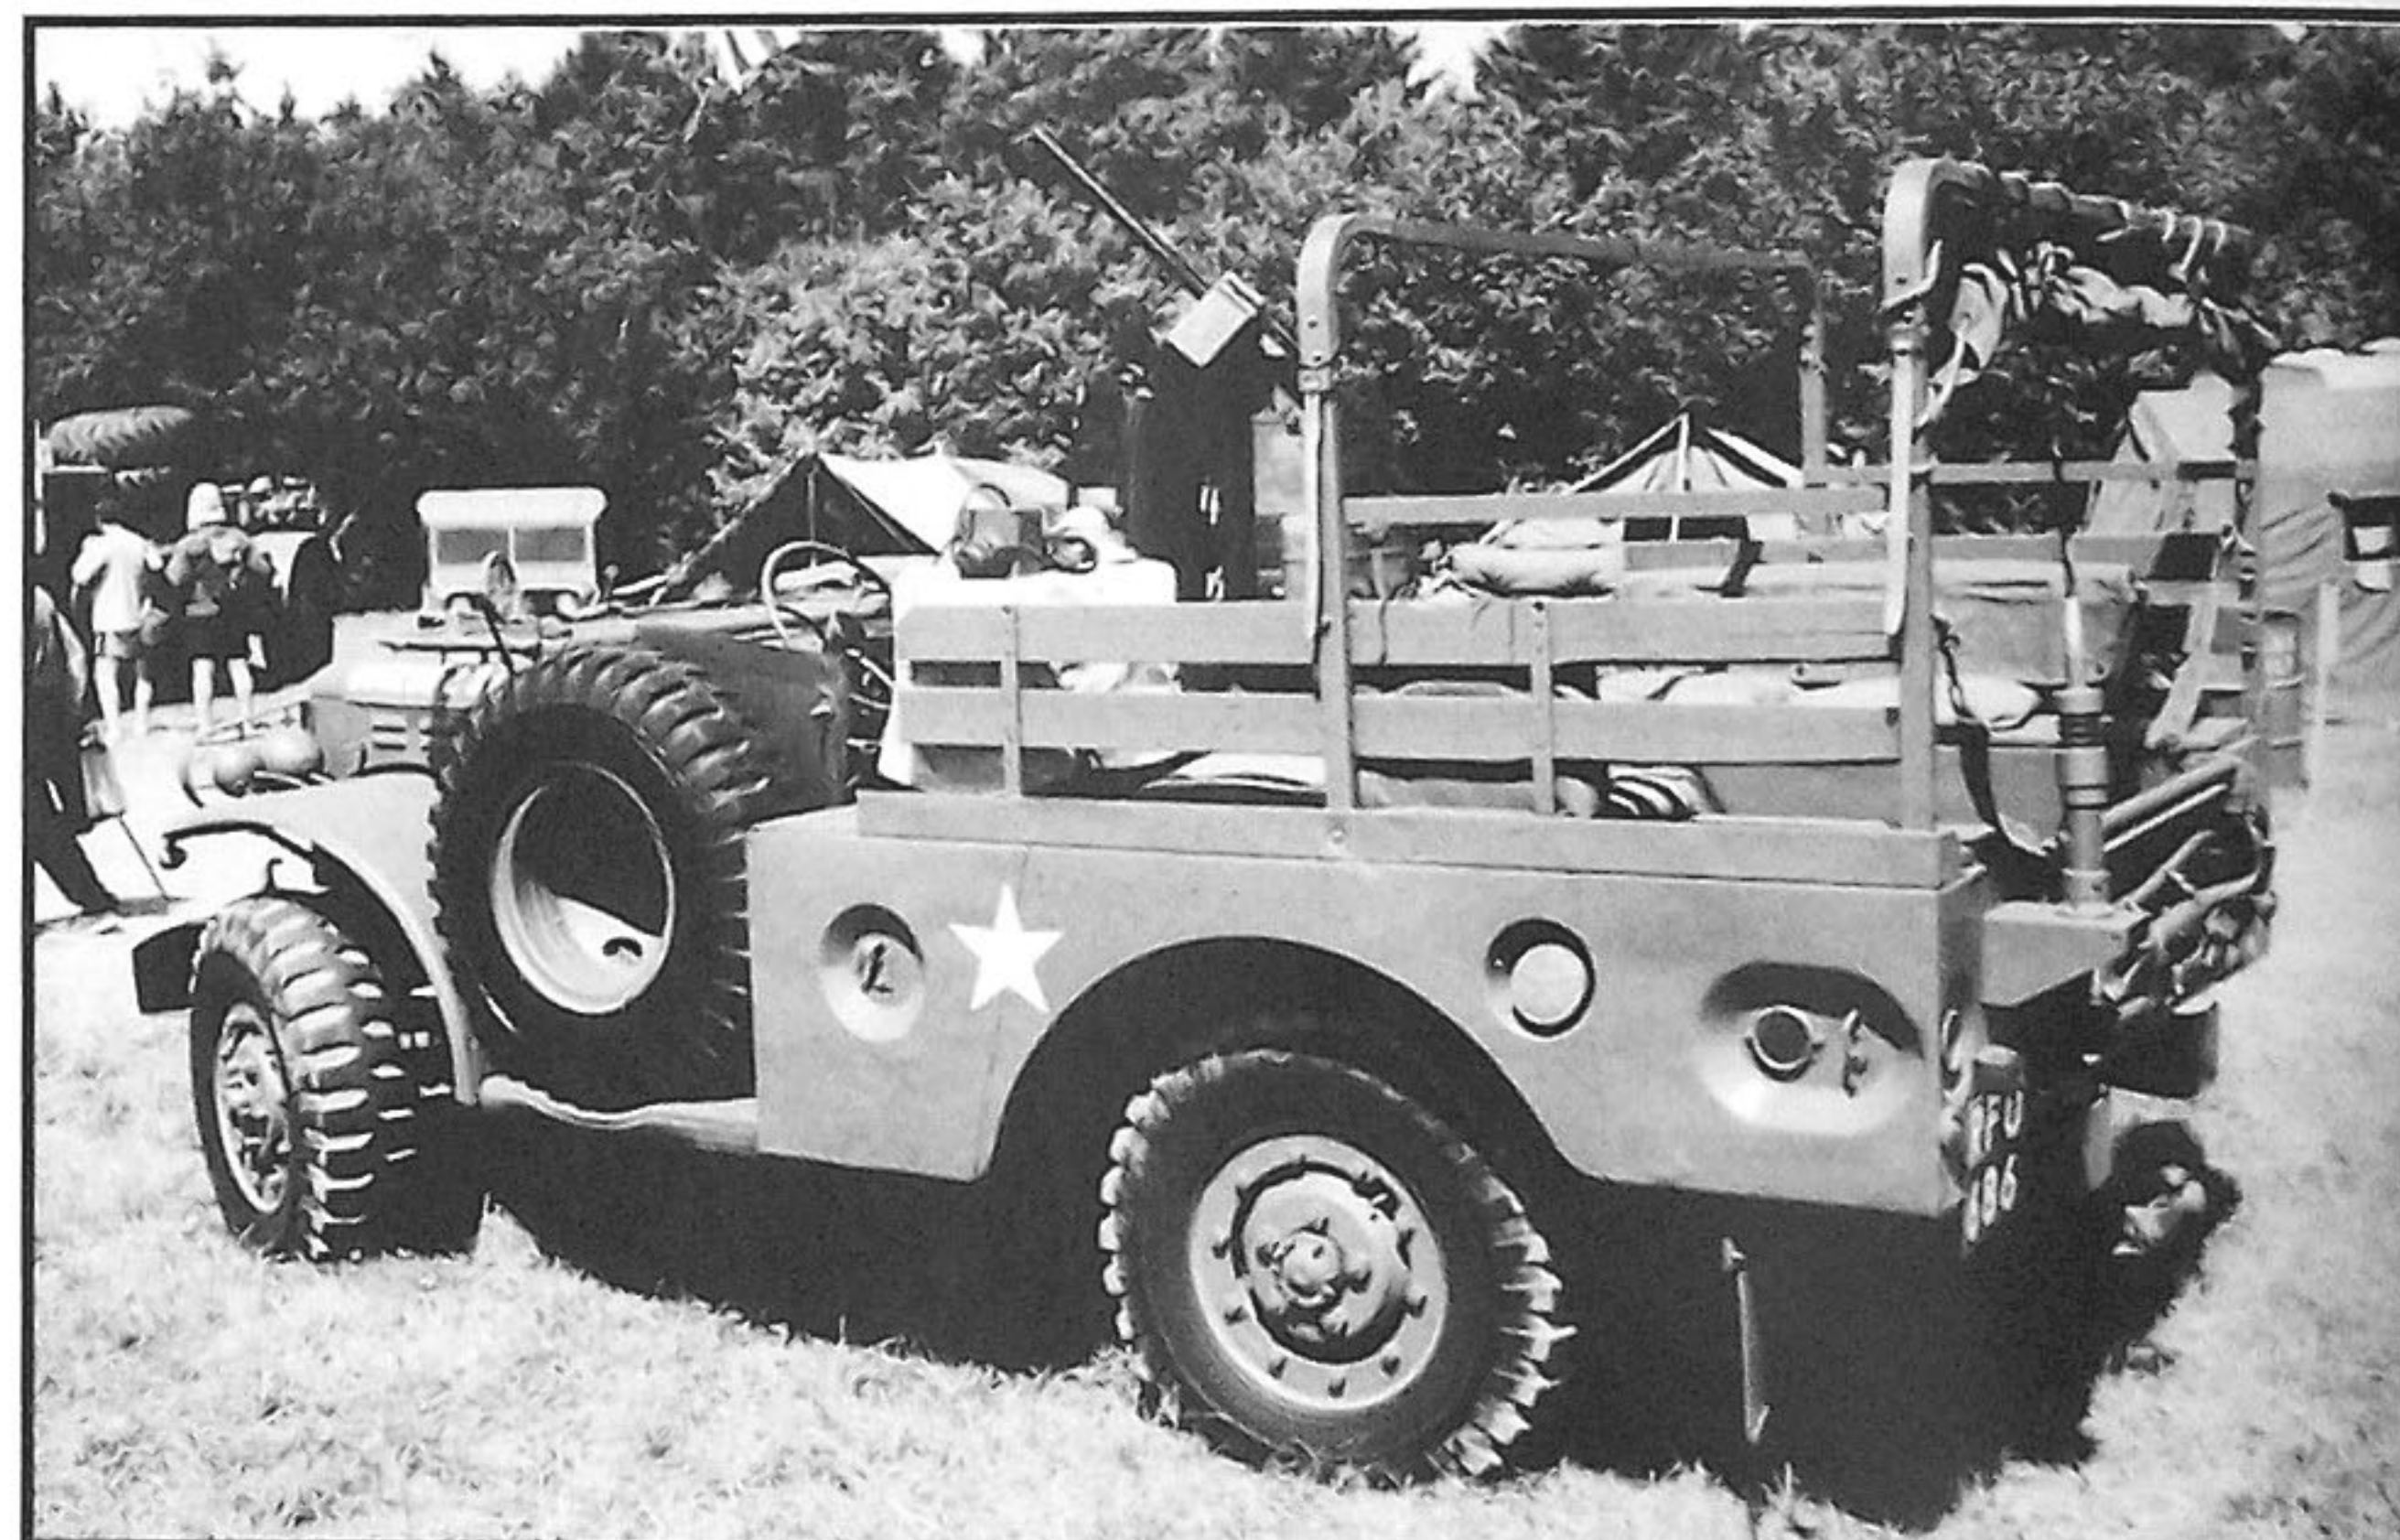
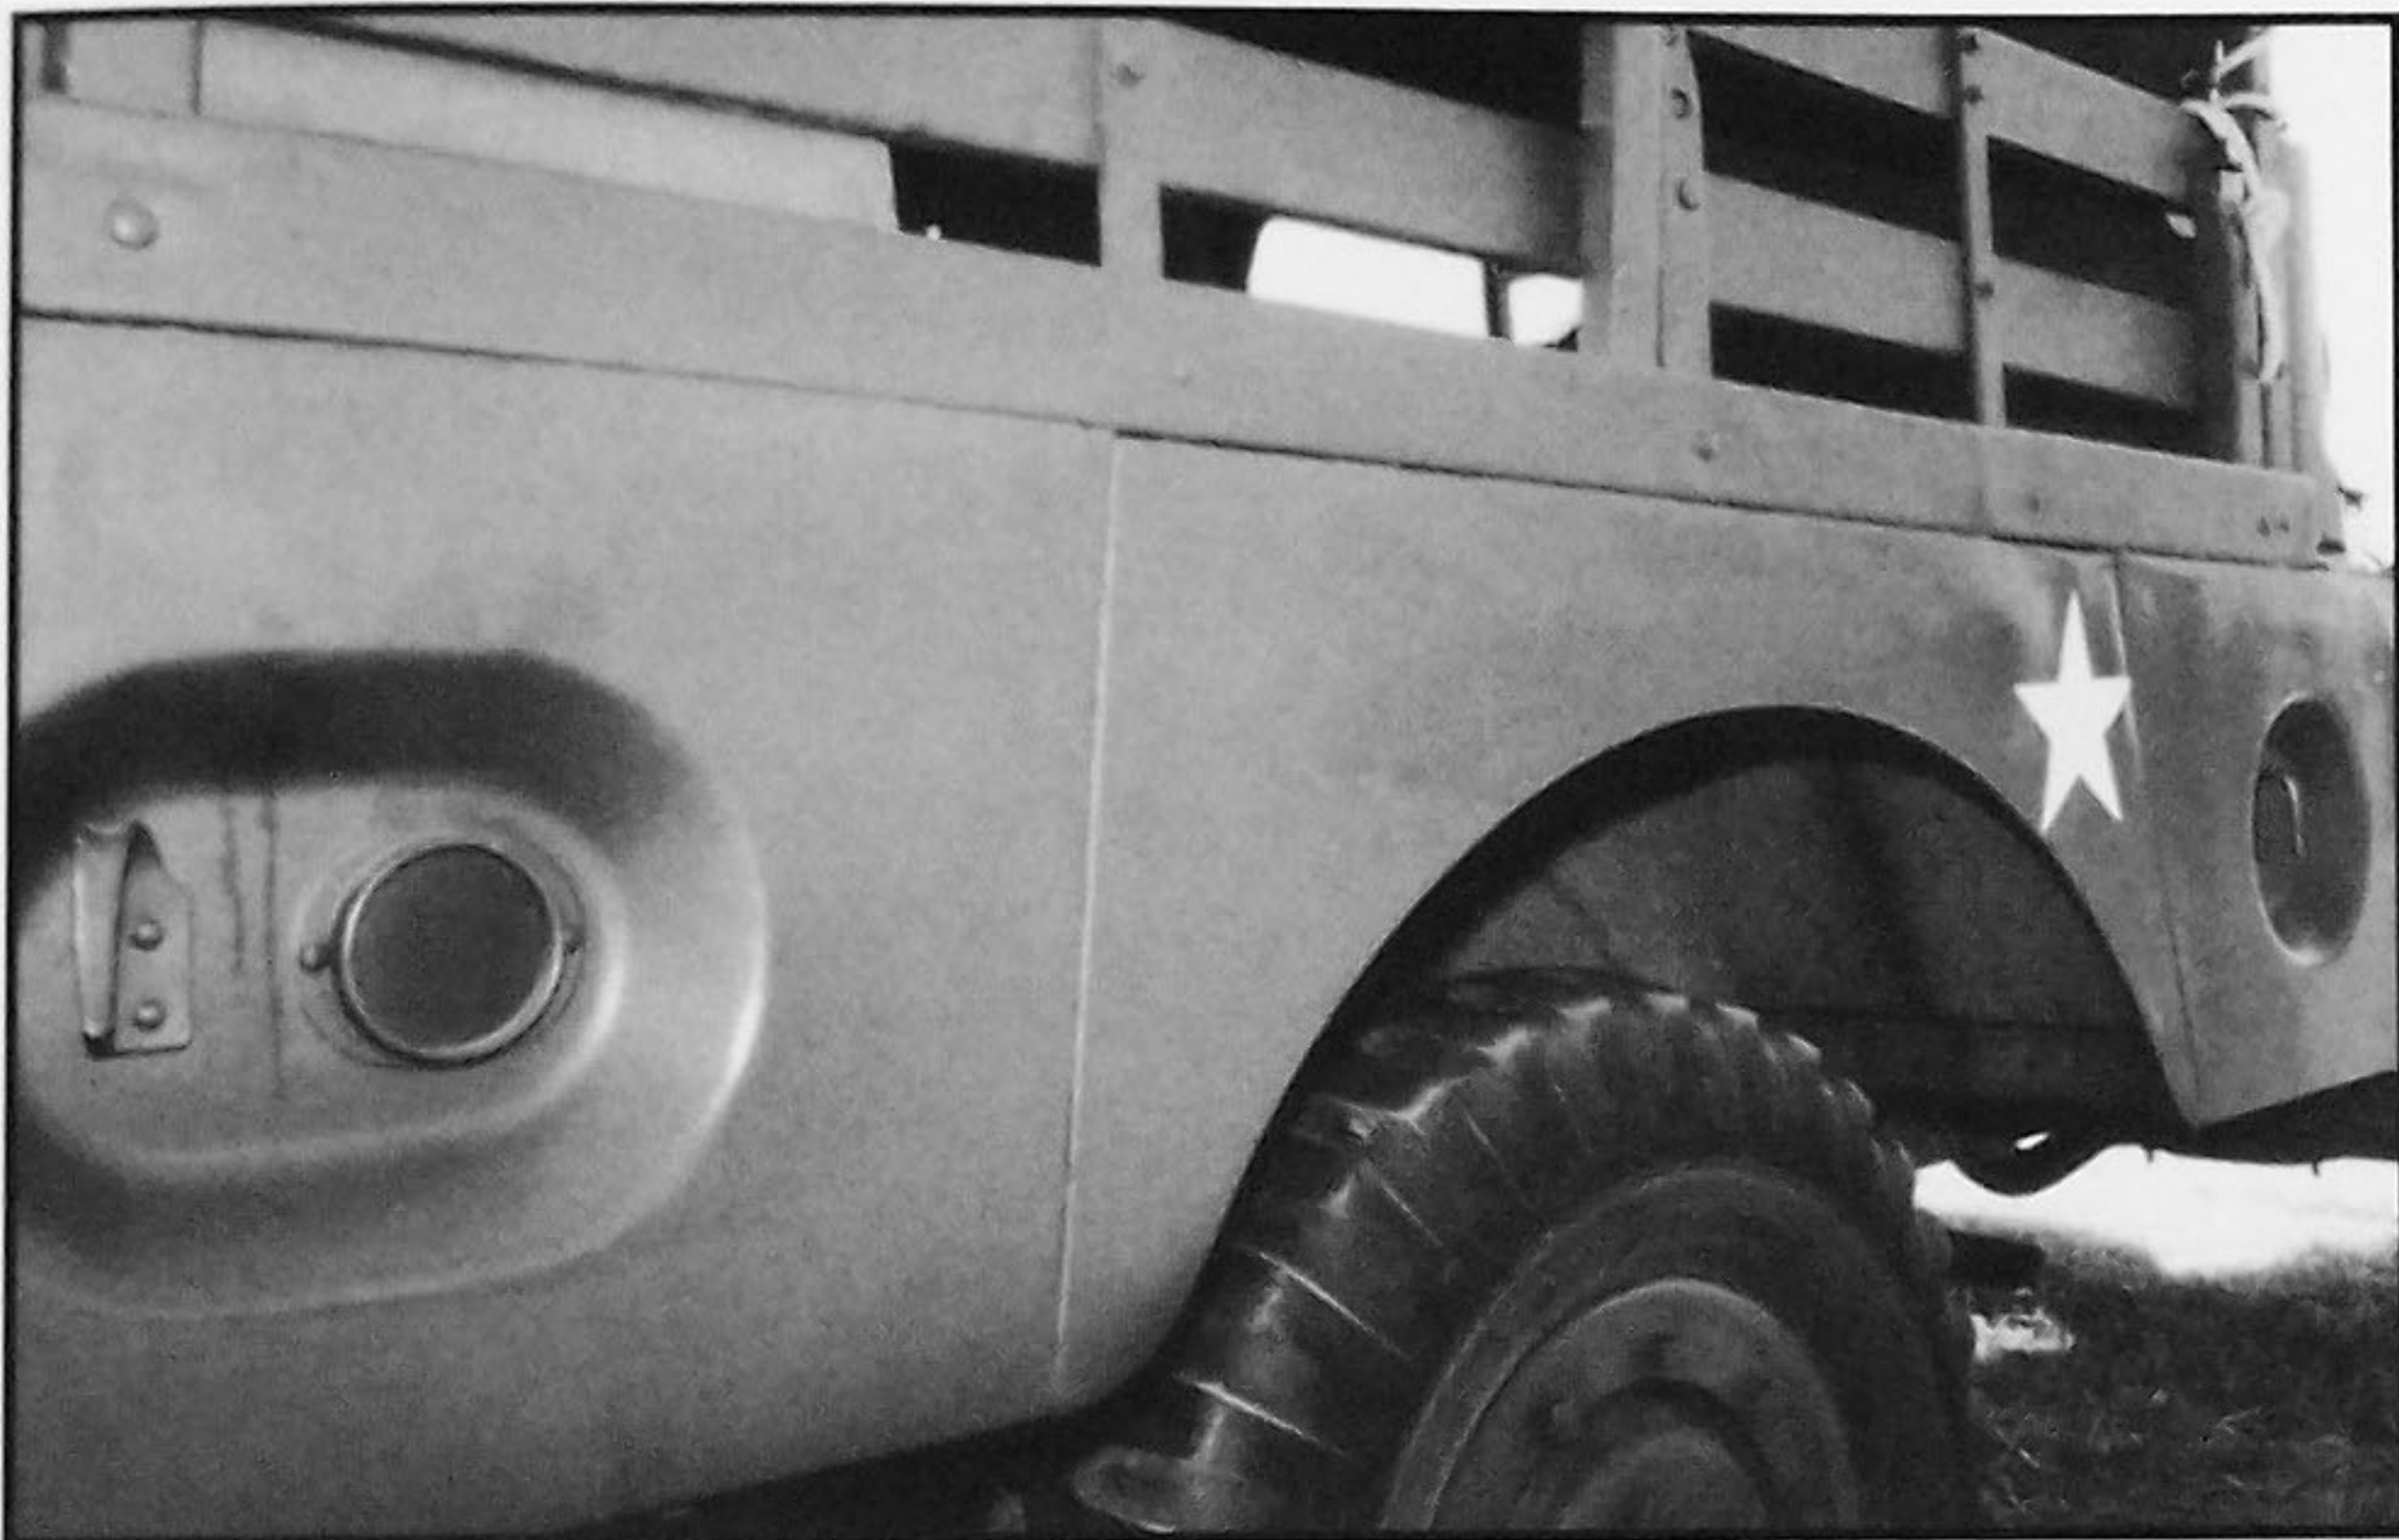
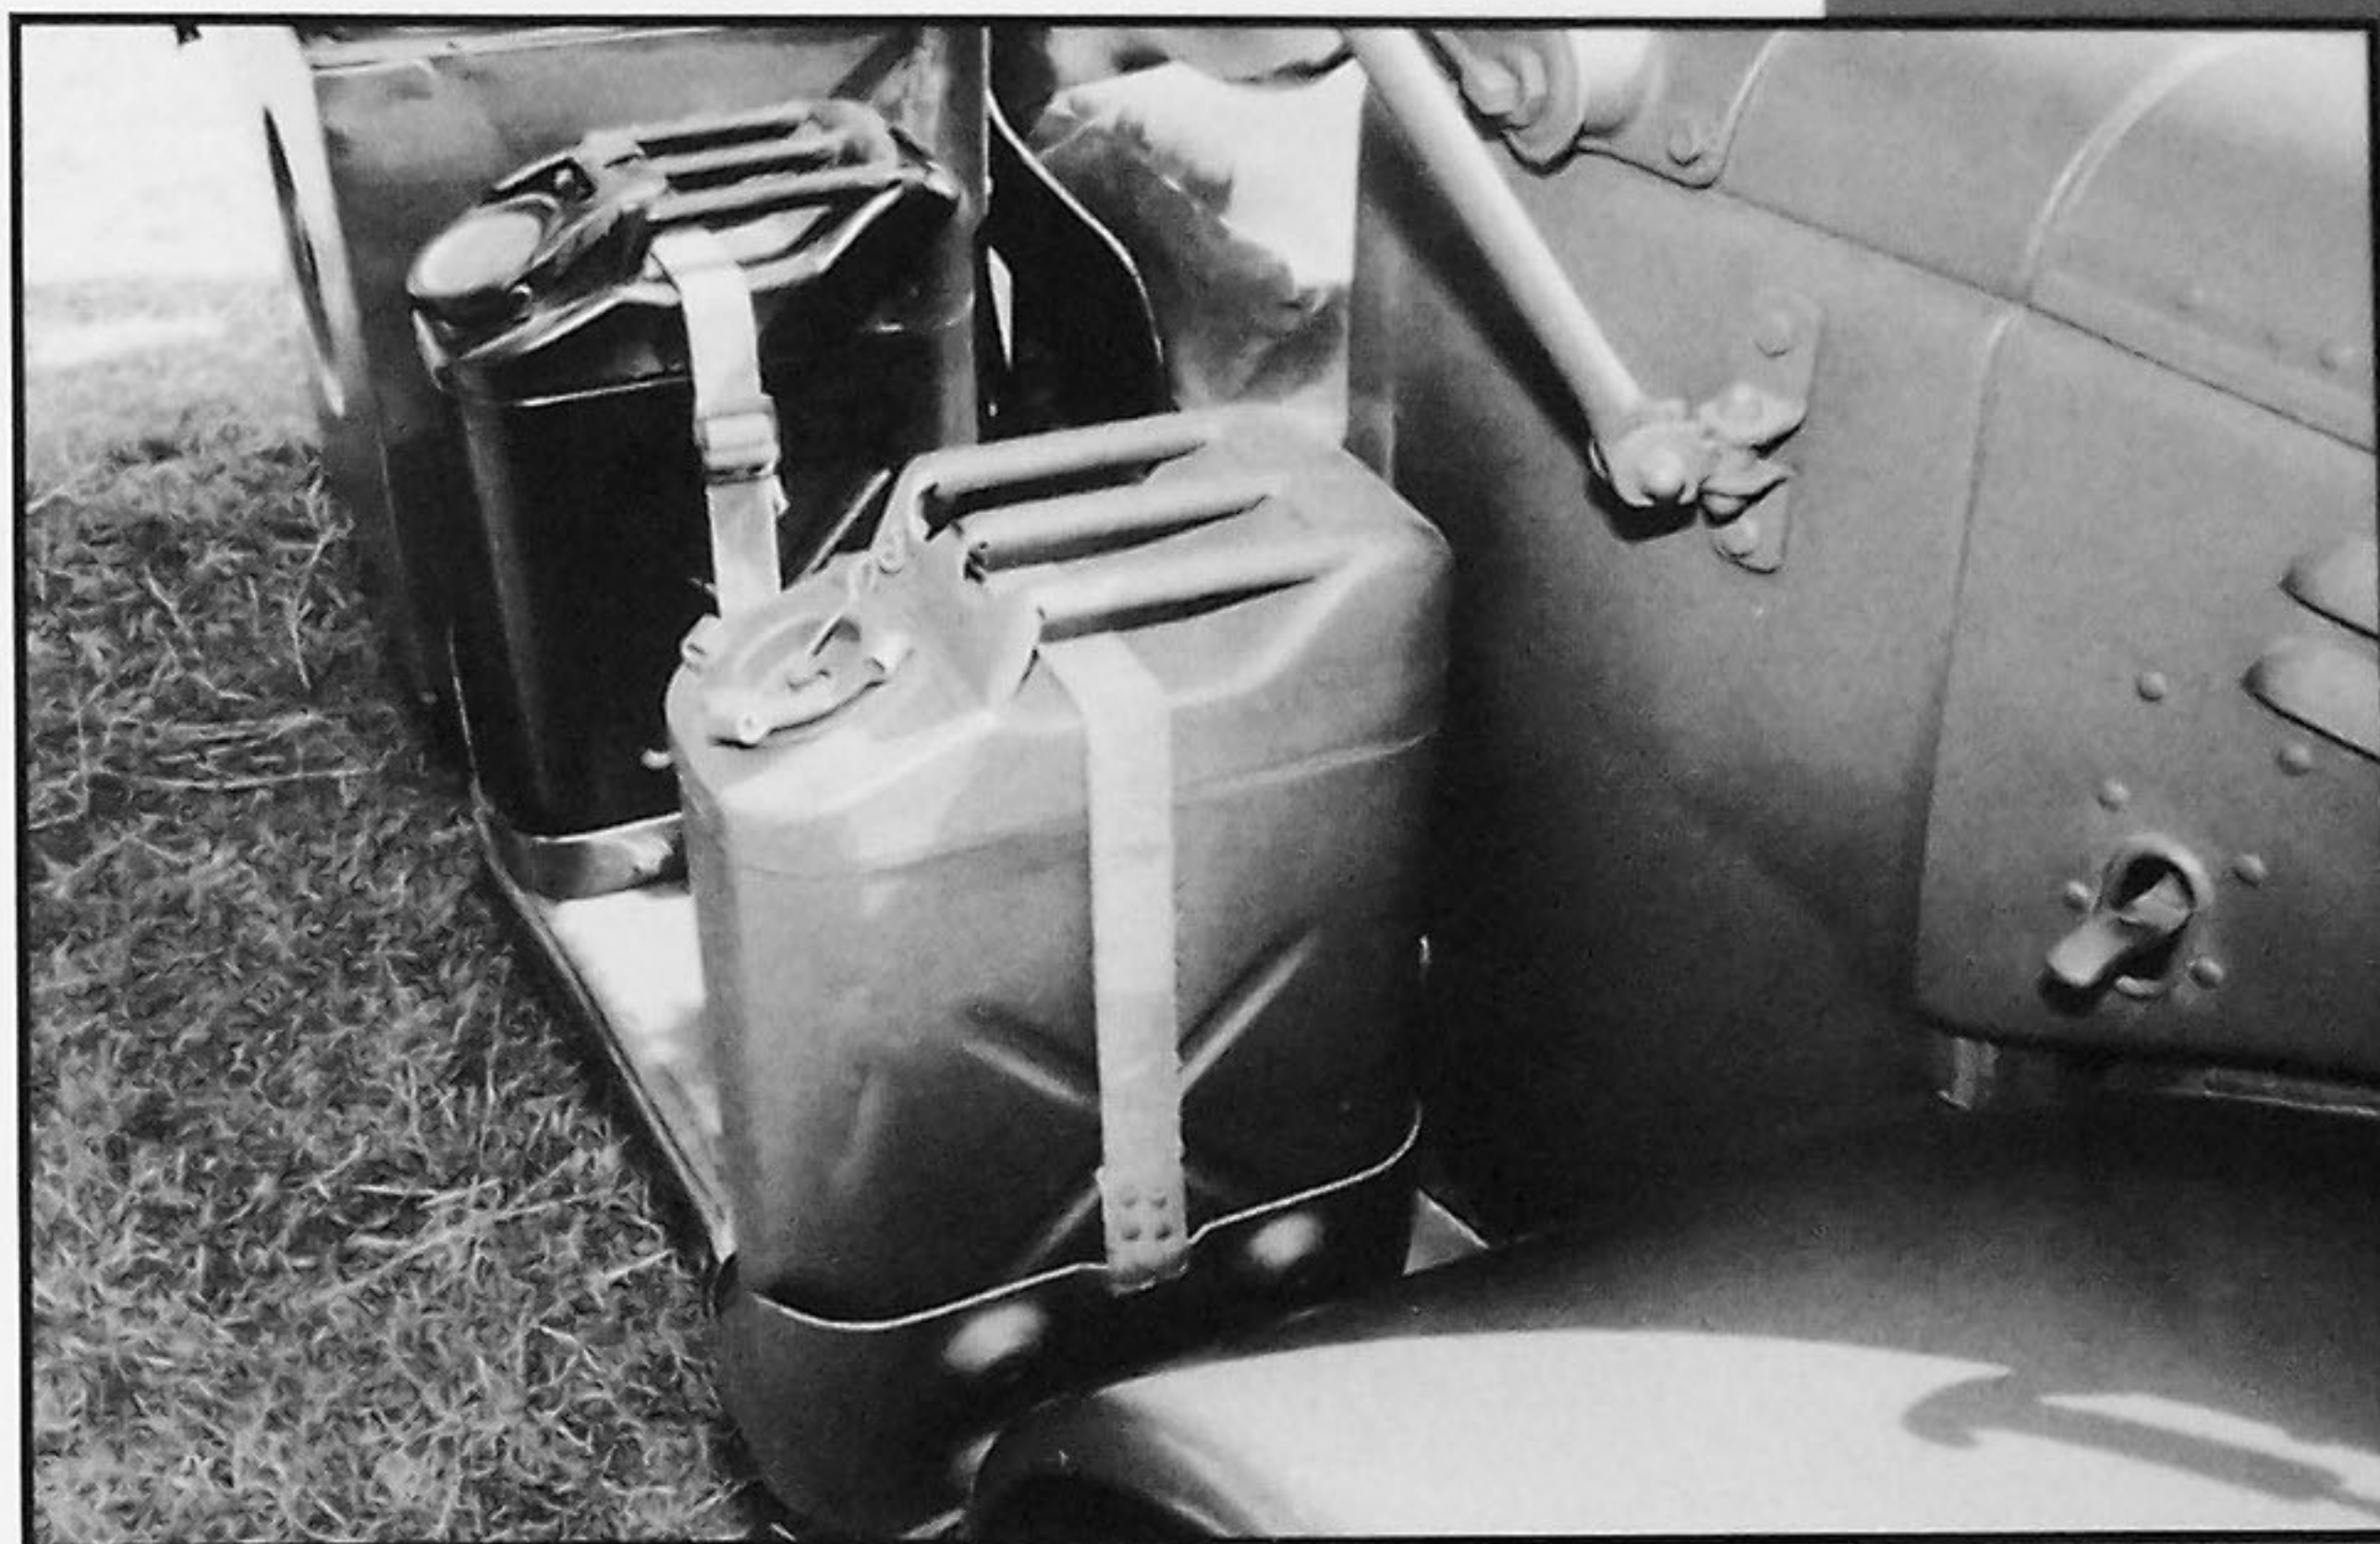
**Top left:** two folded metal hooks are located within depressions on either side of the rear cargo body. These hooks secure the canvas top and the recesses prevented the hooks from snagging on brush or other objects. **Top right:** the rear tailgate could be folded down and was secured on the inside with two safety chains. Note that the rear reflectors are also recessed in the bodywork. This and the photo at the lower left show the standard rectangular tool rack seen on many U.S. soft skins and armored vehicles. This rack held the regulation GI shovel, ax and pick ax. The pick is stored with the head detached. Above left: the WC 51 and 52 were not commonly used as radio vehicles, but this collector has installed an

antenna mount on his truck and has also made provision for the installation of a radio set in the bed. Although this was not an "official" modification, it is certainly probable that such a modification could have been made to a wartime vehicle. **Above right:** military vehicle enthusiasts, much like their counterparts in the vintage car hobby, often attempt to make their vehicles as unique as possible. Many times these modifications are based on a wartime photo and other times they are just at the fancy of the owner. This vehicle has the forward canvas support removed and a pedestal mount installed with a .30 caliber machine gun mounted on top (in this case a non-working replica). He has also installed an antenna.

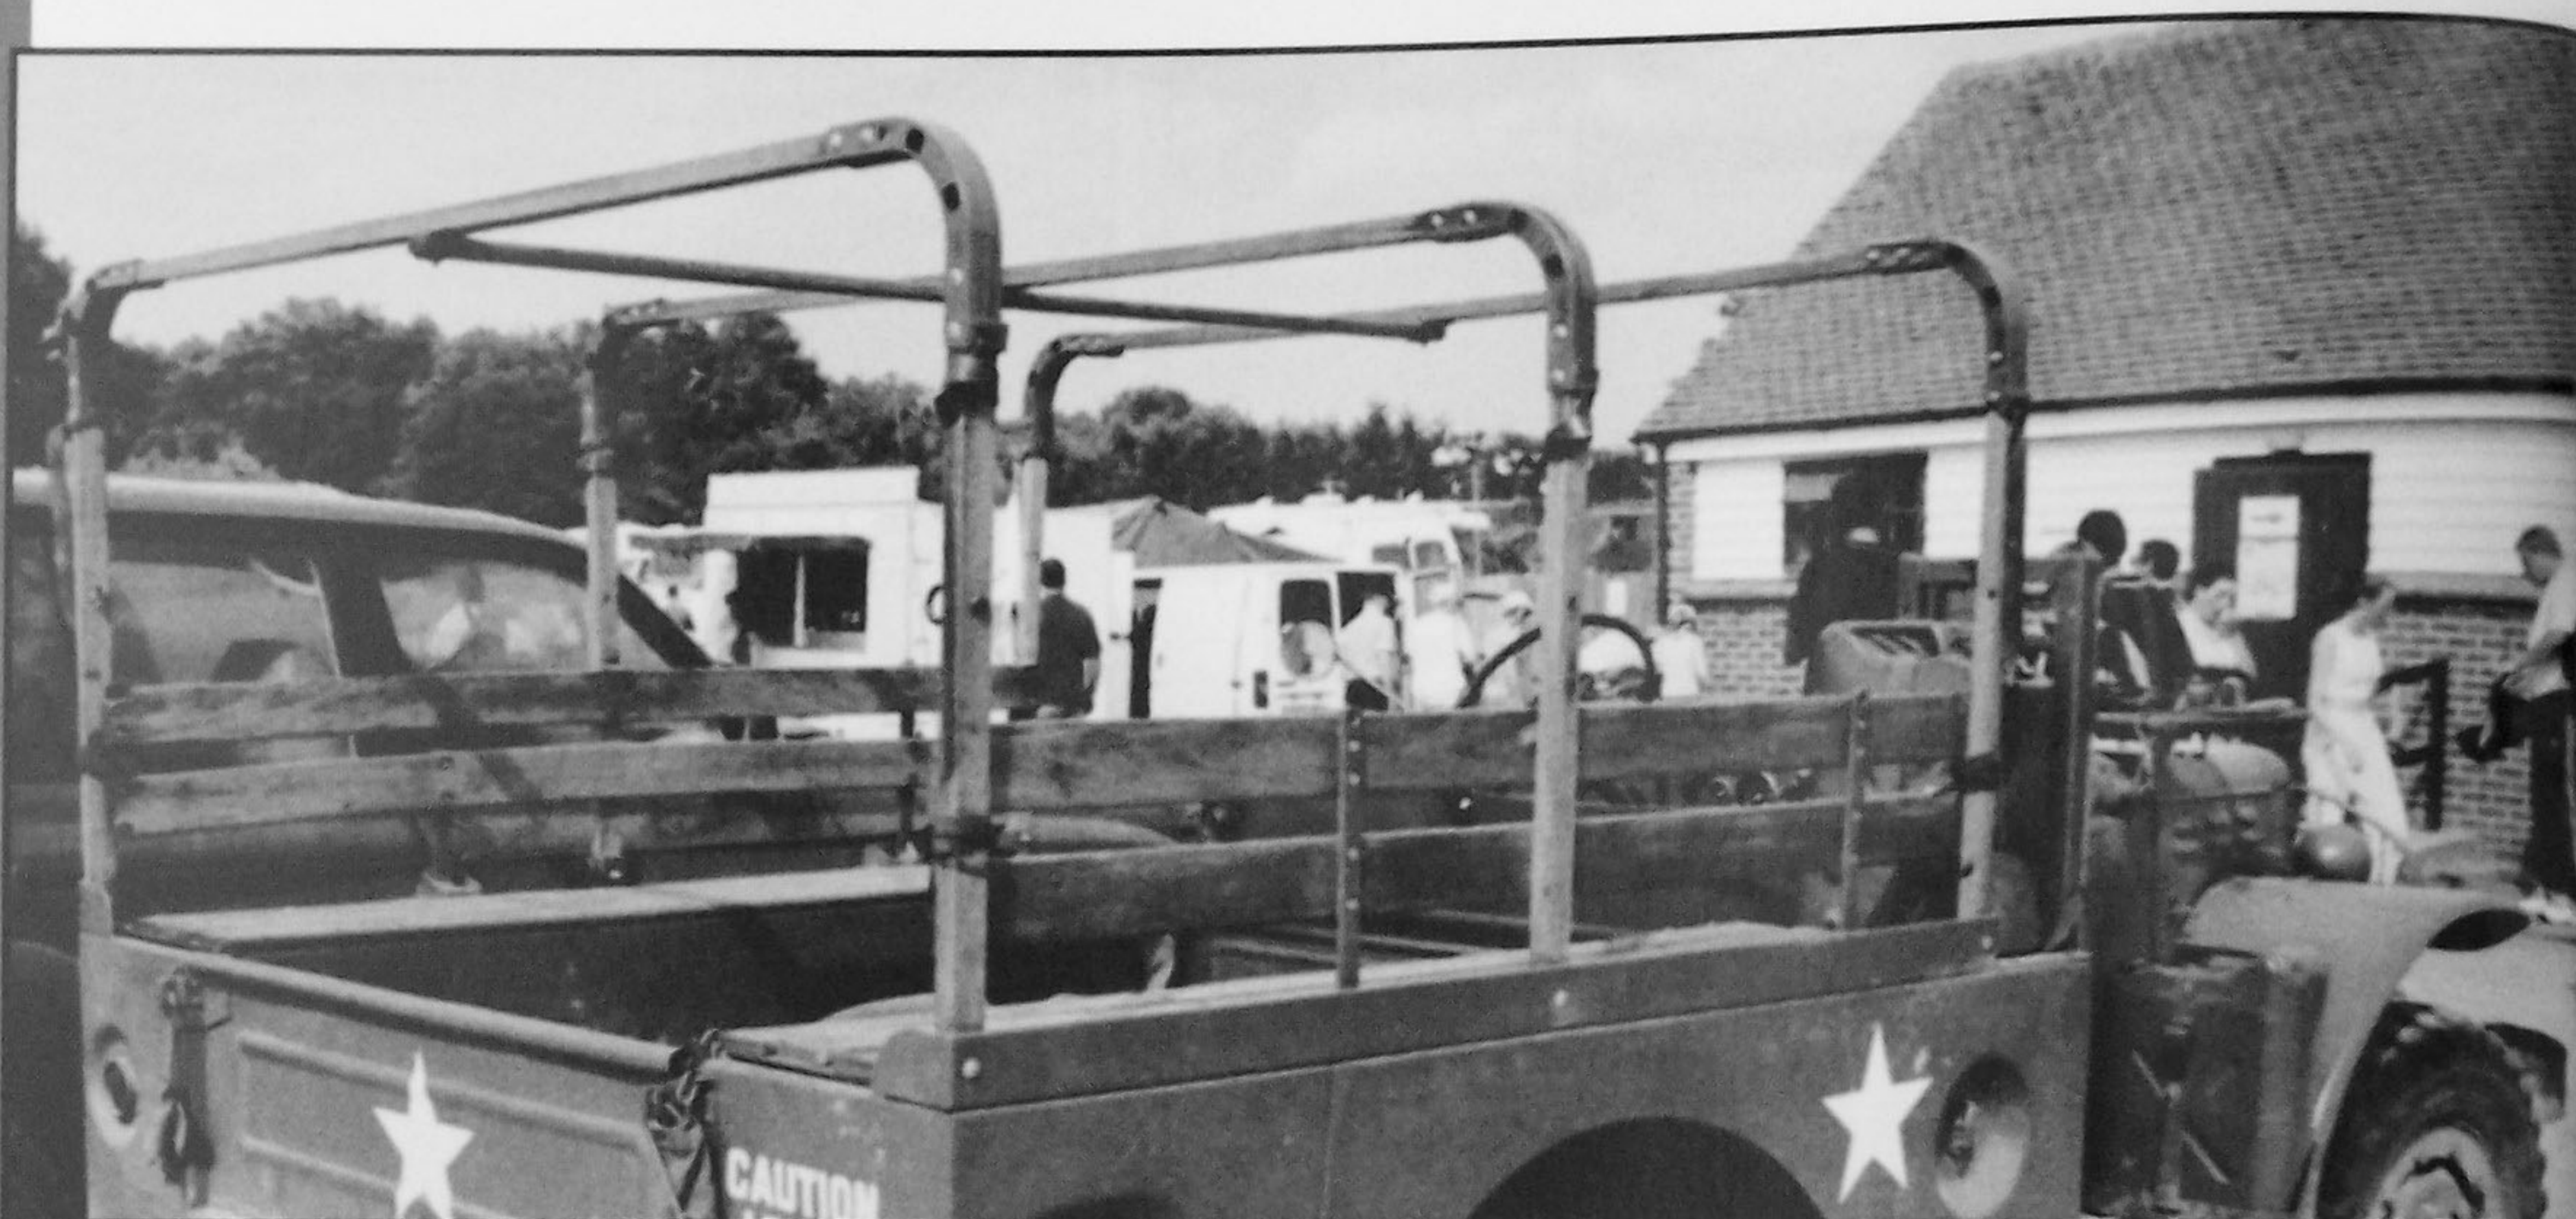
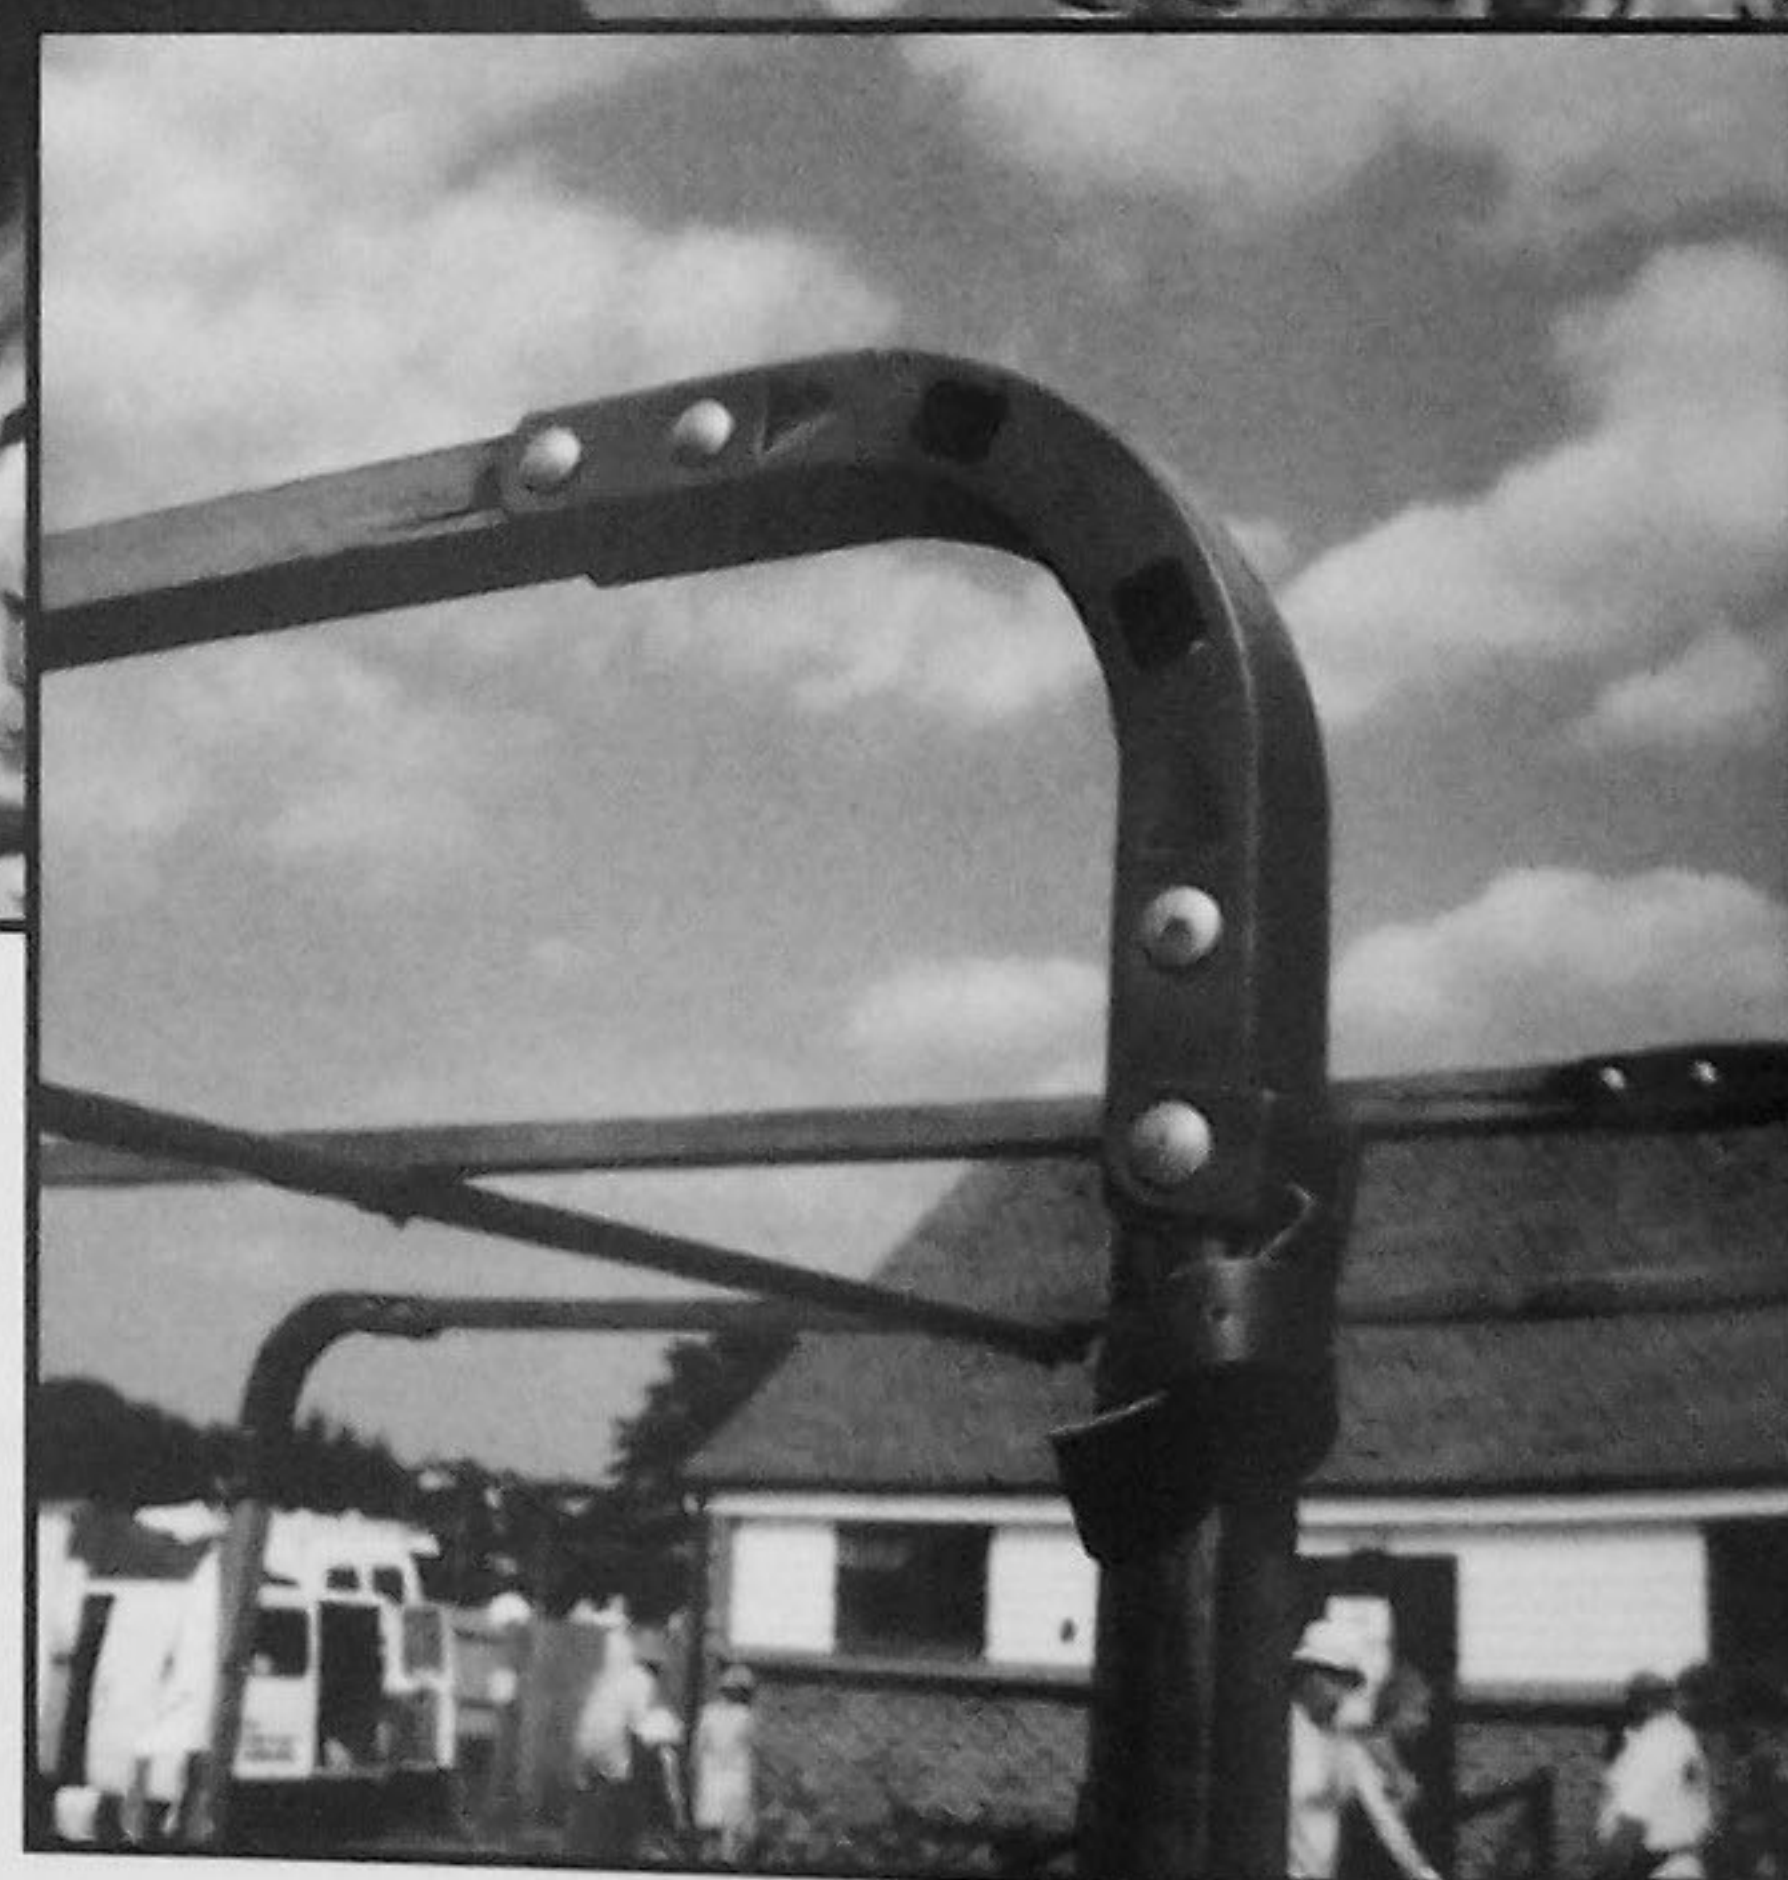
**Top left:** this is the right hand side of the cargo bed, showing the recessed hooks. The rearmost hook location on both sides also encompasses a reflector. **Top right:** this is the early configuration for the right side gas can racks. **Above right:** the left side of the cargo bed. The wooden racks seen here are called "lazy backs" and they could be folded up or down. **Right:** another shot from the British wartime evaluation series. On this very early production model, the tool rack is installed inside the rear tailgate (IWM).

These three shots afford excellent views of the supports and framework of the rear canvas cover. The main components are wood, while the curved linking sections are made from formed steel sheeting. The wooden components of the seating areas were sometimes seen in their natural wood color, but were more commonly seen painted in olive drab. On this example, the lazy backs are secured to the side top supports with leather straps. The large shot illustrates one of the major external changes to the WC 51 and 52, the relocation of the rear tool rack in an upright position to the right side body panel. The left-hand gas can was also relocated just to rear of the rack (also see page 25). This same change was also made to the Dodge 1 1/2-ton 6 x 6 truck, during its production run.
