# Allied-Axis

THE PHOTO JOURNAL OF THE SECOND WORLD WAR

**German  
SIG 33/1  
Grille SPG**

**Kleines Kettenkrafttrad  
WWII Dodge 3/4-ton trucks  
DUKW Amphibious truck**

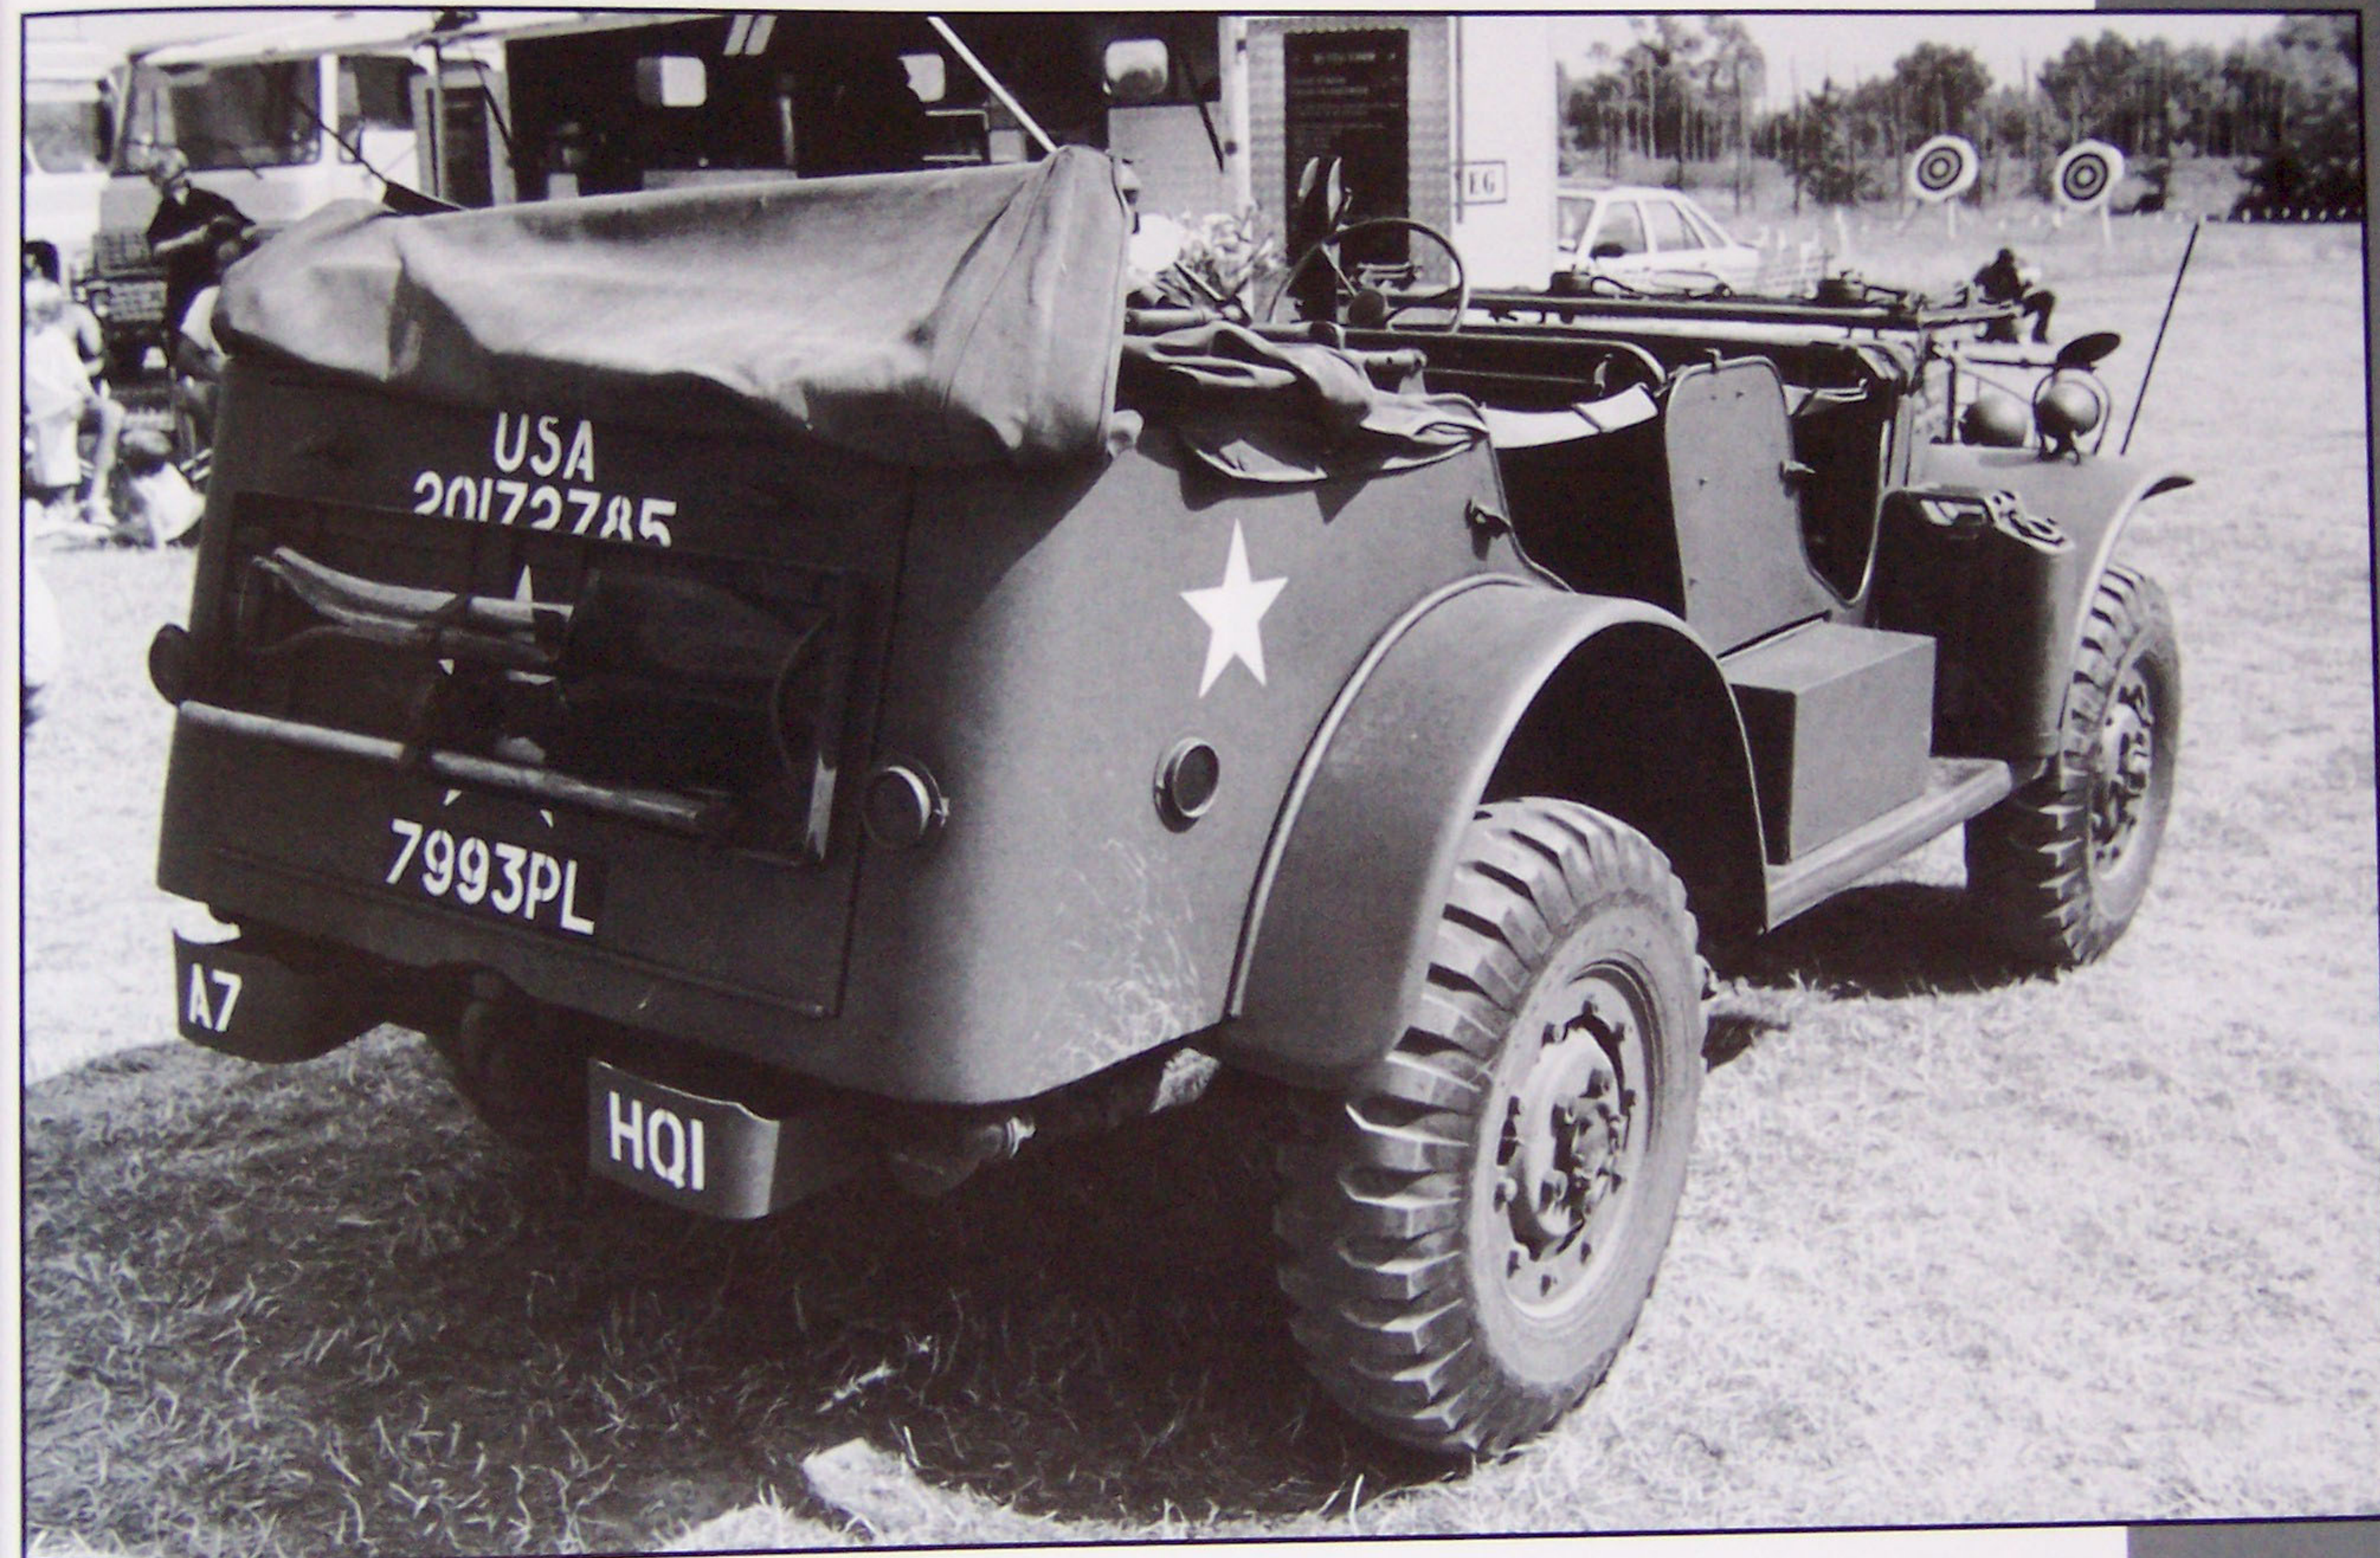
The command car was also built with a radio set permanently installed in front of the rear seat and in this configuration it had the model code of WC 58. All versions of the command car are equipped with an elaborate folding canvas top. This is fitted over a tube frame and is attached with metal snaps to the front windshield and the rear bodywork. Canvas covered metal door frames are also supplied and when not in use they were stored in the rear luggage compartment (also see page 32). **Above:** a rear view of the previous car. The canvas top has been simply pushed back on its frame here. It could also be neatly stowed with straps when collapsed. The large 12-volt battery box can be seen on the right side of the

vehicle. This was a common place to paint the loading stencil, which can be seen on the vehicle on page 27. The British owner of this WC 56, accustomed to a right hand drive vehicle, has installed a metal rod on the right fender to help him better judge its location. The presence of the Dodge logo stamped into the radiator cover (seen in the previous photo) indicates that this is an earlier vehicle. Registration numbers for the WC 56 ran from W-20167957 to W-20182608 and 2091084 to 2092118. WC 57 registration numbers ran from 20184953 to 20185868, 2092119 to 2092618 and 20921158 to 209295751. WC 58 registration numbers ran from W-20182609 to W-20184952.

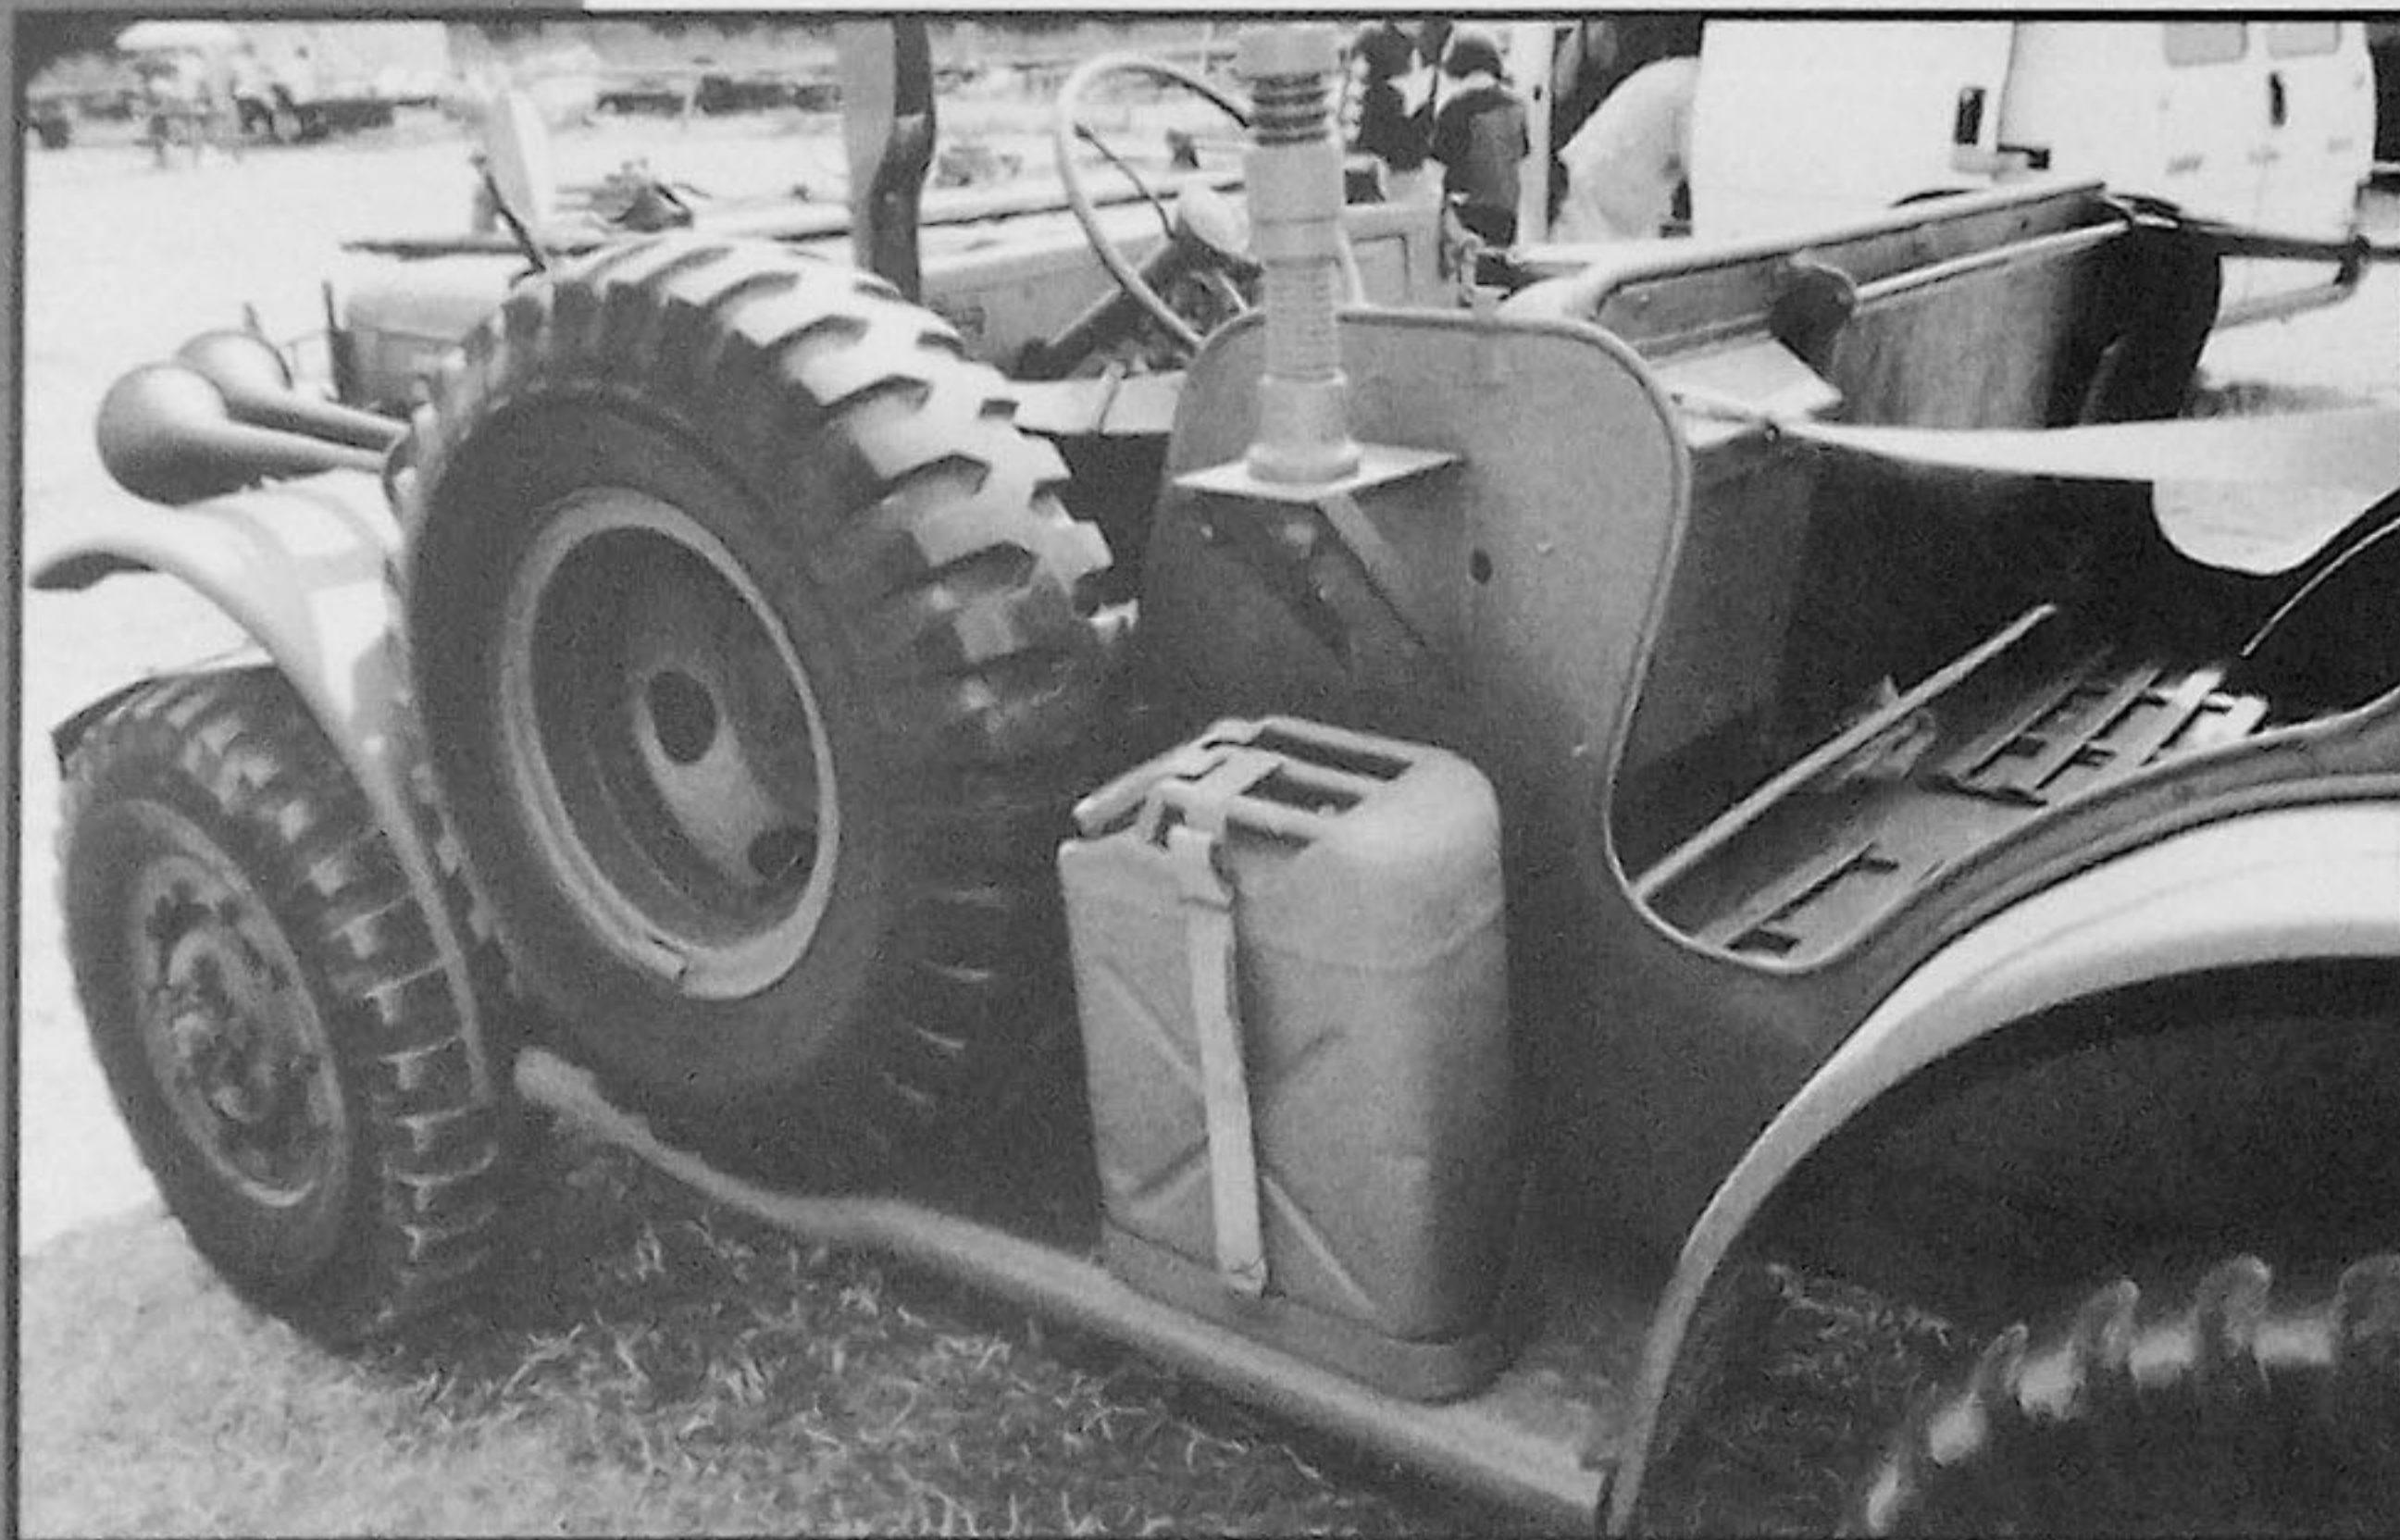
**Top left:** the left hand side of a restored WC 56. This shows the location of the spare tire and the left-side gas can rack. The placement of the spare tire here was common to the weapons carrier, the command car, the carryall and the 1 1/2-ton 6 x 6. Note how the left-hand side running board is formed to fit the tire. **Top right:** this close-up (of a weapons carrier) shows the common connector disk and nut,

which was used to secure the tire to its short frame. **Above left and right:** the backside of the front seat. The large rectangle is the map table, while the smaller object to its left is the map case. The footrest is also visible. Standard equipment for the command car included a large rubber mat to cover the rear floor as seen in the right hand photo.

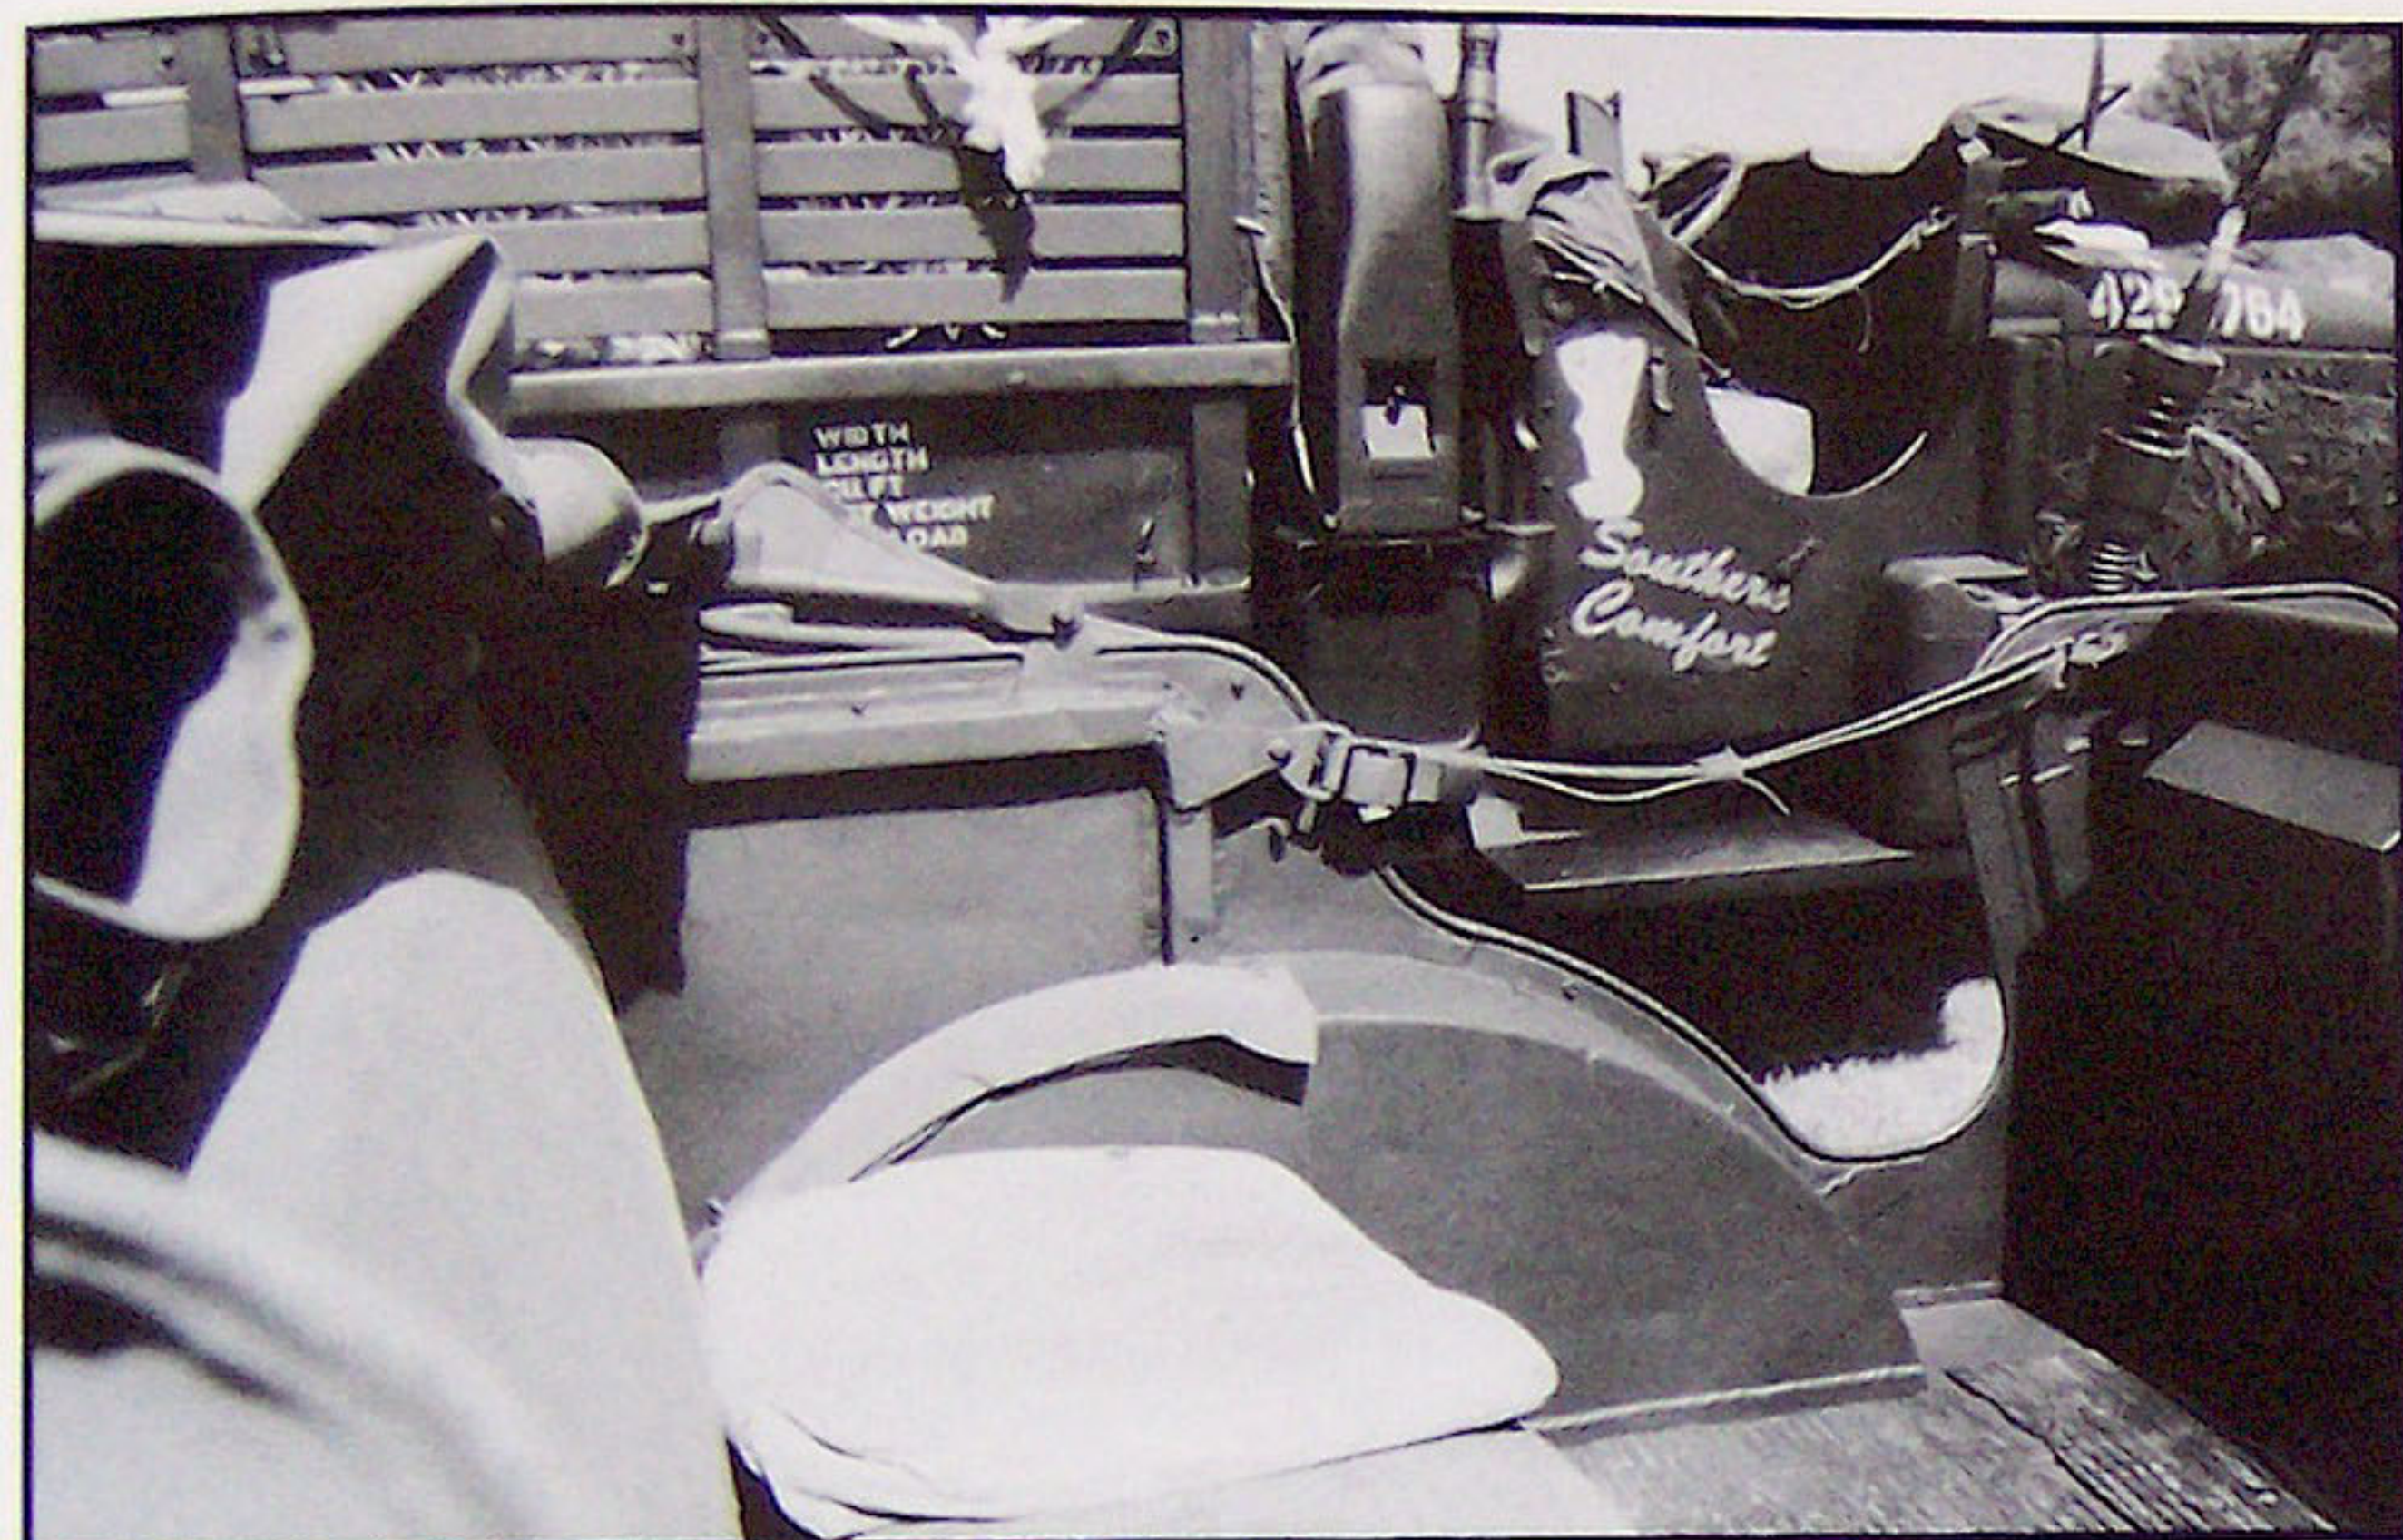
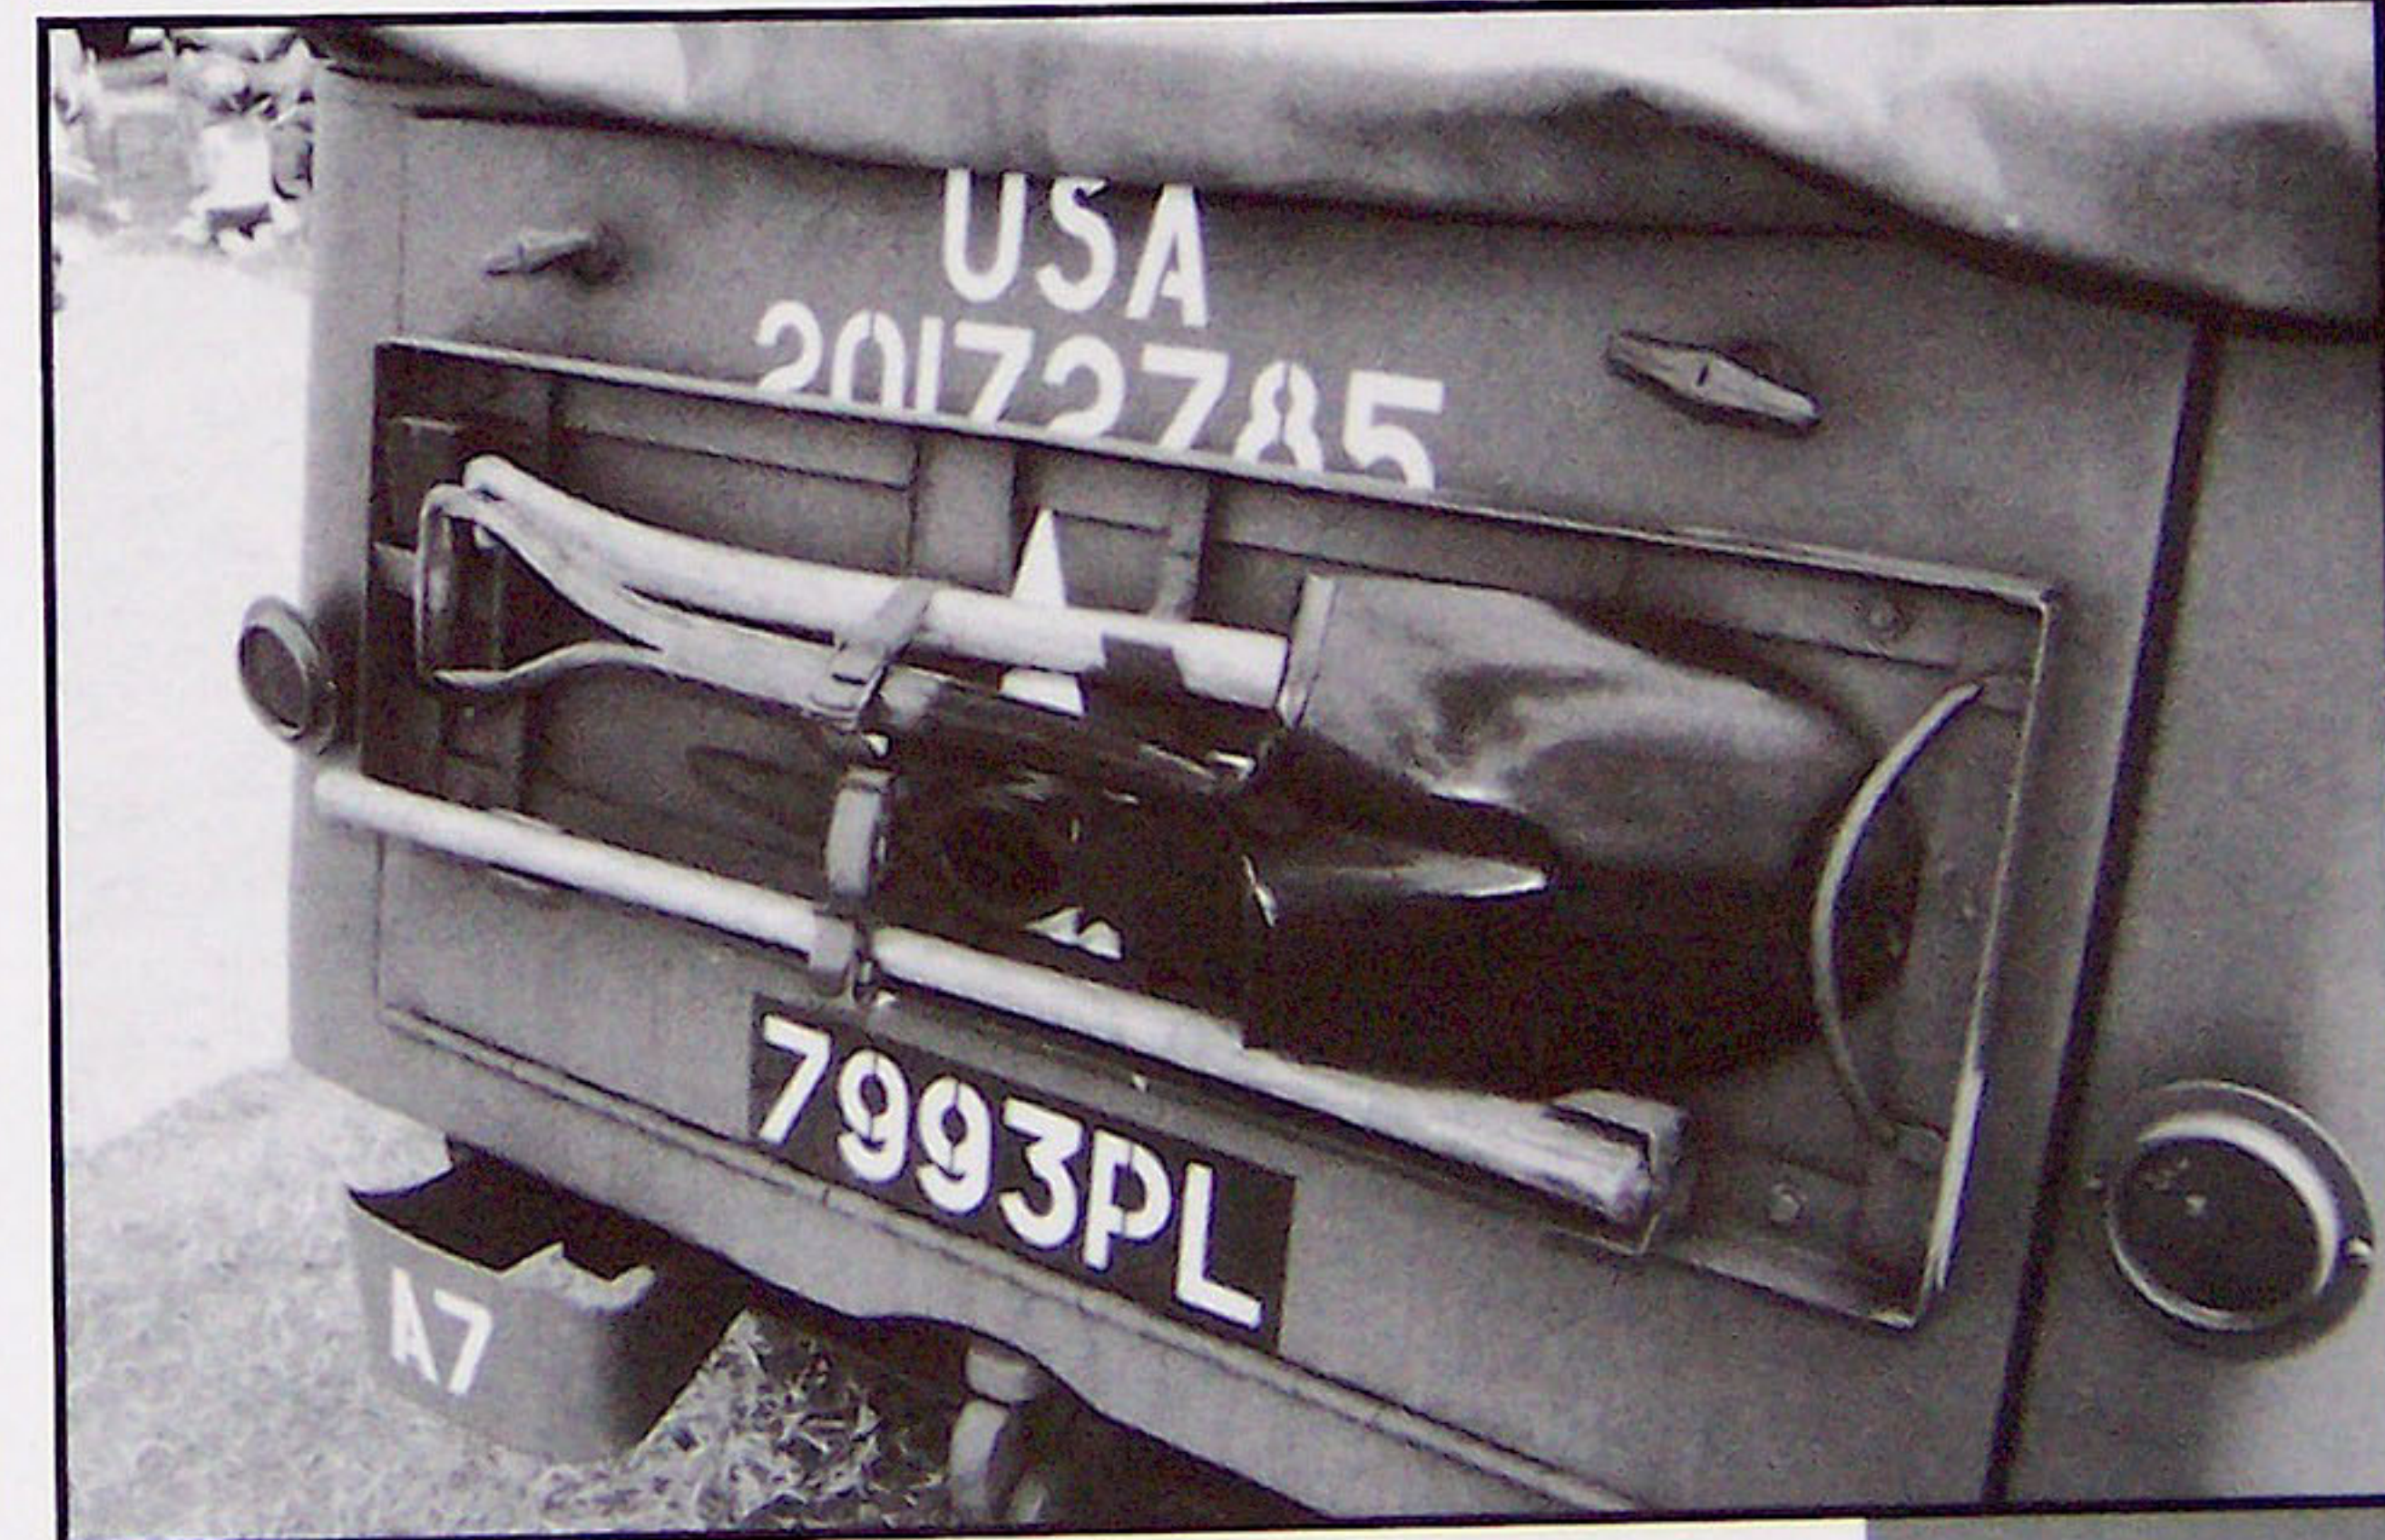
**Top left:** a look at the left rear wheel well. This shows the frame construction of the inner bodywork. Also note the way the safety strap is attached to a pivoting fixture on the left and a metal buckle on the right. This was as close as 1940's military automotive design got to safety technology! The leather seats and the armrests have been recovered with canvas cloth. **Top right:** this is the seat covering that the command car left the factory with. The owner has made a good effort to duplicate the original reddish colored leather. The original leather covering would be quite rare on a restored vehicle and this is

no exception. Also note the leather elbow pads fastened to the top of the wheel wells. **Above left:** the right rear quarter panel. It is interesting how the folded top settles around the bodywork. The small latch at the lower right side of the photo is for fastening the canvas door. These latches can be seen in the other photos as well. **Above right:** a good, close-up view of the rear tool rack. Although the metal portions of the tools here are glossy black, standard issue tools were olive drab. Also disregard the civilian number plate located below the tool rack.
