# Allied-Axis

THE PHOTO JOURNAL OF THE SECOND WORLD WAR

**German  
SIG 33/1  
Grille SPG**

**Kleines Kettenkrafttrad  
WWII Dodge 3/4-ton trucks  
DUKW Amphibious truck**

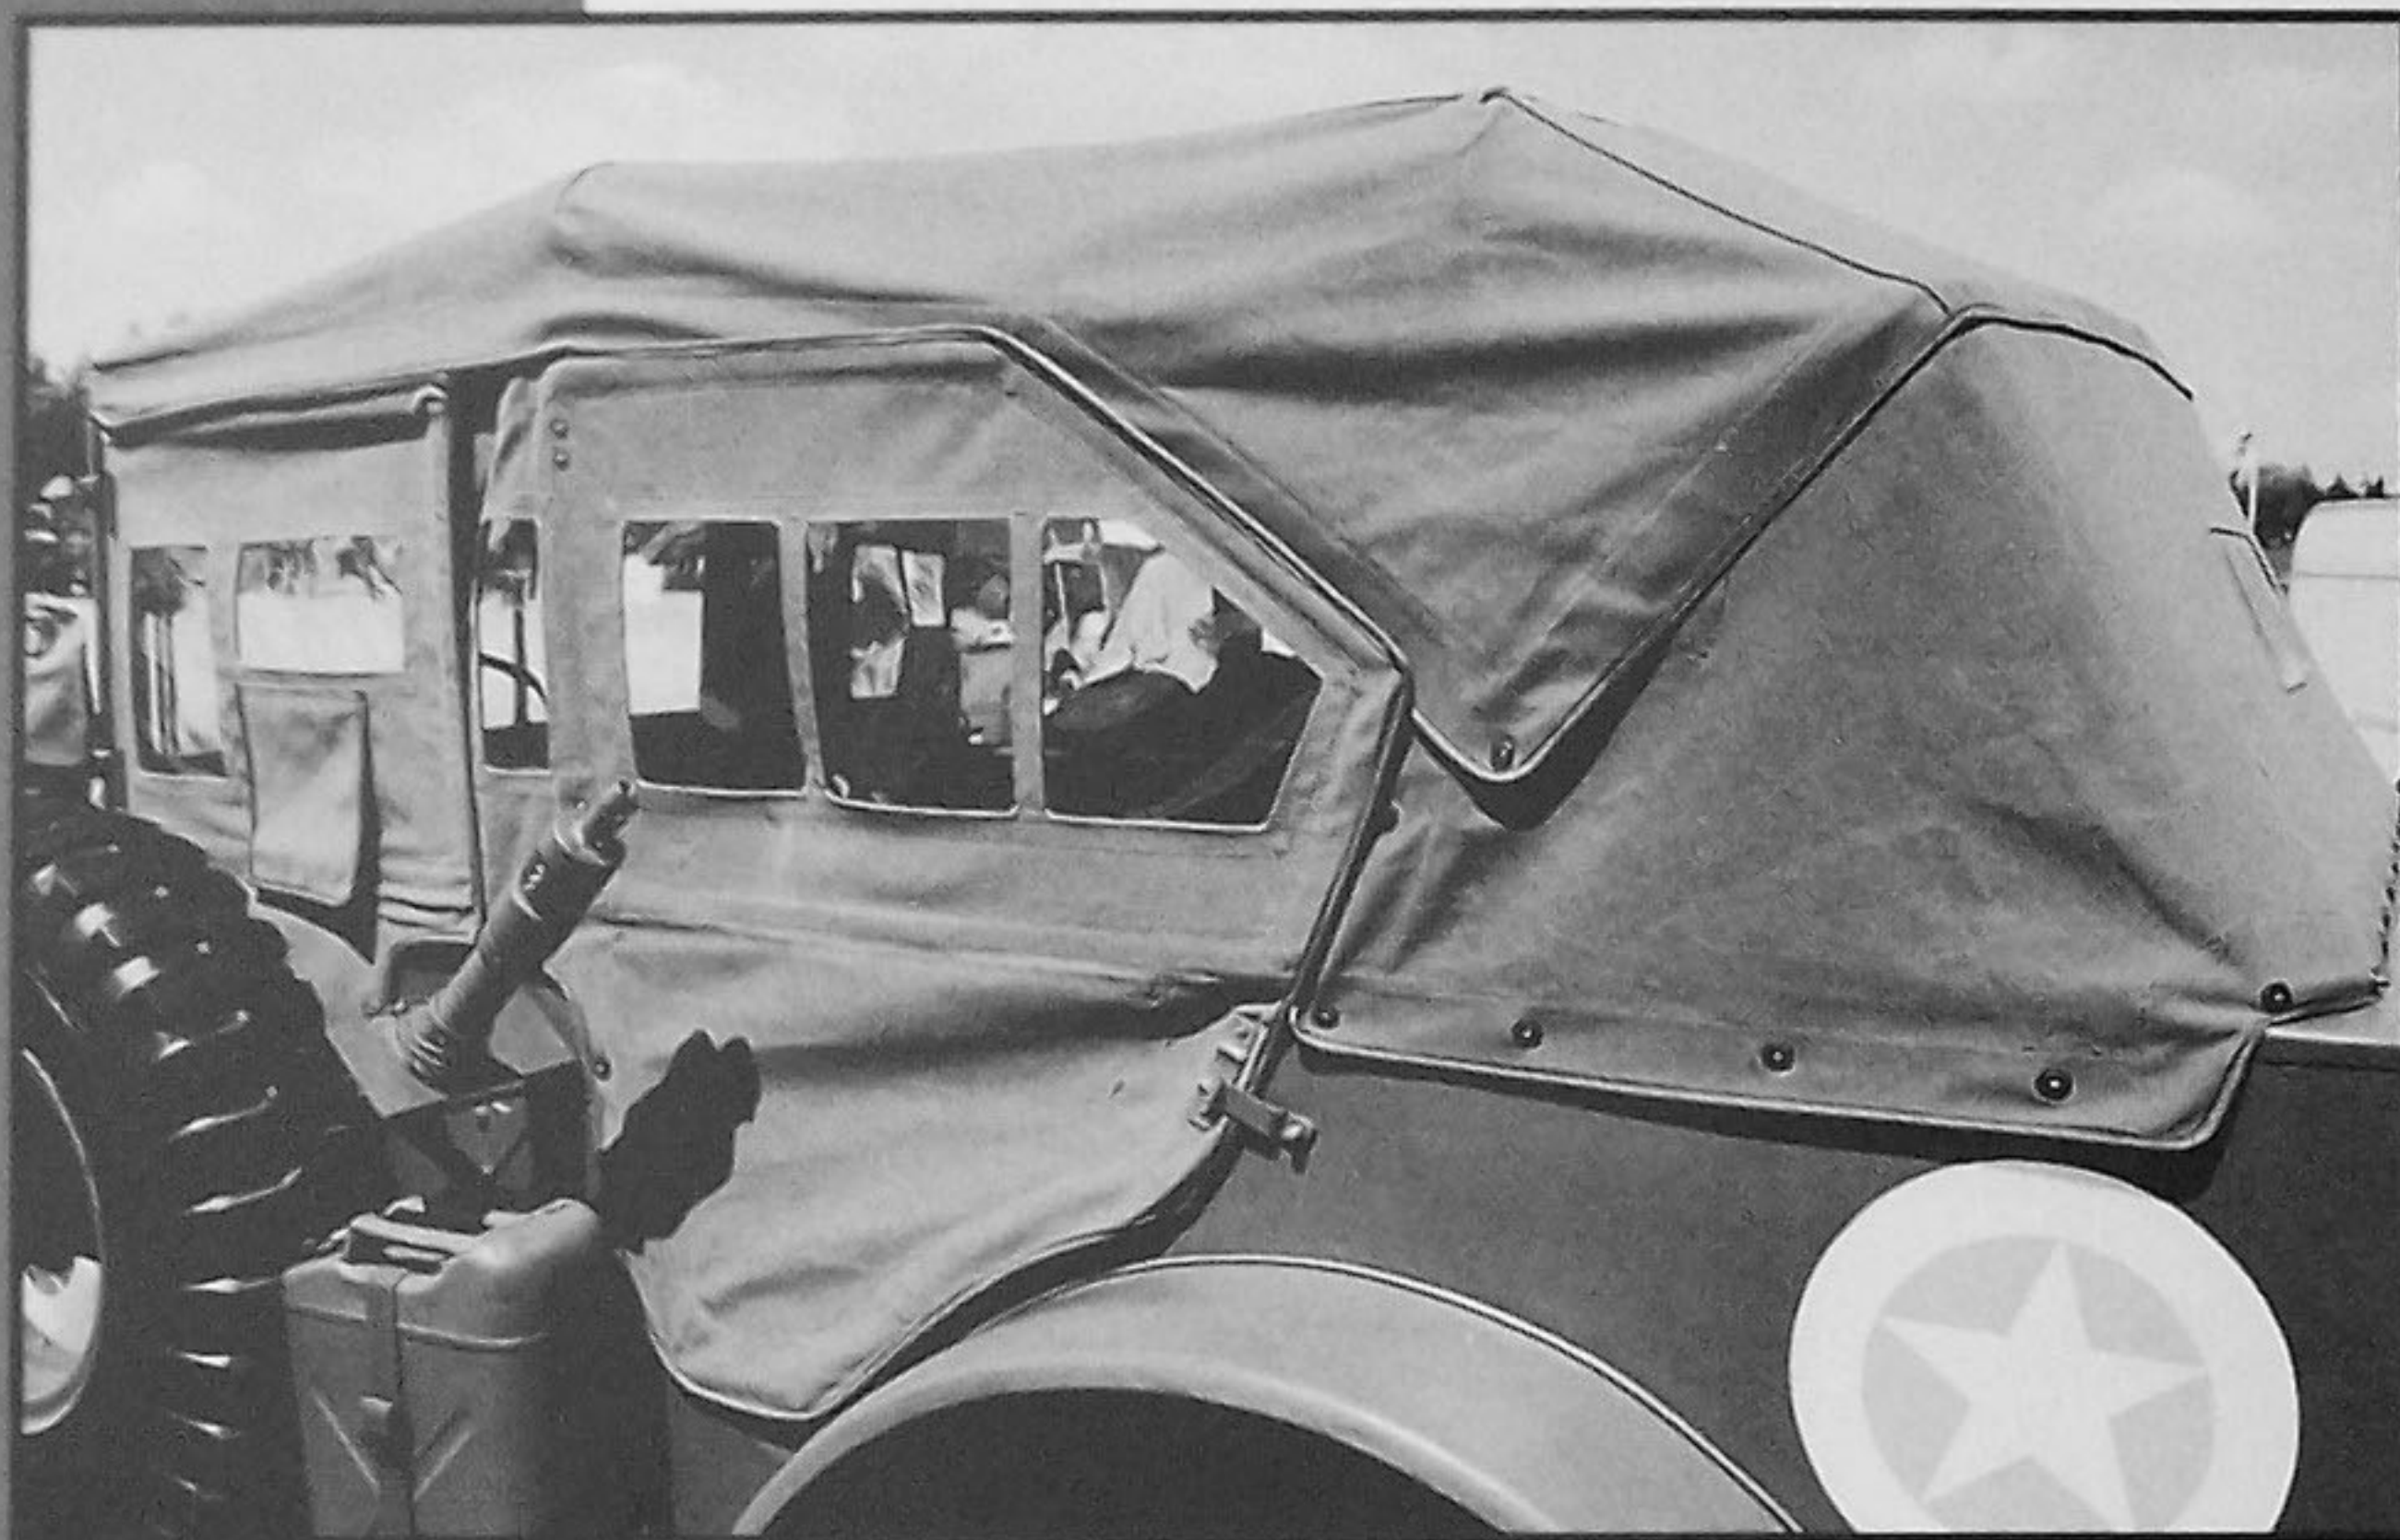
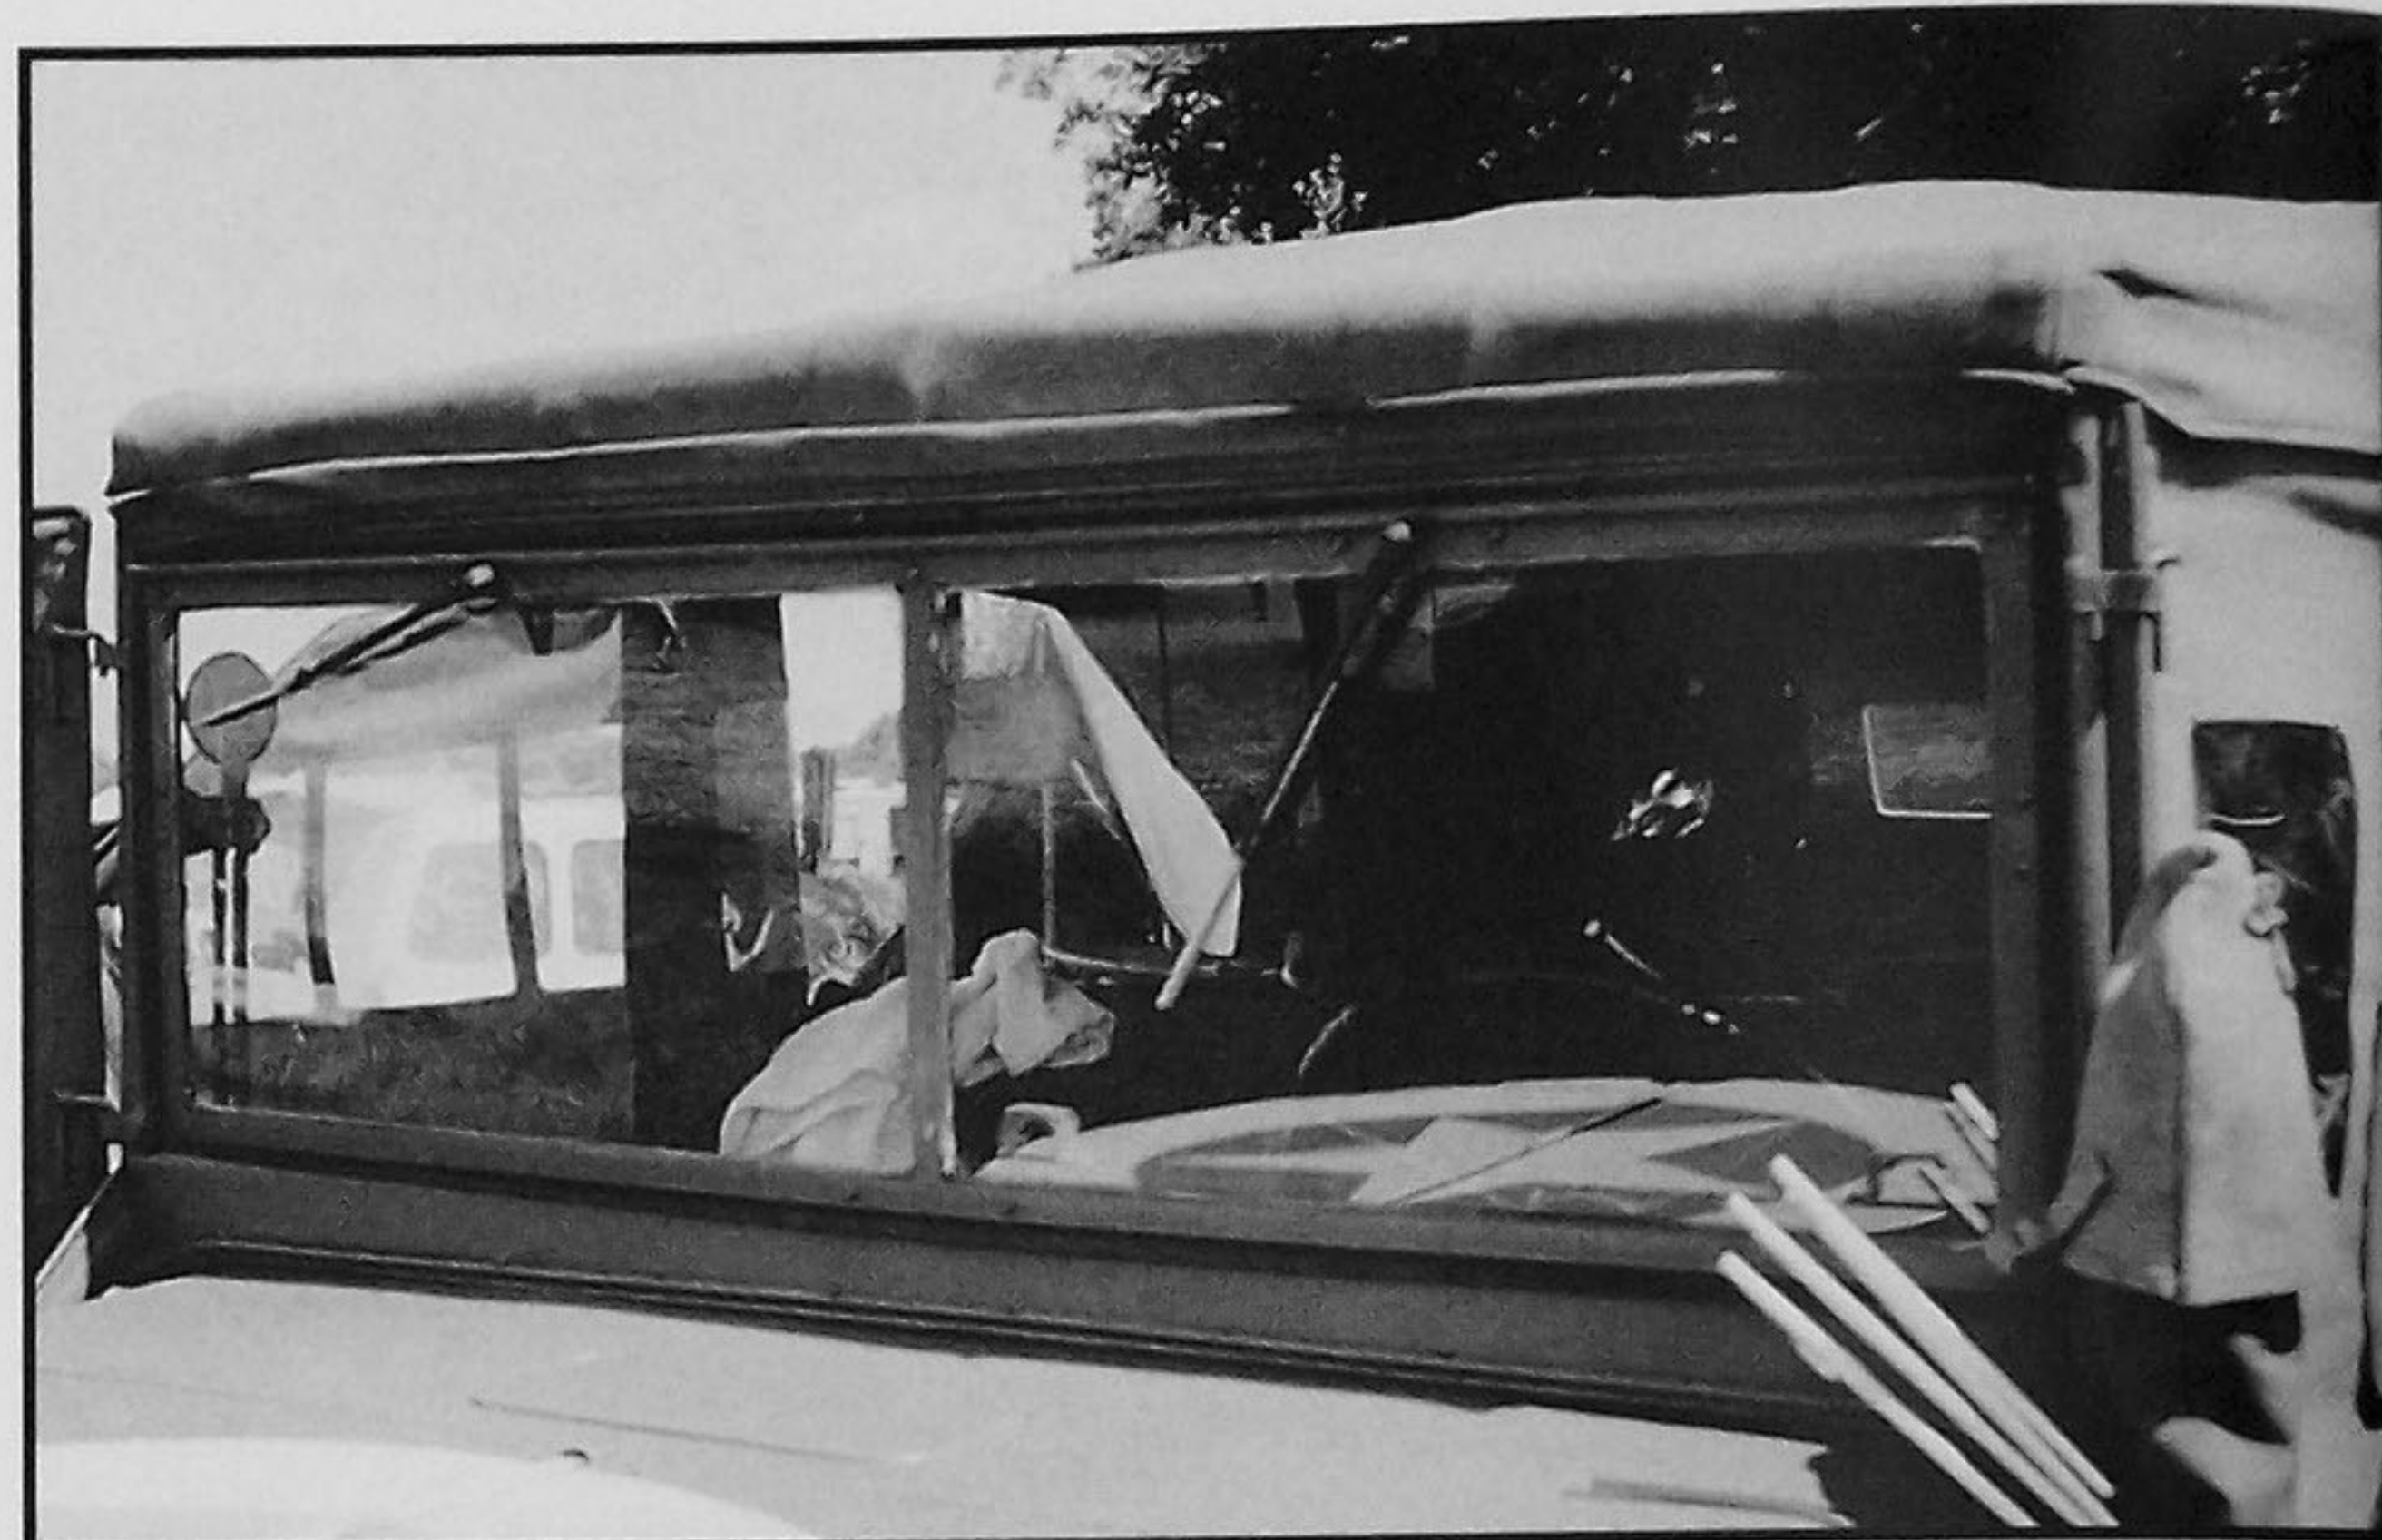
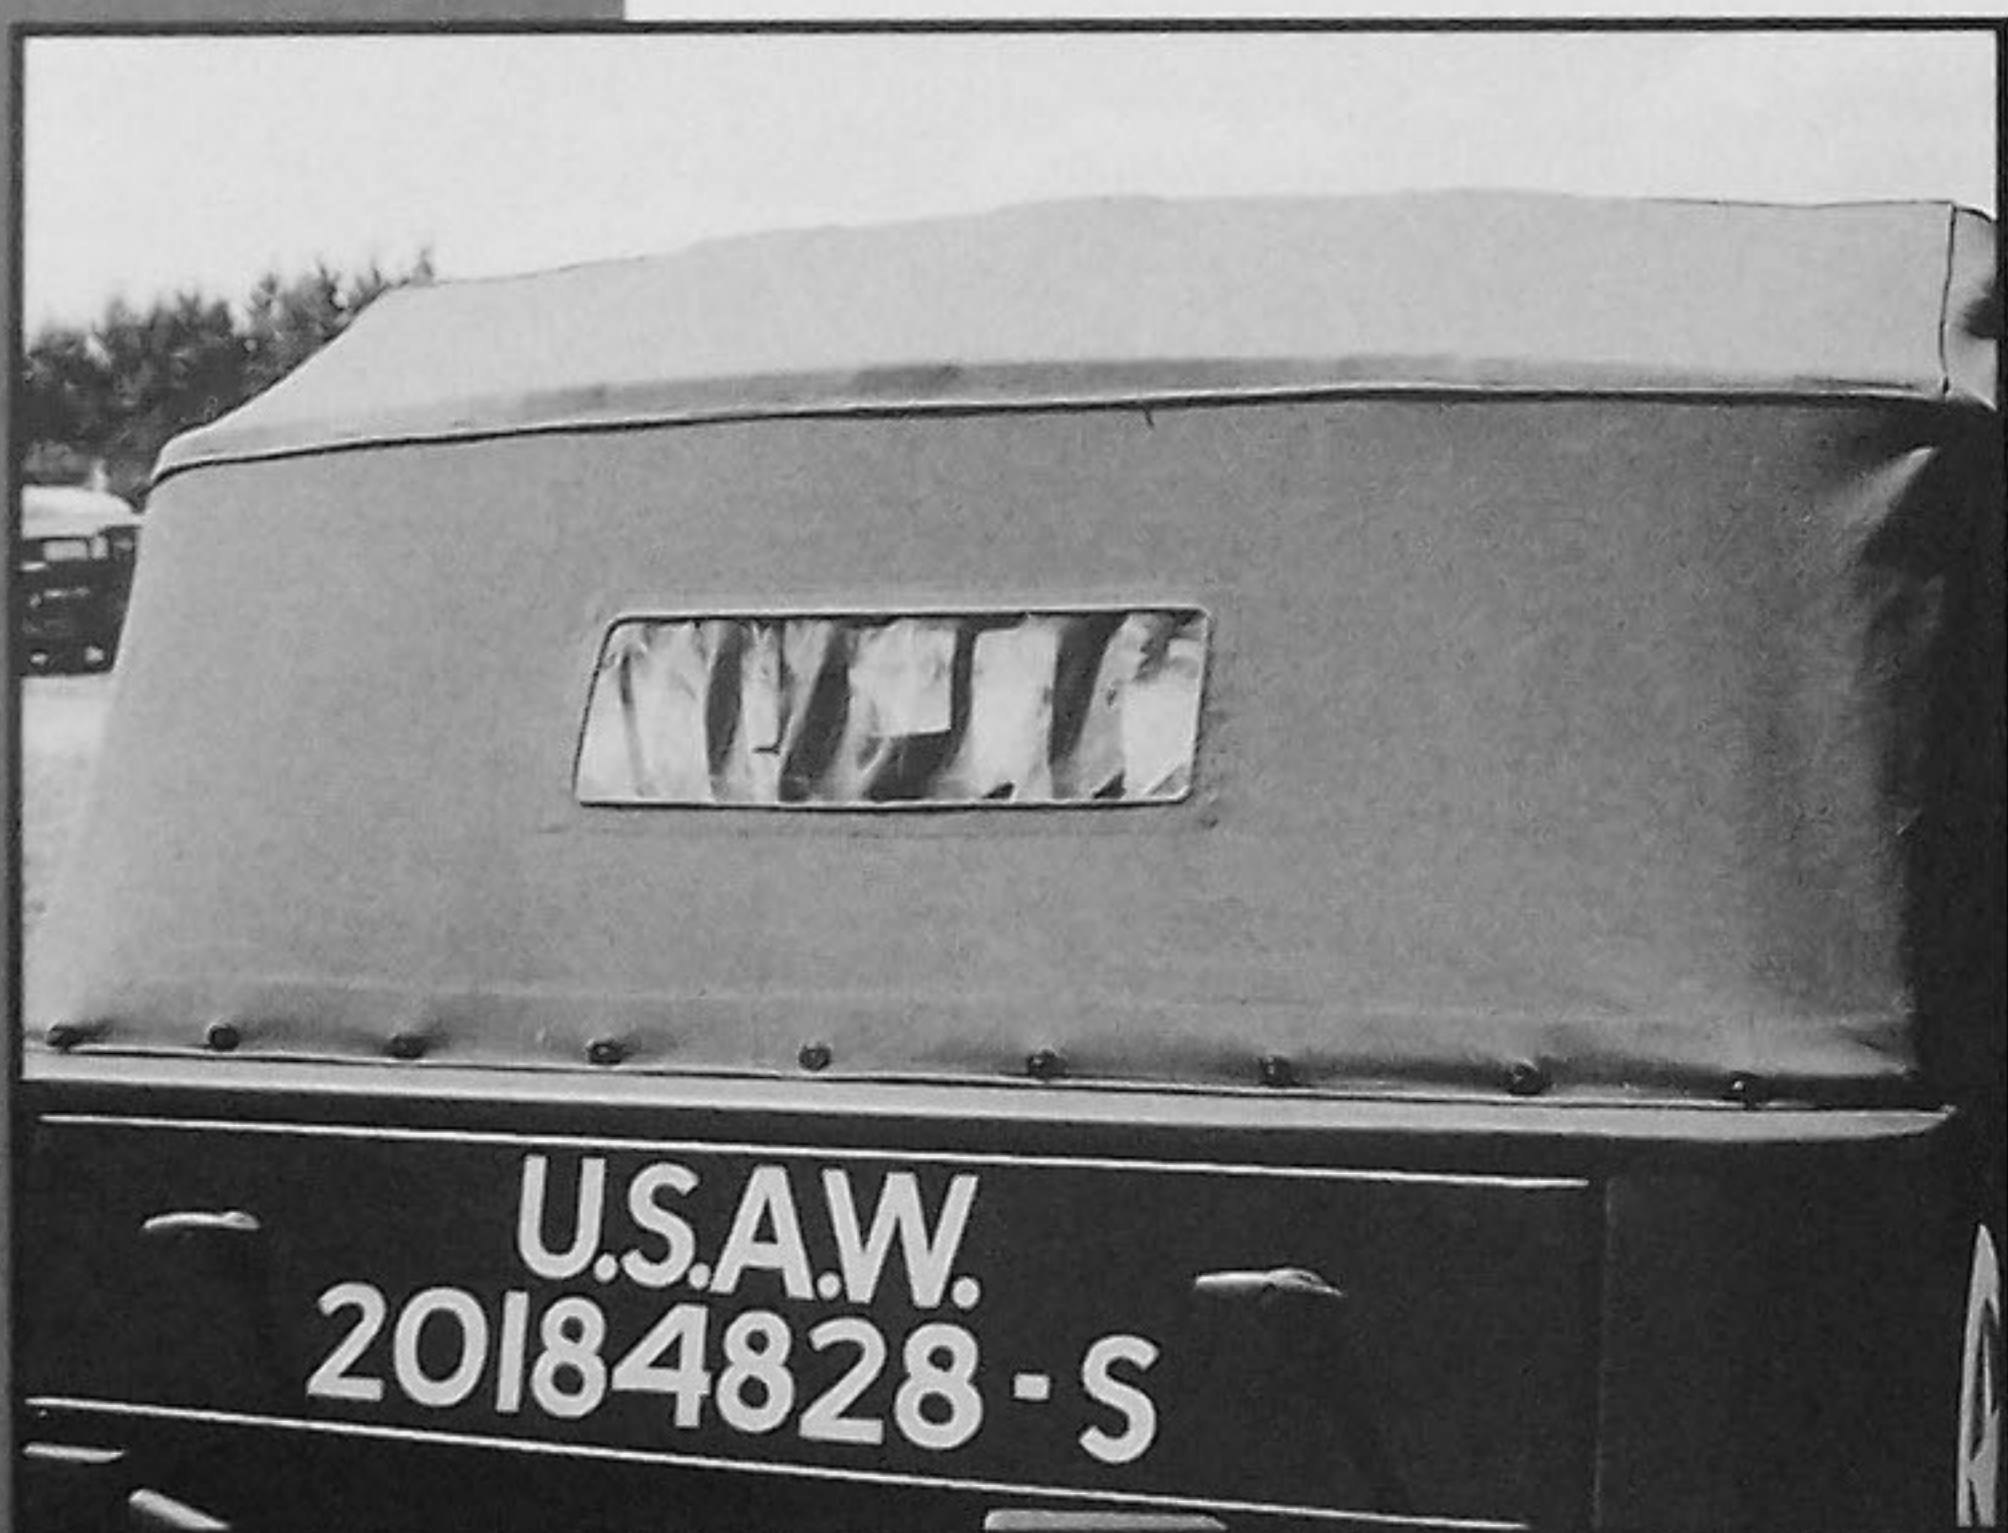
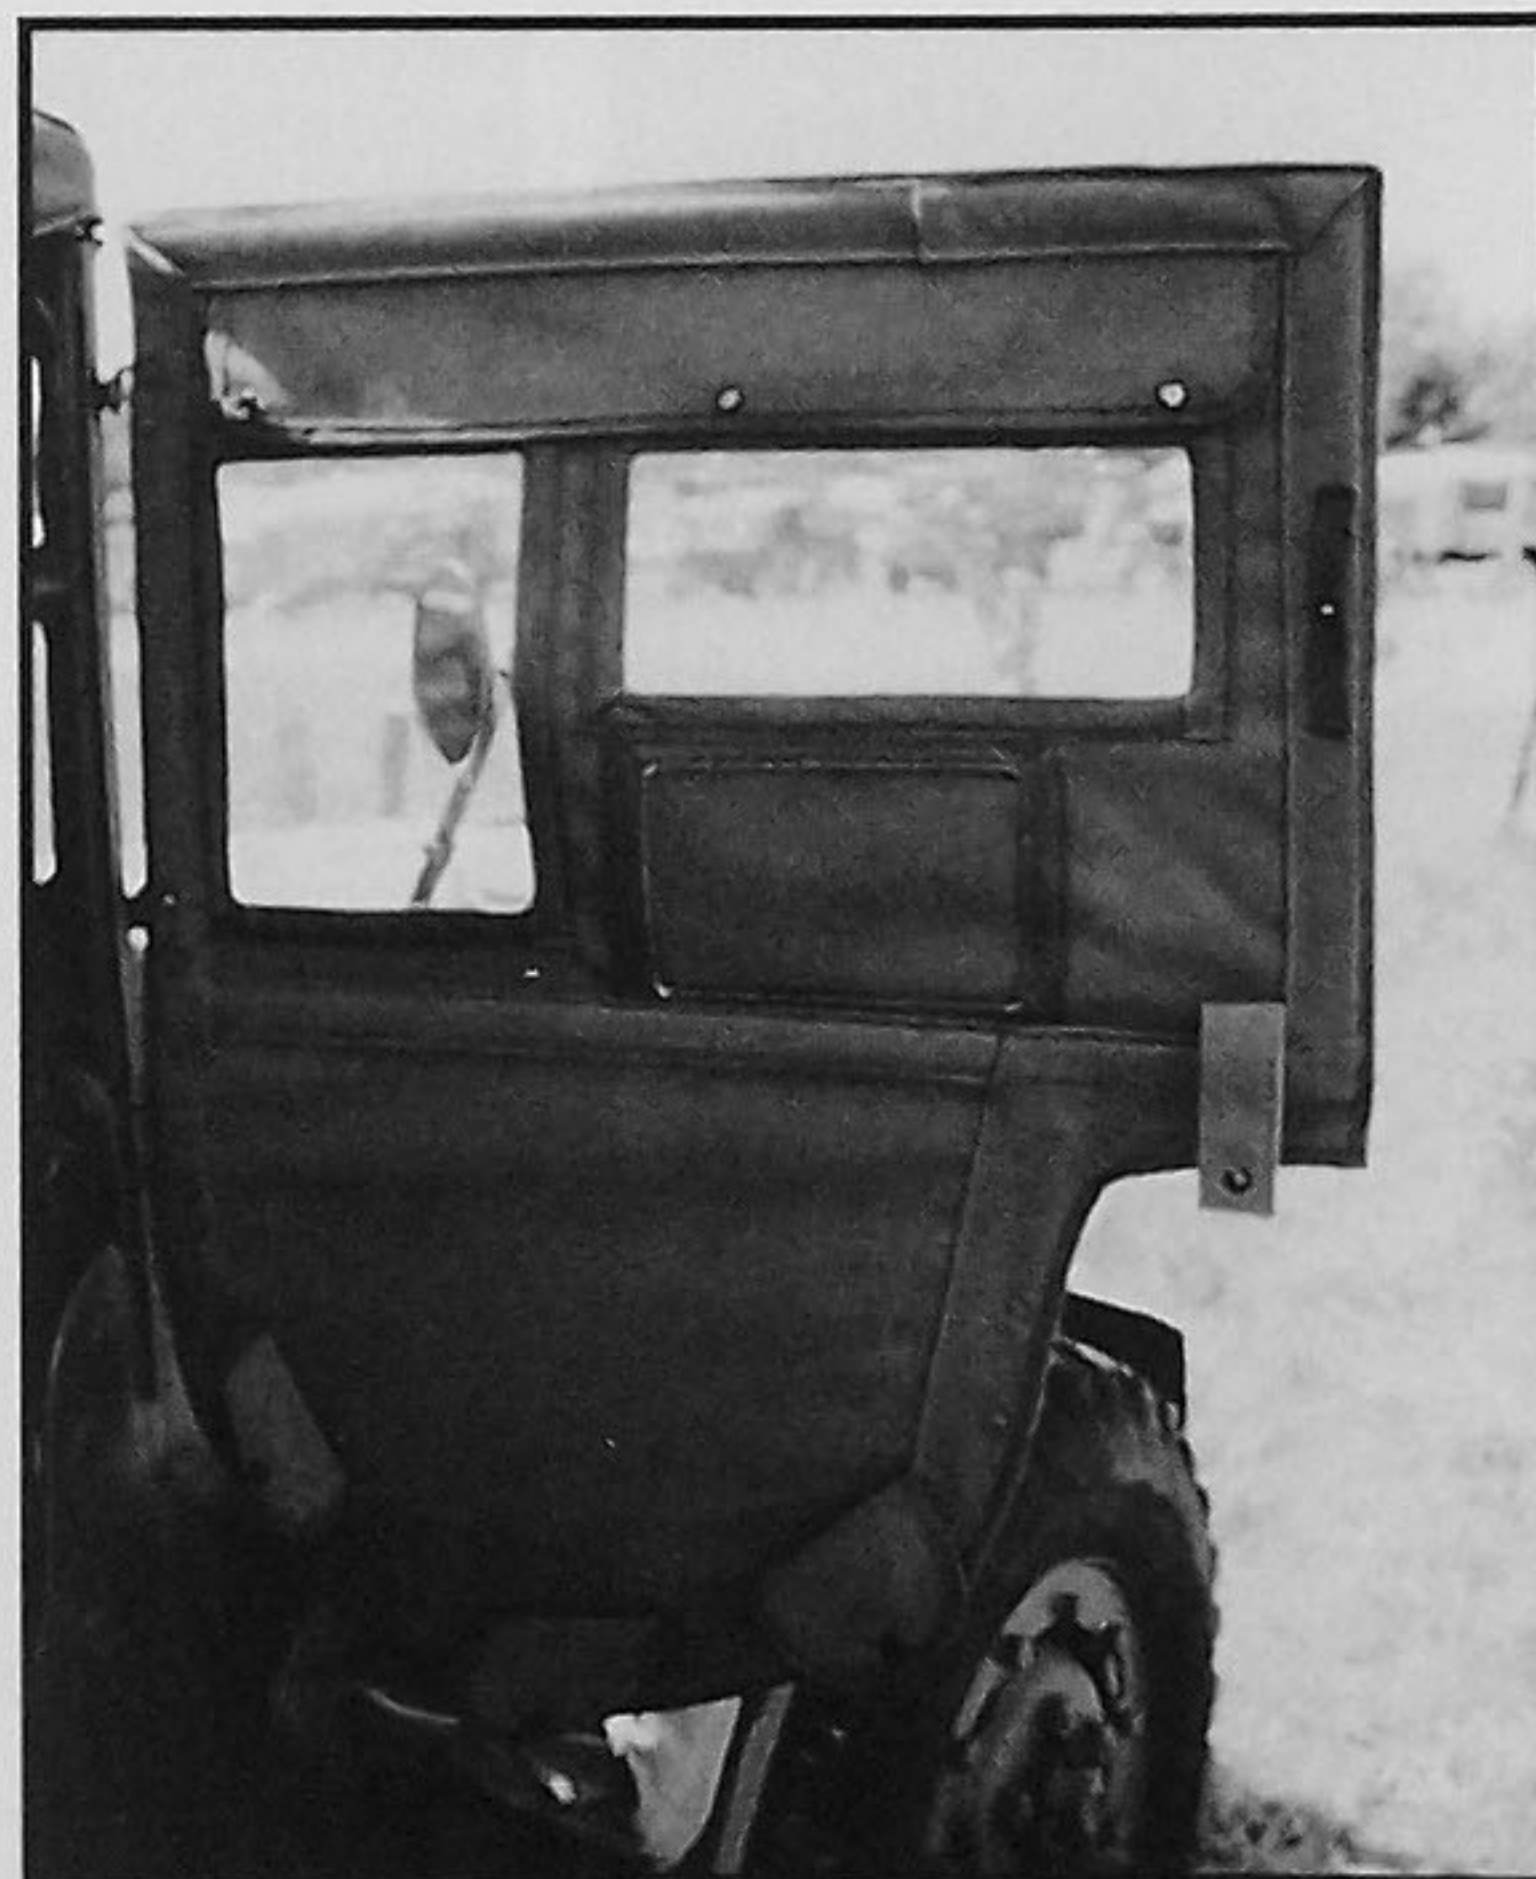
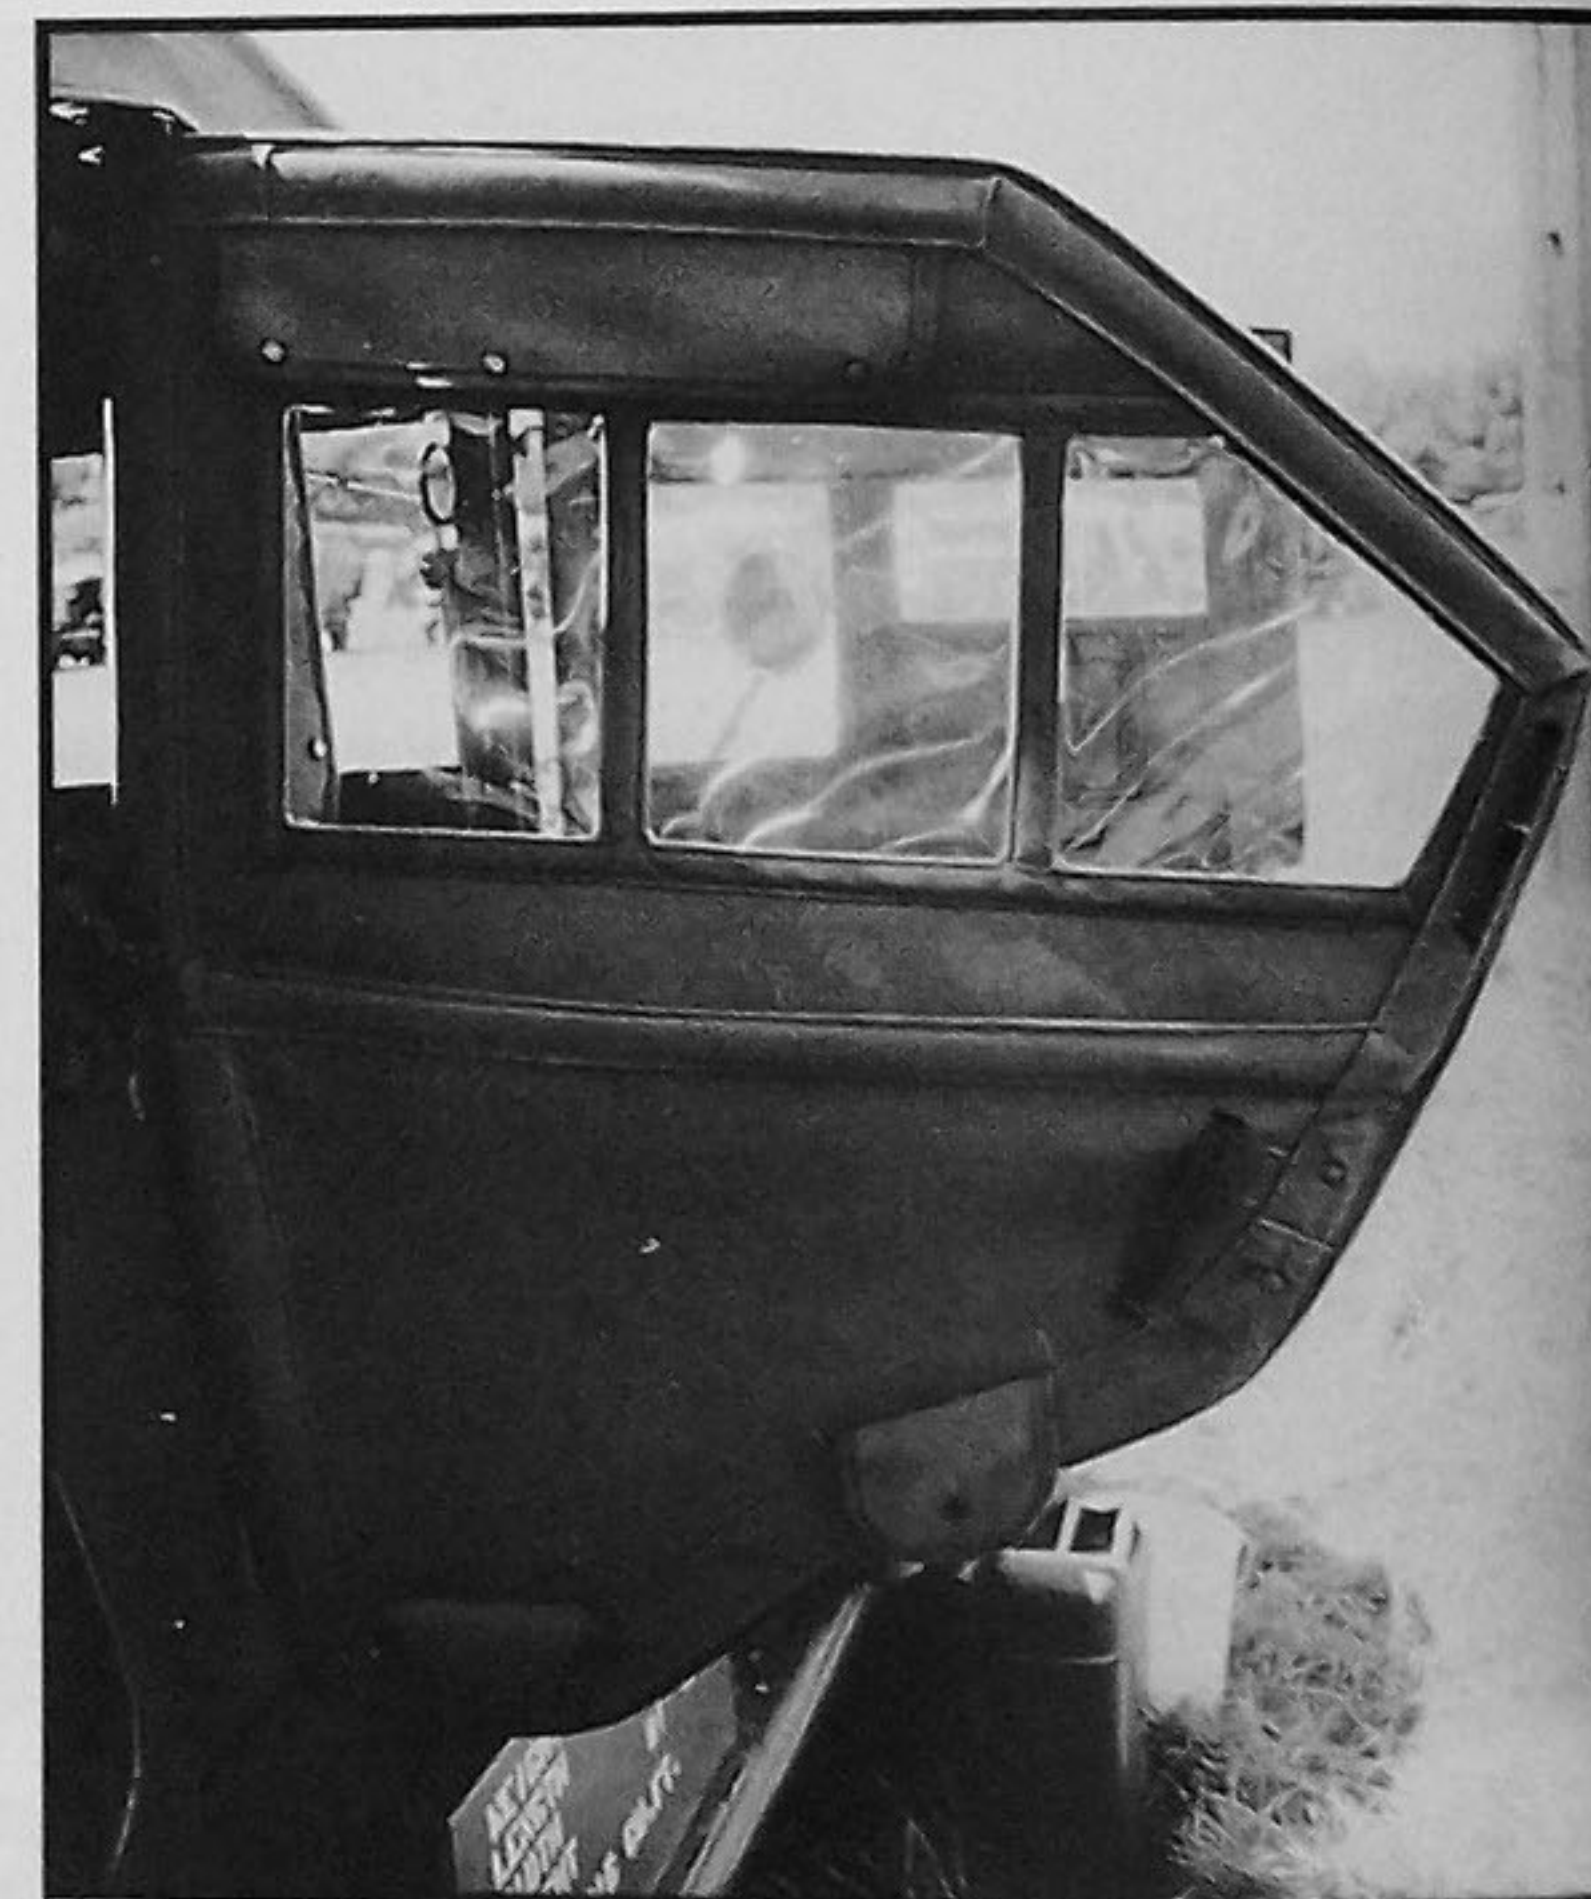
This sequence shows the complete canvas top system in place. This is a reproduction made according to the original specifications. This is quite common on restored vehicles, as the cotton canvas material would have degraded after several years. There are several companies in the U.S. and Europe that specialize in this type of reproduction. The cover is made in several pieces, the largest being the top. This is integrated into the rear portion and a collapsible steel tube frame holds up the whole. Rows of metal snaps run along the area behind the rear seat and along the top of the windshield frame to hold

the top in place. The doors are canvas-covered frames that are hinged off a smaller covered frame installed between them. Small squares of clear plastic provide a view outside. The small canvas panels on the inside of the front doors are used for ventilation.

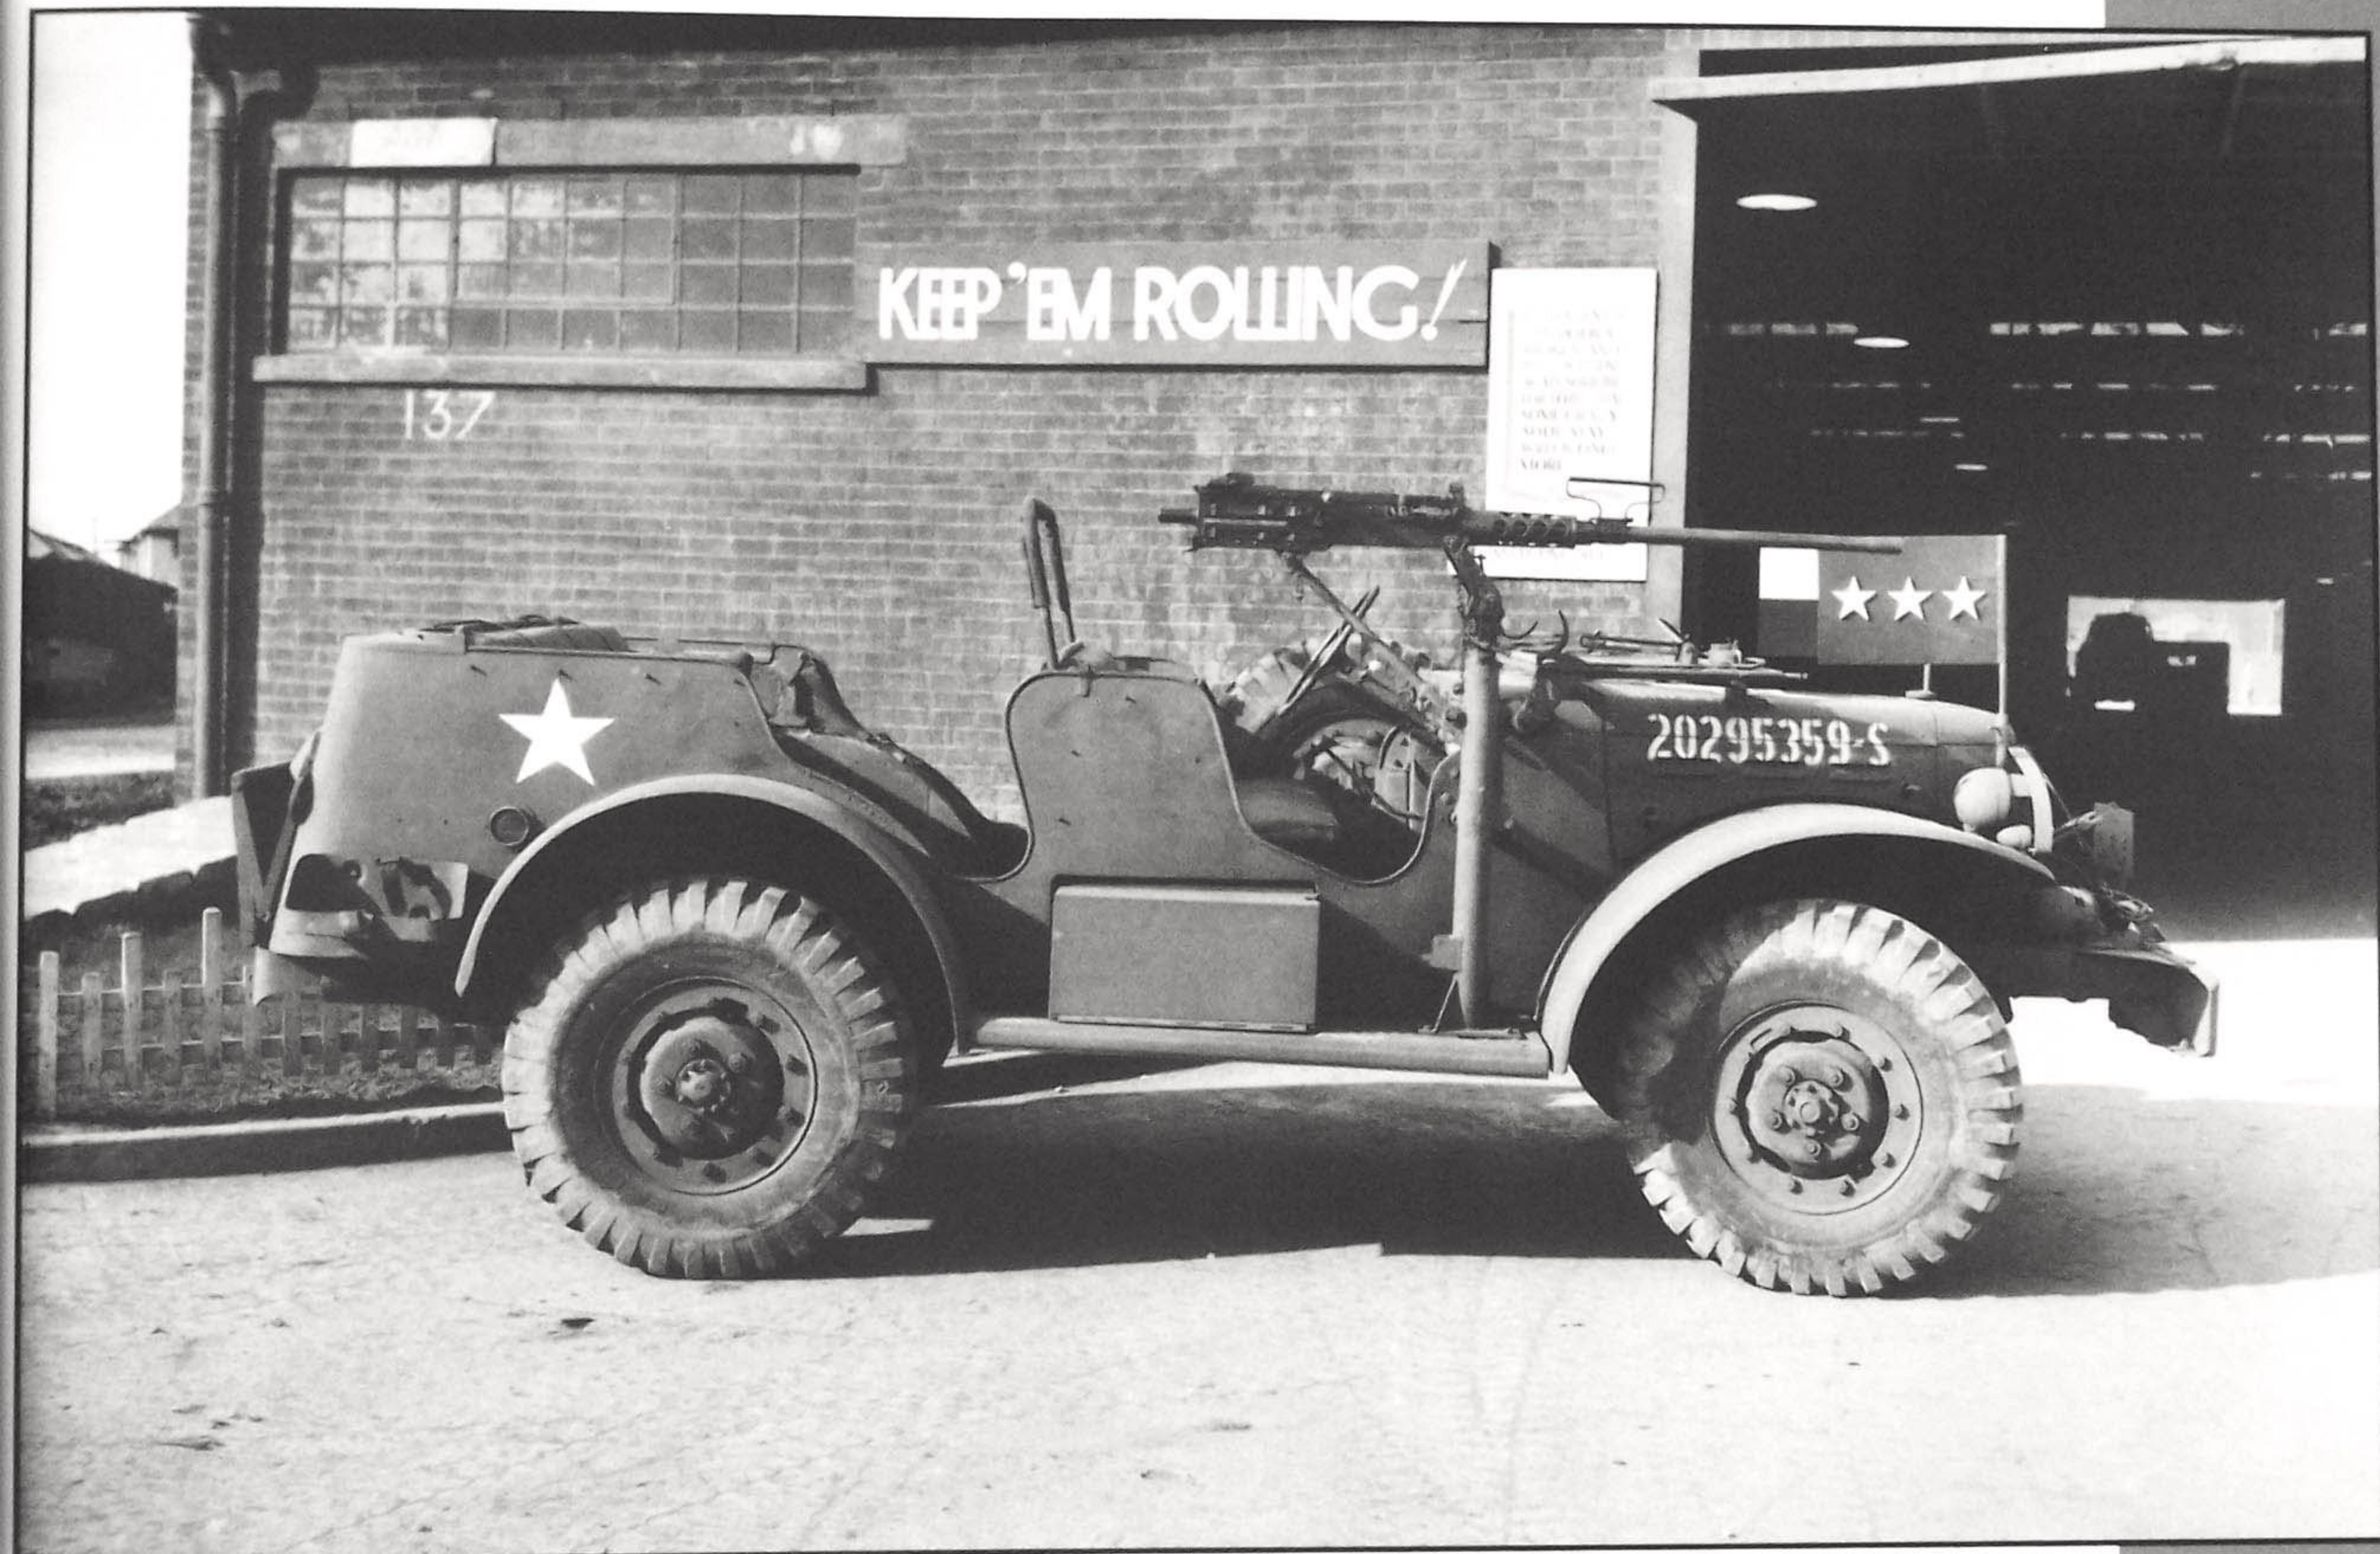
Perhaps the most famous individual Dodge 3/4-ton truck was General George S. Patton's WC 57. This was one of a number of specially modified vehicles that Patton used during the Second World War. His first (in combat) was an M3A1 White Scout Car used in North Africa. This was modified with the addition of armored roof panels and an additional .50 caliber machine gun. In Europe, he also favored a modified M20 utility car. Patton also customized a number of Jeeps and he seems to have preferred to switch vehicles on a regular basis. **Above:** this standard WC 57 command car was modified in the summer of 1944 just prior to the activation of the 3rd Army. The modifications were completed by a

local U.S. Army ordinance workshop in England. The most obvious addition is the large pedestal mount for the .50 caliber machine gun. This has necessitated the relocation of the gas can and rack to the right rear quarter panel. The reflector normally installed in that position has been moved further forward on the panel. The bows for the canvas top have been completely removed (along with the clasps for the doors) and a large bar has been installed over the front seat. This was to allow Patton to stand as he traveled in the car. A small folding panel has been added to the rear of the car to increase its luggage capacity. The panel is fashioned from the rear tailgate of a weapons carrier (NA).
