# Allied-Axis

THE PHOTO JOURNAL OF THE SECOND WORLD WAR

**German  
SIG 33/1  
Grille SPG**

**Kleines Kettenkrafttrad  
WWII Dodge 3/4-ton trucks  
DUKW Amphibious truck**

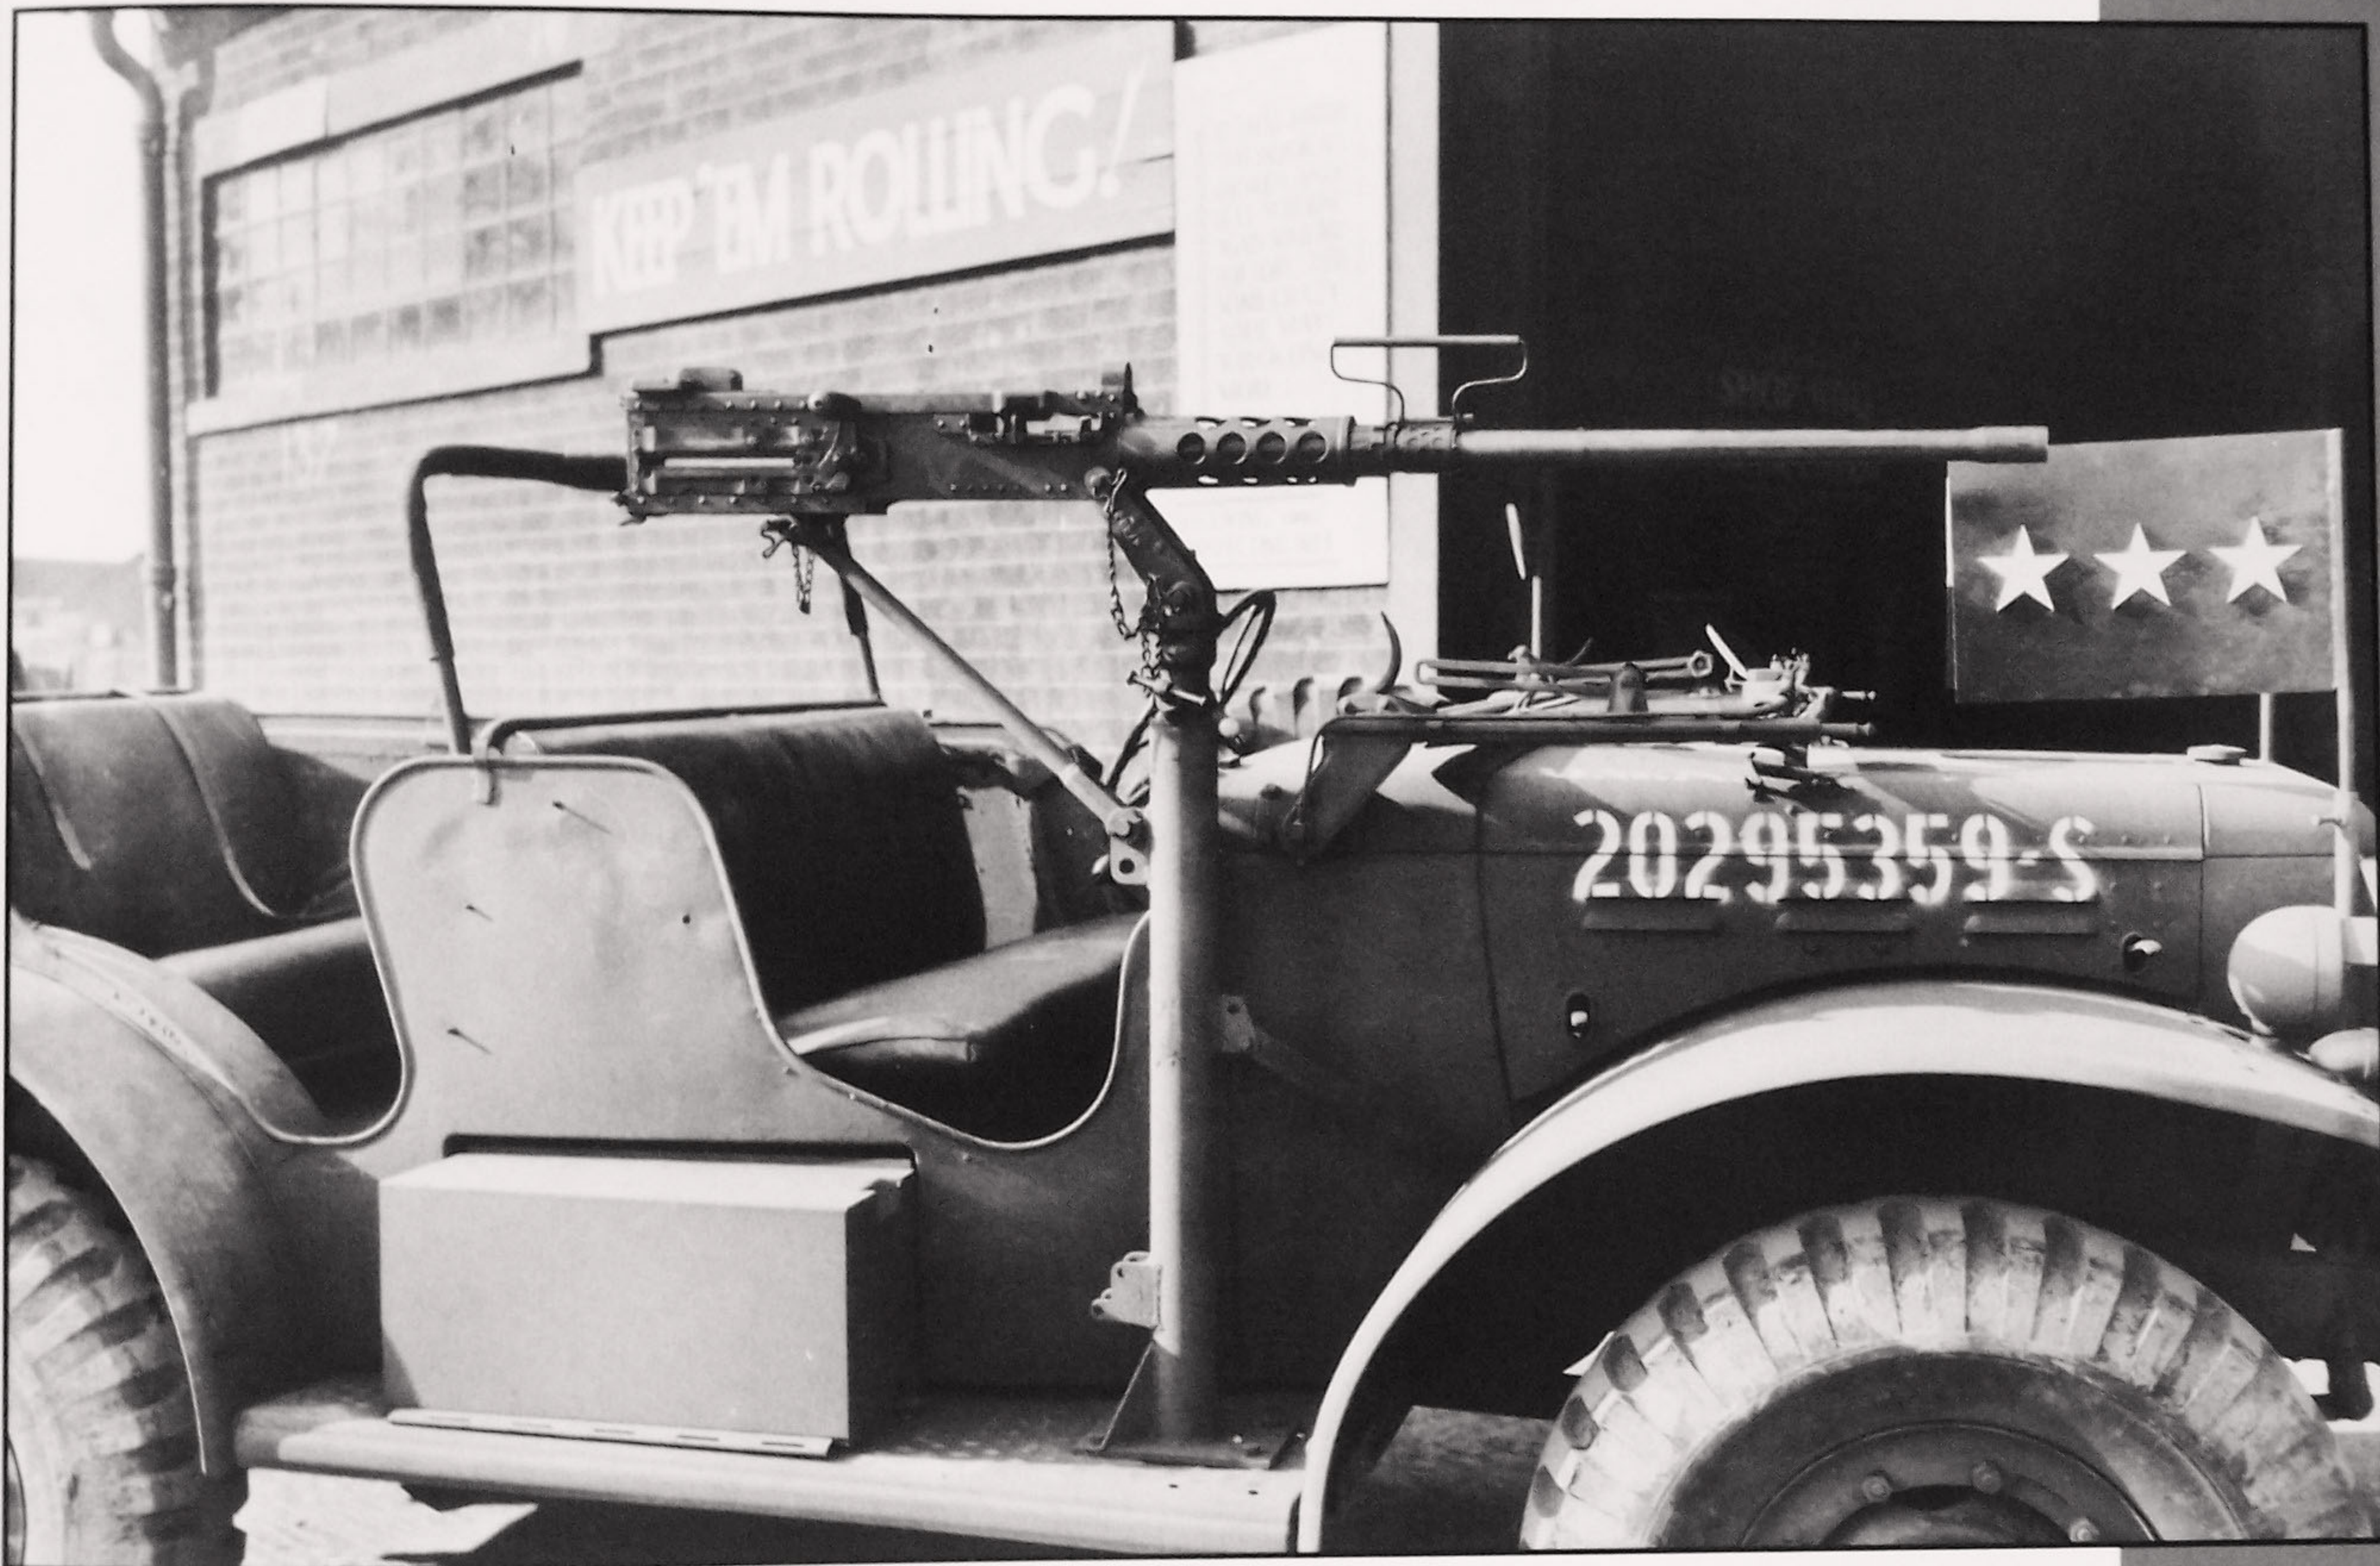
A close-up of the Browning M2 .50 caliber machine gun and its mount. The mount is a modified version of the M24A2 Pedestal Truck Mount. This mount was specifically issued for use on the 3/4 weapons carrier. The mount here has been modified by cutting away two of the three lower braces. A single brace has been retained and this has also been modified to attach it to the front fender. It's not known if the weapon was ever used to defend the car (note the lack of the "butterfly" trigger pieces here), but if adequately supplied with ammunition, it could be a devastating defensive weapon. The M2 .50 caliber machine gun was a 12.7mm weapon that was originally designed as an anti-tank gun. It

could fire a tracer round (Tracer, M1), an armor piercing round (Armor Piercing, M2) and an incendiary round (Incendiary, M1). The weapon seen here is the "flexible" type for use with all types of vehicles. Its rate of fire is from 450 to 575 rounds per minute. To prevent the barrel from burning out, ordinance manuals recommended short bursts of 100 to 150 rounds per minute, with a steady rate of 40 rounds per minute. However, in field conditions the gun proved much more resilient. The M2 was nearly unique in the arsenal of Second World War weapons. In spite of its effectiveness, it was never copied by the Germans like the bazooka or the 8-inch gun (NA).

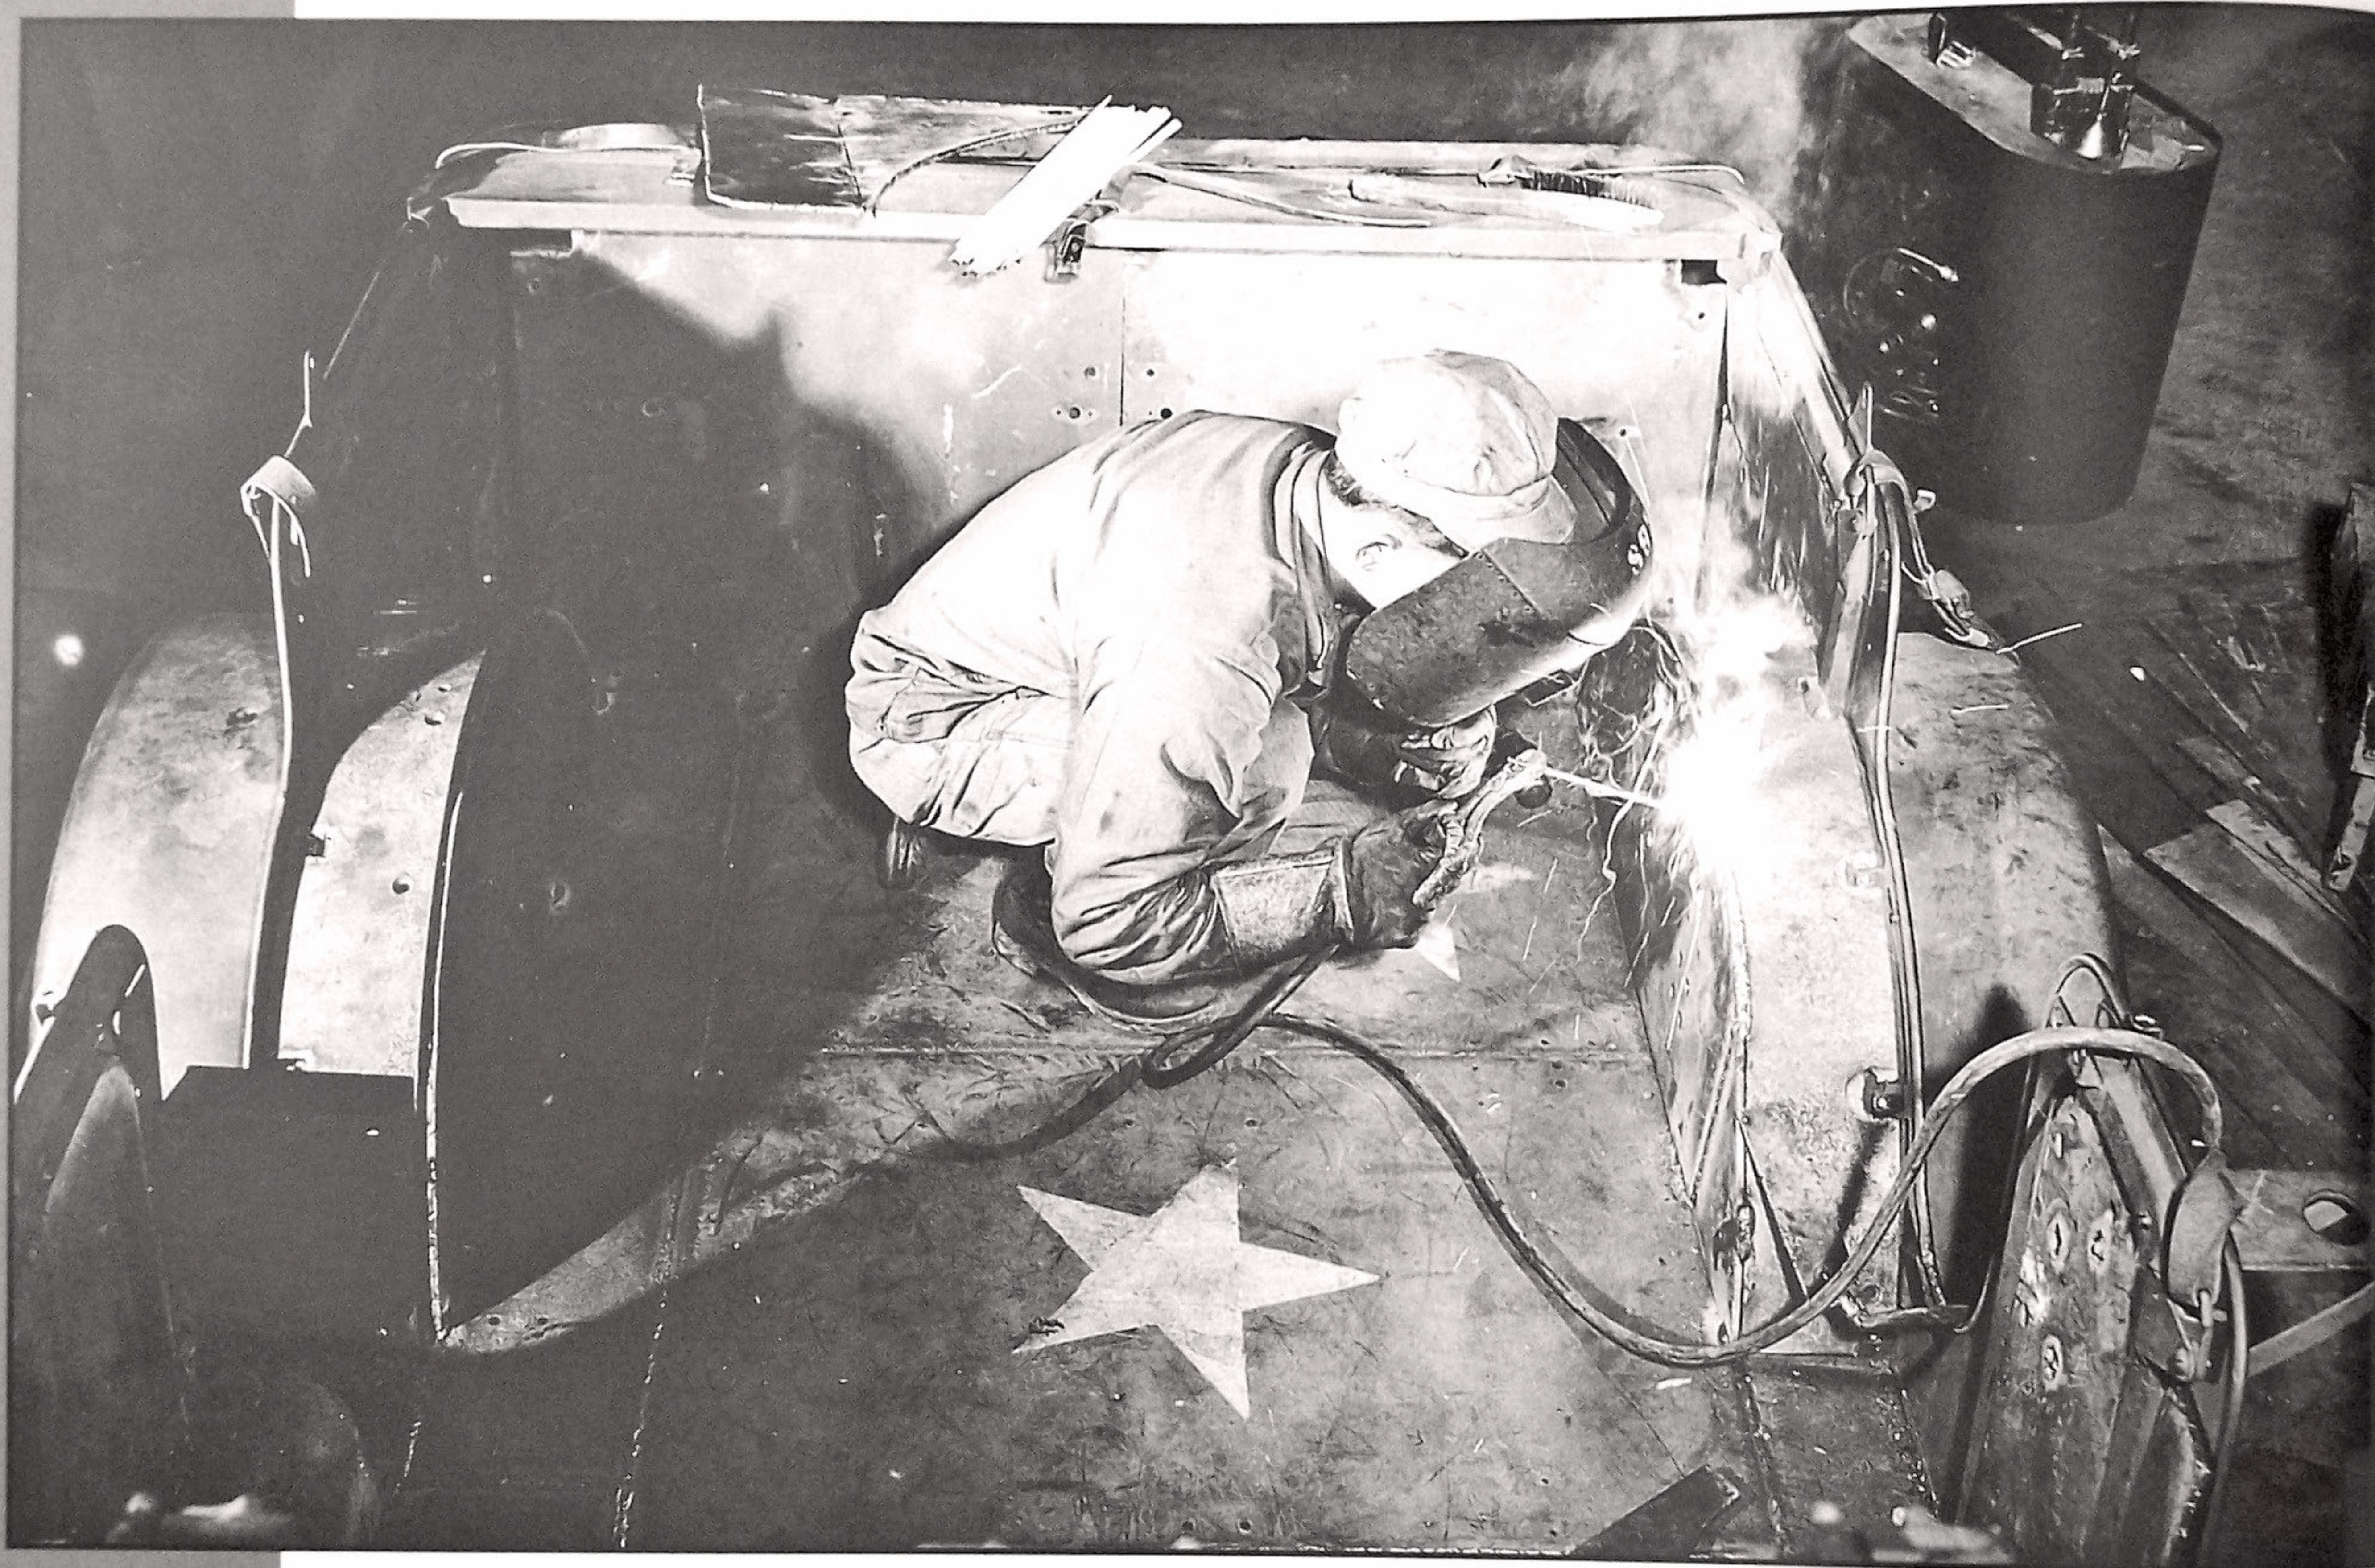
As mentioned above, Patton's WC 57 was armored in certain areas. He was realistic about what and what could not be armored, but the real meat of the added armor was in and around the rear passenger compartment. The entire floor was covered with 1/4-inch steel panels, as were the wheel wells. The Germans were masters at laying and dispersing landmines and were especially good at concealing them on roads. Patton saw the result of these practices first-hand in North Africa and this modification was born from that experience. **Above:** here an ordnance worker puts the finishing touches on the

welds securing the armor plate. The presence of a star on one of the floor panels indicates that this material has been salvaged from another vehicle. The entire interior of the car has been removed for this work and some interesting details have been revealed. The attachment points for the leather arm rests can be seen on the left as well as the wire lead openings for the radio antenna located on the right side of the photo. The small box structure on the left side of the photo is also interesting (NA).

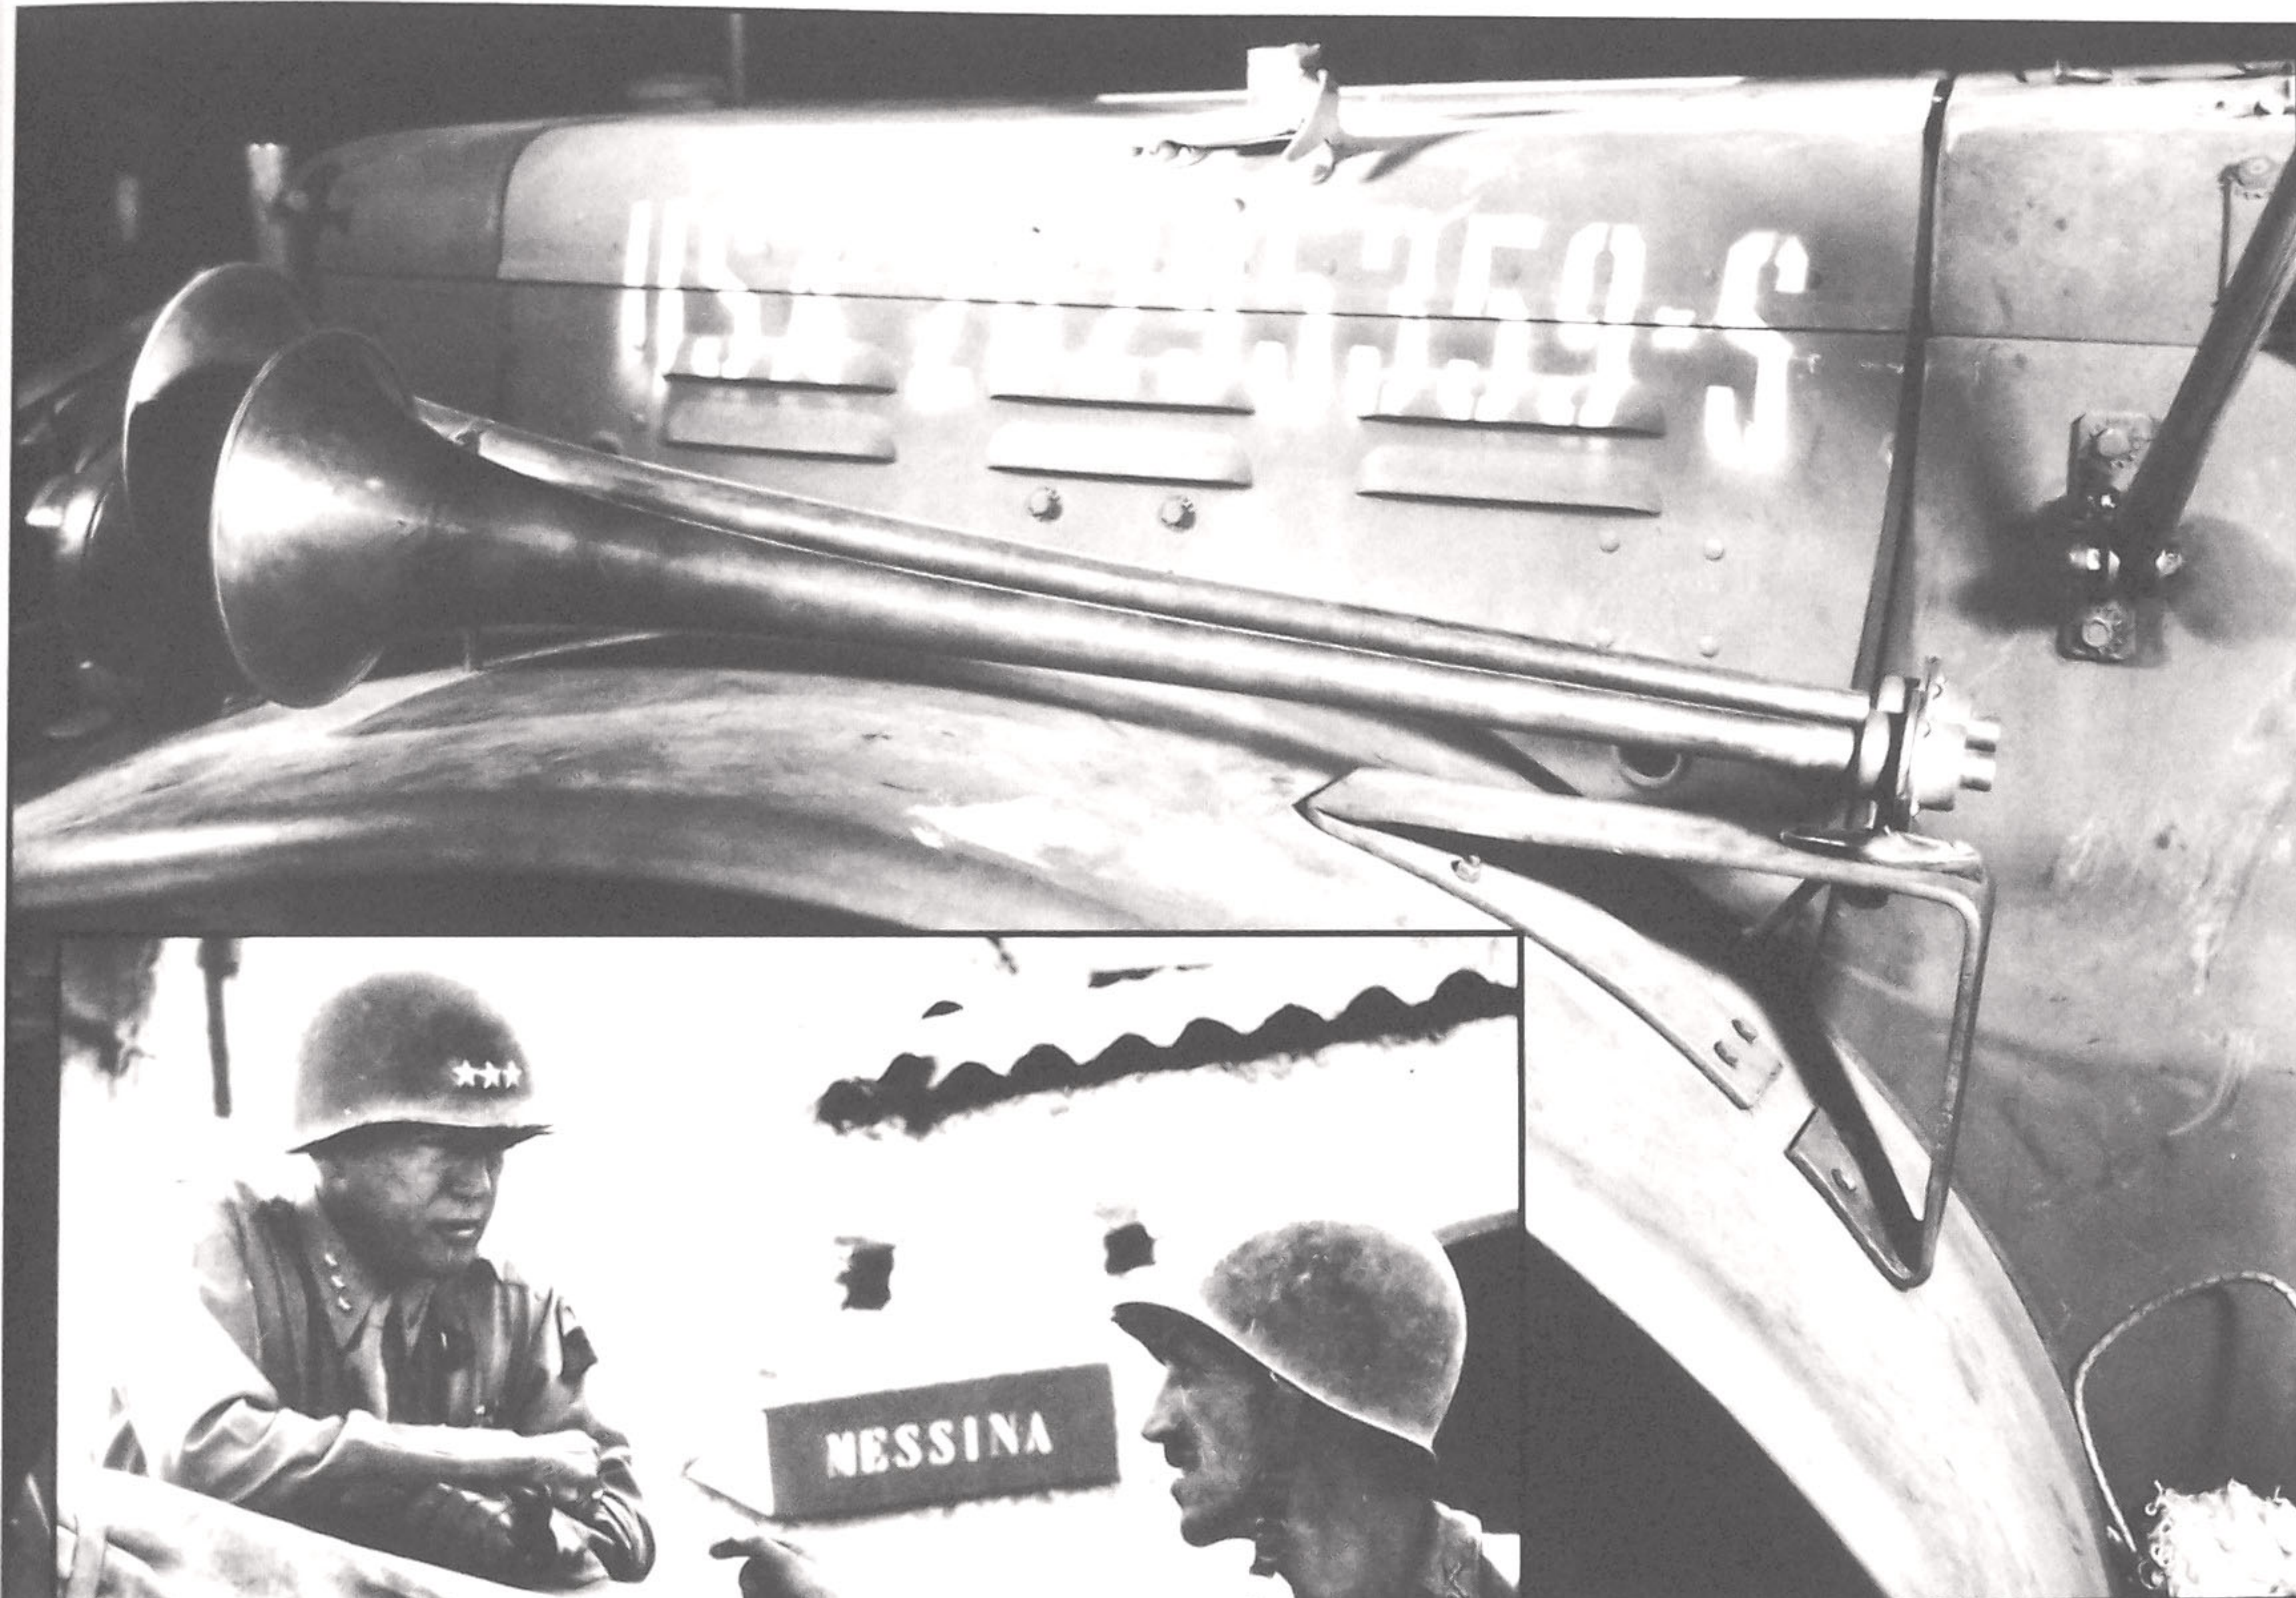
**Above:** regardless of the vehicle modified, Patton always insisted on installing large, loud air horns. The source of these particular parts is not known, but they are most likely custom made for this application. Commercial grade truck air horns were generally installed inside the engine compartment and these examples are nearly as long as the Dodge's front end! A special bracket has been fabricated to support them and the electrical leads are still to be installed (NA). **Left:** Patton also used a Dodge command car in Italy. This was a standard WC 56 car with very few modifications. Patton is seen here speaking with a GI just before his entrance to the port town Messina, Sicily on August 17, 1943 (NA).

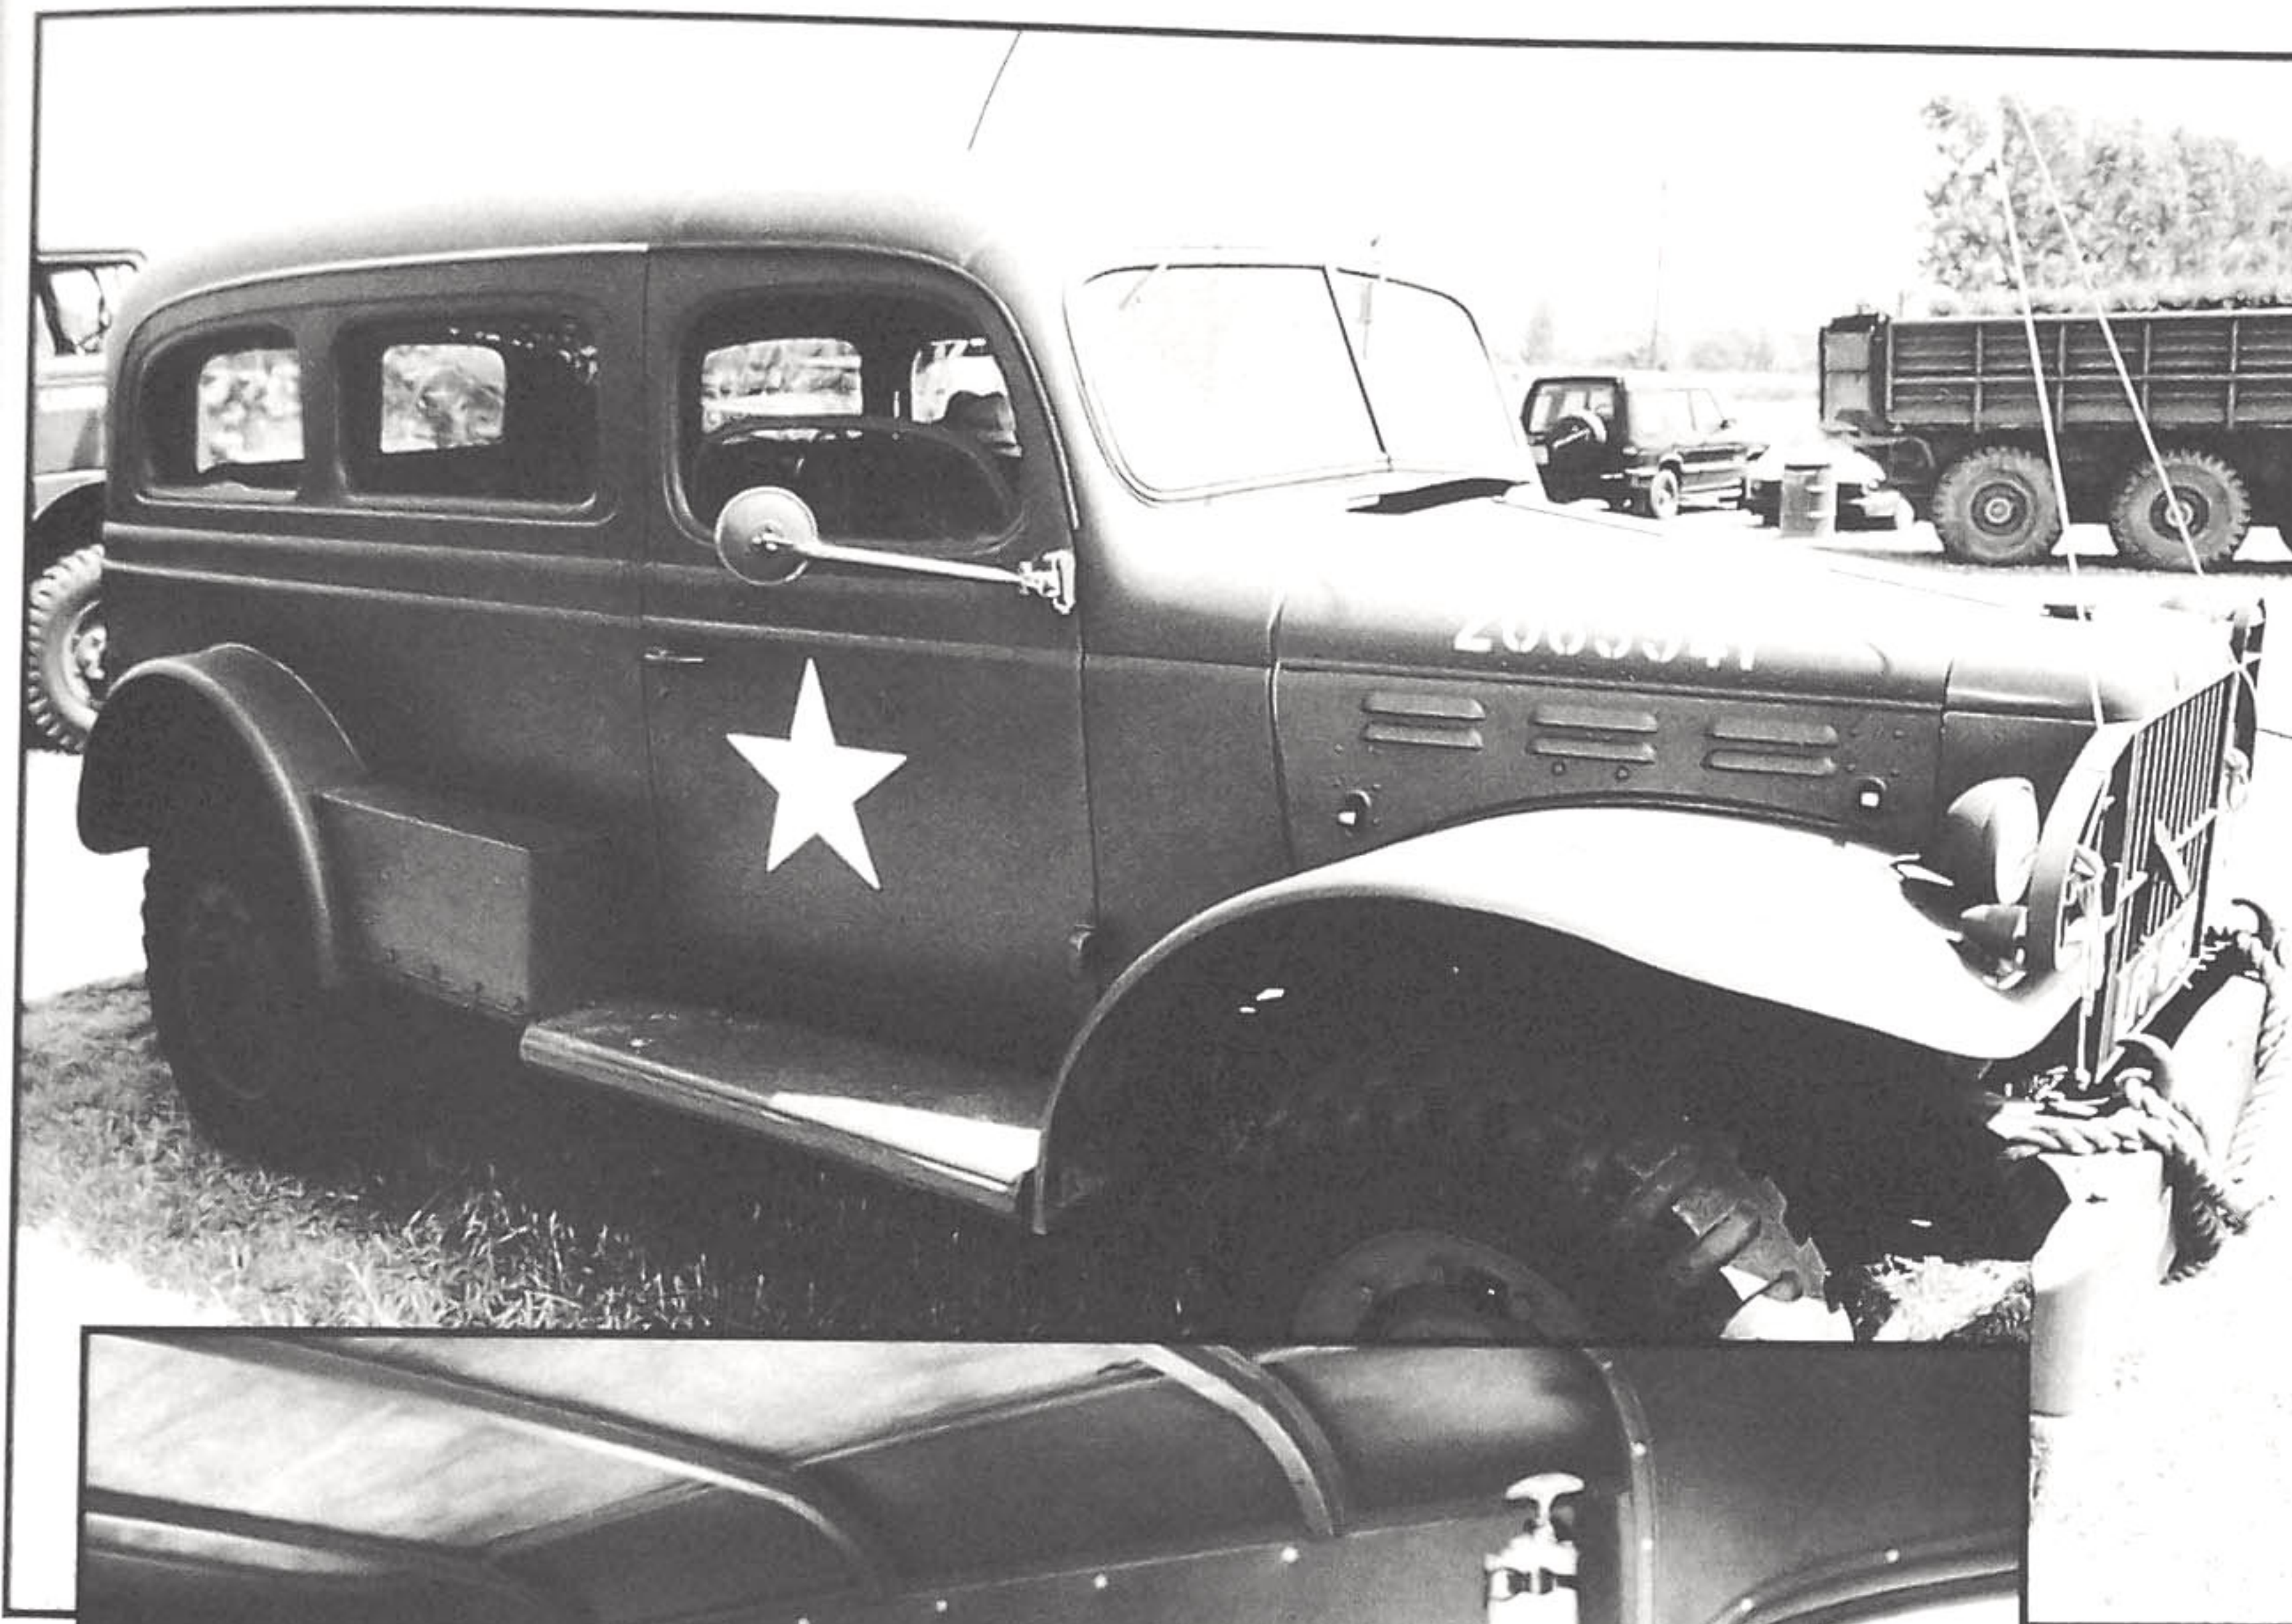
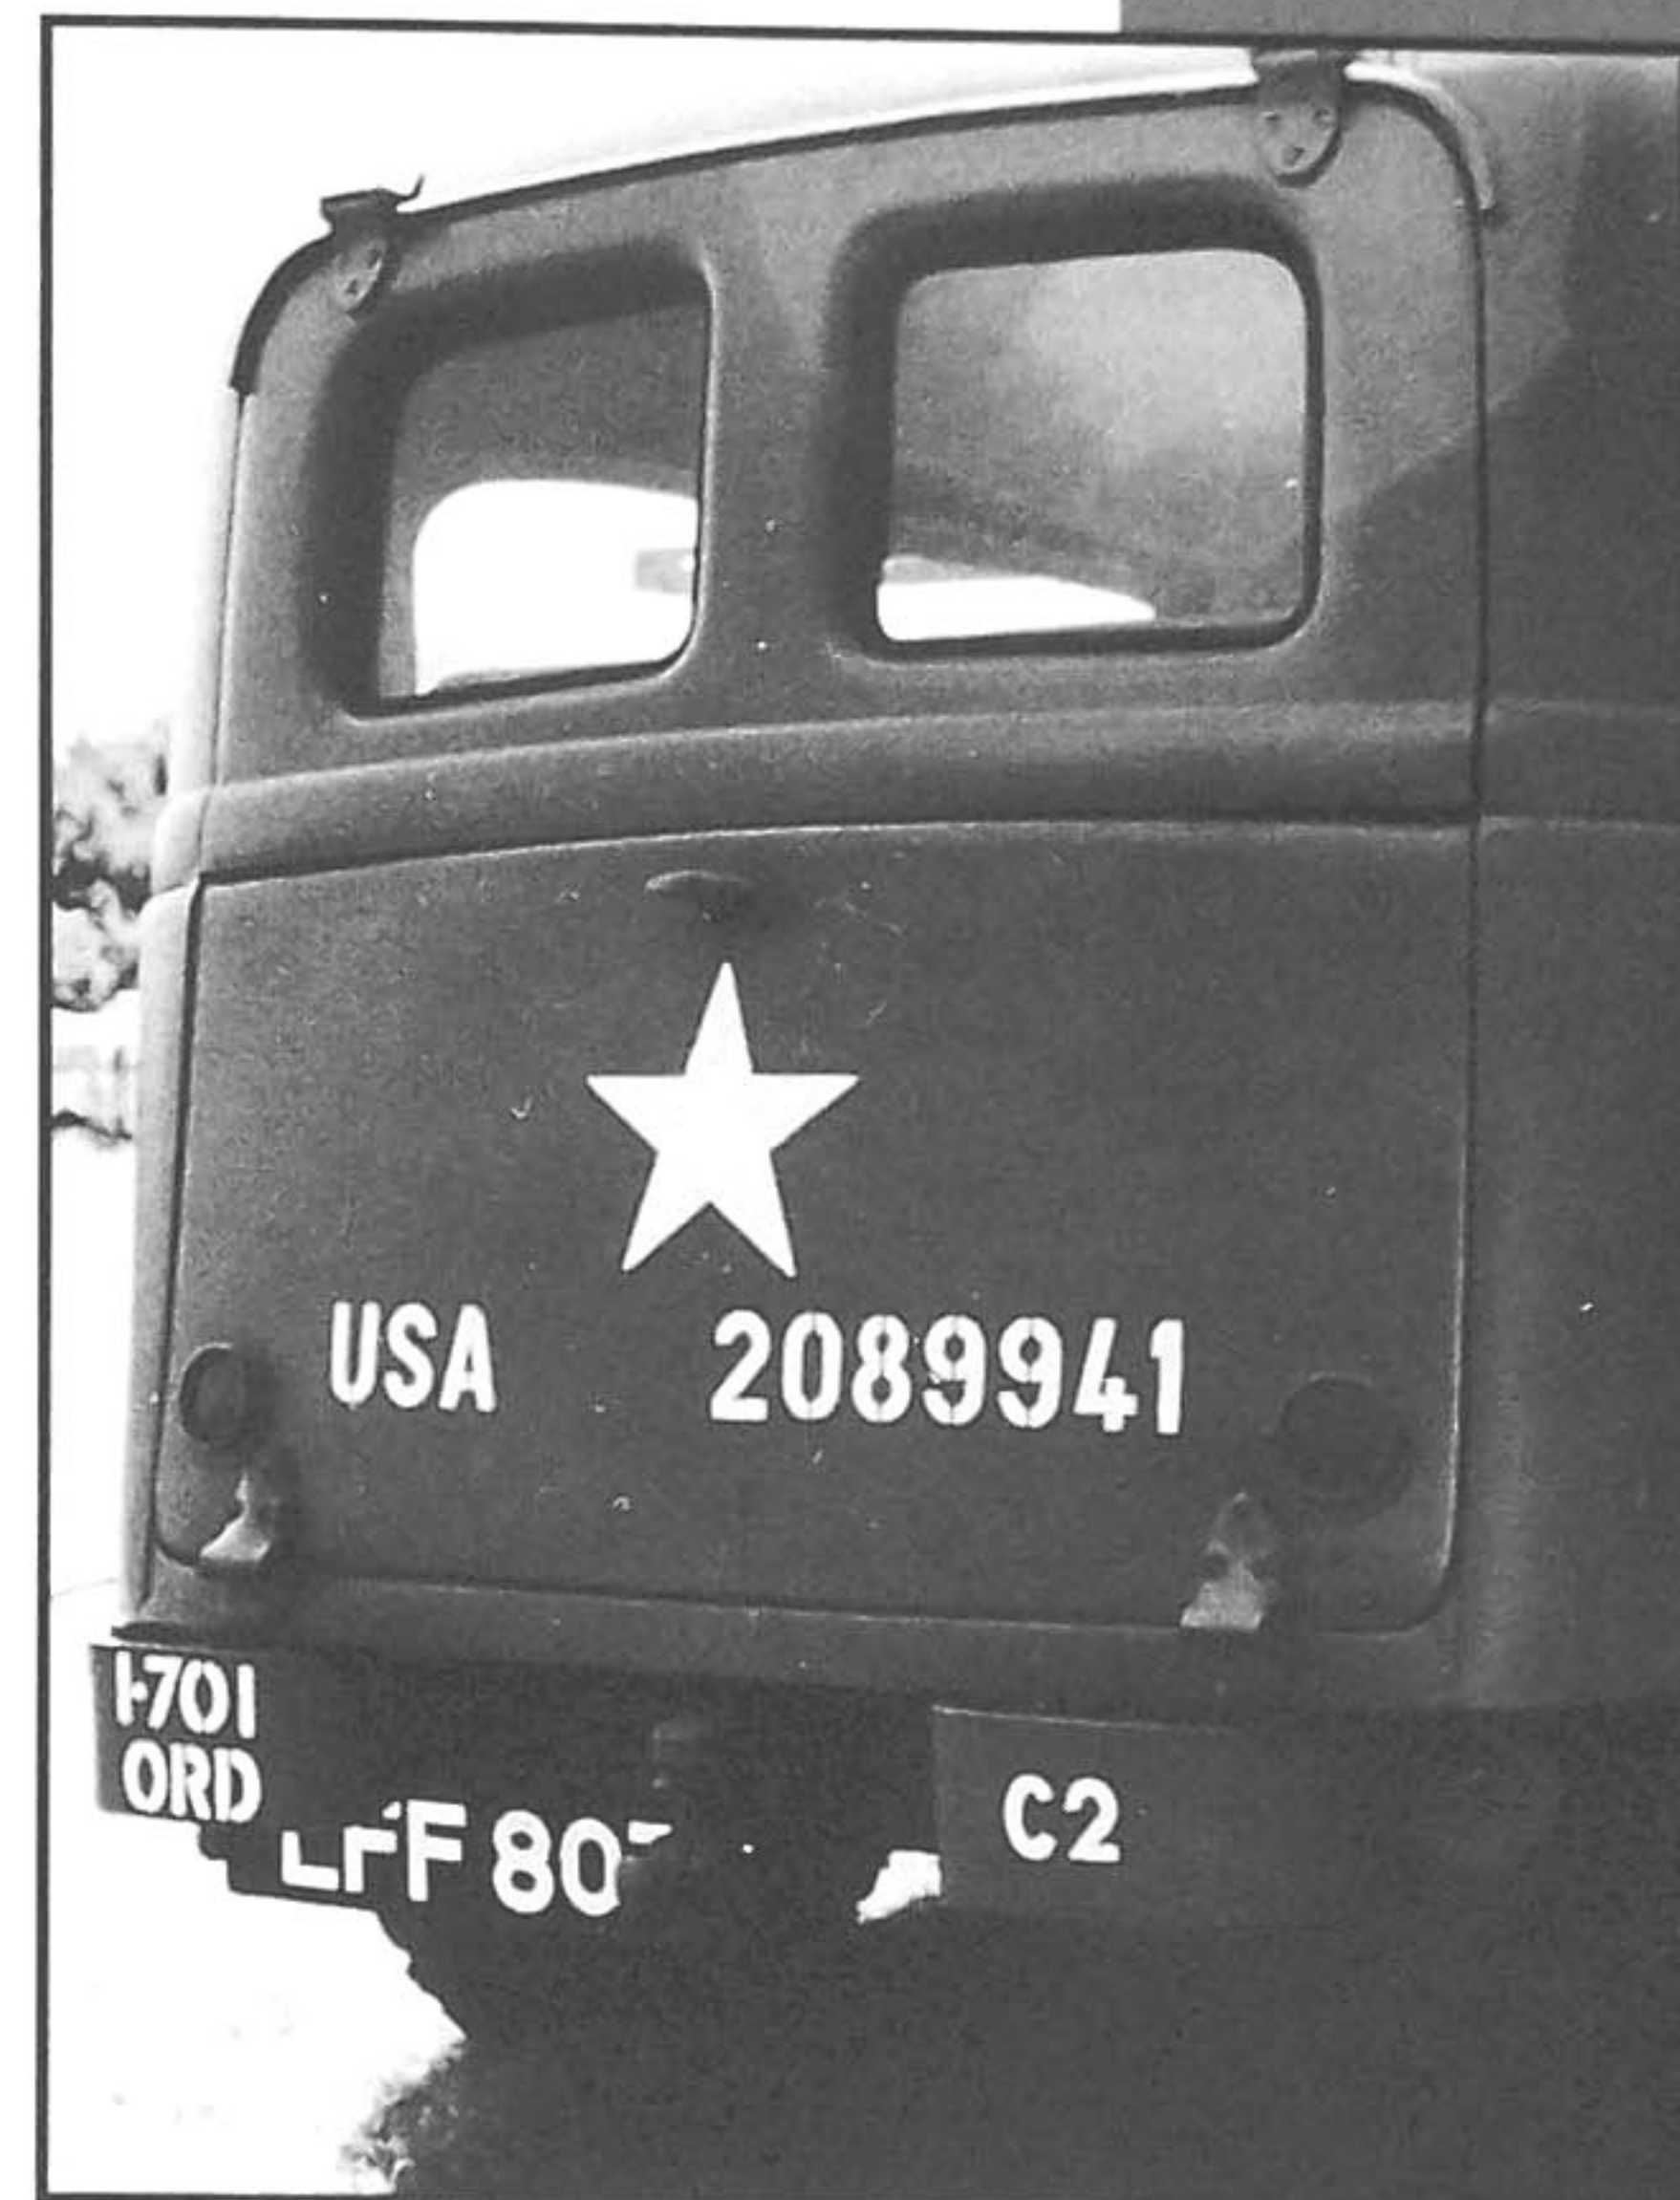
The Dodge "carryall" was a military version of the popular civilian station wagon. It was originally conceived for the 1/2-ton platform and it was also part of the redesigned family of 3/4-ton vehicles. The bodywork was based on a 1930's panel truck with windows installed along the sides. The body is of all steel construction with the exception of the roof, which is stiffened fabric over a wooden frame. This is also sealed to be watertight. The reason for this odd method of closing in the roof was that it was cheaper than producing the large die that would be necessary to stamp out a panel of this size. The carryall was produced primarily for use as a command and radio vehicle and so, like the command car,

it was equipped with the large auxiliary 12-volt battery and box. This was located towards the rear of the right side of the truck. The engine hood was slightly different than the other 3/4-ton trucks in that it sloped upward towards the windshield. It shared this trait with the WC-54 ambulance. The bodywork was constructed for Dodge by Proctor-Keefe Body Co., of Detroit, Michigan. **Above:** This near perfect example is owned by an English collector and was photographed in the summer of 2000. This view shows a number of the unique features of the carryall such as the additional blackout light on the left front fender and the large antenna base and its mount. Also note the dual gas can mounts on the left

running board. 4,800 WC 53 carryalls were produced with registration numbers running from W-2072128 to W-2073327, W-20163146 to W-20167956, 20260793 to 202612157, 2089952 to 2091083, 2089952 to 2091083, 2089156 to 2089175 and 2089176 to 2089947. No WC 53s were produced with a winch. At least two carryalls were converted into Command Field Sedans with the addition of a left side passenger door, a luggage rack and spot lights. **Top left:** this right side shot shows the large 12-volt battery box in front of the rear wheel well. **Top right:** The rear doors consisted of two horizontal pieces that opened out and down. This differed from the original panel truck design that utilized two vertical side-opening doors. **Left:** The interior of the carryall could be configured in a number of ways. Here it has been configured as a radio vehicle. This is the original configuration of this restored carryall and the radio is still operational. The radio is the SCR-528 (SCR = Signal Corps Radio). This set consisted of the BC-604 transmitter (A), the BC-603 receiver (B), the CH-264 chest (C), the FT-237 mount (D), control boxes BC-739-A (E), the A-62 phantom antenna (F) and the related cords, cables, microphones and headsets. When the carryall was fitted with a radio, it carried extensive radio suppression gear that included ground straps, special lock washers for the the body bolts, and filters and resistors throughout the vehicle electrics. Note the location of the decontamination device on the front left door jam.
