# Allied-Axis

THE PHOTO JOURNAL OF THE SECOND WORLD WAR

**German  
SIG 33/1  
Grille SPG**

**Kleines Kettenkrafttrad  
WWII Dodge 3/4-ton trucks  
DUKW Amphibious truck**

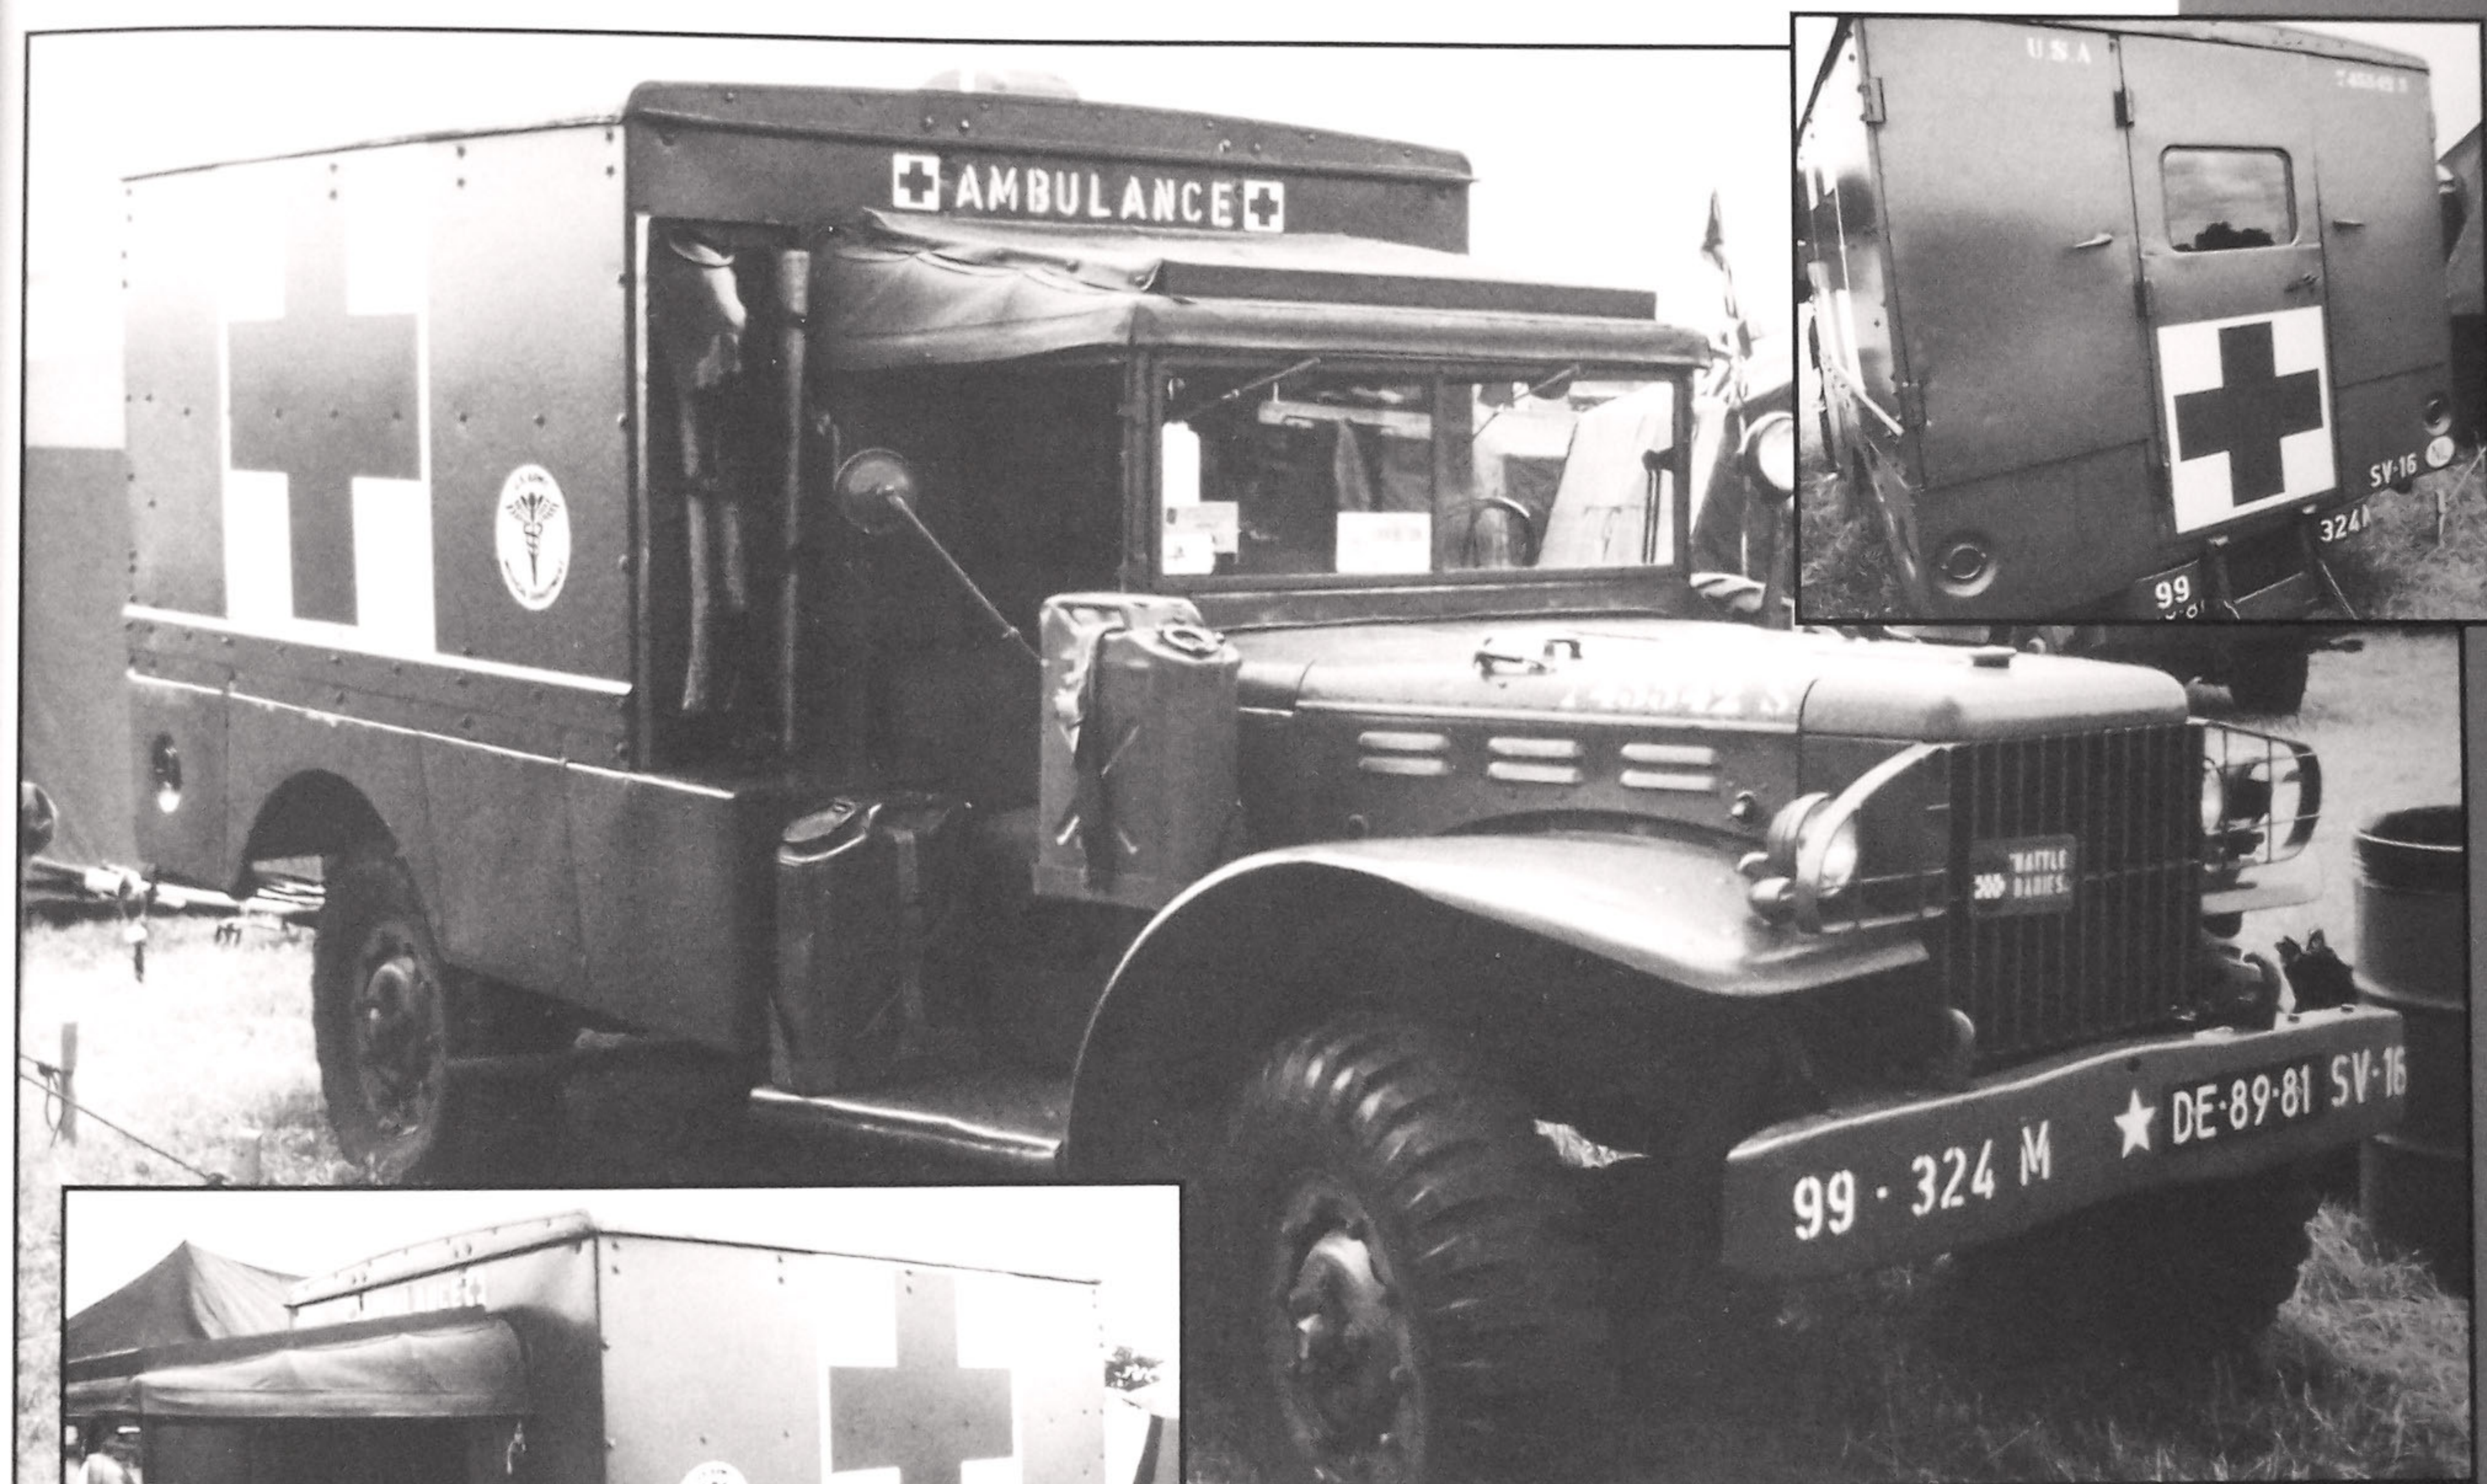
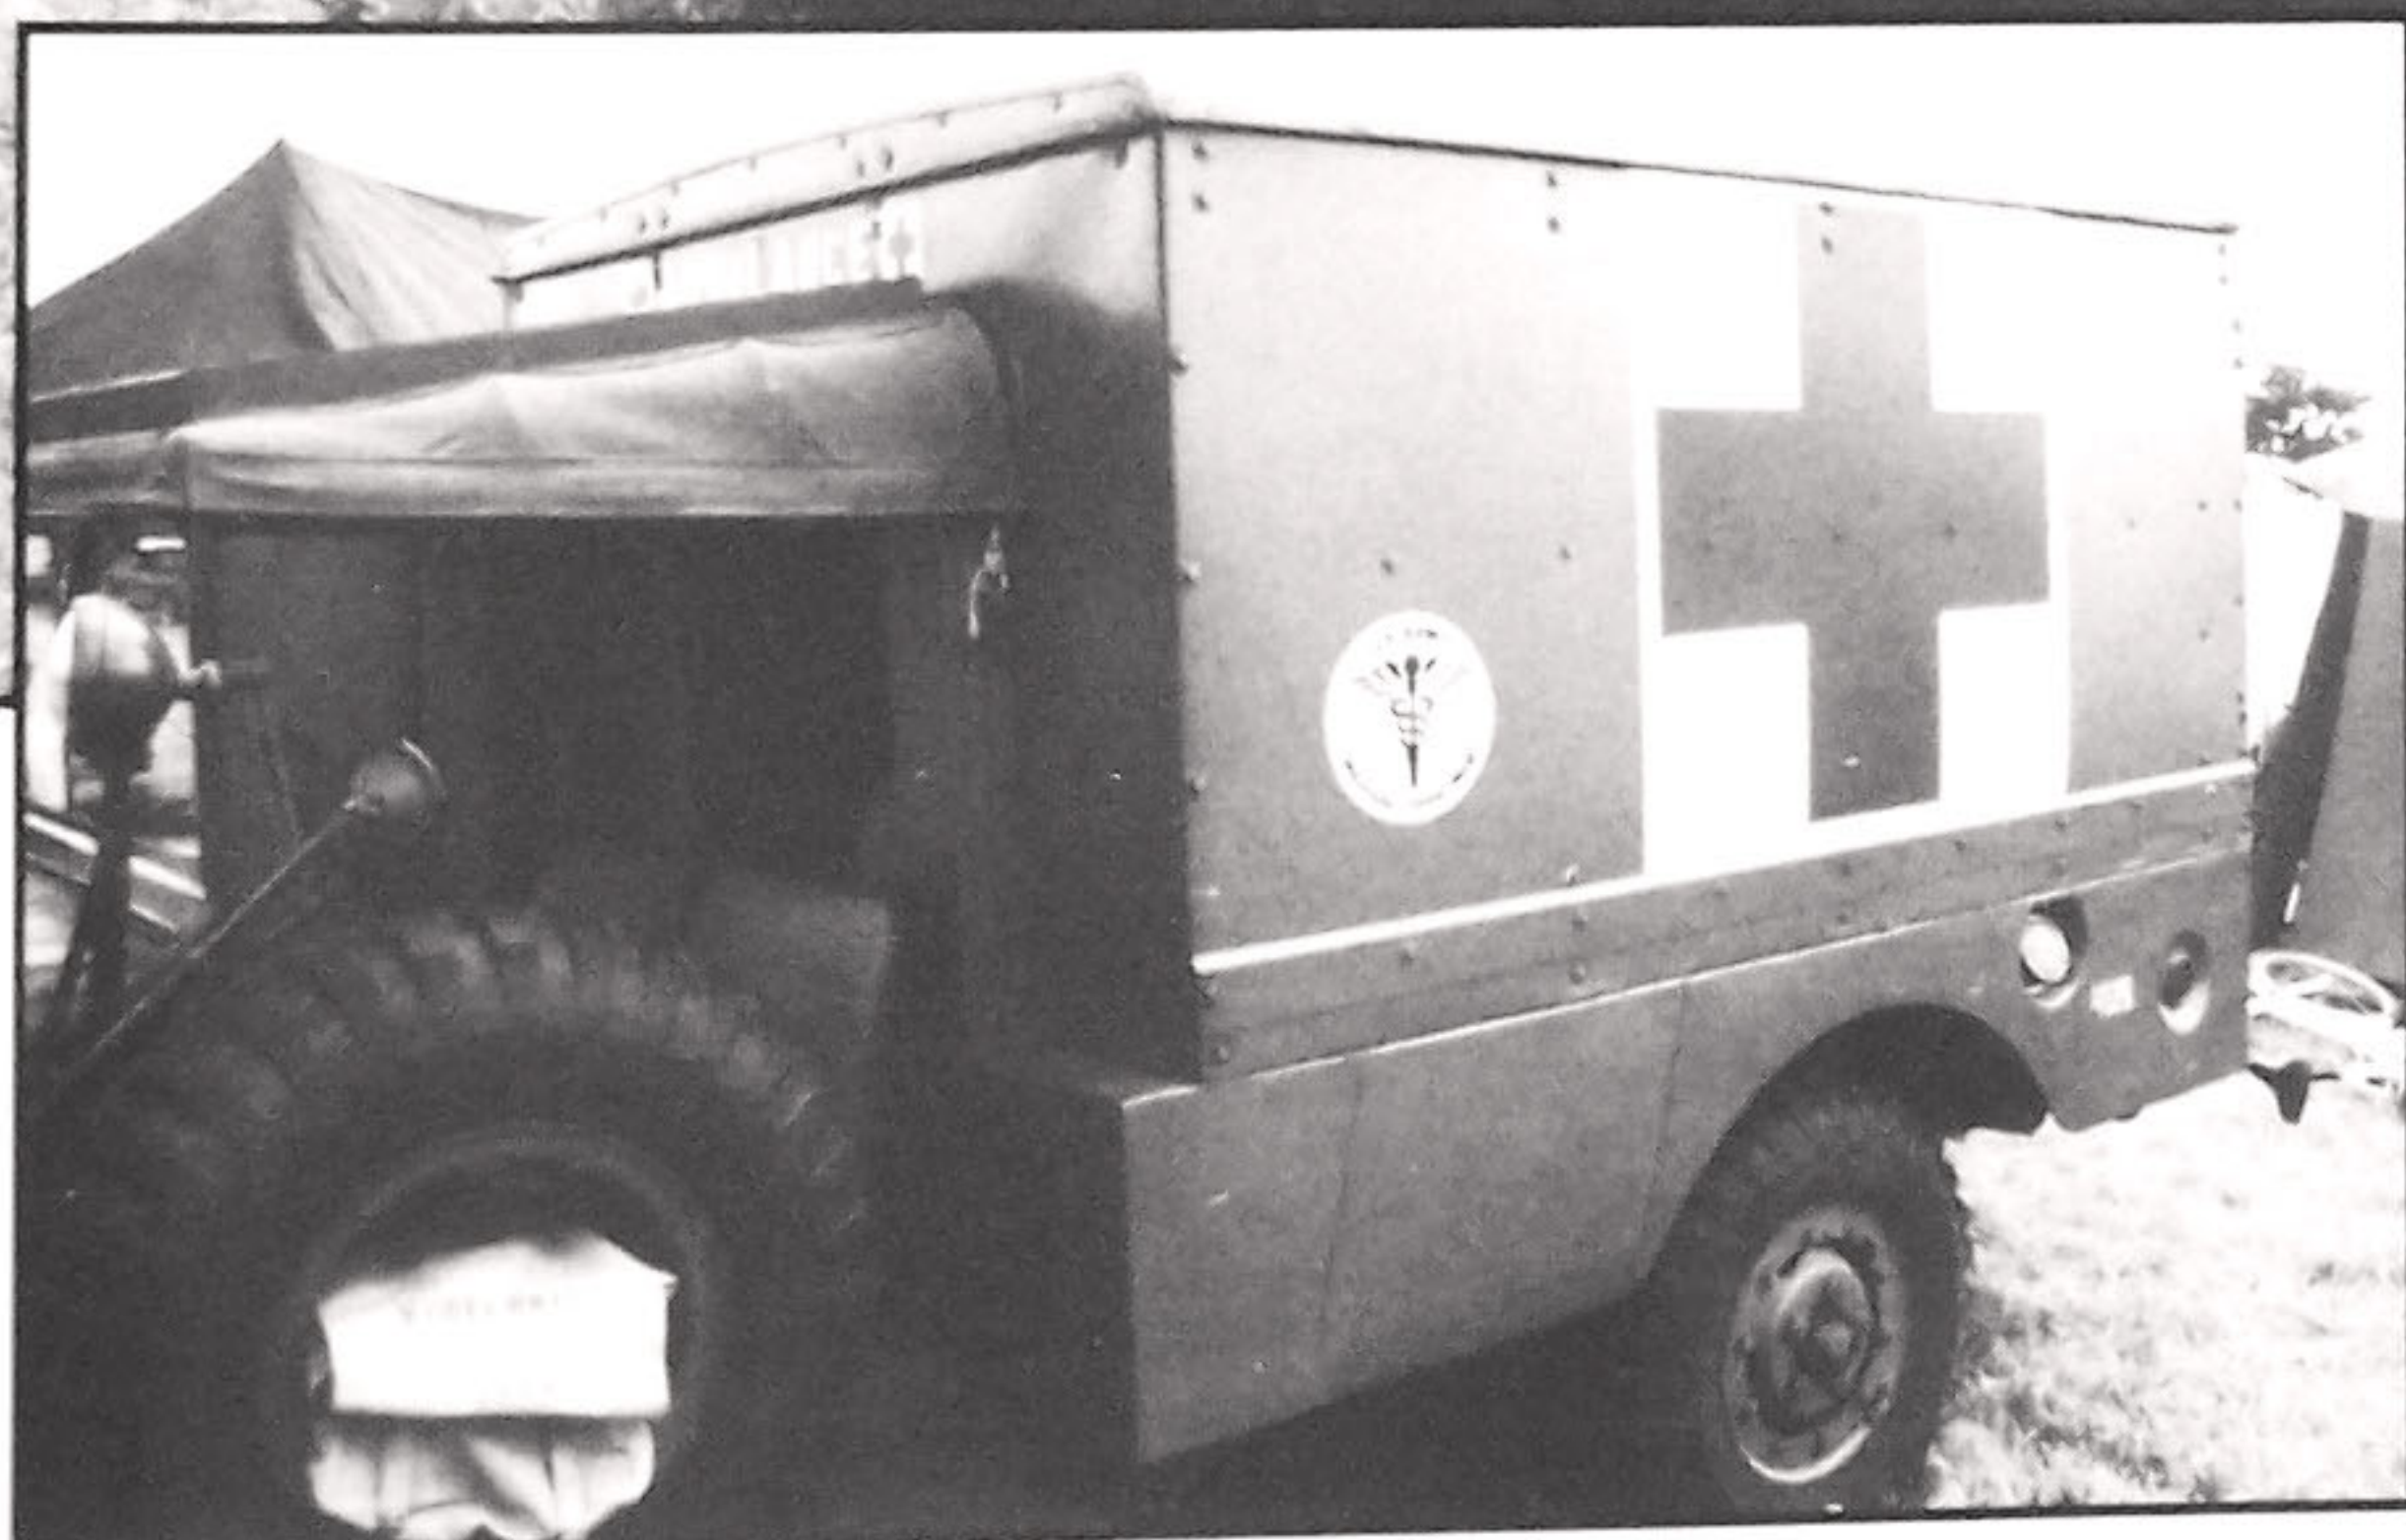
The WC 54 ambulance was yet another redesign of an existing 1/2-ton vehicle. It shared a similar body design with its predecessor, but utilized all the new components of the 3/4-ton series. The WC 54 was a big leap ahead in evacuation technology and greatly improved the comfort of wounded soldiers. The body was all reinforced steel sheet and the engine hood, windshield and front side doors were identical to the carryall. The WC 54 did have a huge, stamped metal roof panel. Two large vertical doors and a metal step provided access to the rear compartment. To improve sanitary conditions, the interior walls and roof were covered with Masonite board and the metal floor was covered with linoleum. There were two upper

stretcher racks with two folding seats below. These could also each accommodate a stretcher. The interior was provided with a dome light and small ventilator that was mounted in the roof. The rear springs were altered to provide a smoother ride and the trucks longer wheelbase (114 inches, versus the 98-inch wheelbase of the weapons carrier) also assisted in this. WC 54 ambulance bodies were produced for Dodge by Wayne Works of Richmond, Indiana. 22,857 WC-54s were produced with registration numbers running from W-77841 to W-78690, W-78691 to W-79999, W-710000 to W-718635, 75068 to 75083, 718636 to 719045 and 721000 to 732635. WC 54 ambulances were not manufactured with a winch.

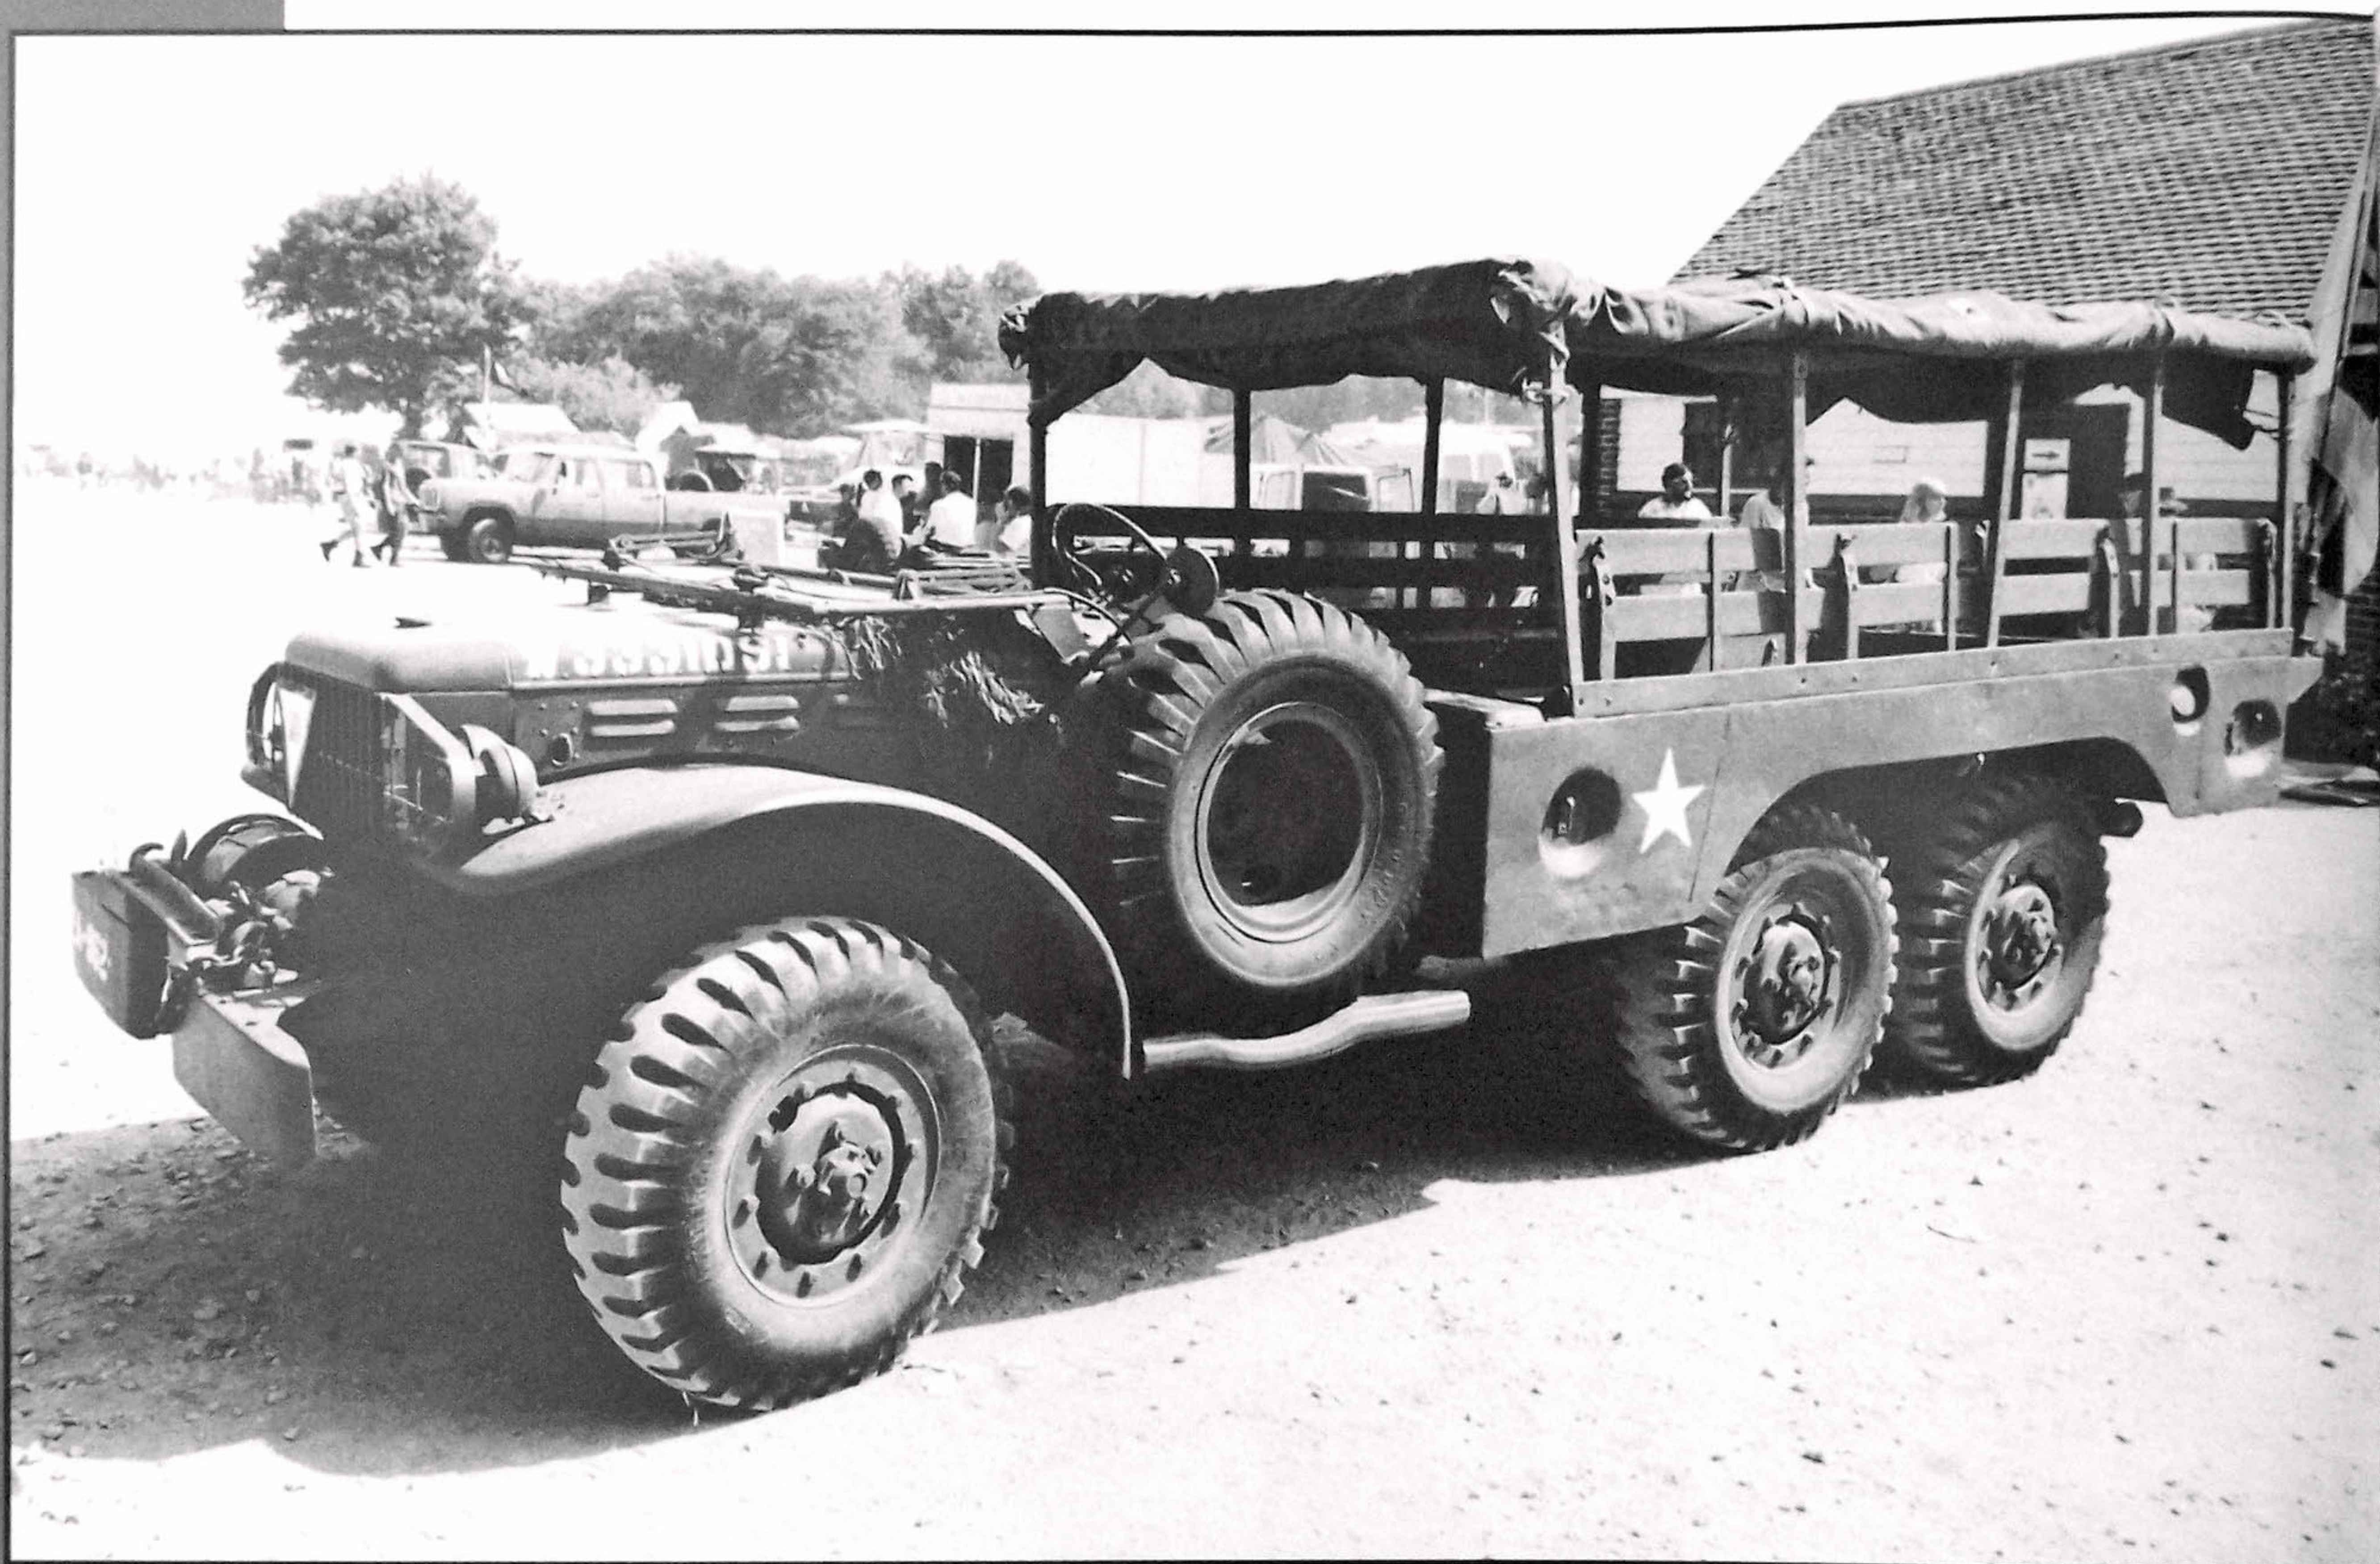
There were never enough WC 54 ambulances to meet the demand and starting in January of 1945, surplus WC 51 weapons carriers and M6 GMCs were rebodied to receive a folding ambulance structure made of wood and other non-strategic materials. This vehicle received the designation of WC 64 KD. The ambulance structure was shipped into theater knocked-down, hence the term "KD." **Above and left:** it is rare to see this vehicle restored and these photos show the added ambulance structure from several angles. The truck retains its entire original bodywork forward of the rear structure. The KD body had three access doors for the rear compartment and this made it much easier to remove patients in cold weather. The WC 64 also had modified rear springs to soften the ride. After the war, a more elaborate modification of surplus vehicles was created with a substantial sheet metal body. This was known as the S7 MA 51 Boyertown ambulance. Thousands of both types were supplied to Europe and other areas of the world through MAP.

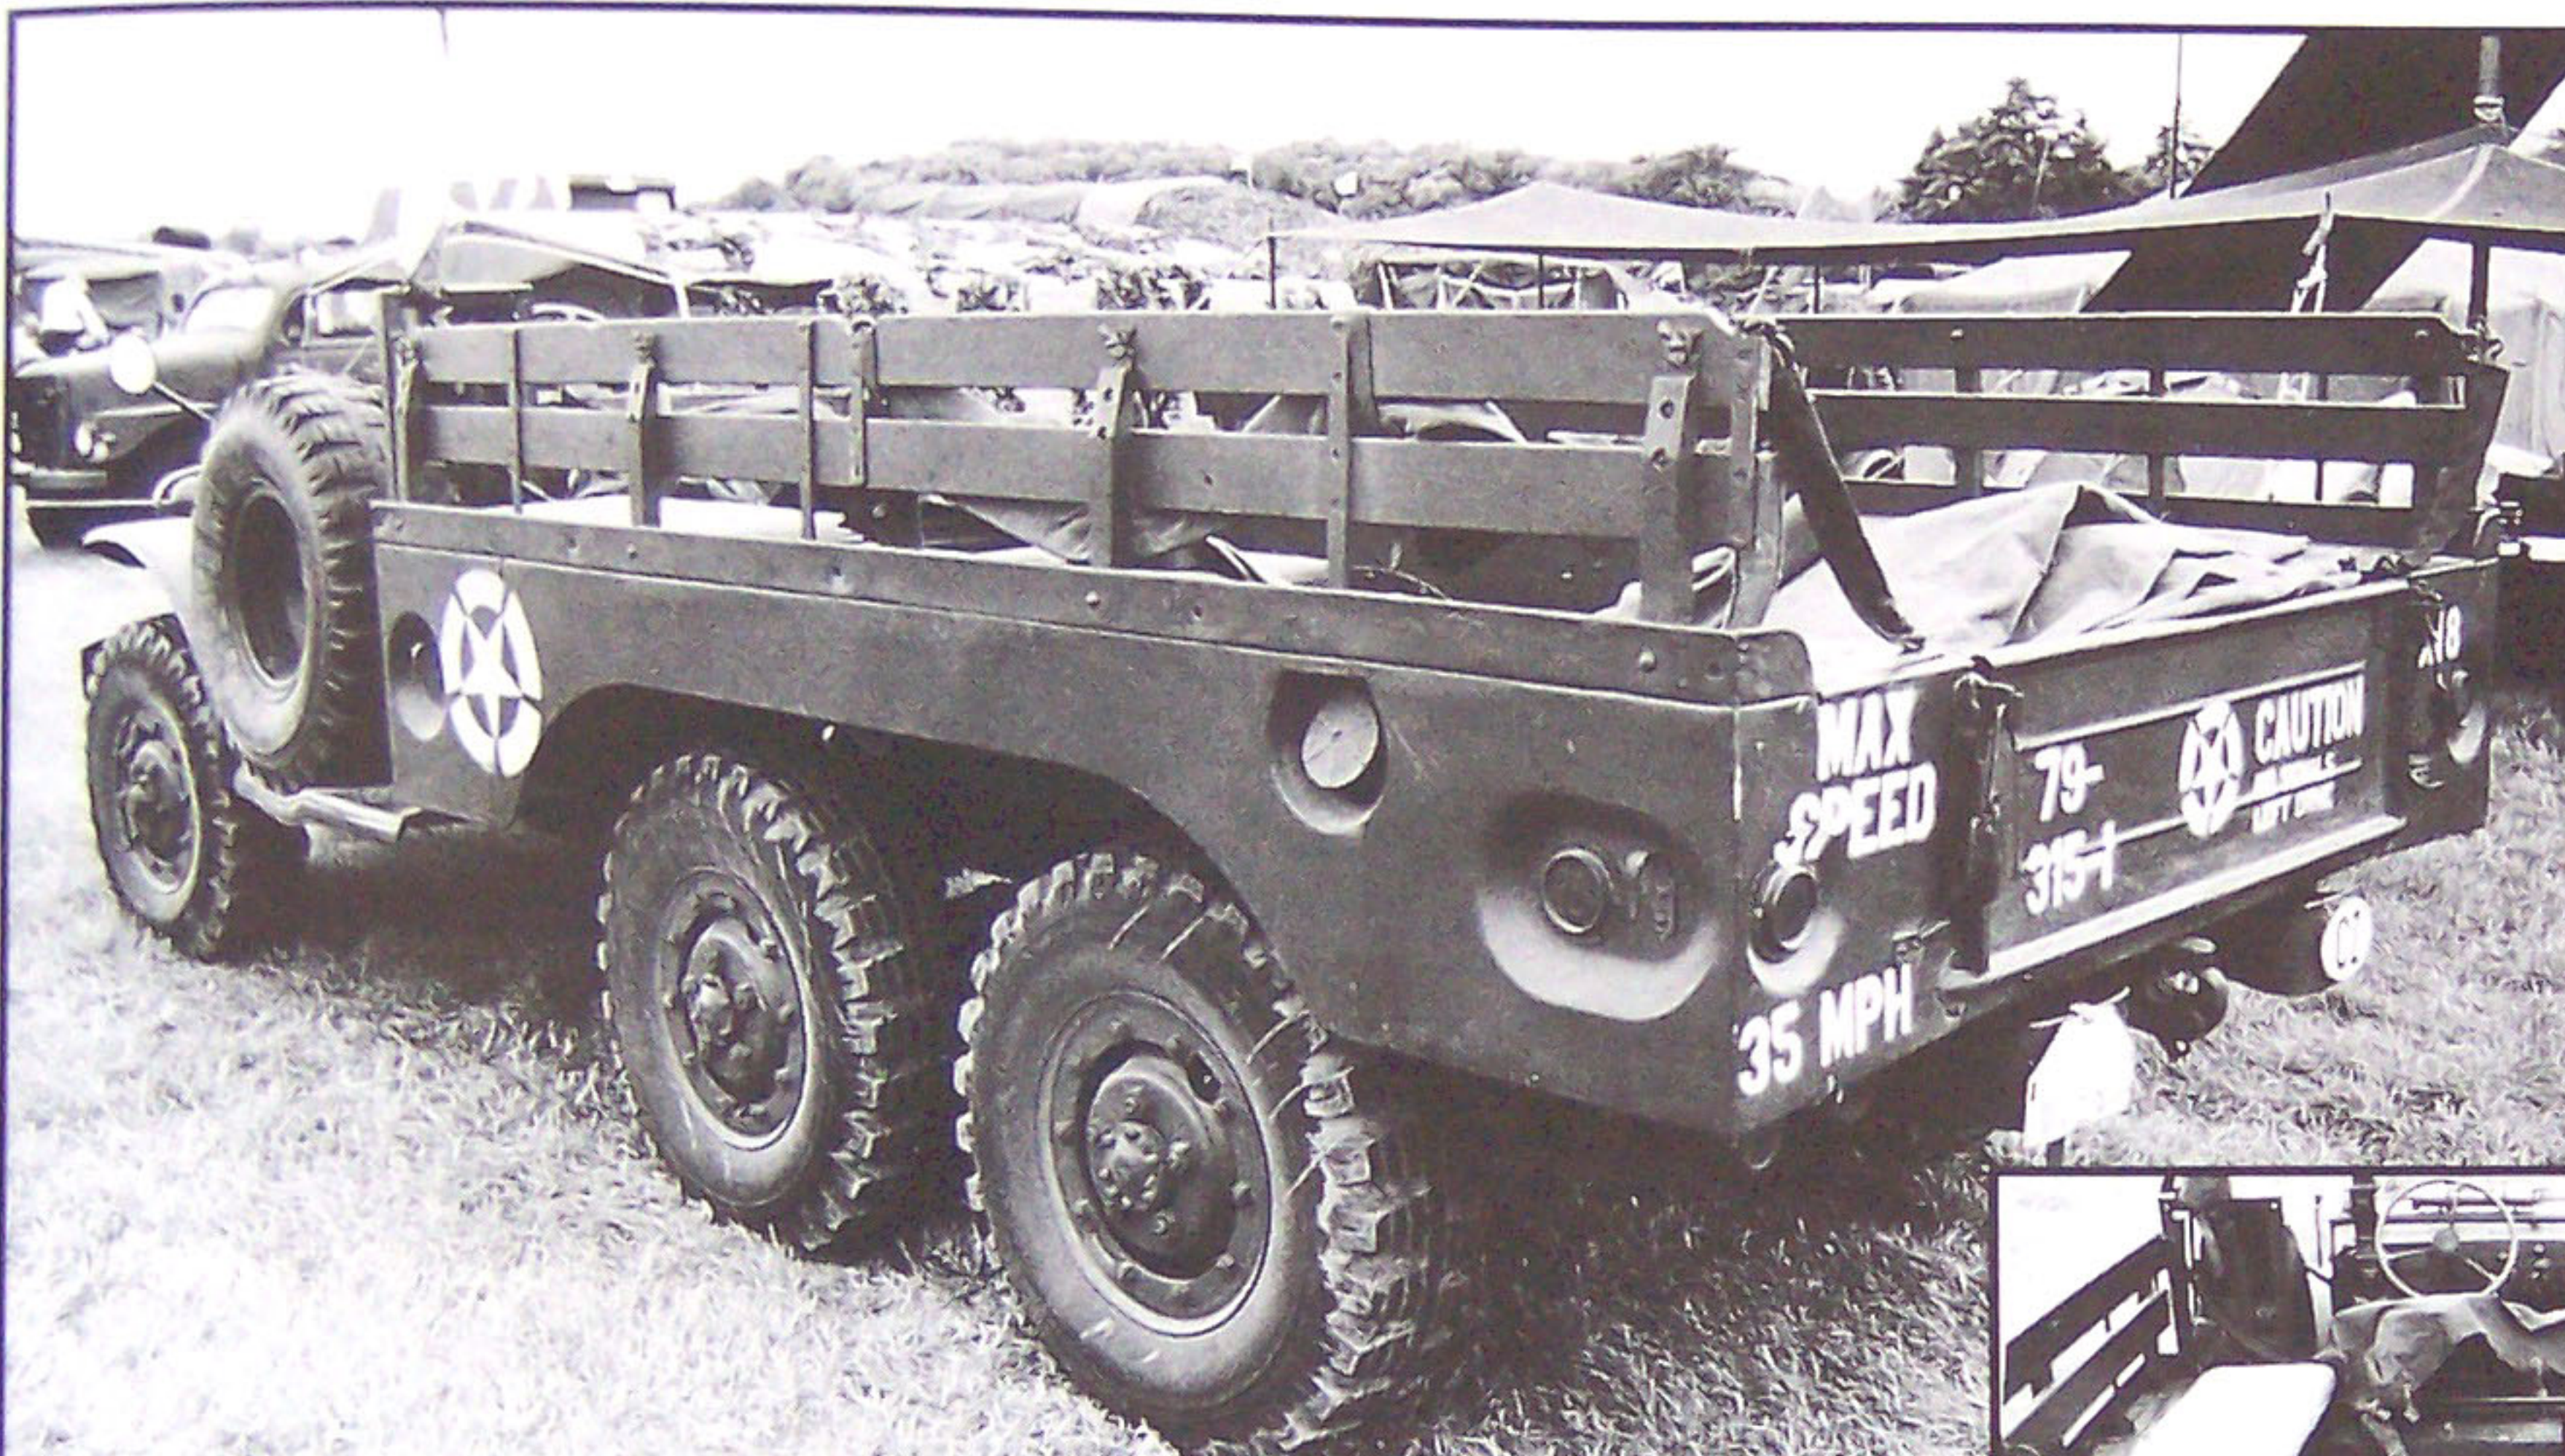
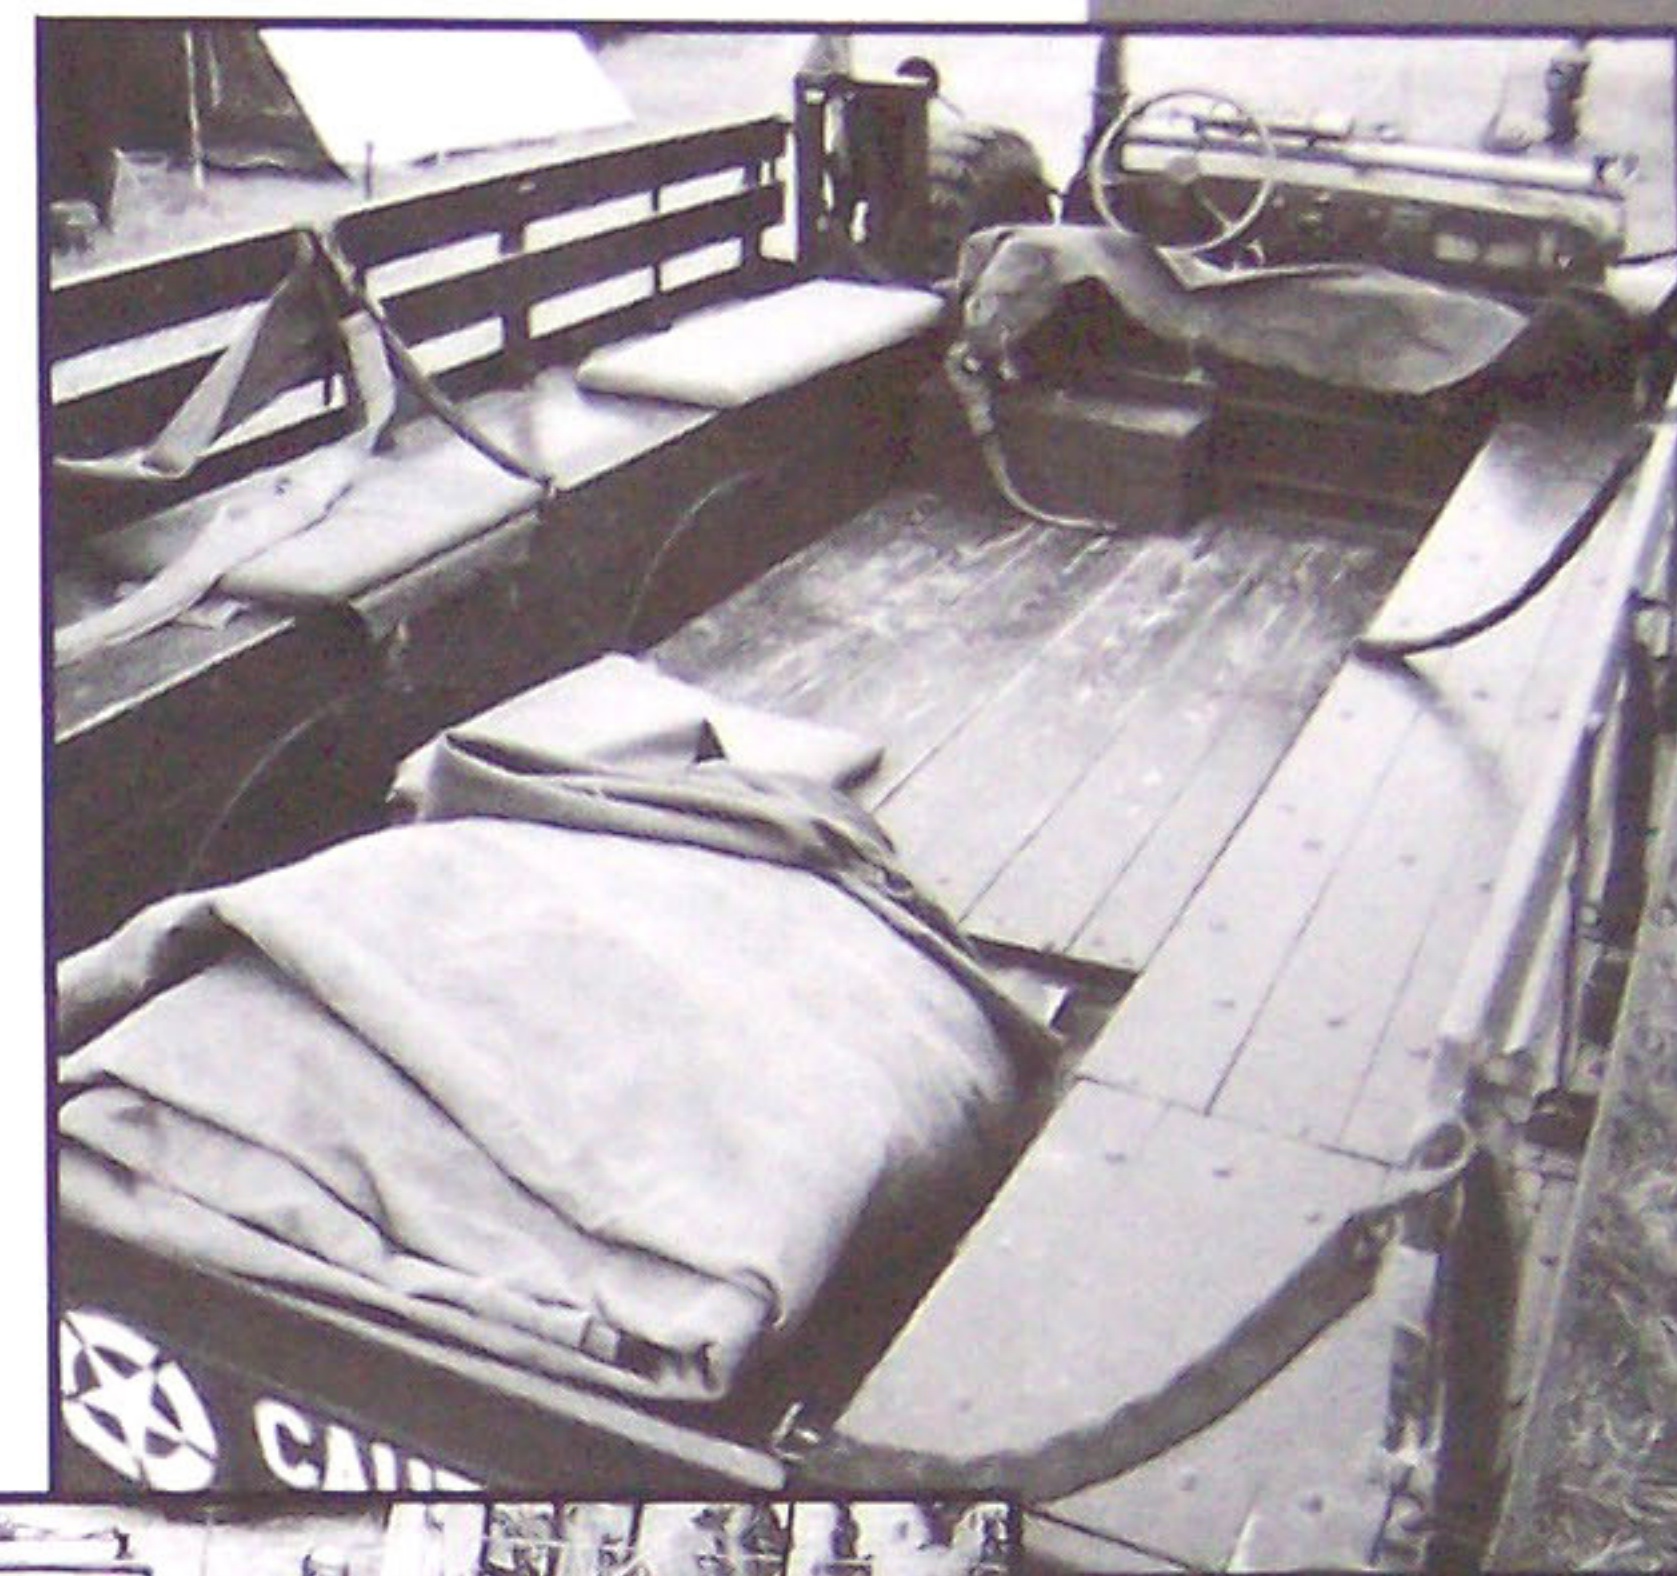
When the U.S. Army changed its rifle squad from eight to ten men, it was requested that Chrysler look into the possibility of creating an elongated version of the standard WC 51 weapons carrier. The result was the 1 1/2-ton 6 x 6 T223 series of vehicles, known as WC 62 with no winch and WC 64 with a winch installed. The truck was truly a stretched version of the weapons carrier and its service parts were 96% interchangeable with those of the 3/4-ton series. From the cab forward it was nearly identical to the 4 x 4. The new, lengthened cargo bed could carry up to 12 troops on two large side benches. There was also an additional rear-facing seat located between the two front seats. The role of the T223

was as a general personnel, cargo and towing vehicle and at this, it excelled. Its introduction came at a time when the GMC 2 1/2-ton truck was in high demand and in many respects the T223 filled the shoes of the GMC admirably. Its many uses included being a prime mover for the 57mm gun and it was sometimes used as an ambulance where additional cross-country mobility was a factor. Several of the changes that were later made in the production run of the 4 x 4 series were originally made on the 6 x 6. Many of these were internal, but some of the significant external changes were the relocation of the tool rack to the front right side and the remounting of one of the five-gallon cans and its rack just

behind it. Certain mechanical components, introduced in the 6 x 6 series, were also later incorporated into the 4 x 4. Designed slightly heavier for use in the 6 x 6, these parts included the front axle and the steering arm and drag link, among others. The engine was the same as that found in the 4 x 4 T214s, but it used a separate serial number. Because of the 6-wheel drive configuration, the T223s used a two-speed transfer case instead of the one-speed used on the T214. The engine and drive train of the T223 offered only a slight reduction in speed when compared with the 3/4-ton trucks, coming in at 50 mph. The shots on these pages represent two different restored vehicles. The shot on page 42 shows how the rear soft-top could be rolled into itself. The forward portion was normally attached to the front windshield. **Top left:** this shows off the rear cargo body to good advantage. The long rear lazy backs could be folded down for carrying cargo. The tires are not original. **Top right and above right:** the cargo body was quite spacious. The very first T223s had metal cargo bodies, but this was changed to wood with steel panels with the 3,100th vehicle produced. **Left:** another change started with the T223 and integrated into all later Dodge trucks with a windshield, was the relocation of the decontamination unit to the windshield's lower edge. Approximately 43,000 T223s were produced with registration numbers running from 3297503 to 3328846 on the WC 62 and 3328847 to 3342502 on the WC 63.
