# Allied-Axis

THE PHOTO JOURNAL OF THE SECOND WORLD WAR

**German  
SIG 33/1  
Grille SPG**

**Kleines Kettenkrafttrad  
WWII Dodge 3/4-ton trucks  
DUKW Amphibious truck**

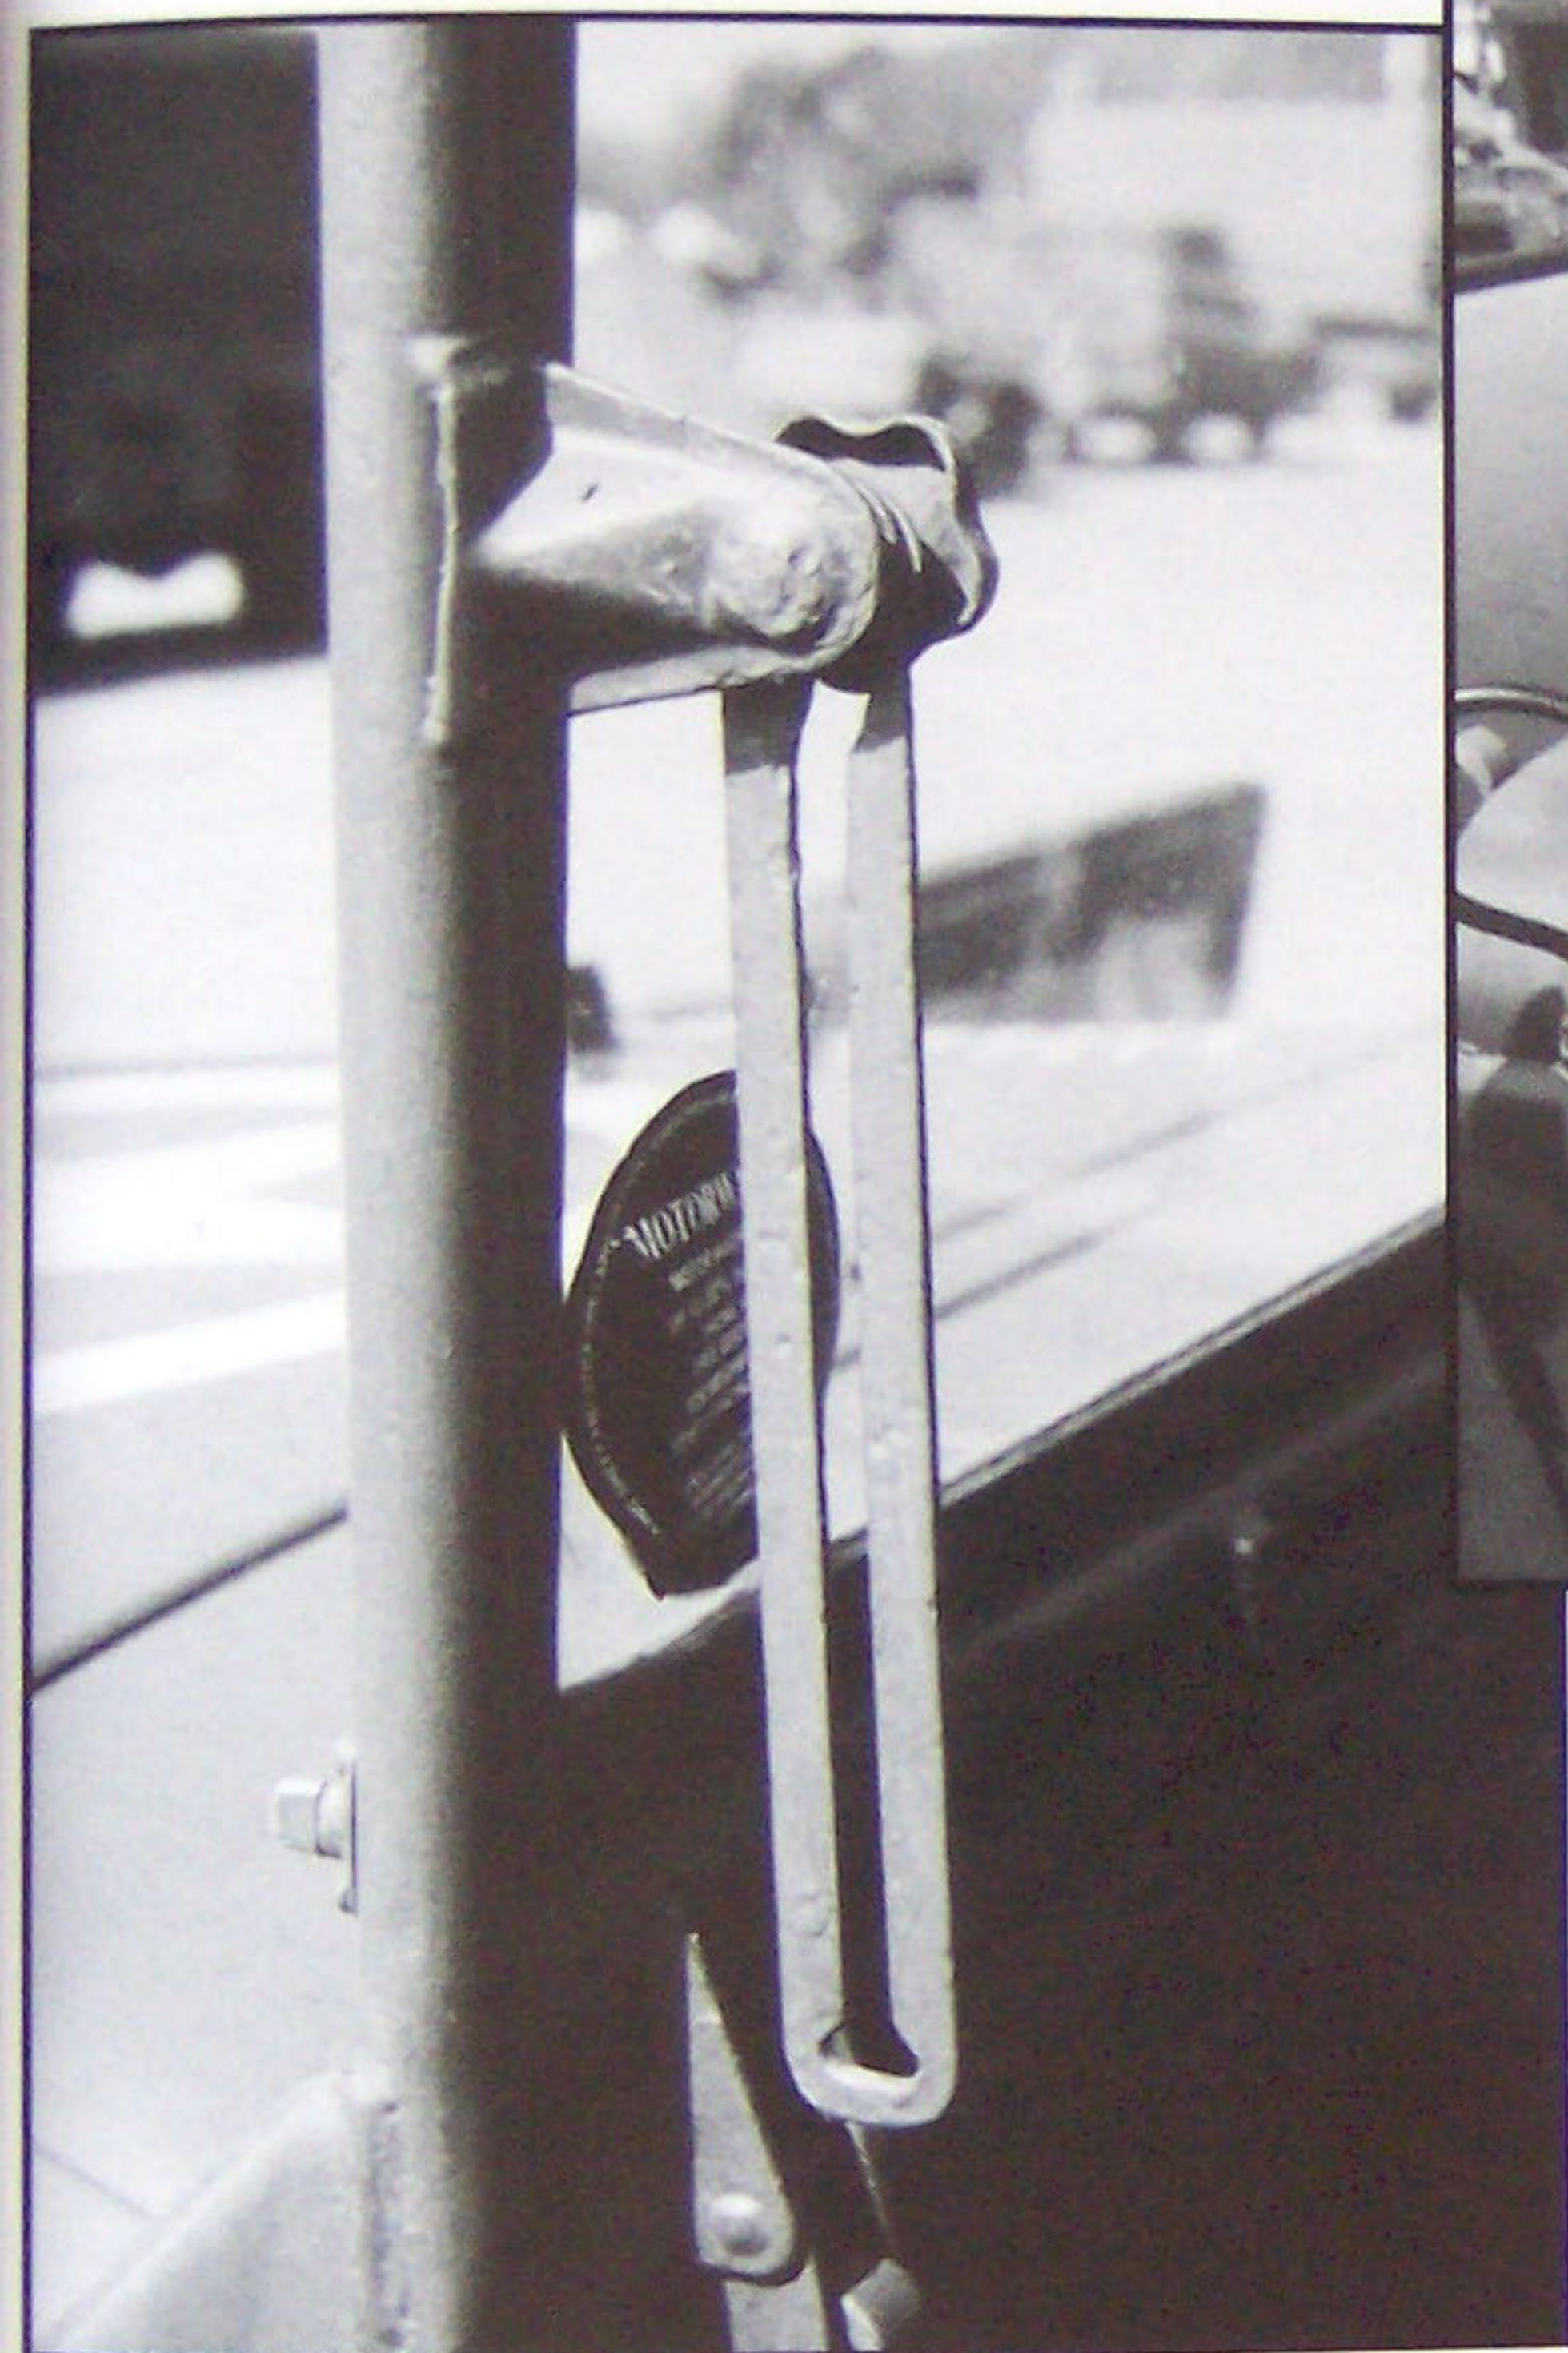
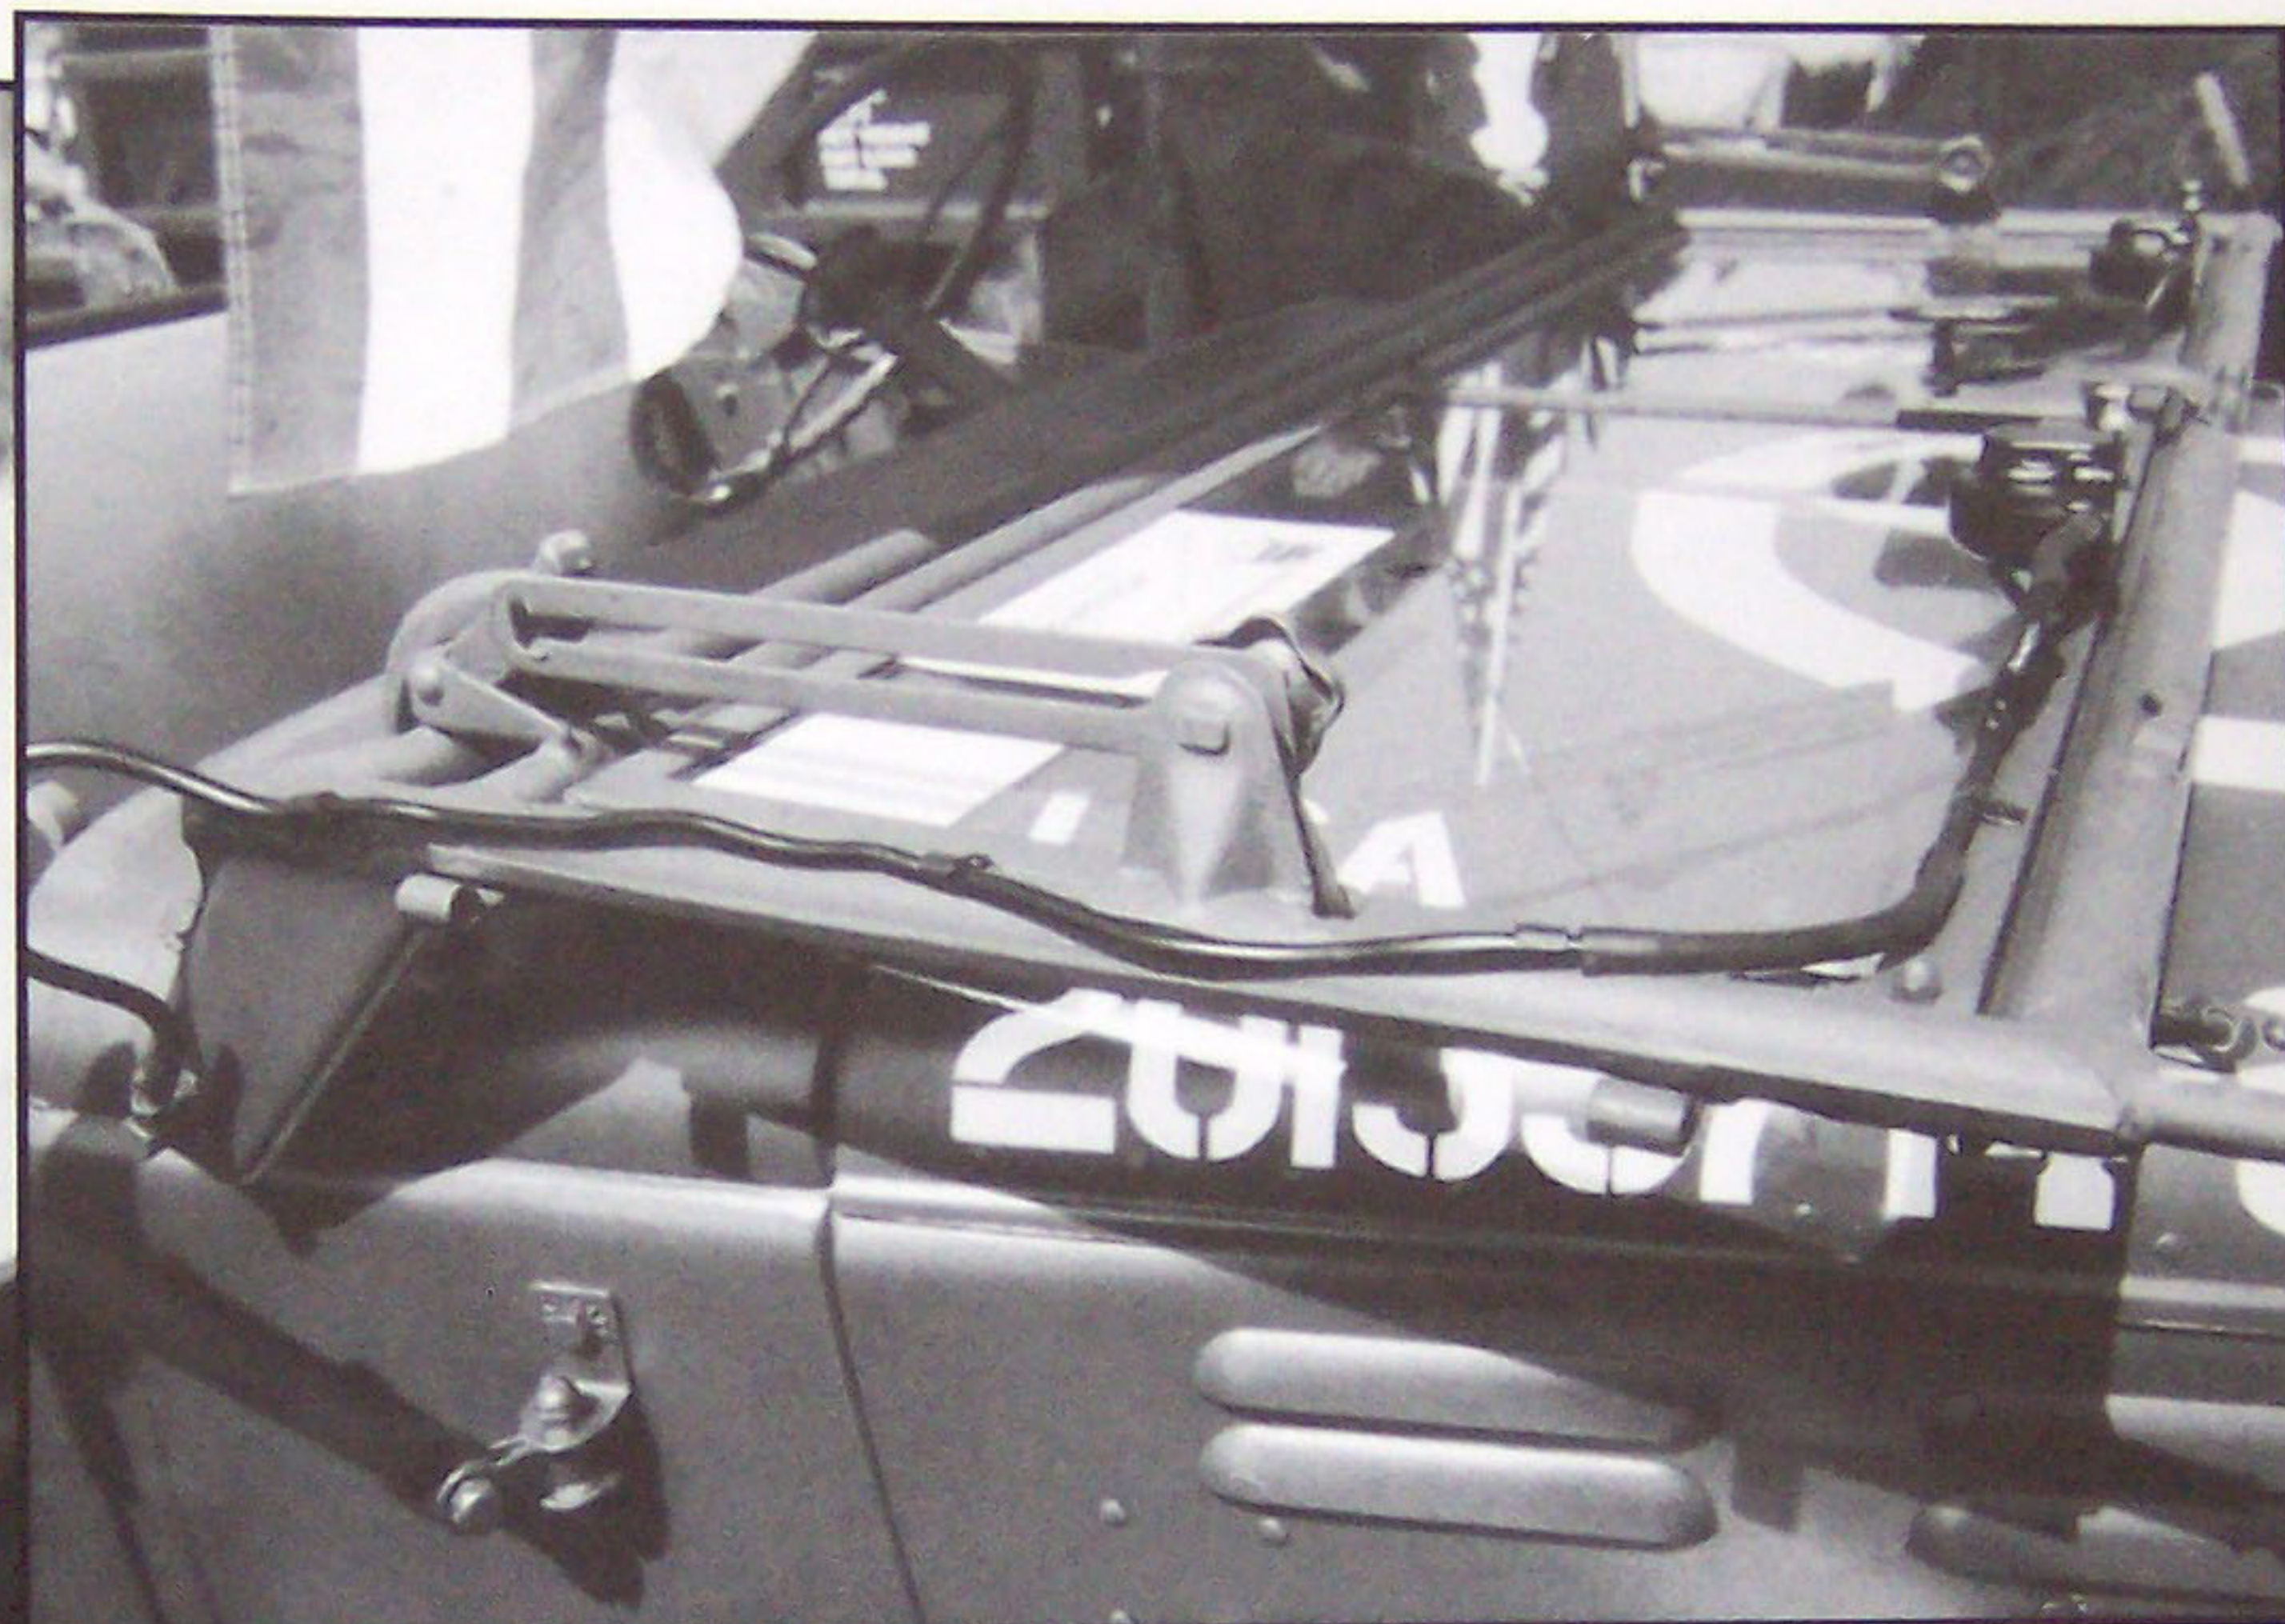
The Braden 5,000-pound winch (seen in the two top photos) was standard equipment on the WC 52, WC 57 and the WC 63 trucks. All the winches for the Dodge 3/4-ton trucks were supplied by the Braden Winch Co., of Tulsa, Oklahoma. The winch was a power take off type that was linked to a shaft leading to the transmission. This shaft was engaged by a lever in the driver's compartment. It had neutral, high and low positions. Later, the 5,000-pound winch was superseded by a 7,500 pound model (seen in the bottom two photos), also made by Braden. To engage the winch, the shift yoke and the PTO lever inside the driver's compartment first had to be placed in the neutral position. The shift yoke is the knob-like device

located at the front of the winch on the 7,500 pound model and in the rear on the 5,000-pound version. This released the winch drum and allowed the cable to be played out by hand. It was recommended that all of the cable be played out in order to maximize the pulling power of the winch. When the load was secured, the yoke was shifted to the engaged position and the PTO lever shifted to either high or low, depending on the load. The heavy chain seen in these photos was also standard equipment on any winch-equipped Dodge truck. These were supplied to Dodge by the American Chain Co., of York Pennsylvania. The canvas and leather cover shown above is an interesting and rarely seen detail.

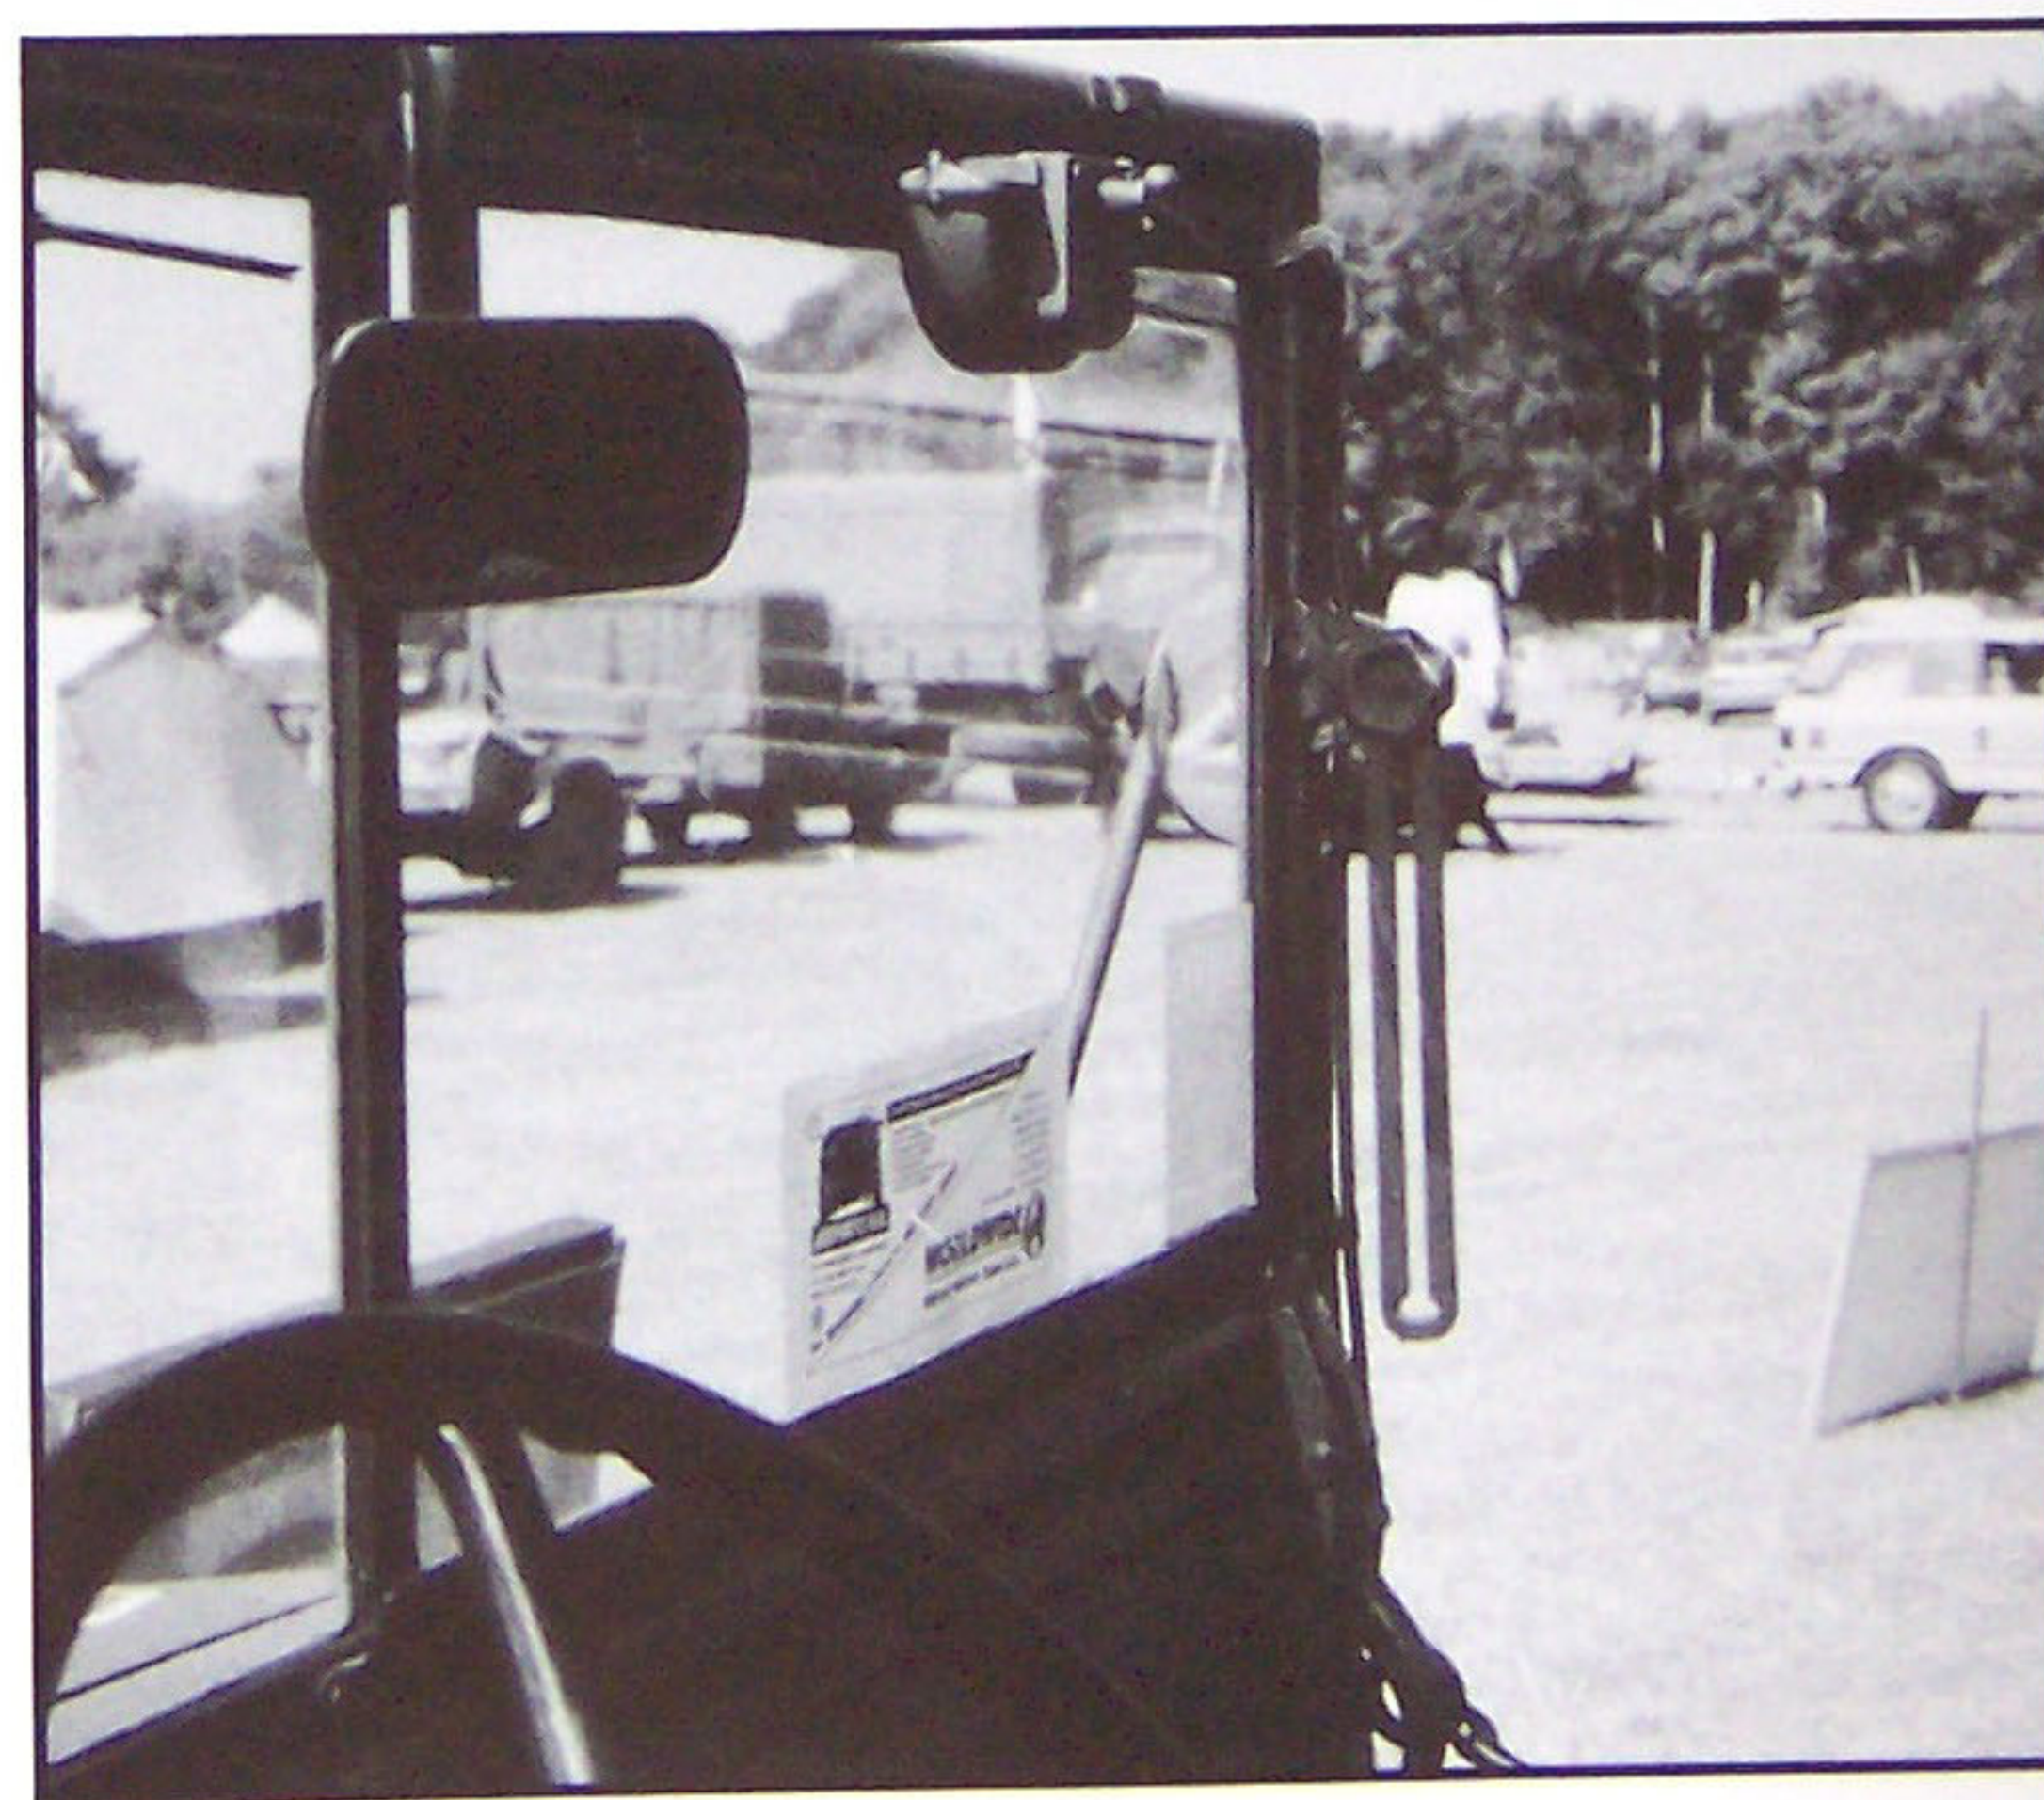
These three views of the windshield show the mechanism used to adjust the windshield glass. The star shaped knob was loosened and, as the windshield glass moved out, the knob axle moved along the sliding track. The two shots at right also show the windshield wiper motors and their wiring.

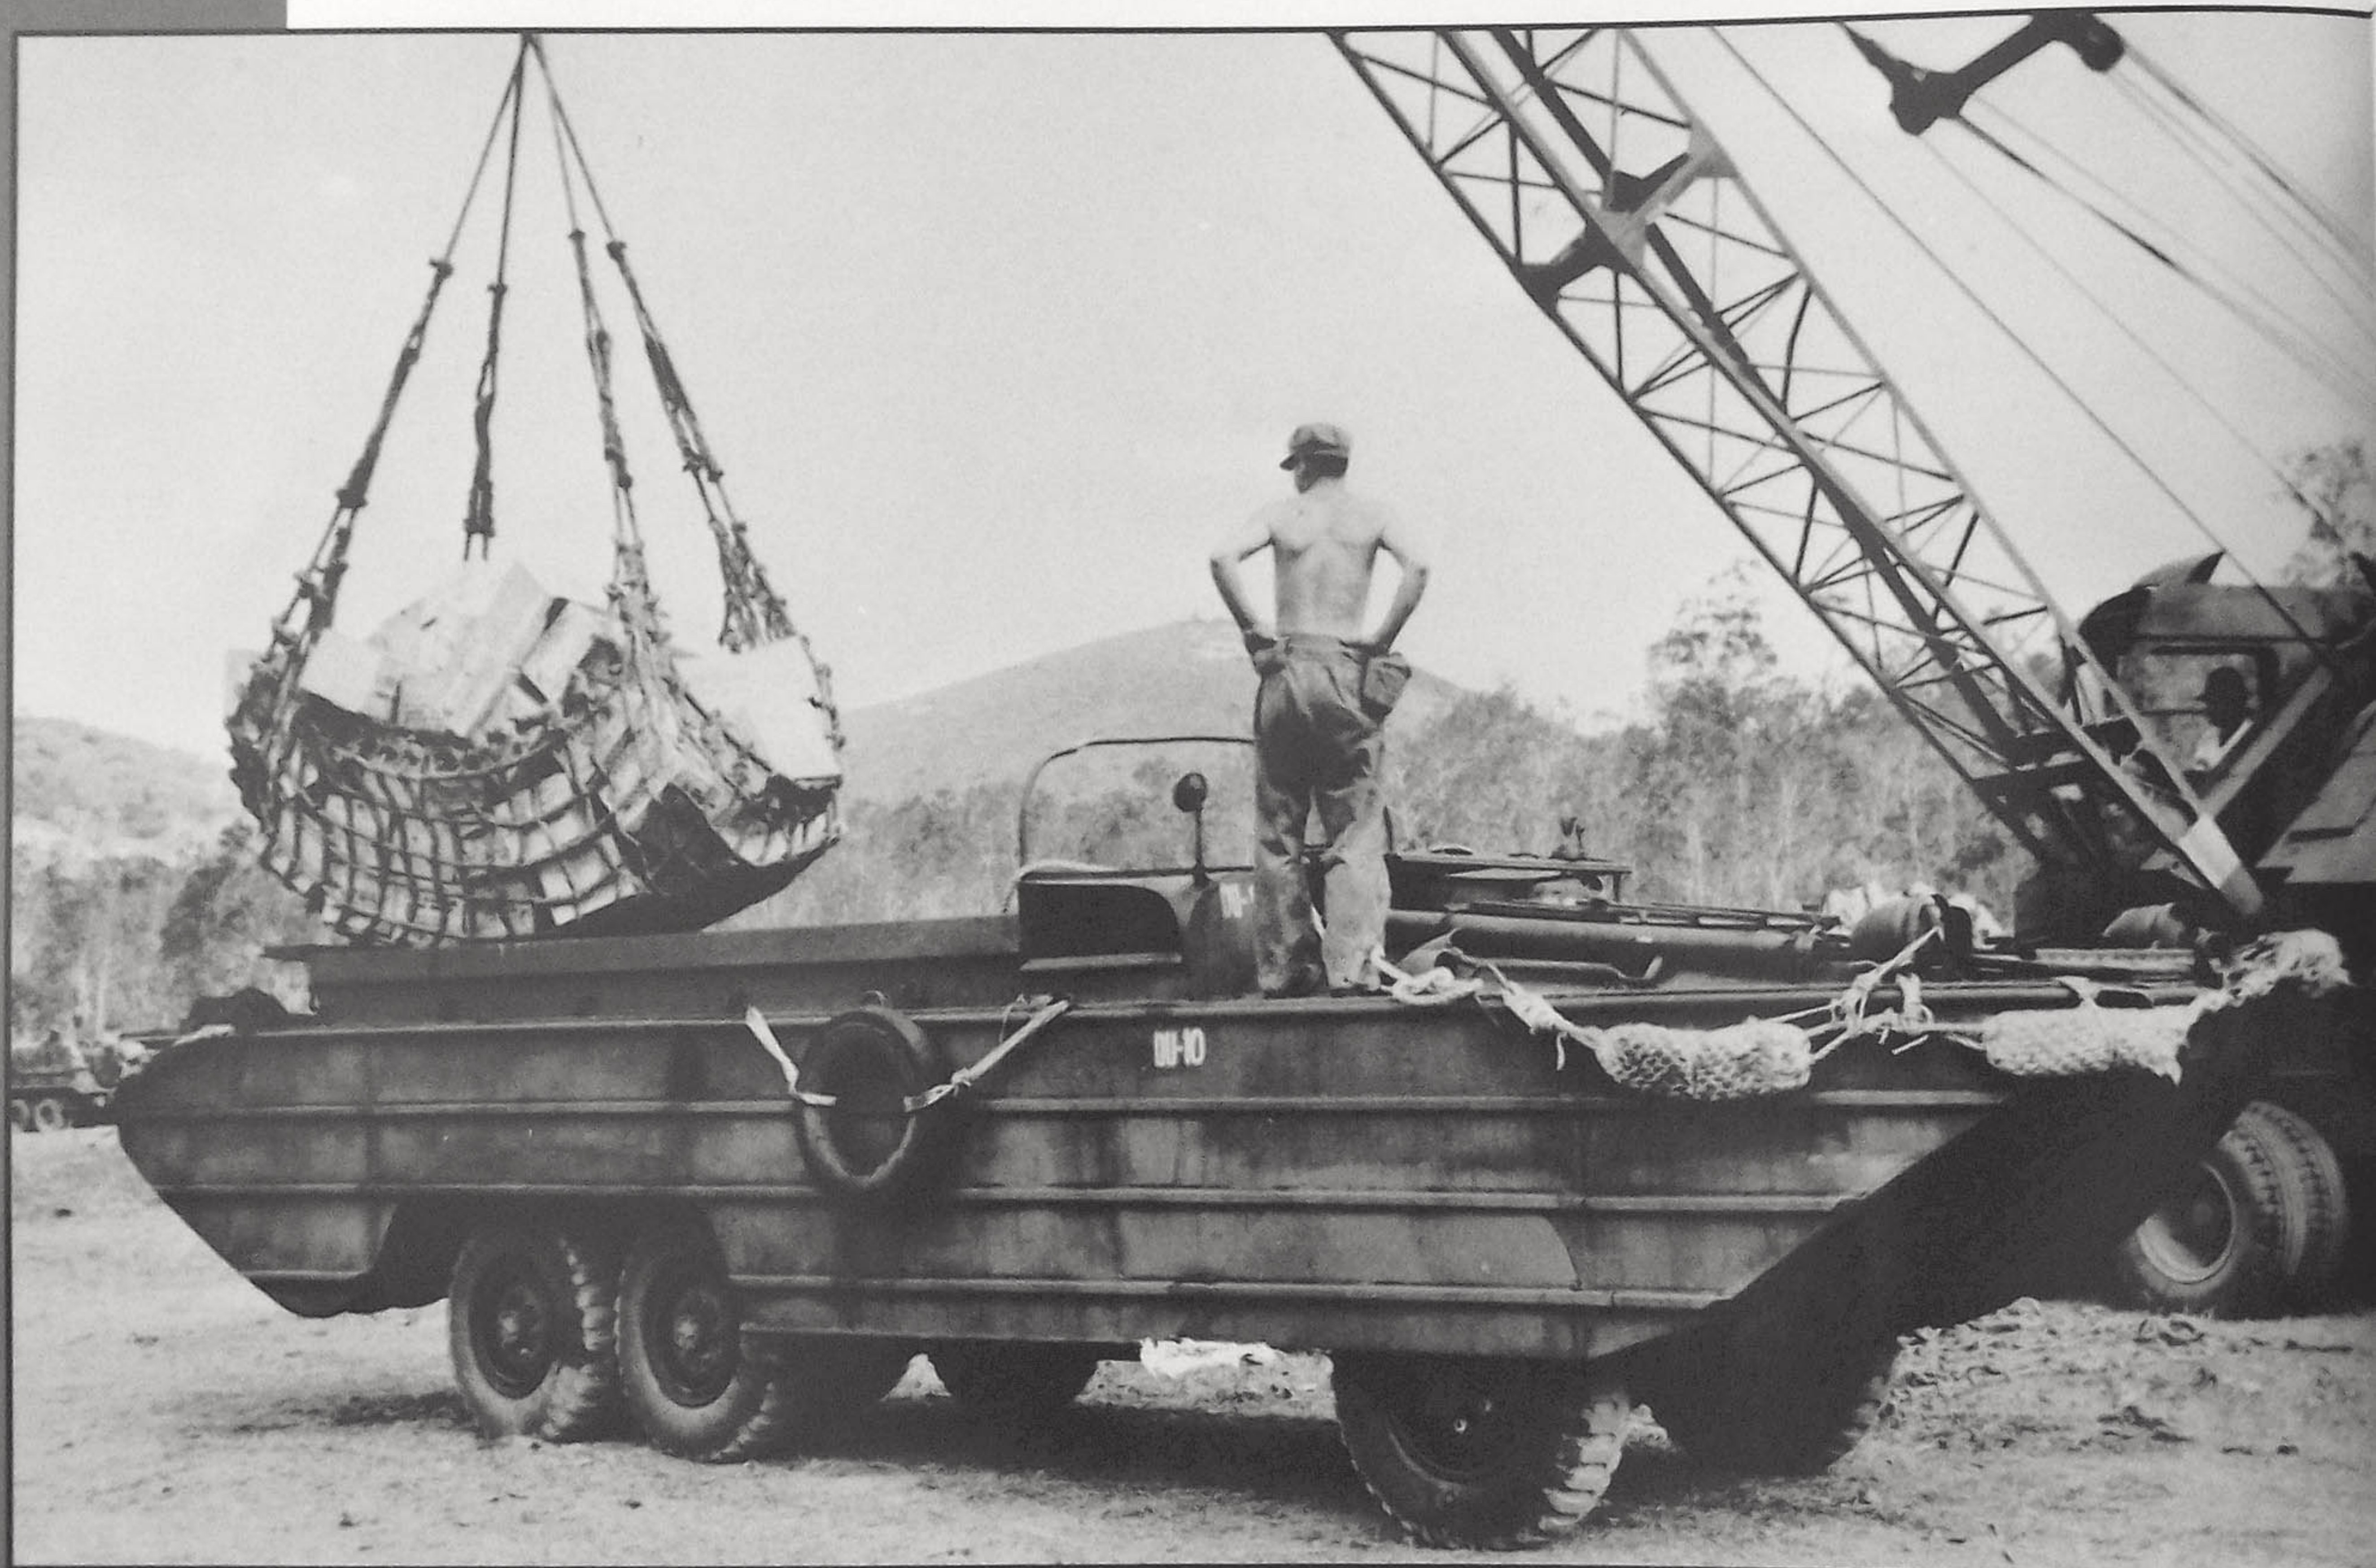
**Above:** whenever possible cargo was kept within its sling as it was off-loaded. This meant for a quick trip on the shore side. When the weather was good and the surf calm, the driver could lower the surf shield and the windshield as shown here. The crane appears to be the massive Biderman P1 Crane Truck, which is equipped with the 20-ton Michigan TM16 crane (IWM).

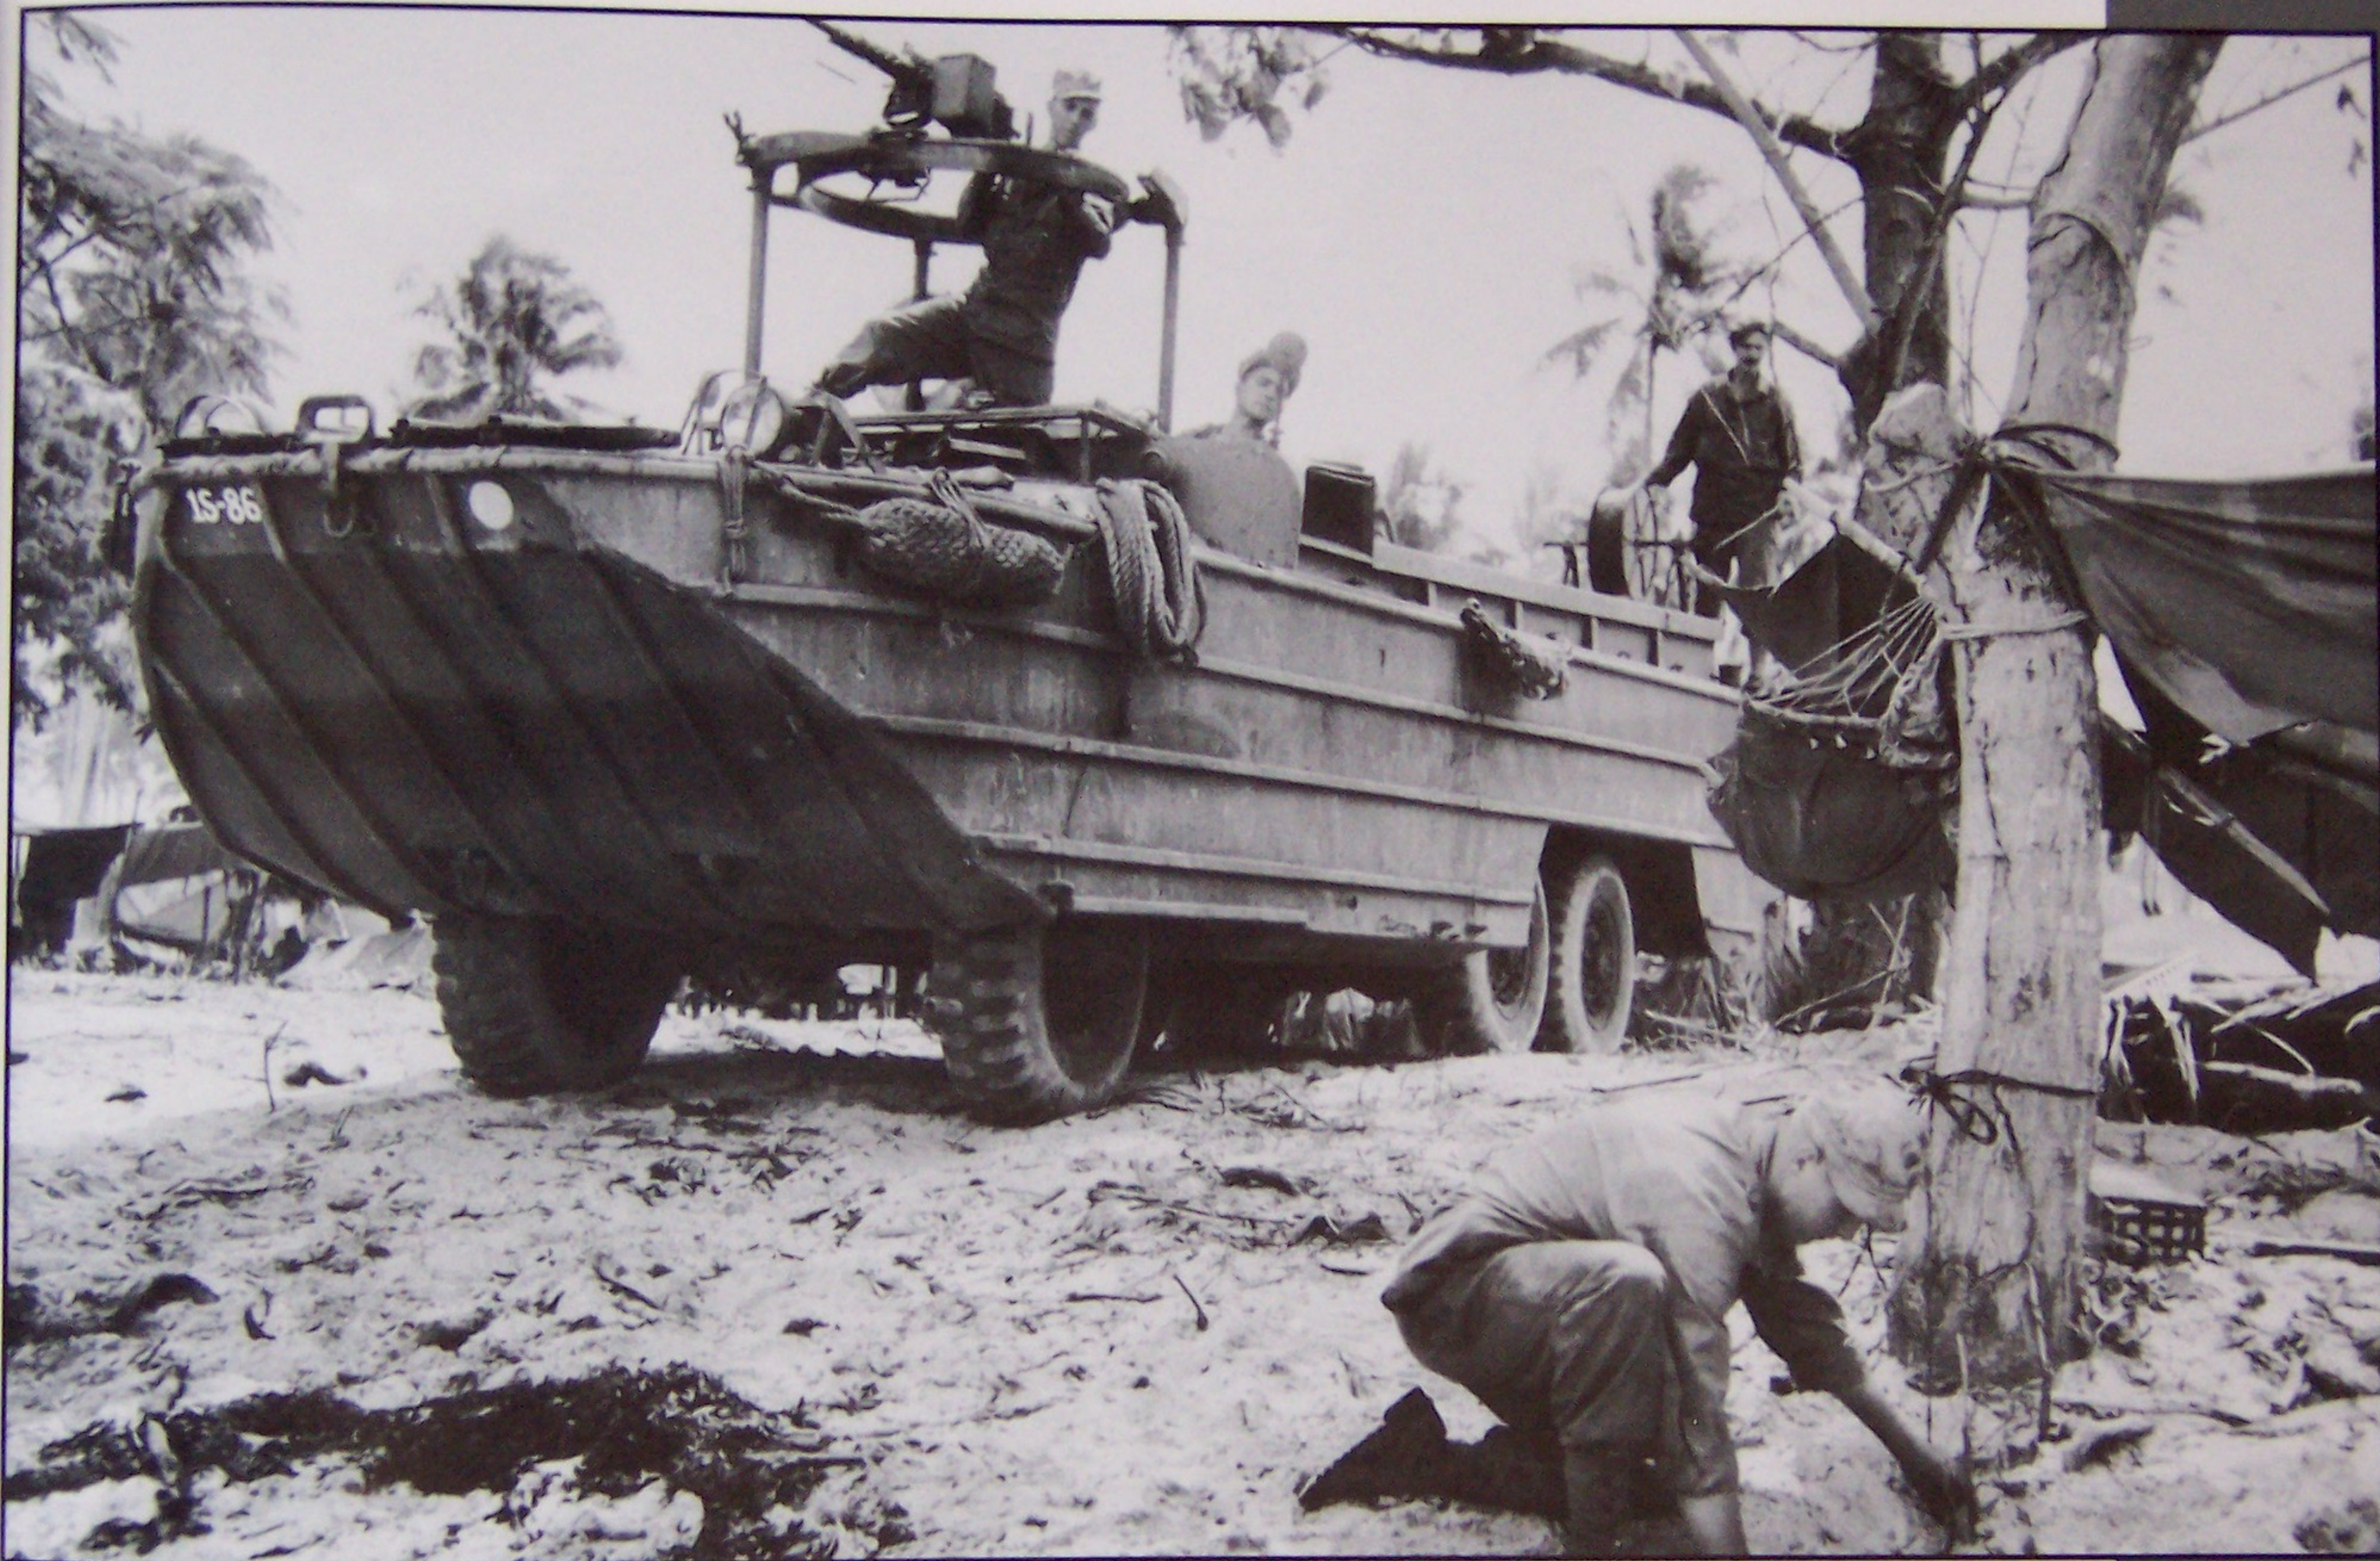
The Duck is equipped with a two-speed transfer case and this permits drive of both the front and rear axles, or only the rear axle, as required. The water propeller transfer case, mounted in line between transmission and transfer case, permits engagement or disengagement of the water propeller. A marine rudder and controls are provided for use in water. **Above:** one of the many uses for the Duck was the running of

communication wire across both land and water obstacles. Here, an Army Duck is employed at this task on an island of the Admiralty group in the Southwest Pacific. Every fourth Duck was outfitted with the M36 Truck Mount, which could mount either the .30 caliber or .50 caliber machine gun. Interestingly, the soldier in the foreground wears the popular molded rubber and canvas jungle boots (IWM).
