# Allied-Axis

THE PHOTO JOURNAL OF THE SECOND WORLD WAR

**German  
SIG 33/1  
Grille SPG**

**Kleines Kettenkrafttrad  
WWII Dodge 3/4-ton trucks  
DUKW Amphibious truck**

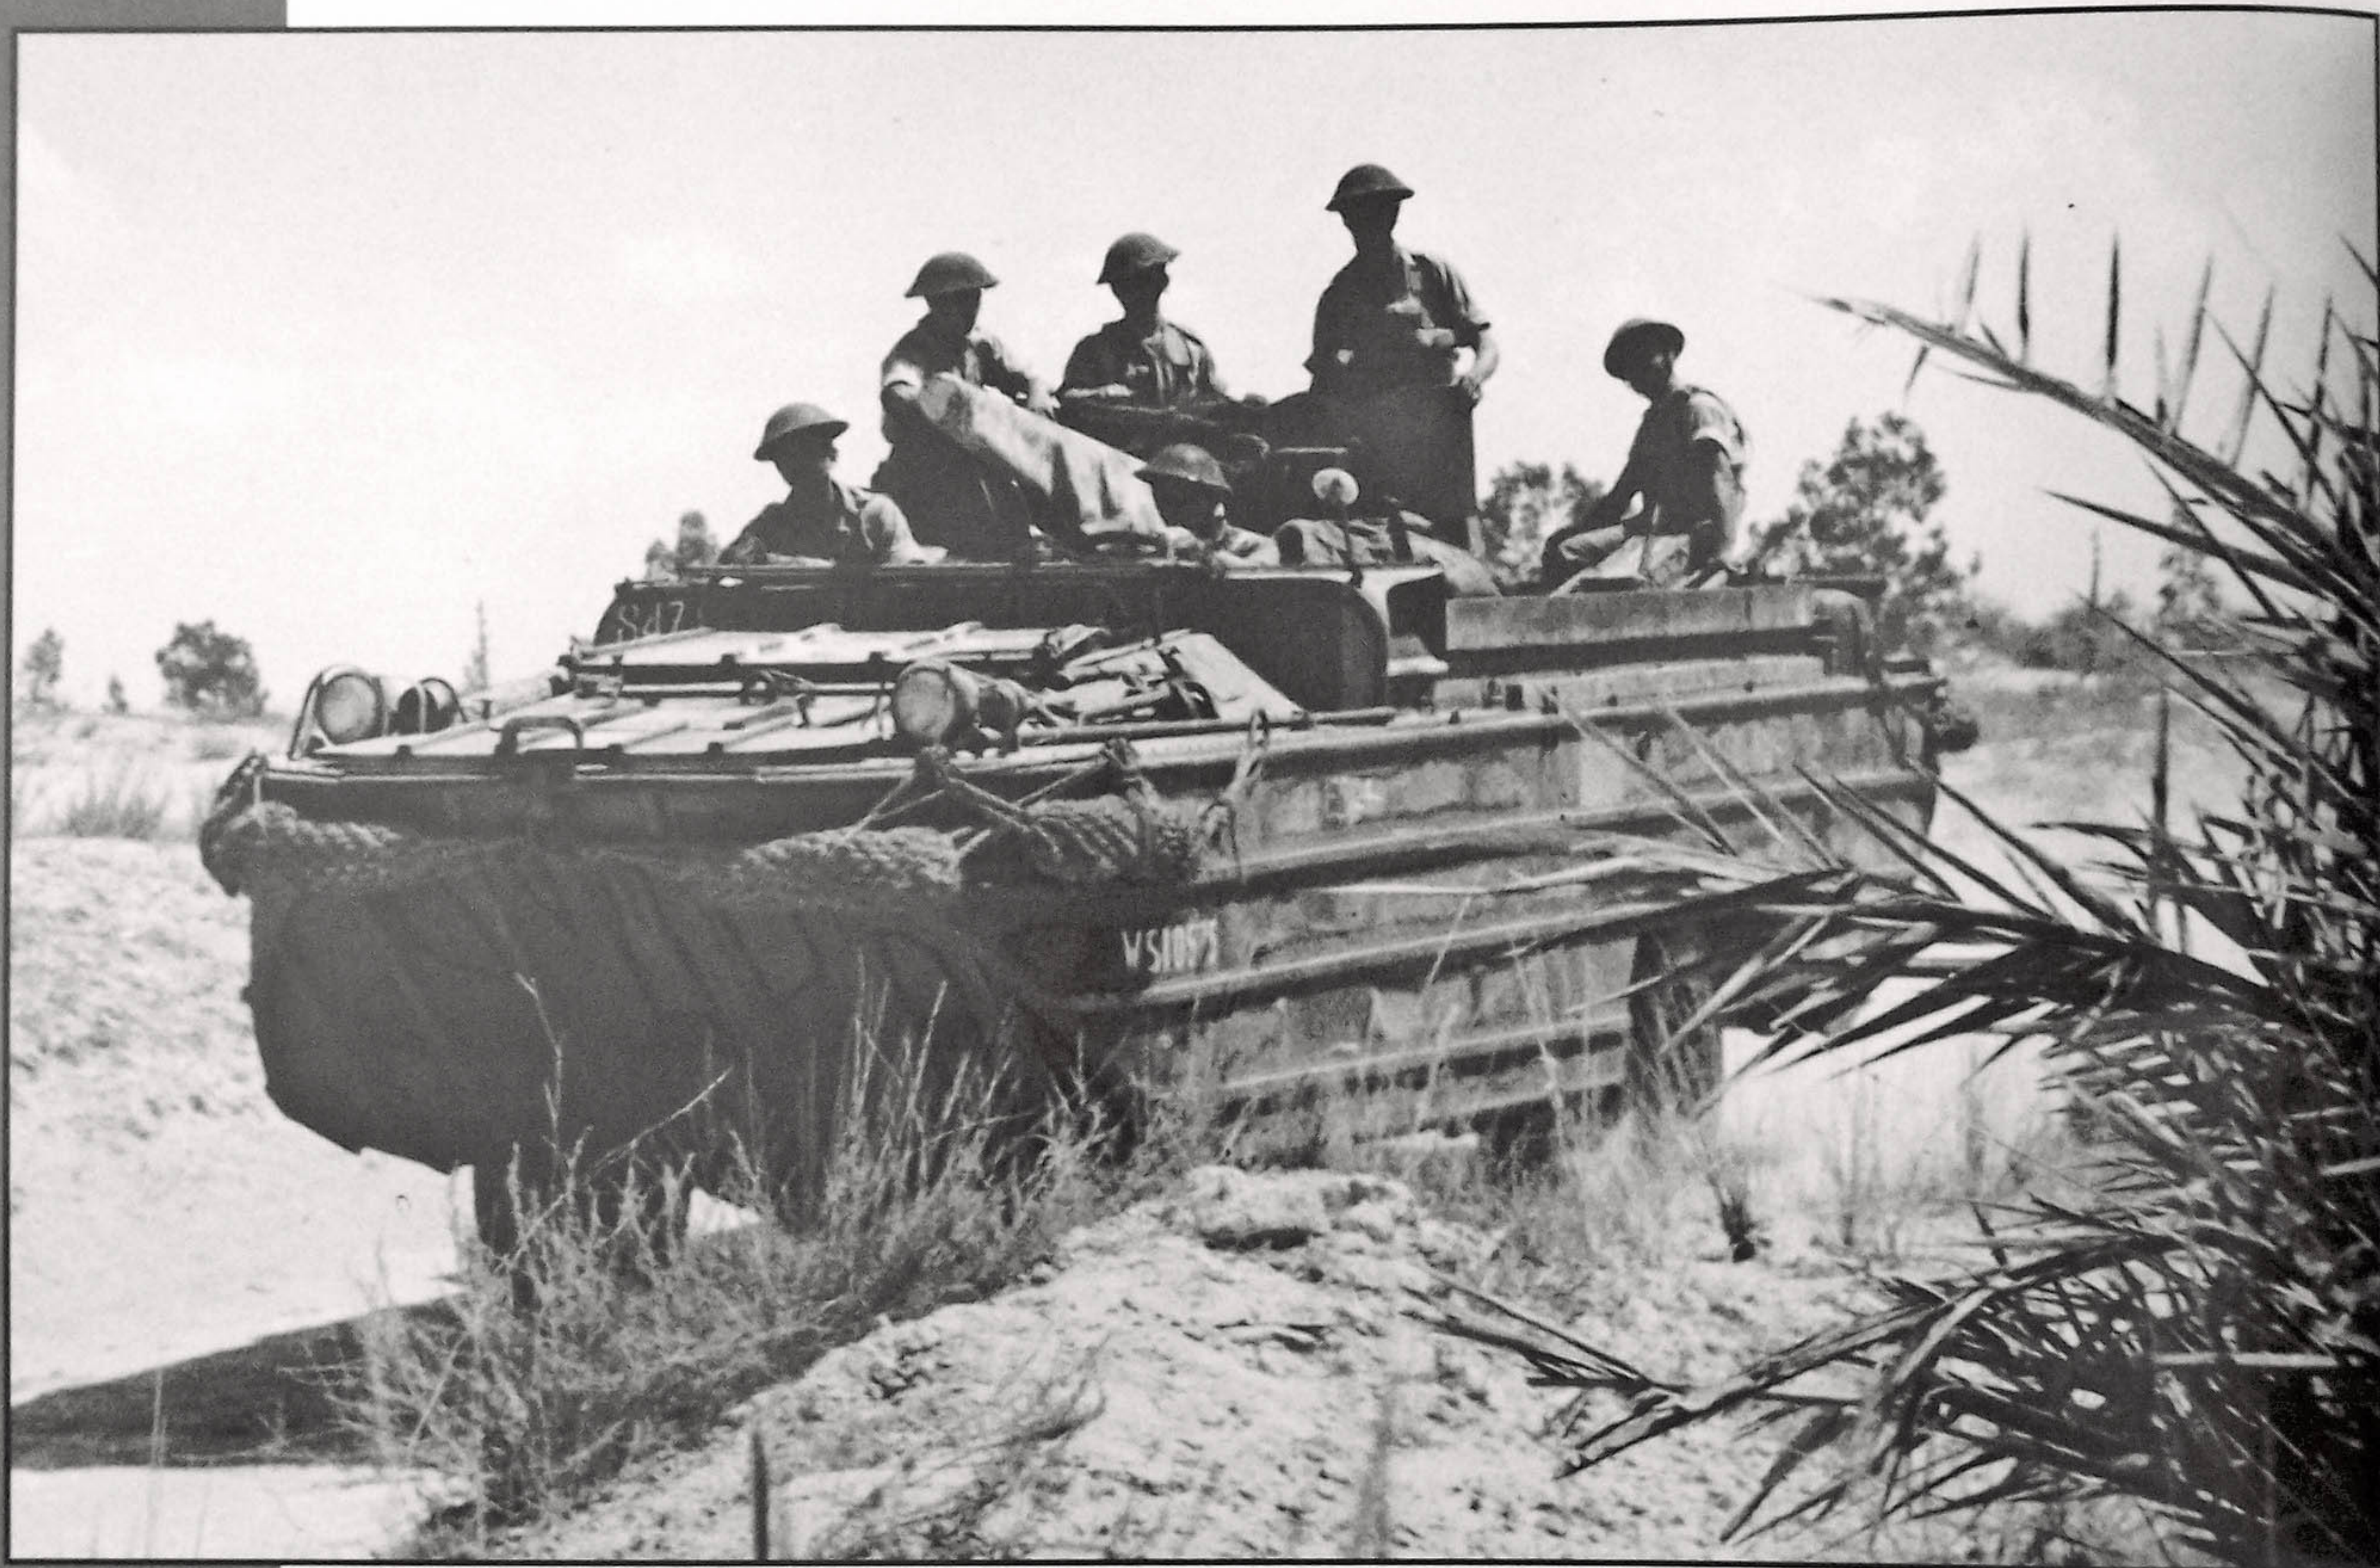
**Above:** another of the British test vehicles participating in invasion exercises for the upcoming Sicilian operation. The W-S serial number is interesting. This Duck is numbered sequentially with the vehicle on the previous page and it also is loaded with a 6-pounder. The gun would still have to be lifted out of the cargo compartment with a crane. One of the major drawbacks of the Duck was that it was not equipped with a loading ramp. The designers felt that the addition of a ramp would compromise the vehicle's watertightness (IWM).

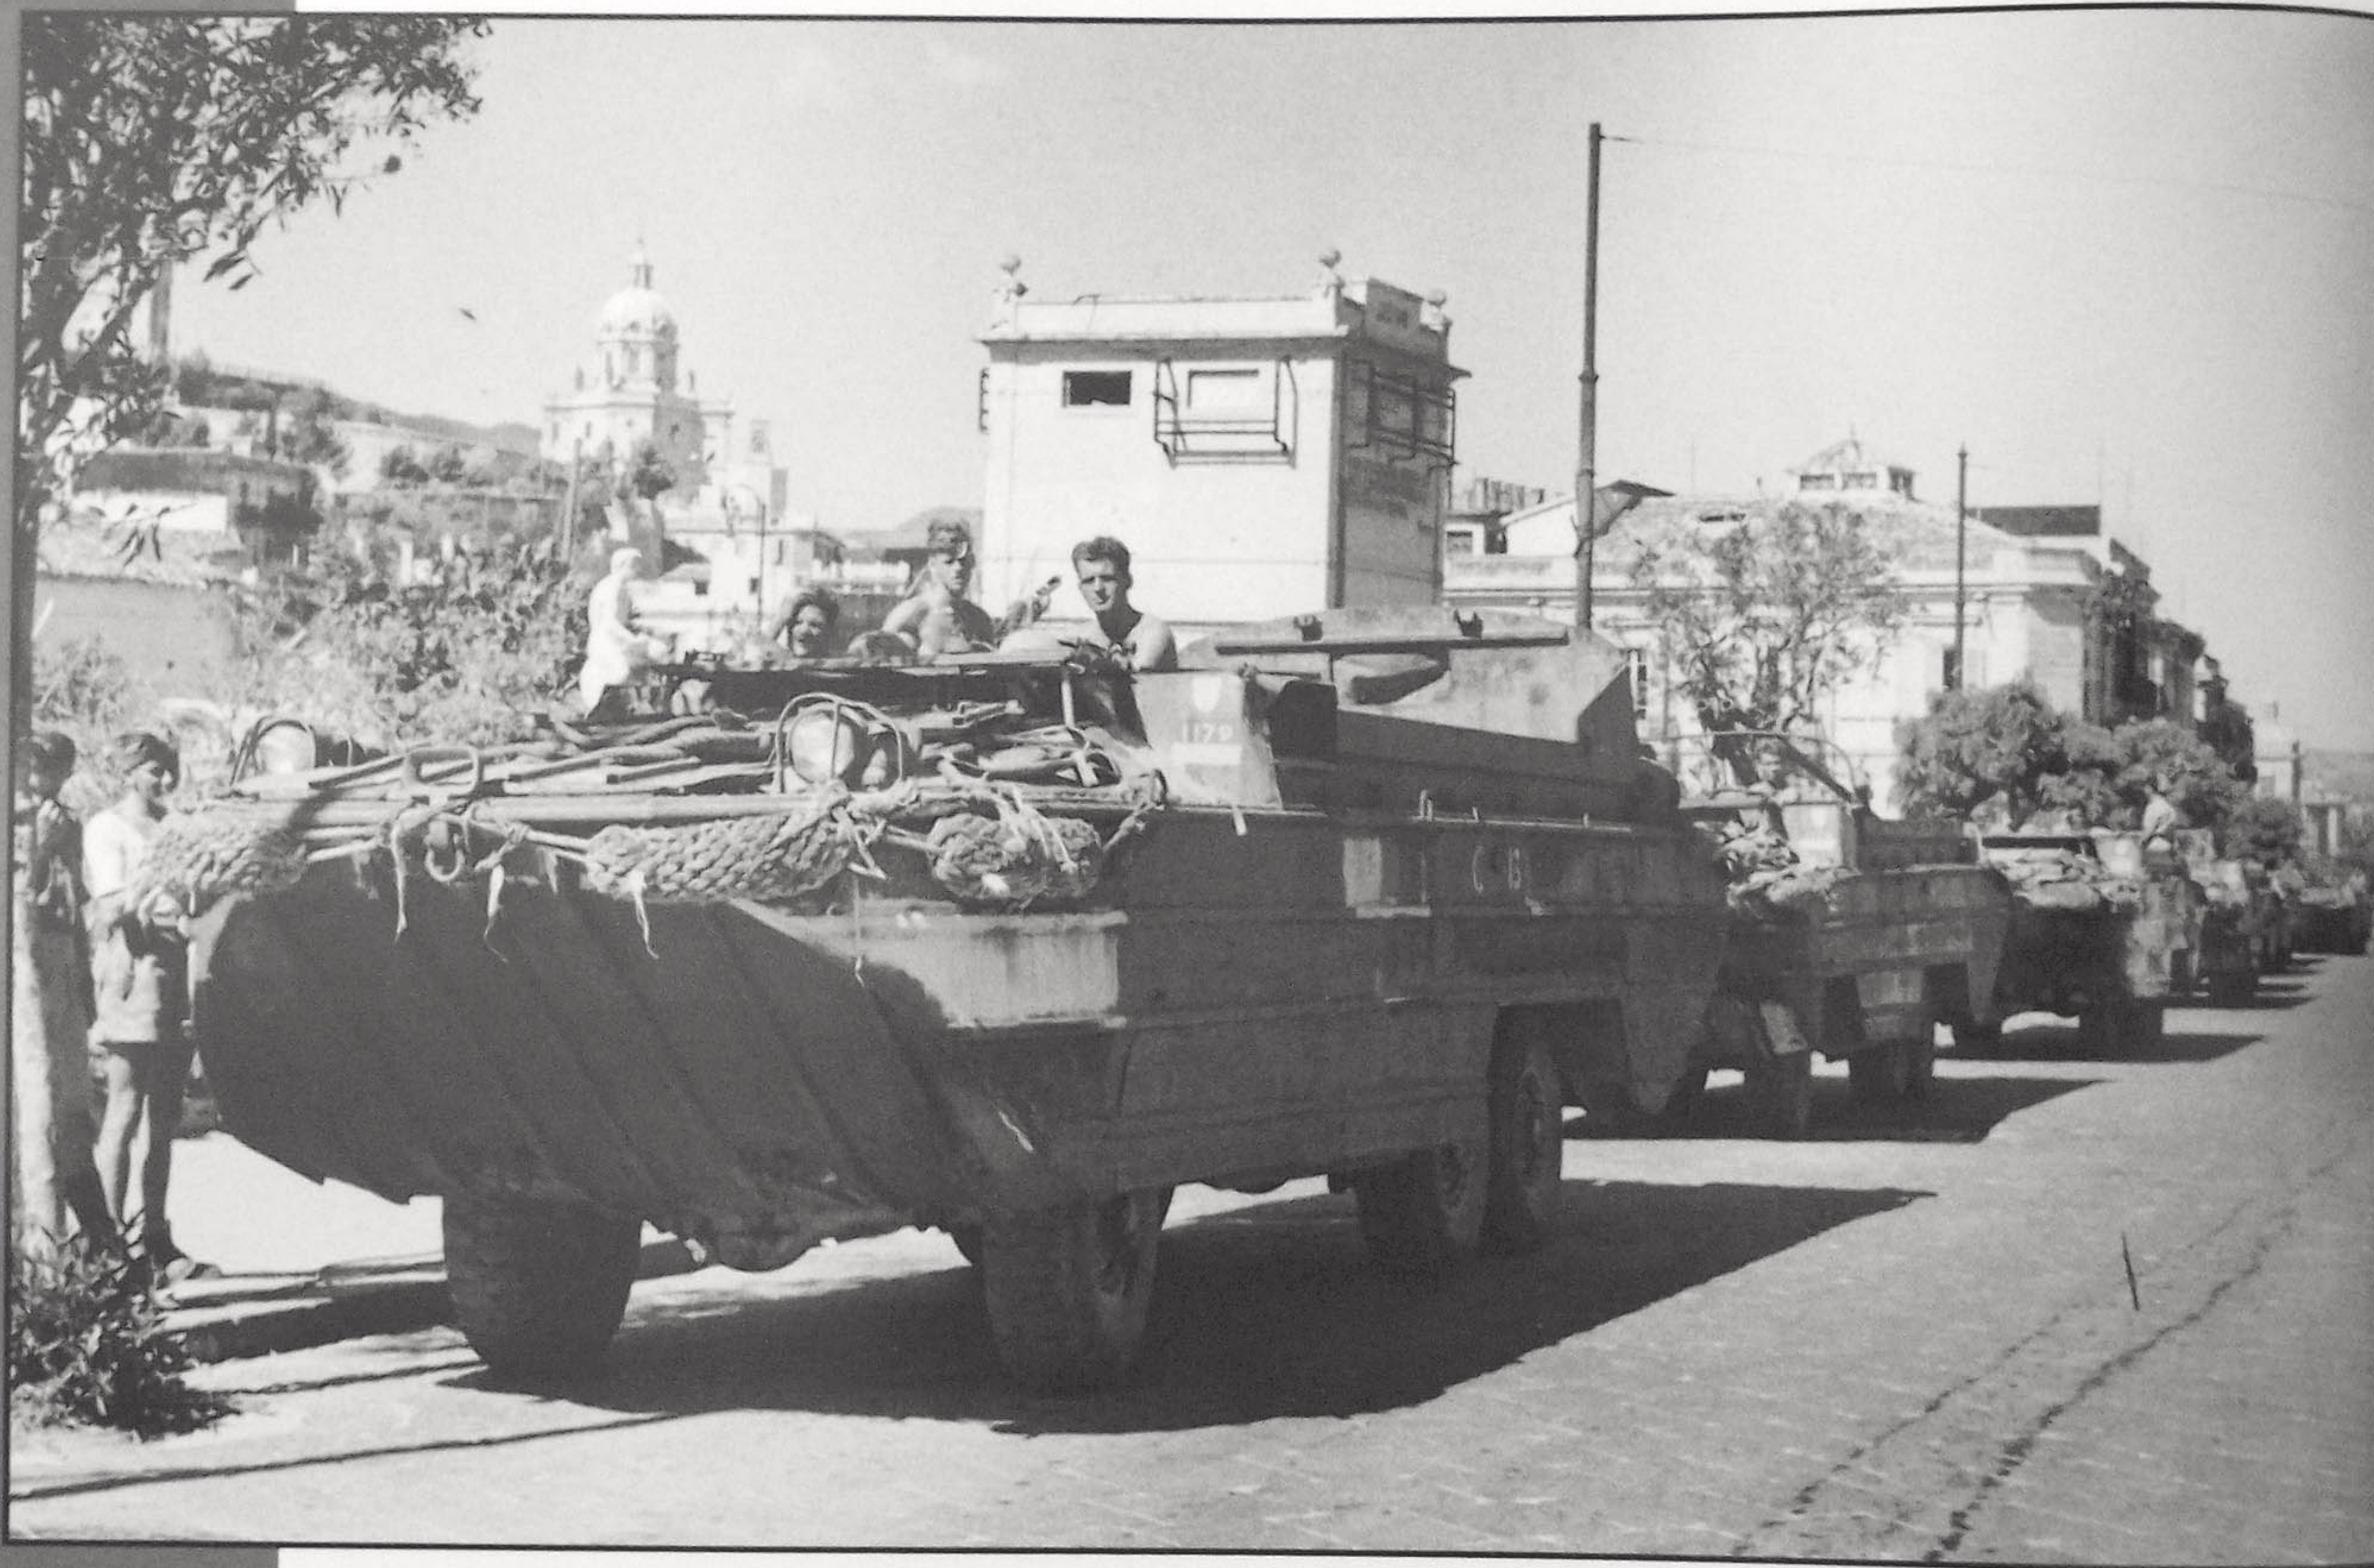
**Above:** taken on July 9th, 1943, this shot shows a line of British Ducks waiting to take on a load of palletized five-gallon fuel cans. These Ducks are transporting supplies between the Sicilian port of Messina and the Italian mainland. The forward-most vehicle has its rear splash shield in place. This served to prevent water from splashing back into the cargo compartment and was also the rear support for the cargo bed canvas cover. This shot provides an excellent view of the front rope bumpers and davits. Note also that none of the vehicles seen here have their rear wheel fairing in place (IWM).

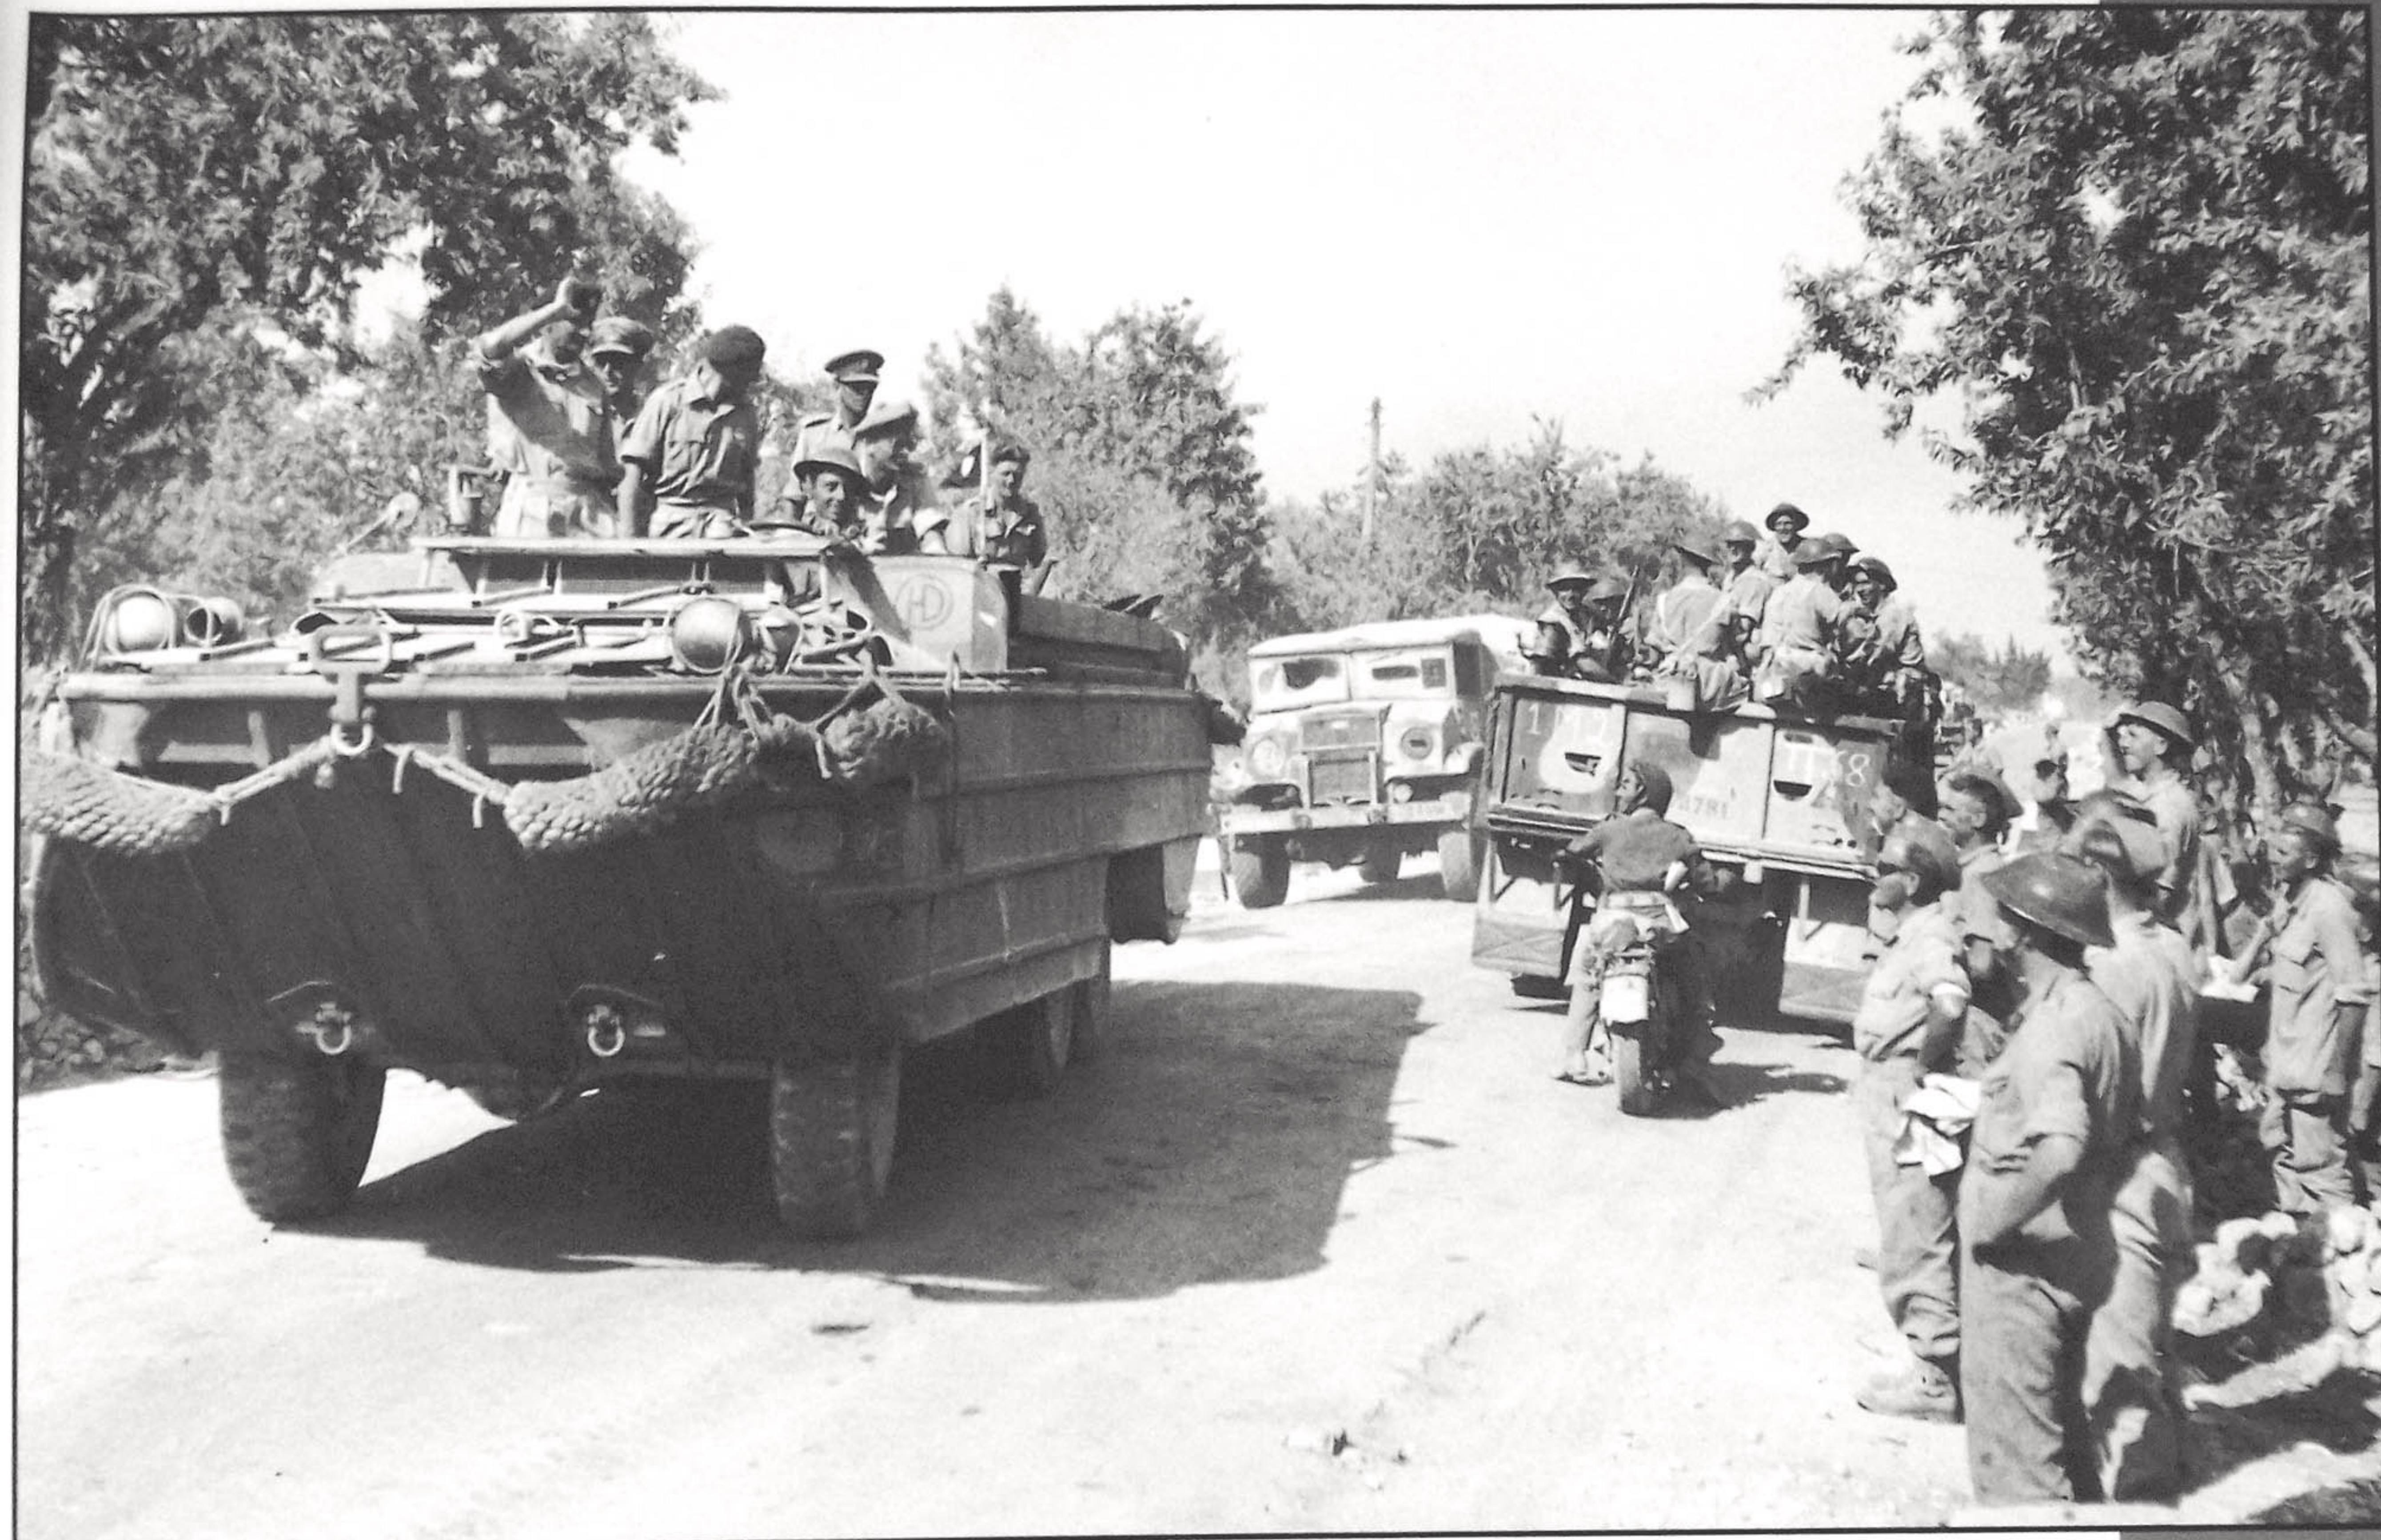
**Above:** British General Montgomery uses a Duck while touring of the troops in early July, 1943. This photo was taken on July 12th while Monty was on his way to visit Lord Louis Mountbatten in Syracuse, Sicily. The Duck has a number of interesting features. It contains the "HD" marking indicative of the British 5th Infantry Division on the driver's bulkhead. This division was attached to the 8th army at this time. The lower front end of this Duck is particularly well lit and the lower tow shackles and their enclosures are visible (IWM).

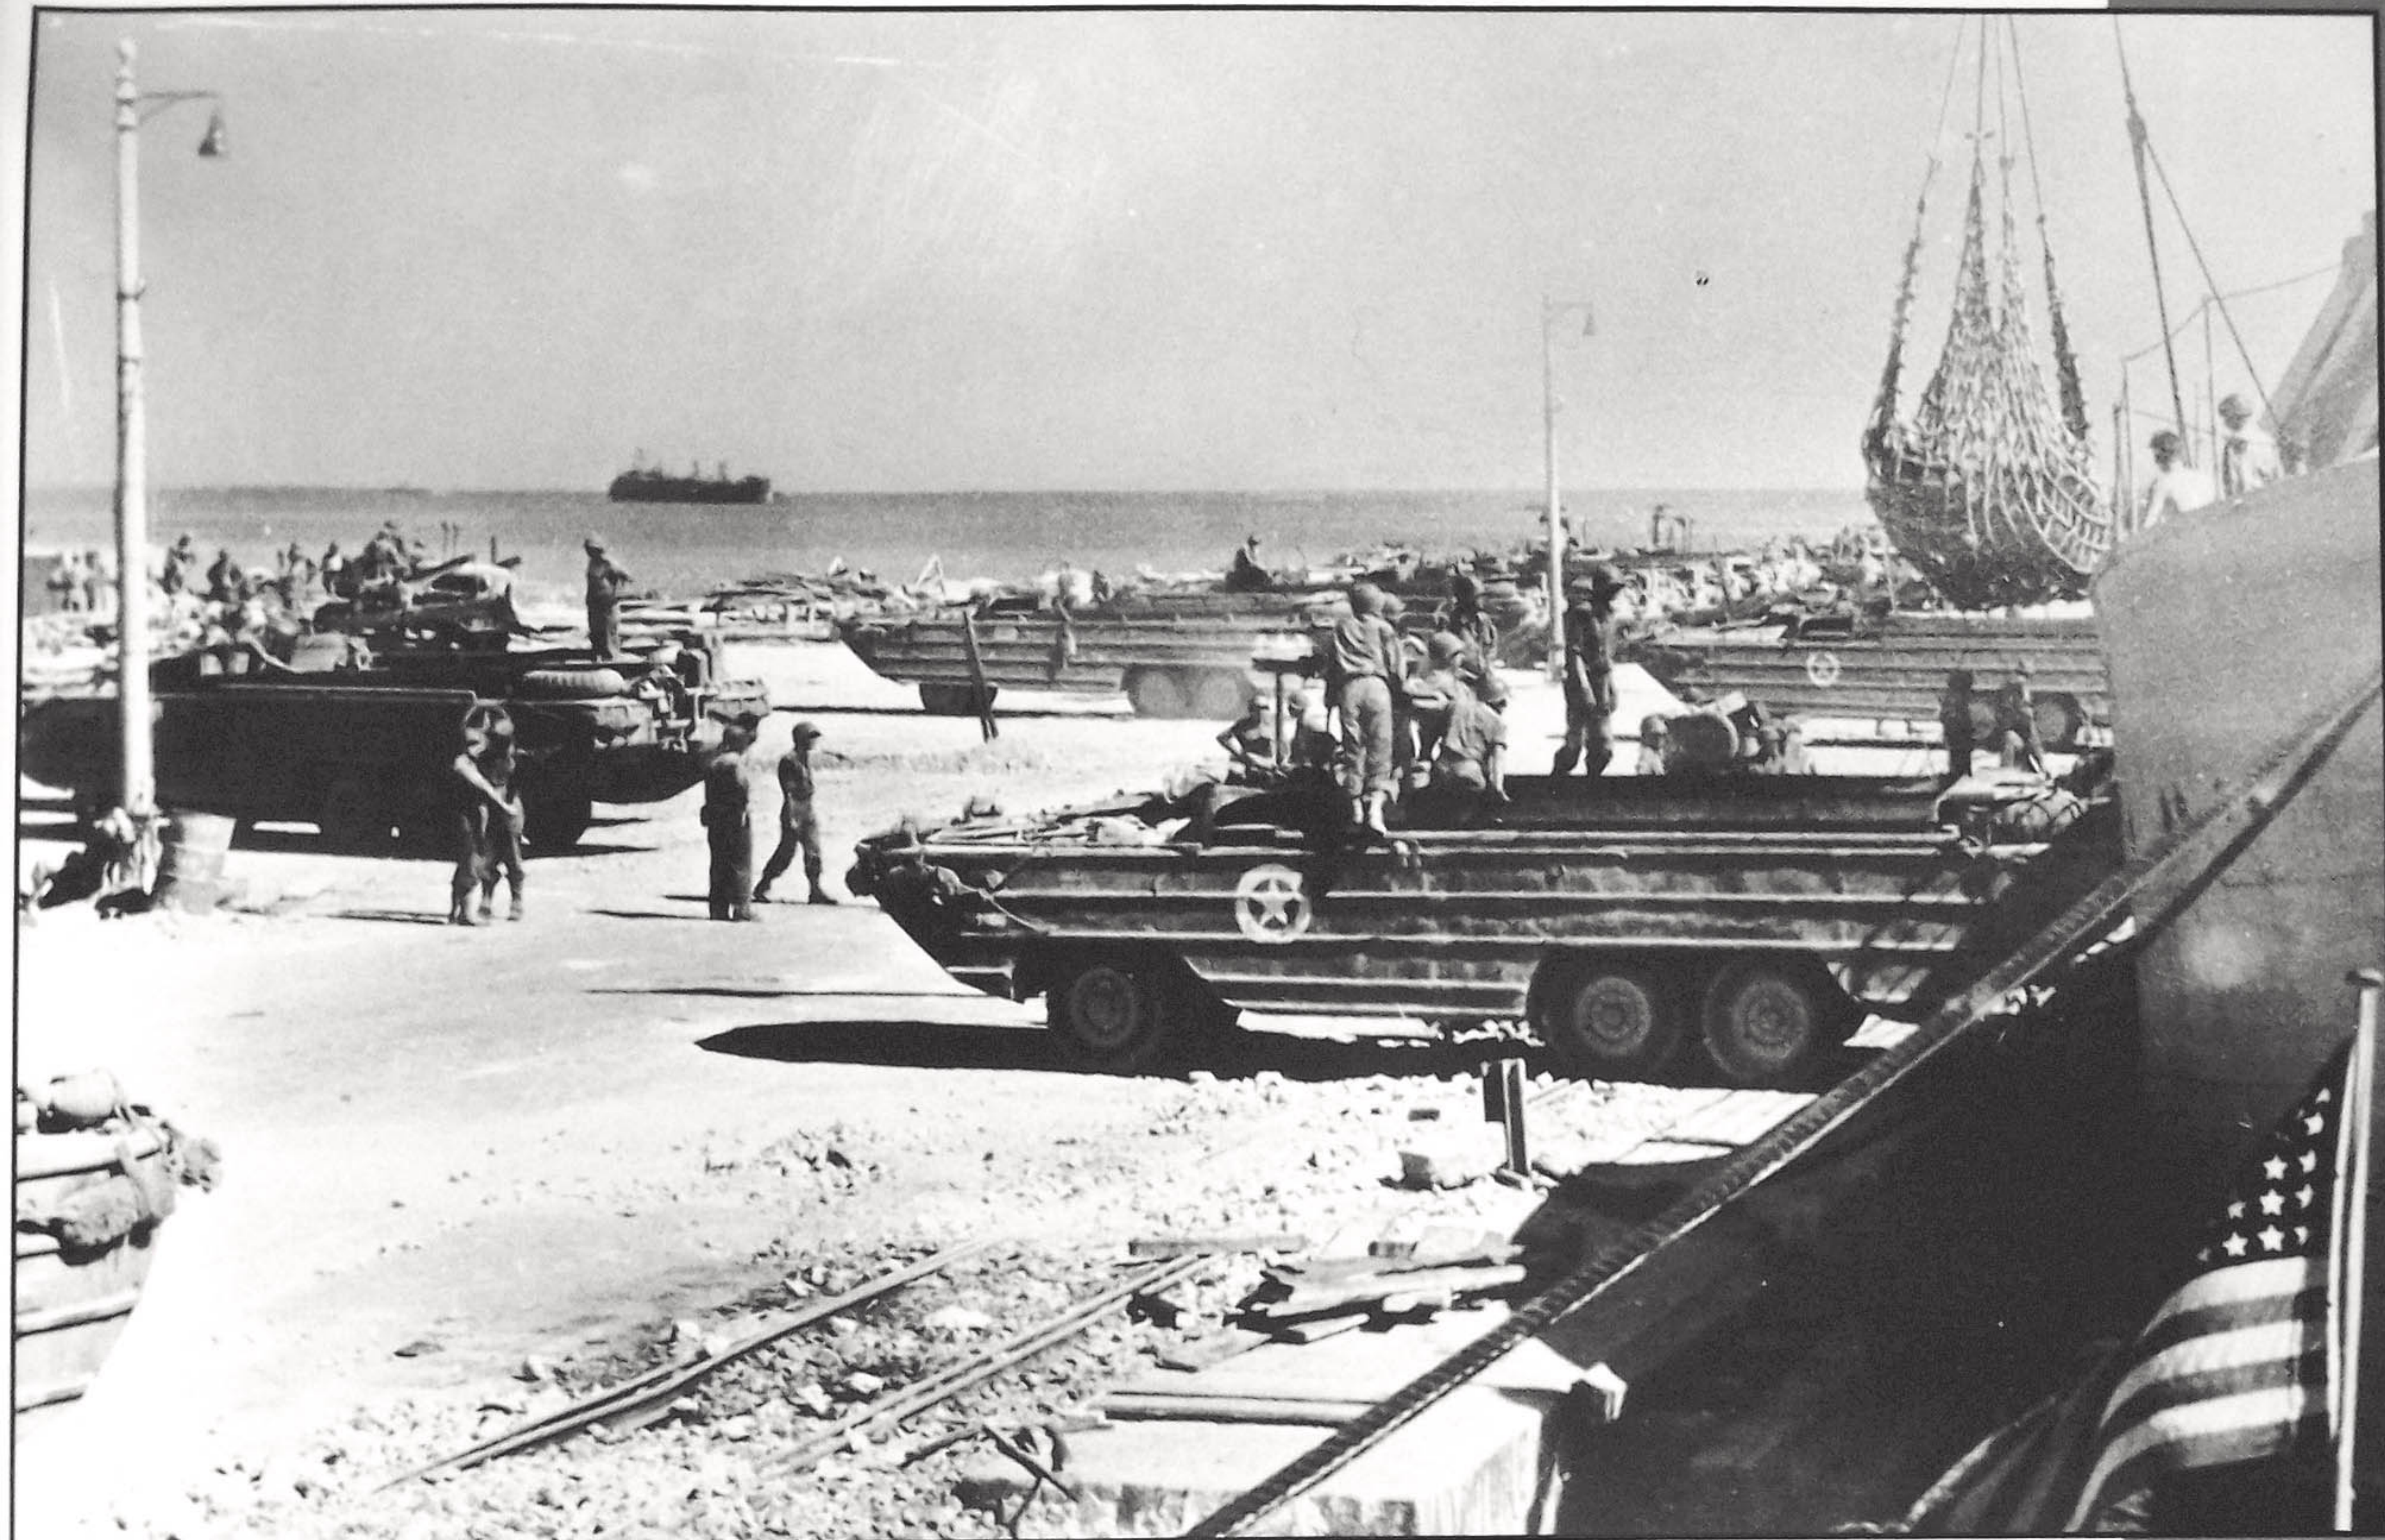
**Above:** prior to the invasion of Southern Italy in late August of 1943, the harbor facilities at Reggio, Italy were heavily damaged by the retreating Germans, making them ineffective for use with ships. This was a role in which the Duck shined. Shortly after capturing the town, engineers cleared ramps in the harbor to allow the Duck to run in and out from the harbor. Here, a U.S. registered Duck makes its way to one

of those ramps. This photo shows how much the draft of the Duck increased when it was not loaded. Compare this with other photos of fully loaded vehicles. The lack of freeboard was not a hindrance in the balmy warm weather conditions of the Mediterranean, but it would be in the rougher seas of Northwestern Europe (IWM).

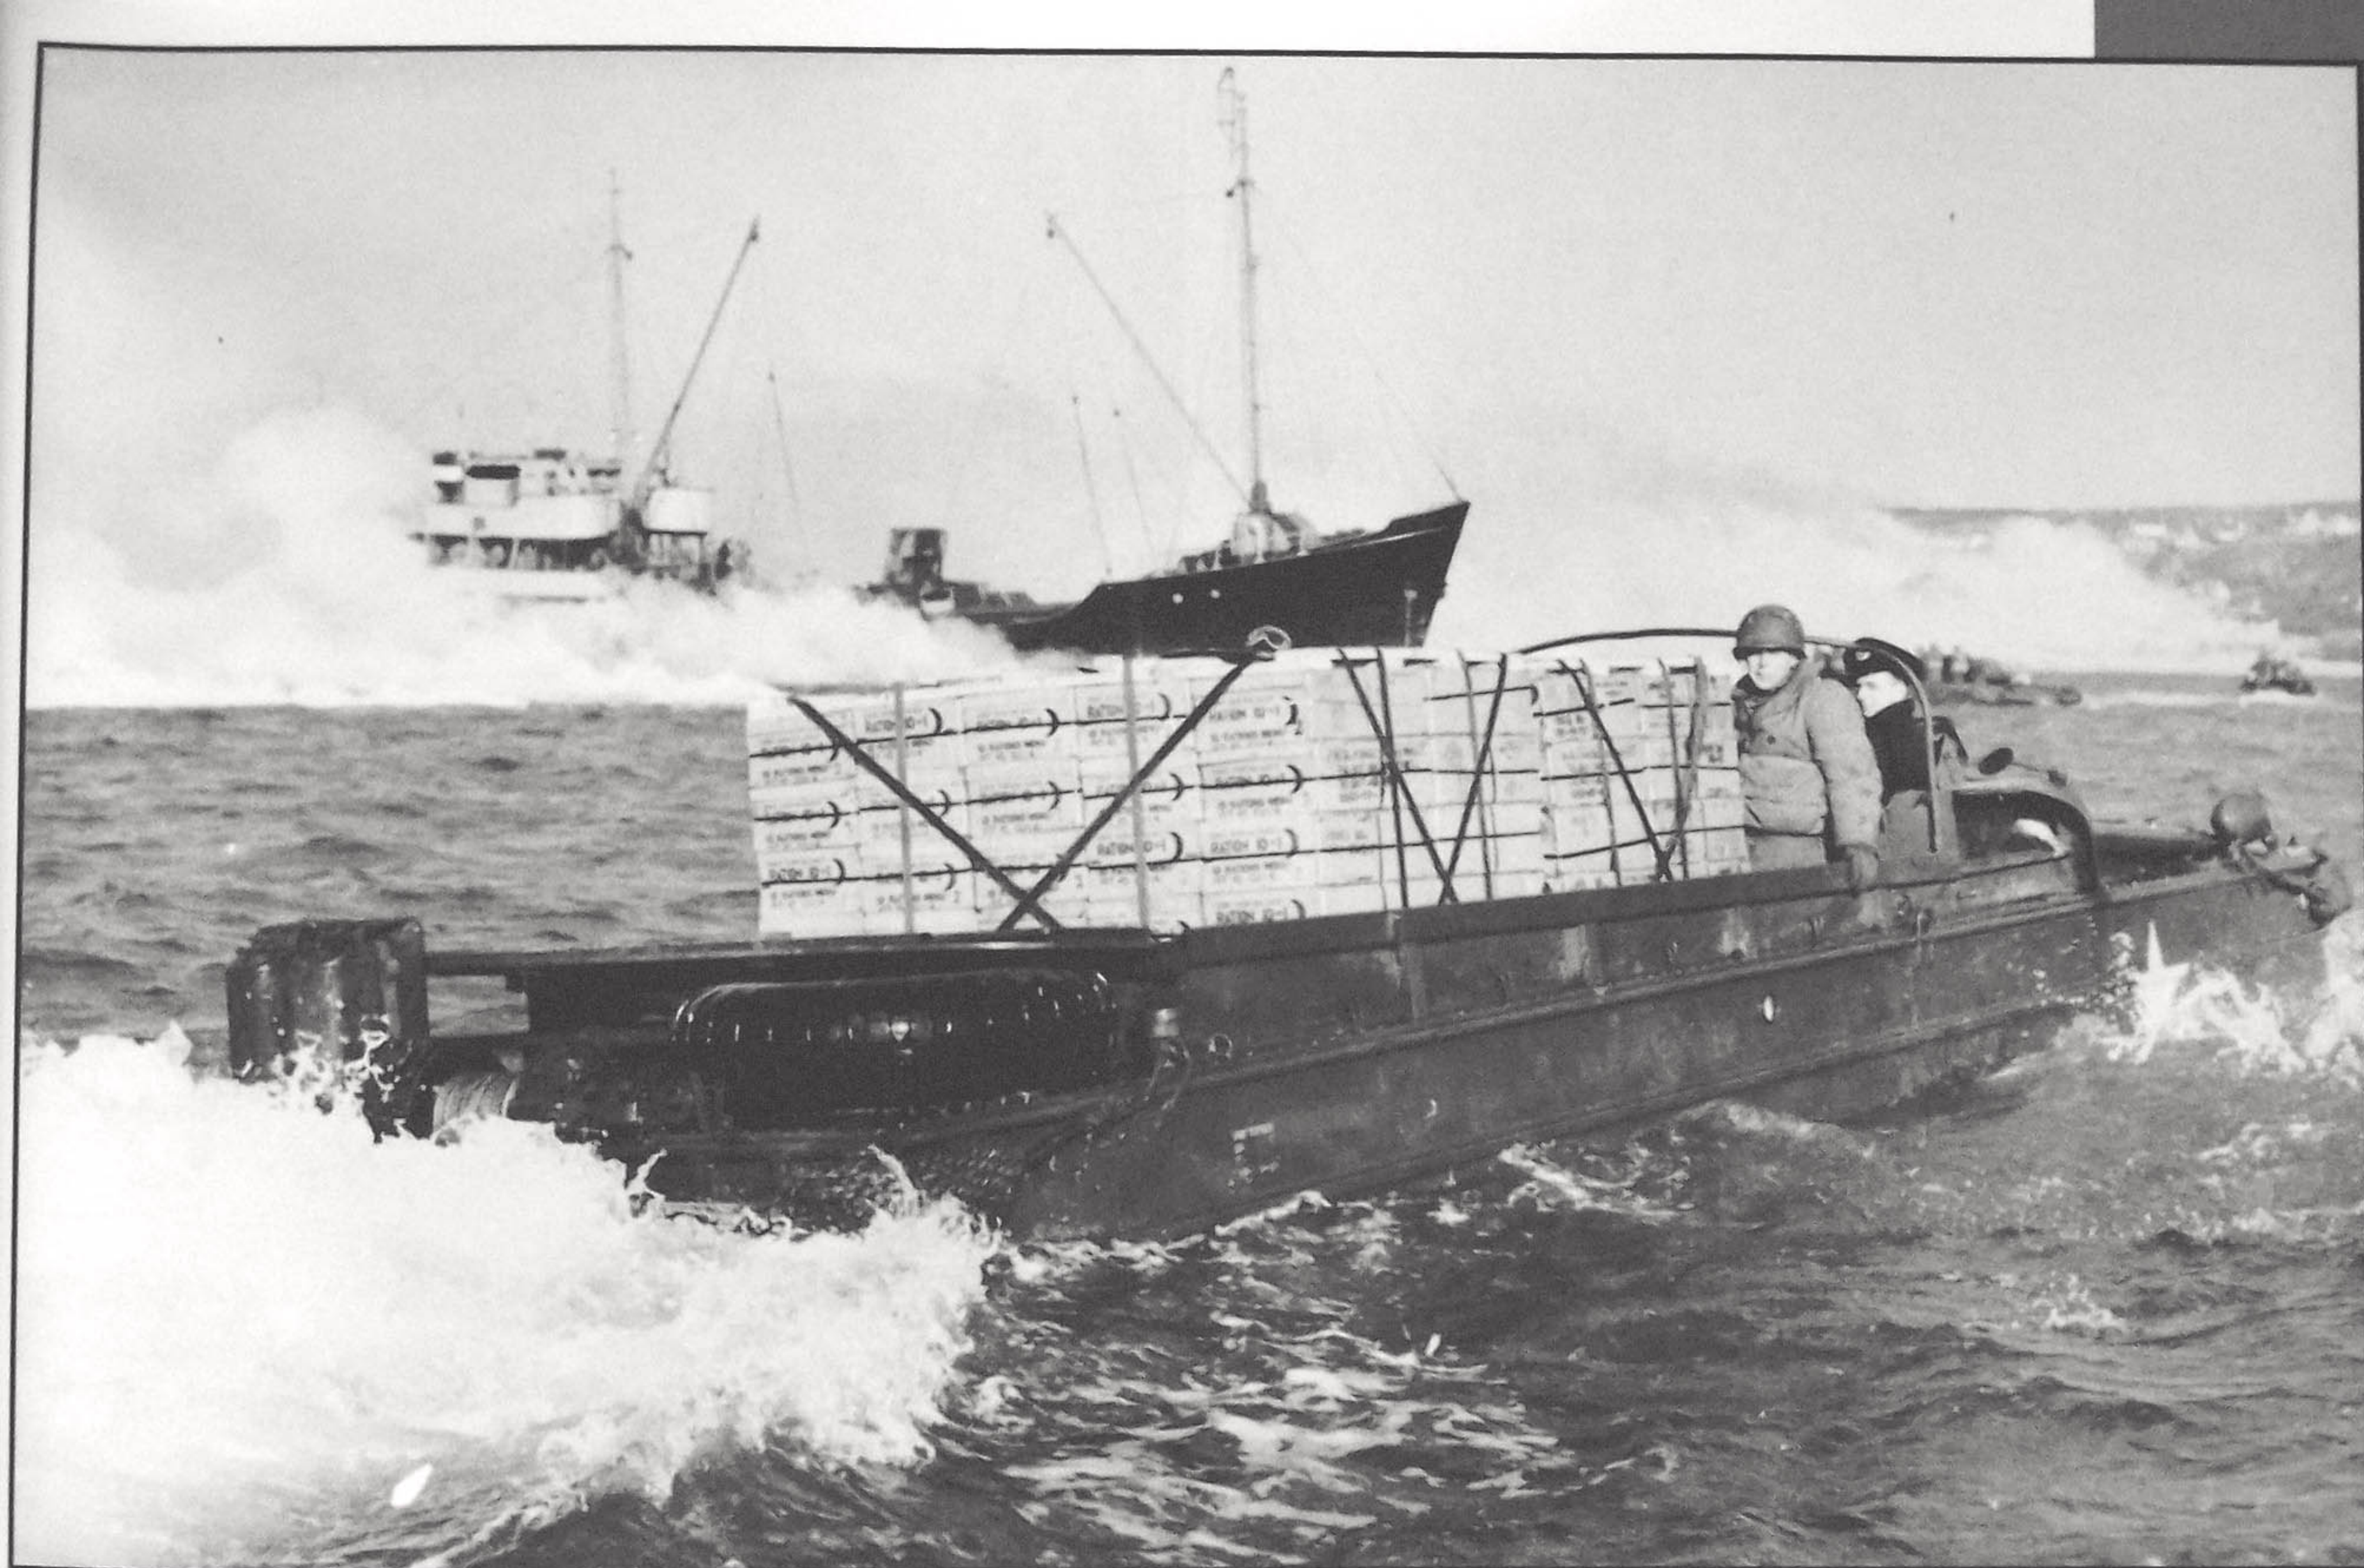
Prior to the Normandy landings, there were several practice exercises to work out the wrinkles in not only combat landing procedures, but also cargo landing procedures as well. Here, Ducks off-load a cargo of C-rations from a Liberty ship anchored off the southern coast of England. This photo was taken from another Duck and it shows how little freeboard the Duck had while fully loaded (IWM).
