# Allied-Axis

THE PHOTO JOURNAL OF THE SECOND WORLD WAR

**German  
SIG 33/1  
Grille SPG**

**Kleines Kettenkrafttrad  
WWII Dodge 3/4-ton trucks  
DUKW Amphibious truck**

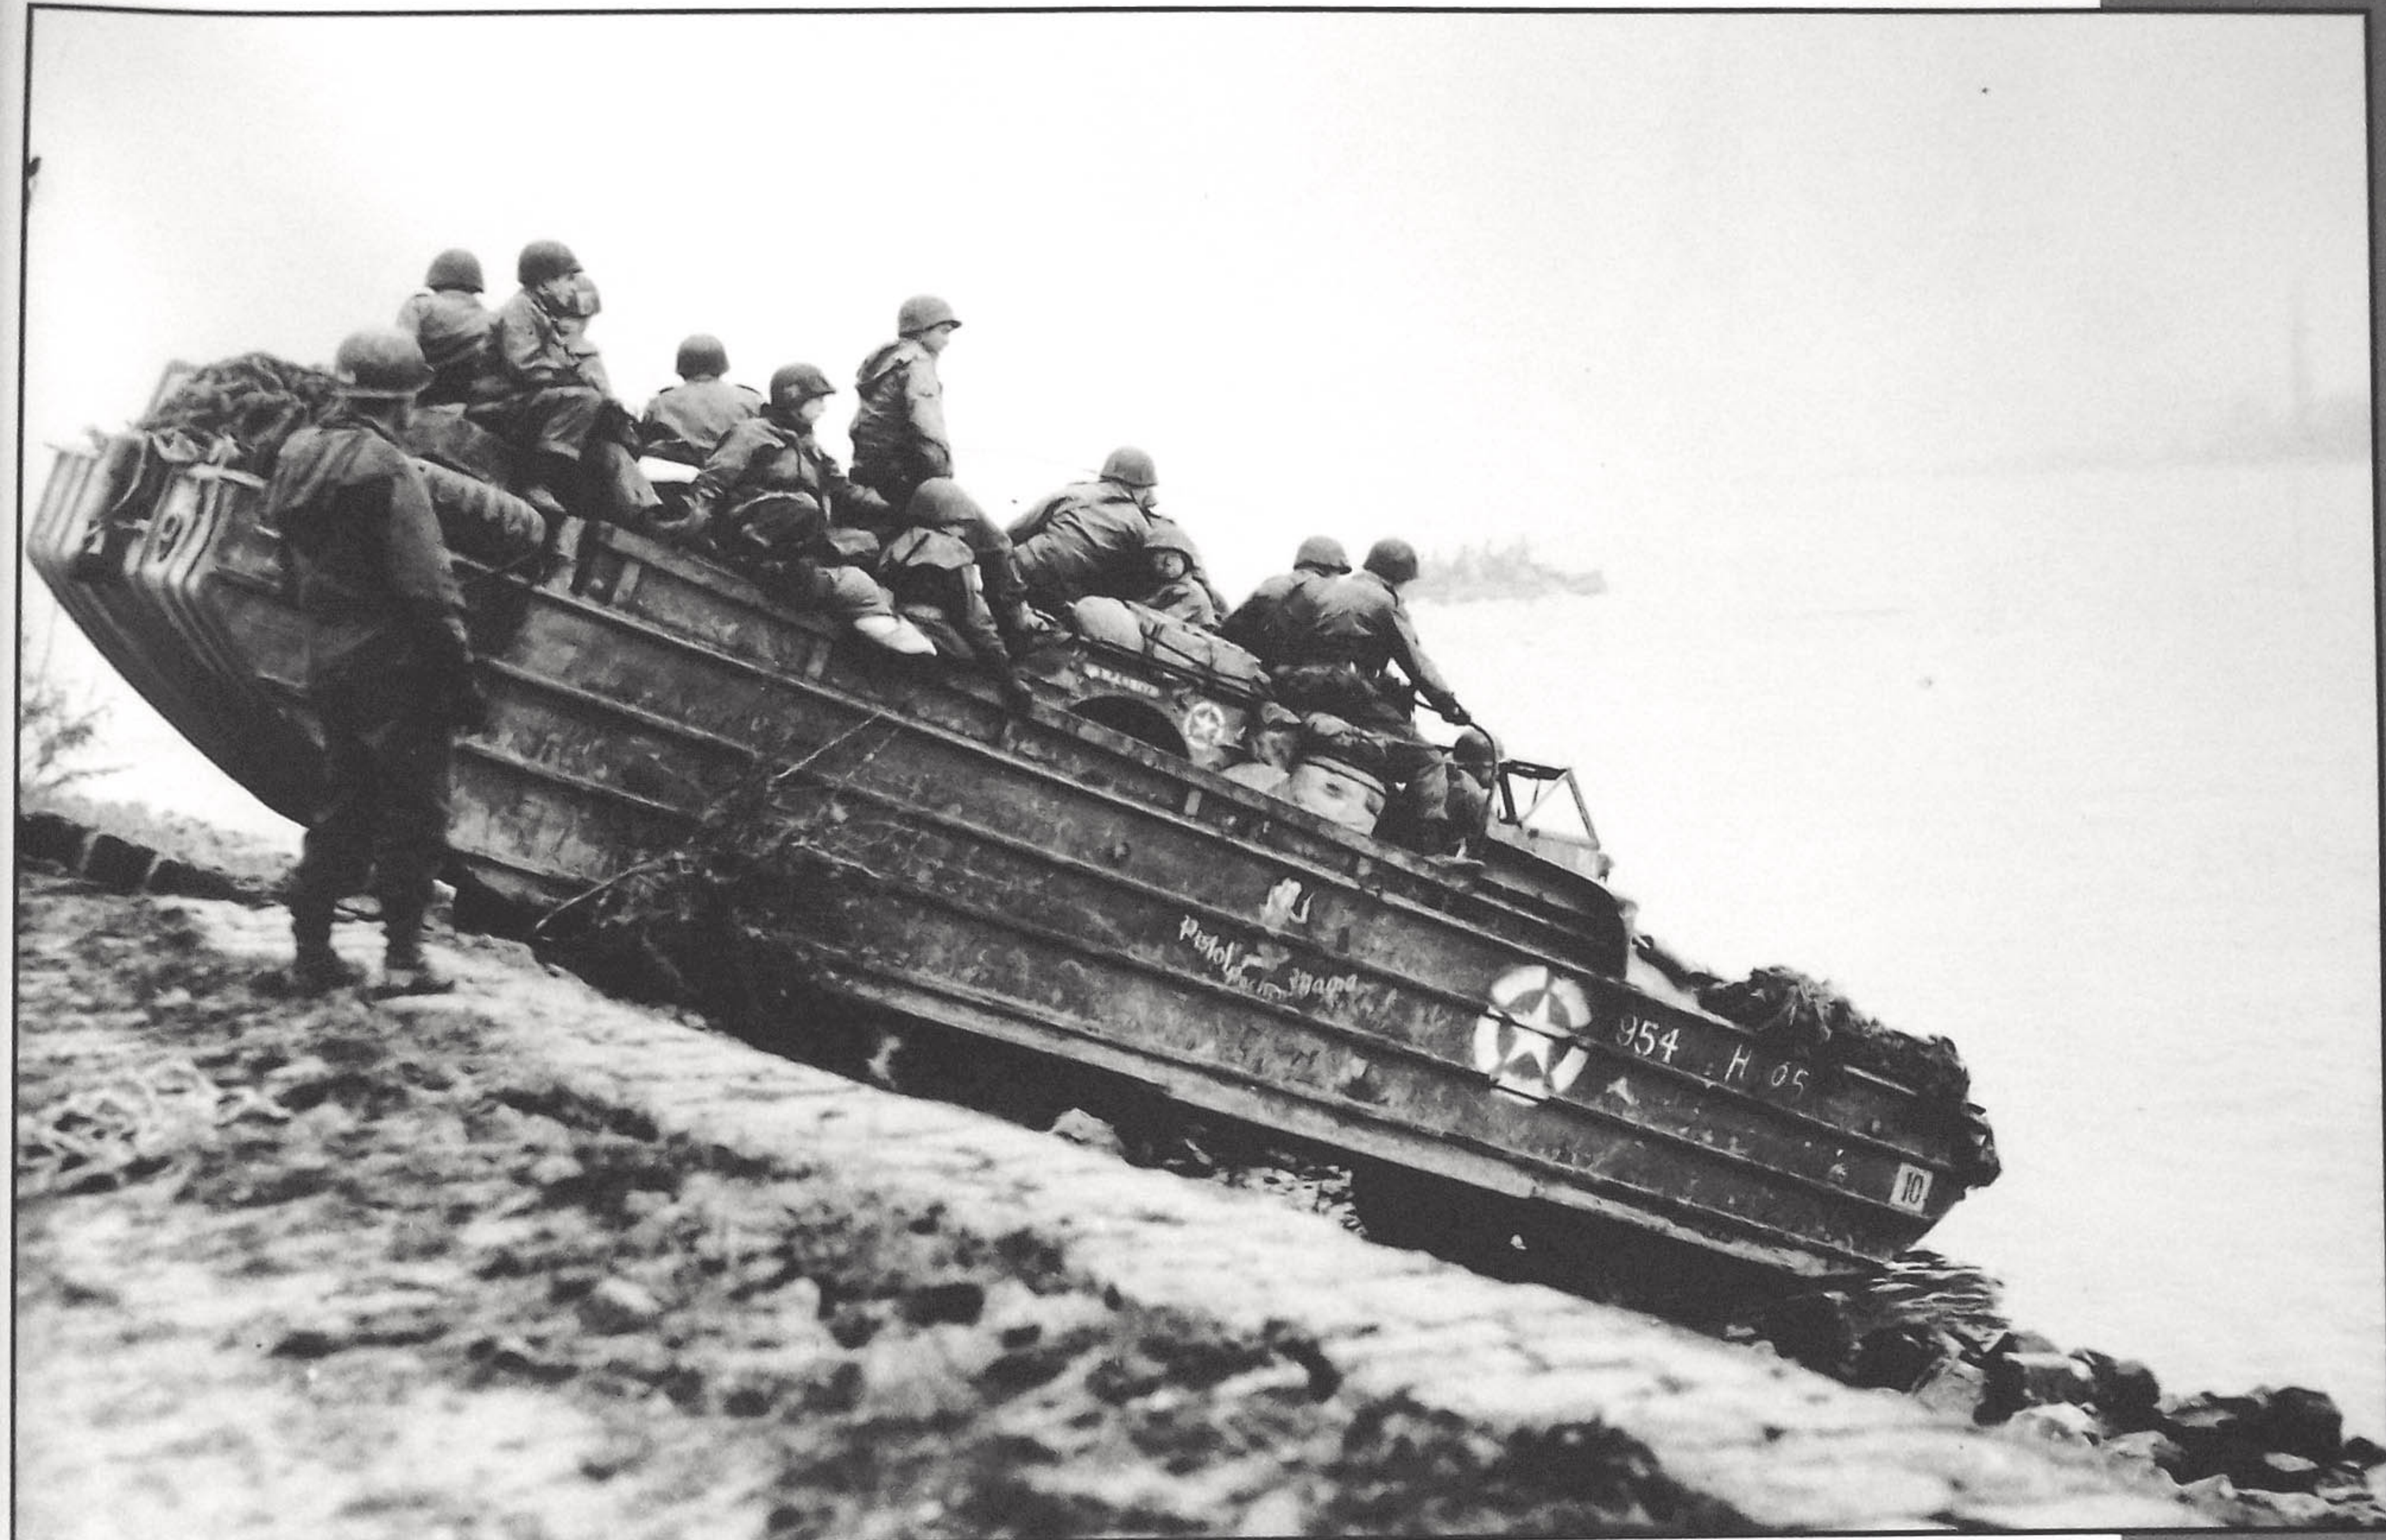
**Above:** another Seventh Army Duck slides into the Rhine. The considerable size of the cargo here and in the other photos strongly indicates the presence of a crane or a hoist near the loading sight. The lack of a loading ramp, such as that installed on the LVT-3 and LVT-4, meant that cargo such as the Jeep seen here, needed to be lifted in and out of the vehicle. After 1943, approximately one in five Ducks

were equipped with an A-frame lifting jib. This consisted of two steel tubes joined at the top and supported by cables attached to the body of the Duck. This was installed over the rear winch so that it could be used as a power source. This vehicle, as well as the others in the sequence, contains large and elaborate name artwork (NA).

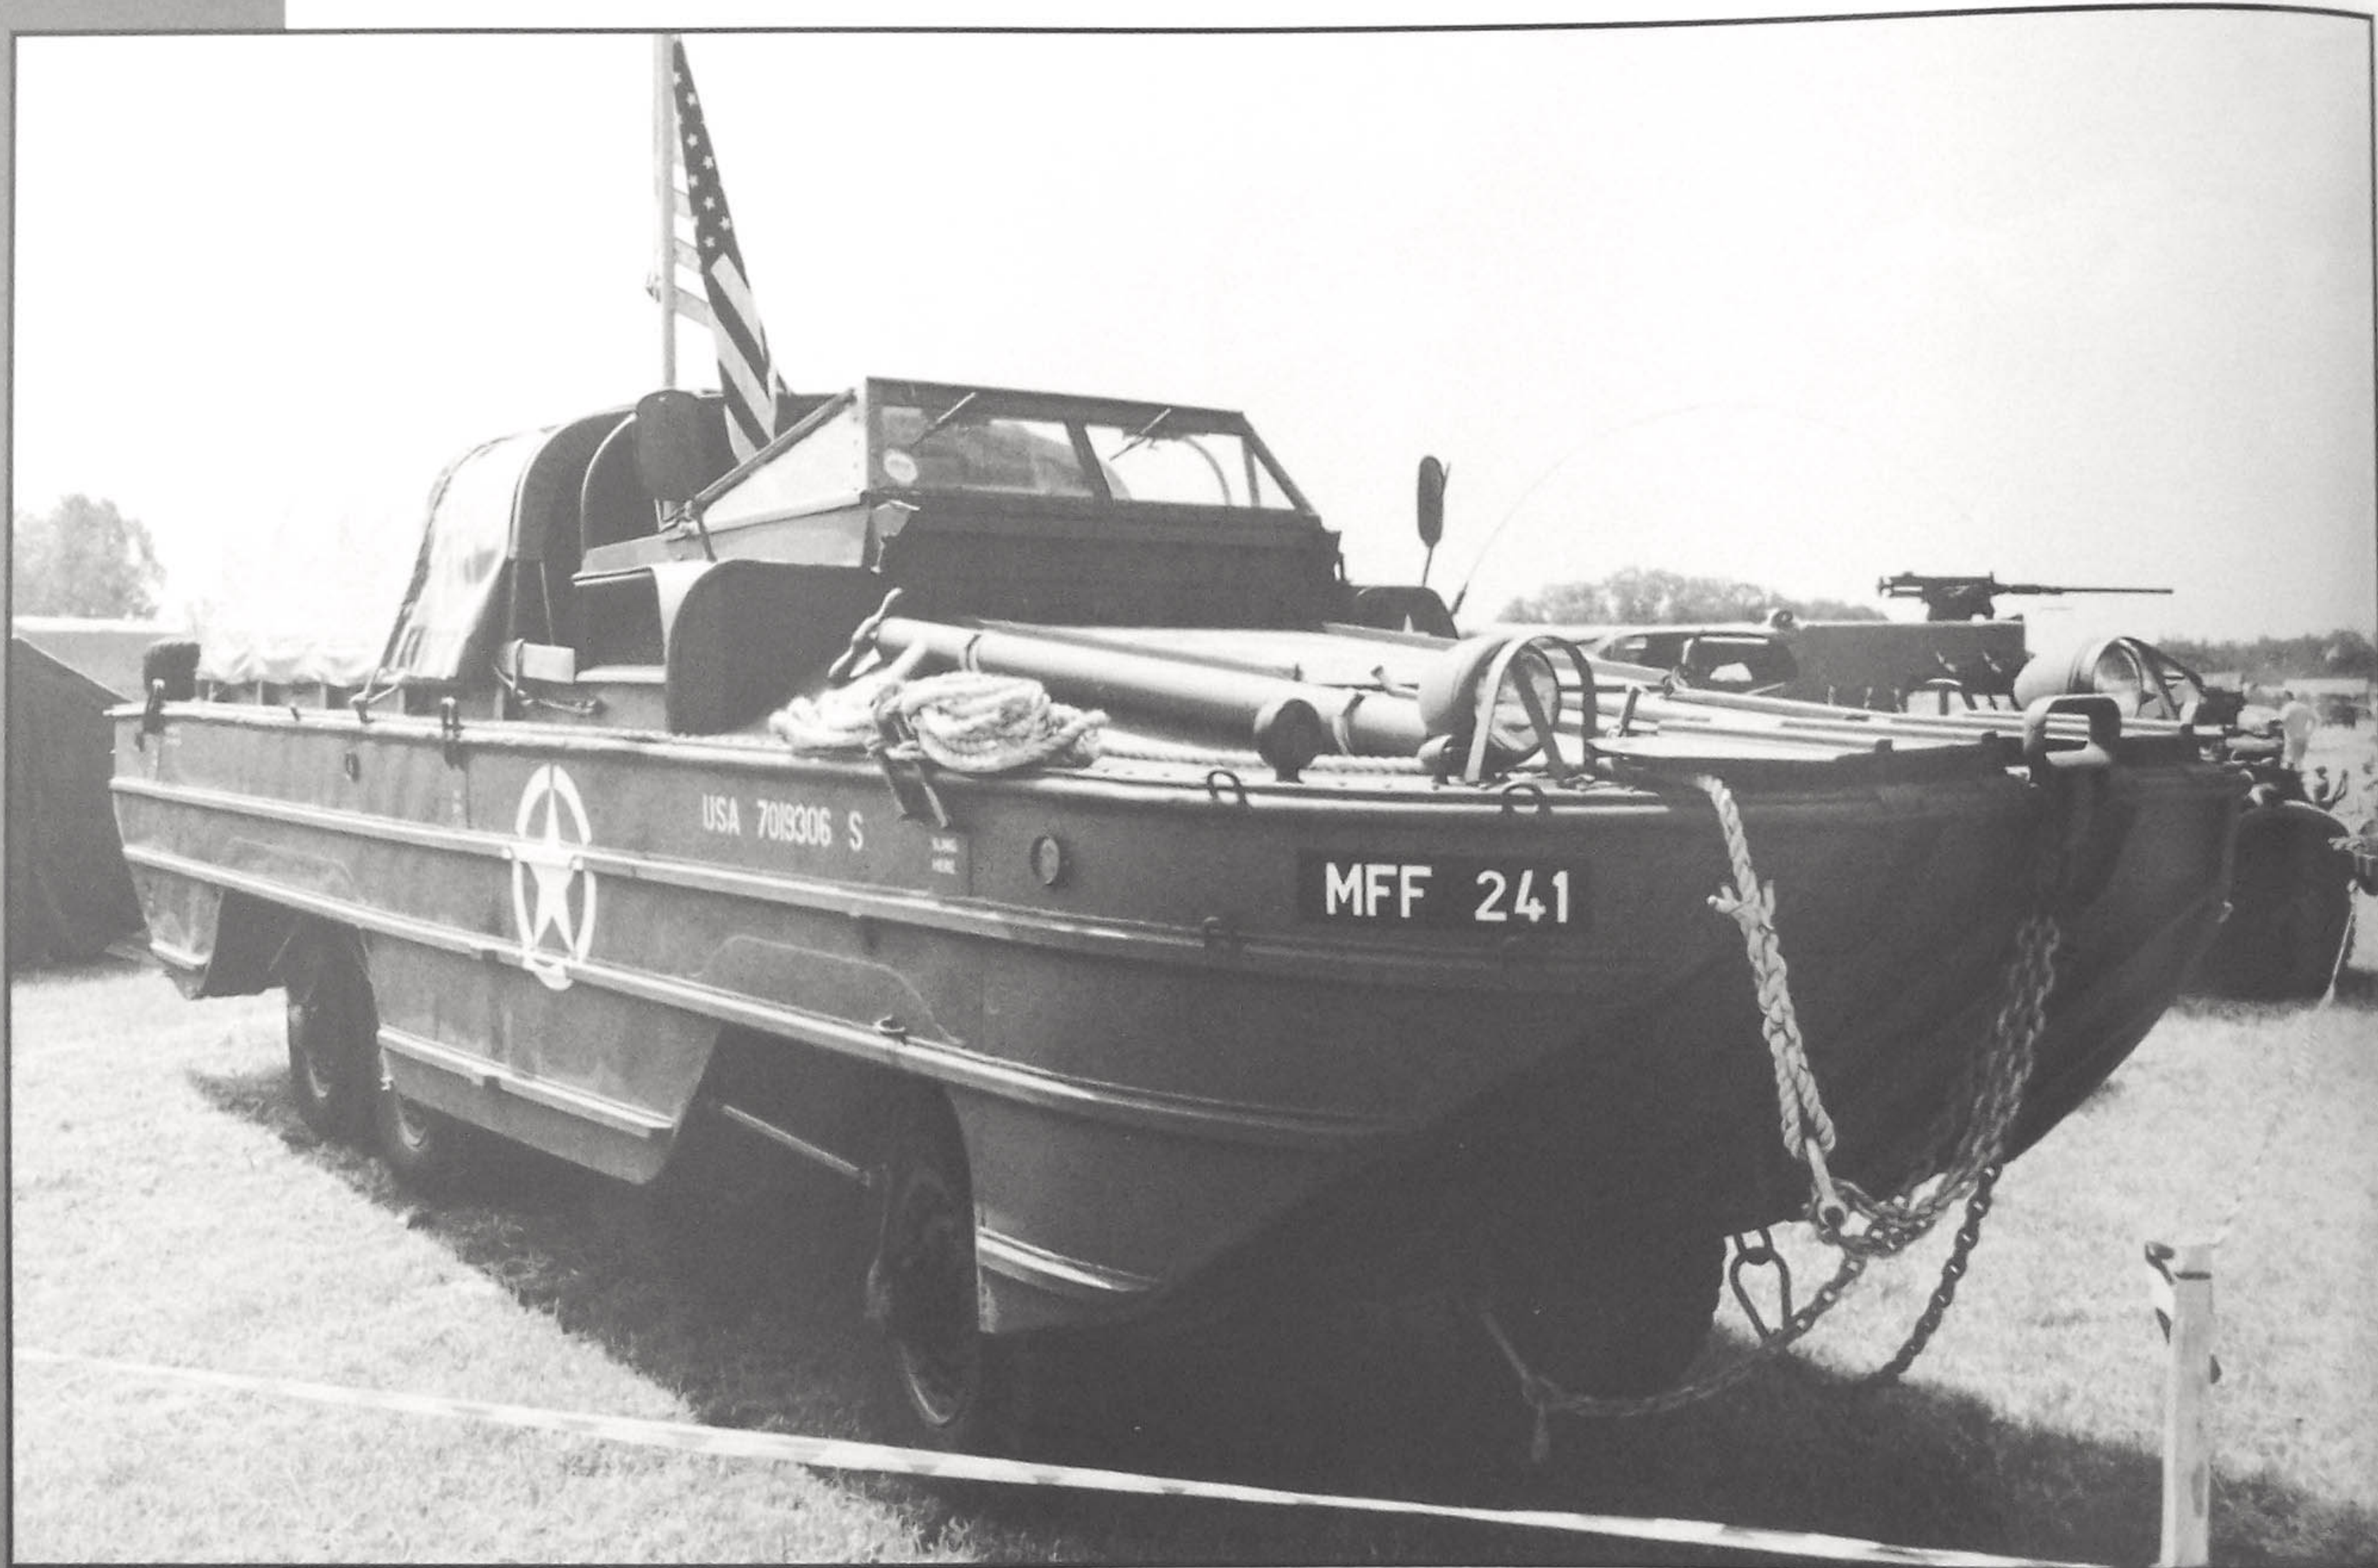
Over 21,000 Ducks were produced during the war for the U.S. Army and Marines as well as lend lease. Thousands of Ducks survived the war to see service with NATO armies, where they continued to be used extensively. The British only retired their Ducks in 1974. The French Army and the Mexican Army are known to have relinquished their Ducks as late as 1980! Ducks were also popular with civilian authorities involved in water rescue and some of those remained in service into the 1990s. **Above:** this is a Duck owned by a private collector in the UK. This vehicle was purchased from the French Army and extensively restored. It is a later pattern Duck, note the presence of the air inflation system on the tires.

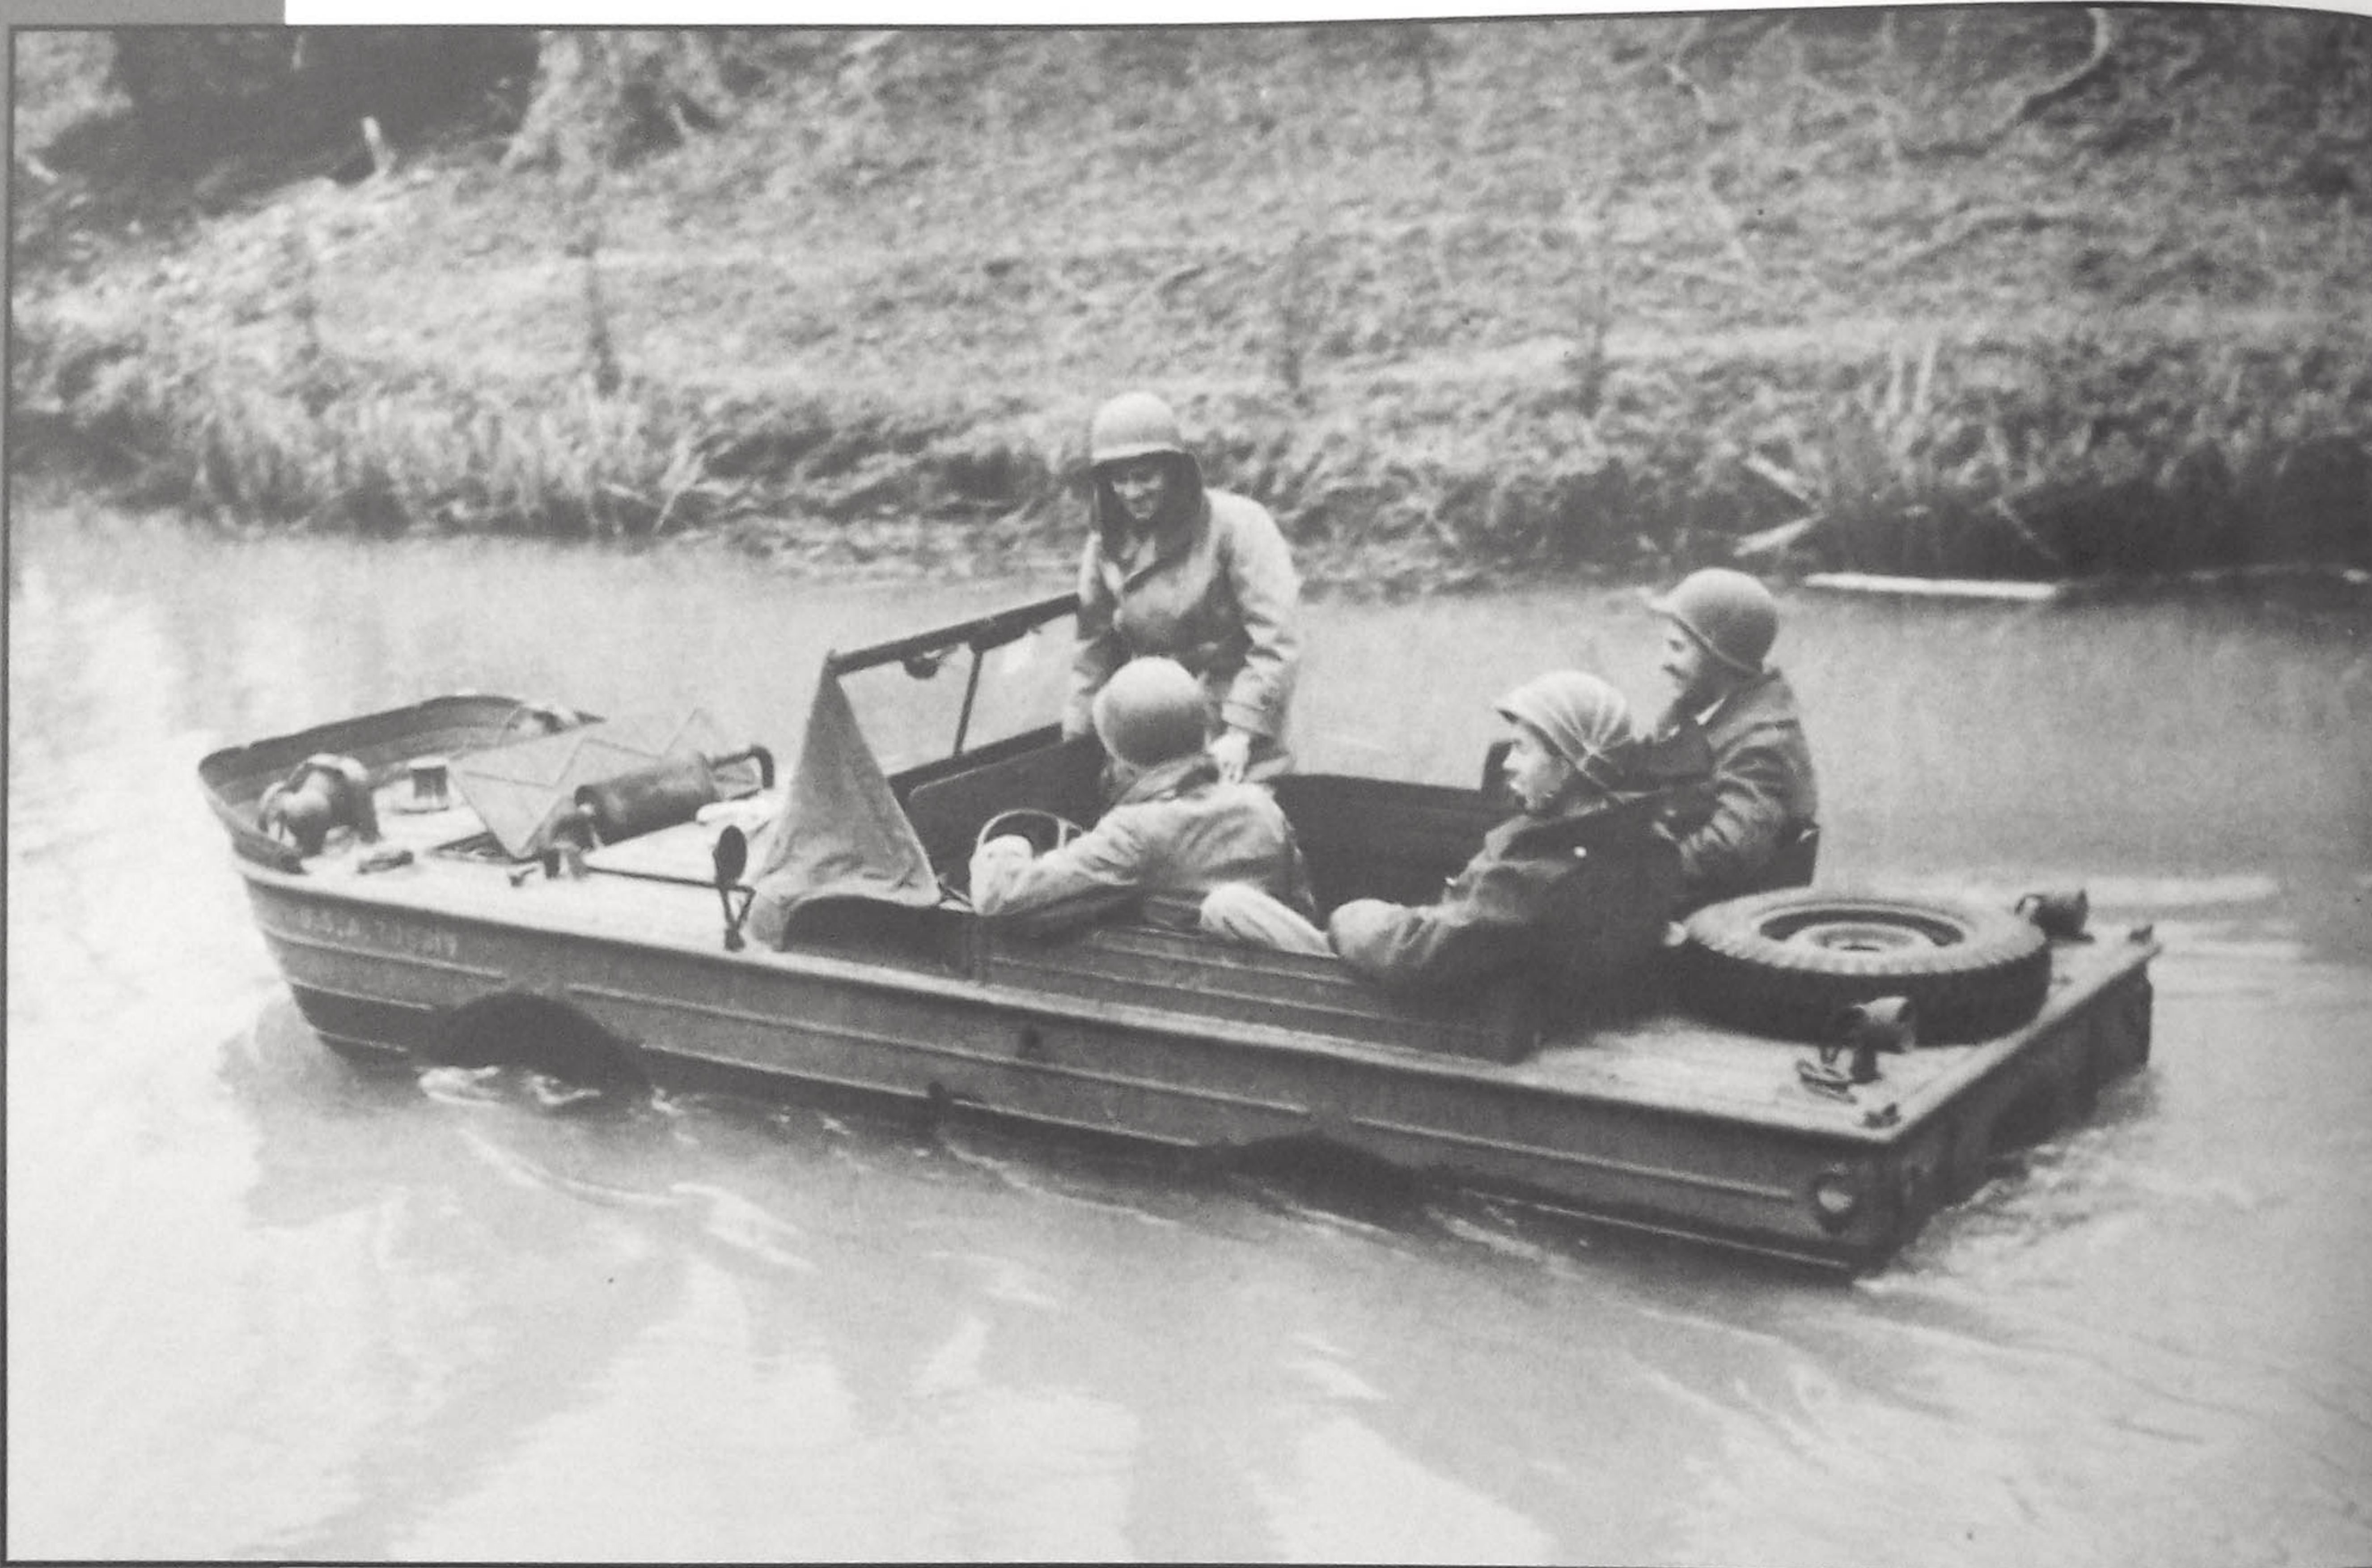
**Top left and right:** the grates located behind the front seats are part of the Duck's engine cooling system. An exterior vent would not have practical on the Duck, for obvious reasons. The mounting points for the M36 gun mount can be seen in both photos. These were provided on every Duck manufactured. In the top right photo, the fire extinguisher and the rifle rack (to its left) can be seen. **Above left:** the Duck used the GMC Model "270" six-cylinder in-line engine. The engine was nearly identical to that

used in the standard 2 1/2-ton truck, but the transmission differed considerably due to the many additional shift levers and linkages used on the Duck. **Above right:** the Duck was equipped to get itself out of difficult situations. Among the many devices supplied to assist in this was a large sand anchor. This could be wedged into solid ground and attached to the vehicle's winch. This tech manual shot shows a lab-coated technician placing the anchor in soft sand.

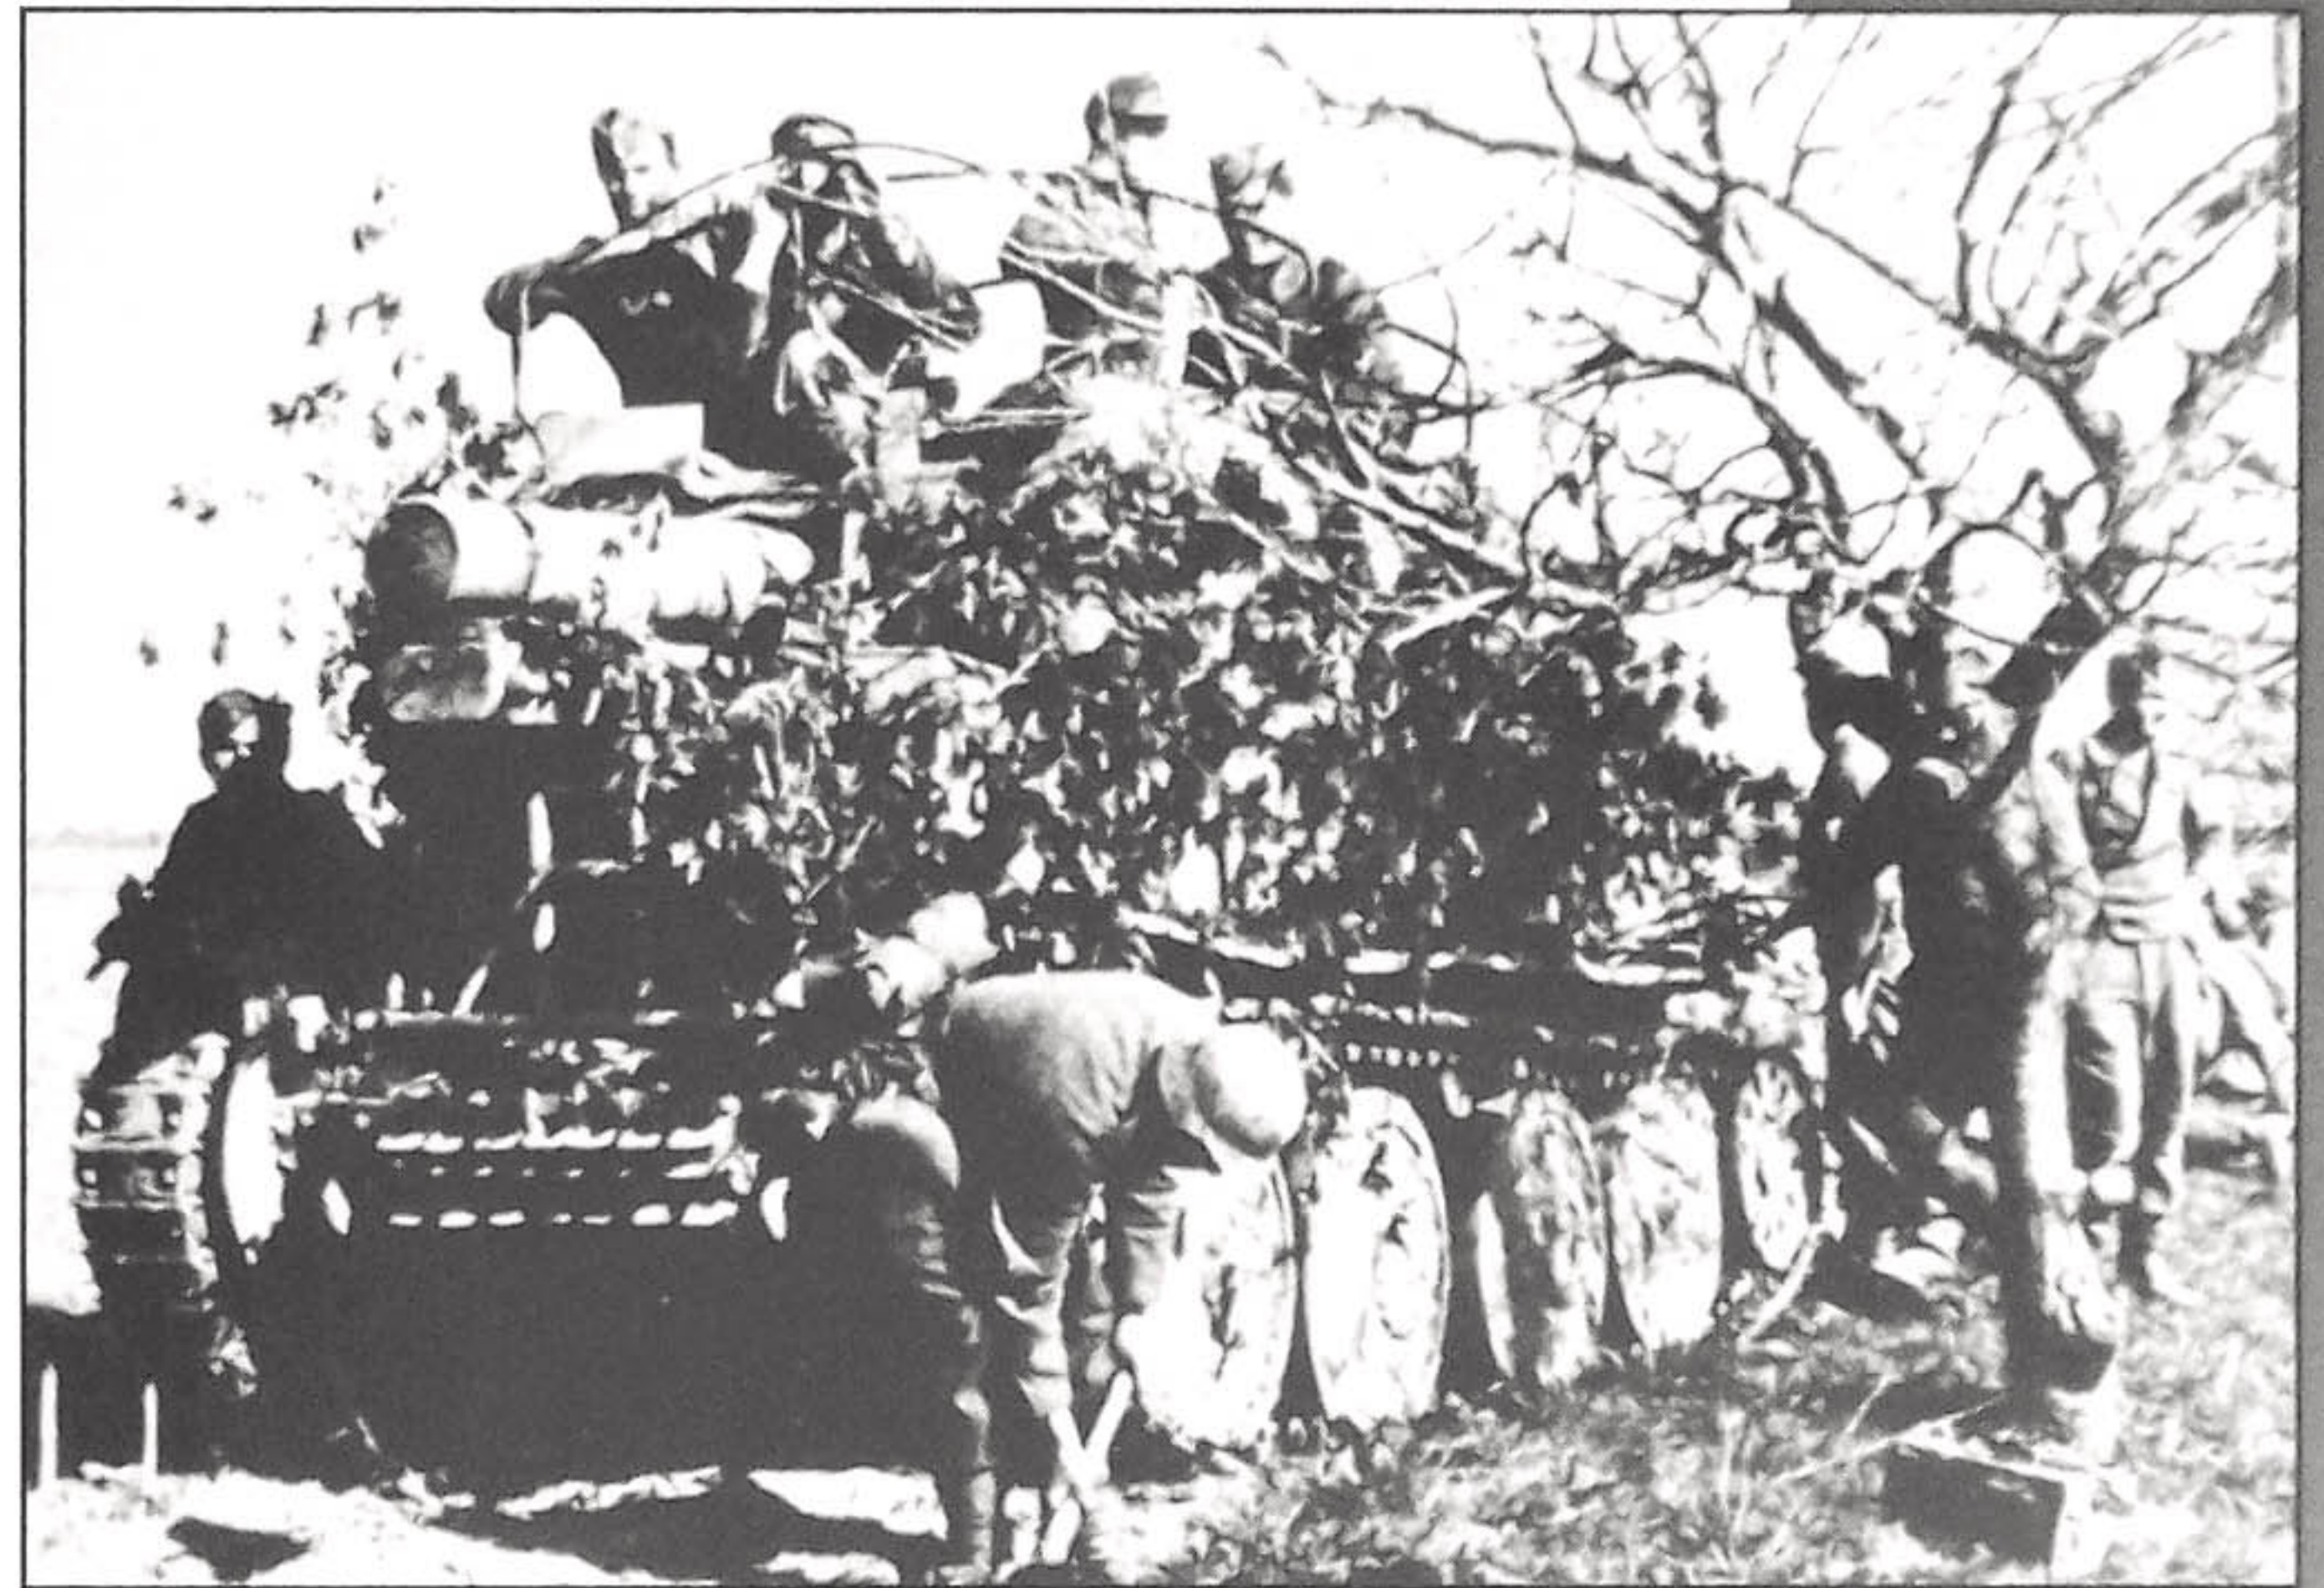
**Above left:** the rear view unveils more details. Next to the tactical marking the key symbol of "LAH" is visible. The exhaust air outlet upon the engine cover shows a small dome, which can be closed with a shutter. This was possibly done in winter to accelerate warming-up of the engine. (Photo Netrebenko)

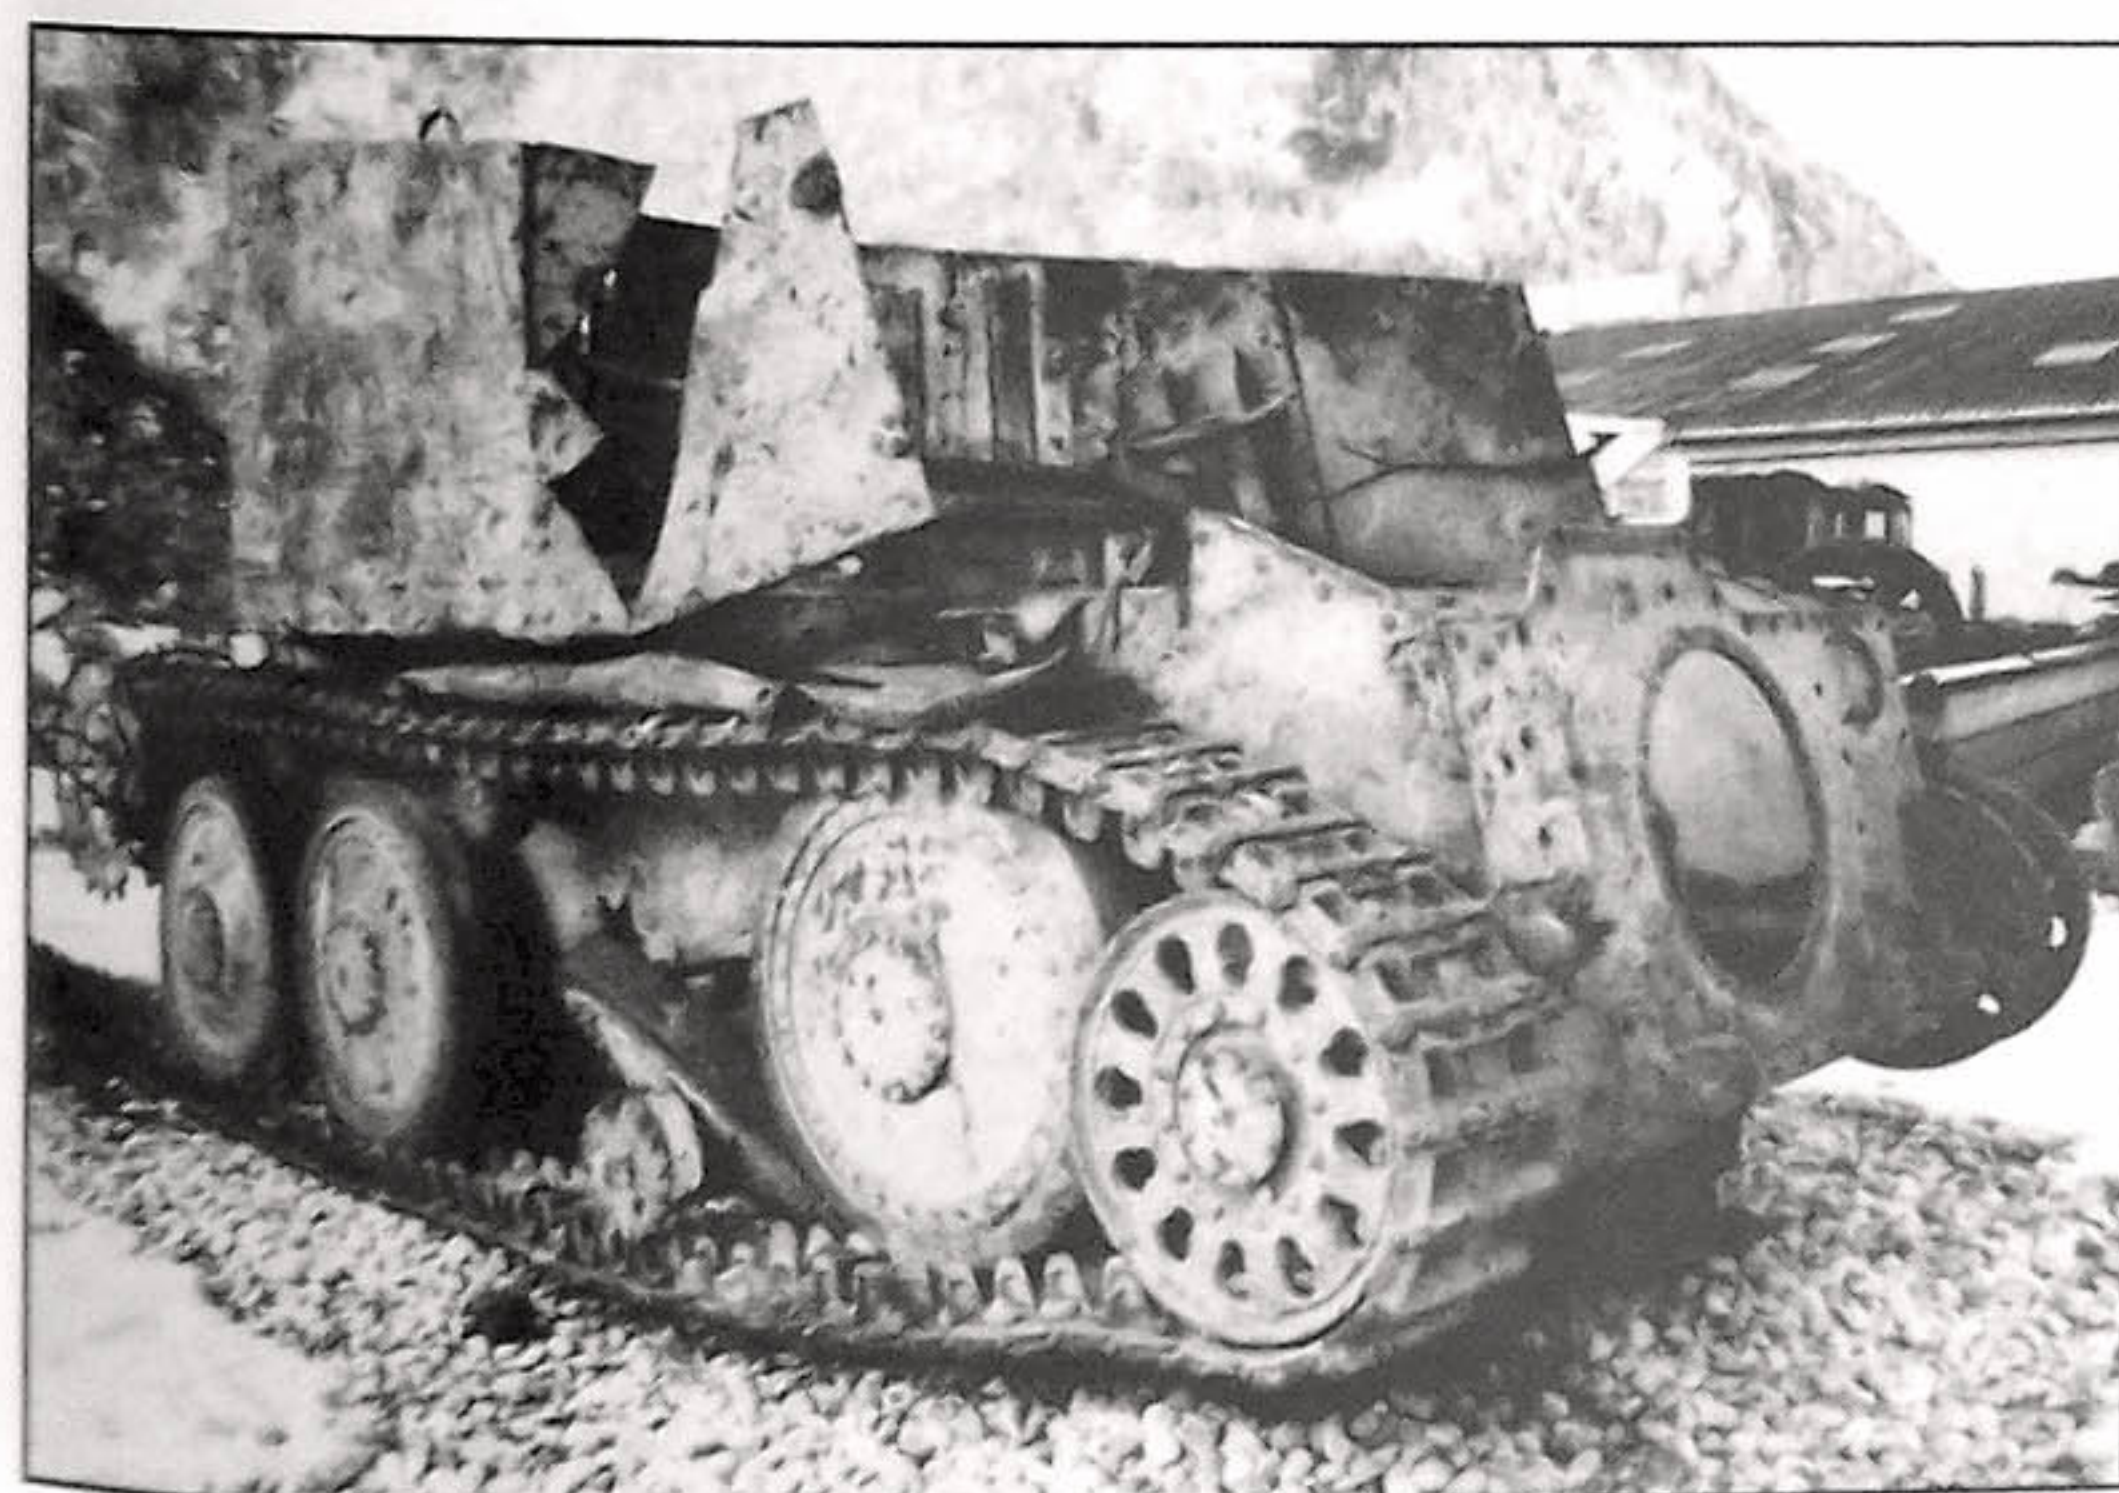
**Above left:** the gun receives a wash with a rust-converter, partly to loosen 40 years of rust, partly to conserve the parts until further restoring takes place. (Photo Loidl) **Above right:** the Grille from the right hand side. The drive sprocket is damaged and the complete front running wheel assembly is missing. The chassis of the Pzkw 38 (t) was used almost unchanged. **Right center:** the left part of the superstructure shows a broken plate, probably damaged when the tank was sunk in the river. The drive sprocket is missing some teeth. **Below right:** the armor plate at the extreme right is broken as well. When hitting the ground, the rear running wheel assembly was also destroyed. **Left:** this photo shows the engine compartment. The engine and engine cover plate were already removed.

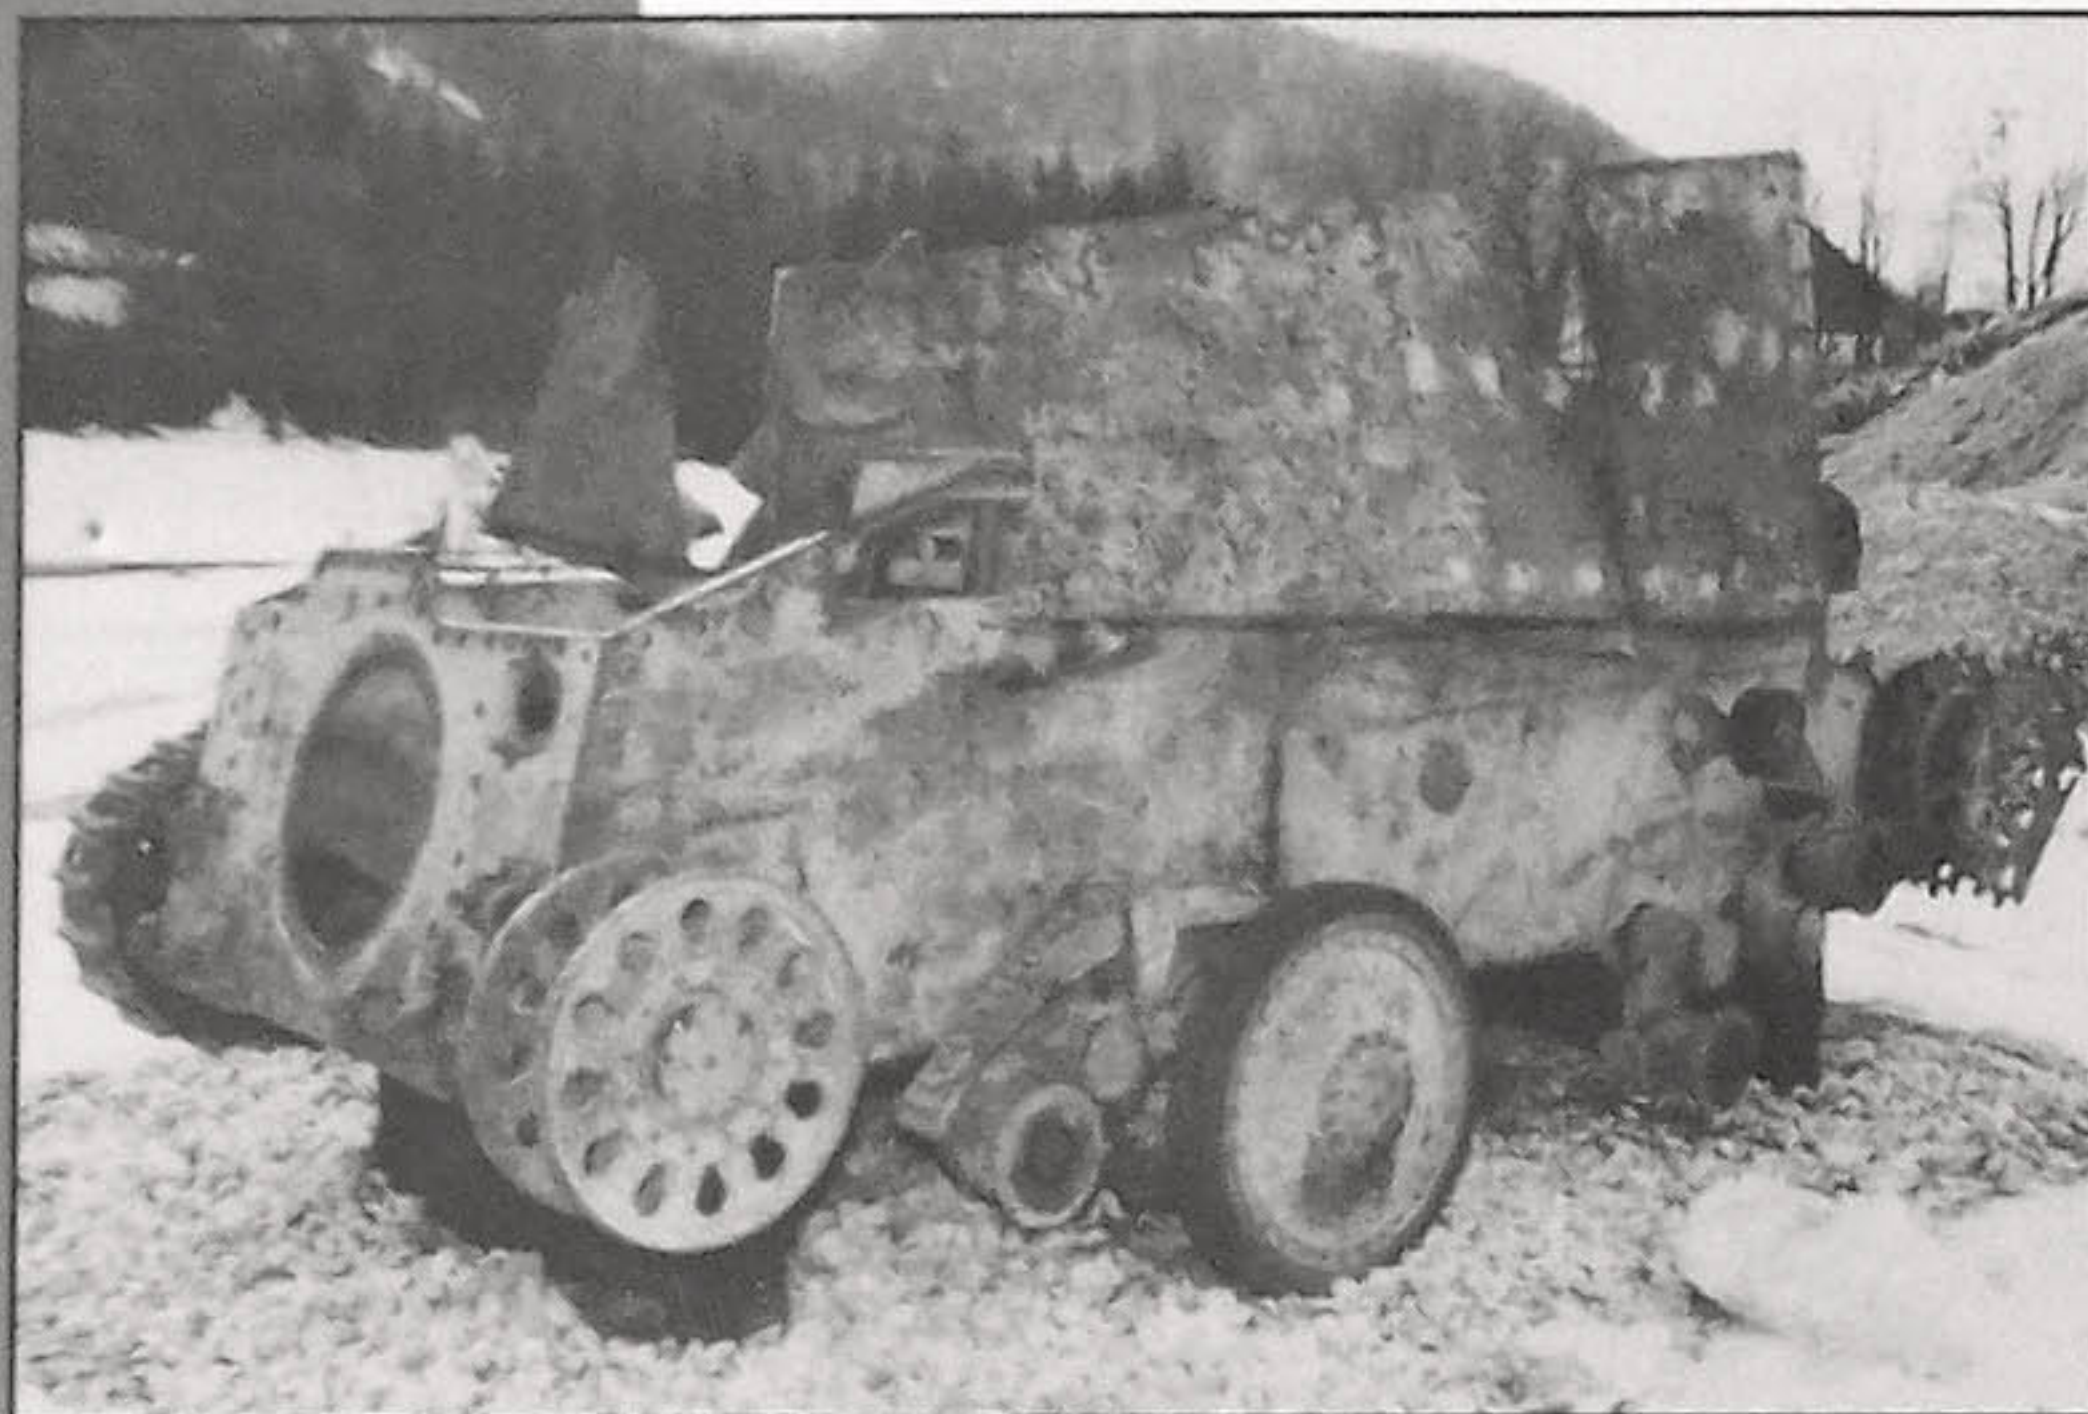
**Above left:** this view shows the degree of damage inflicted to the running gear.
