# Allied-Axis

THE PHOTO JOURNAL OF THE SECOND WORLD WAR

**German  
SIG 33/1  
Grille SPG**

**Kleines Kettenkrafttrad  
WWII Dodge 3/4-ton trucks  
DUKW Amphibious truck**

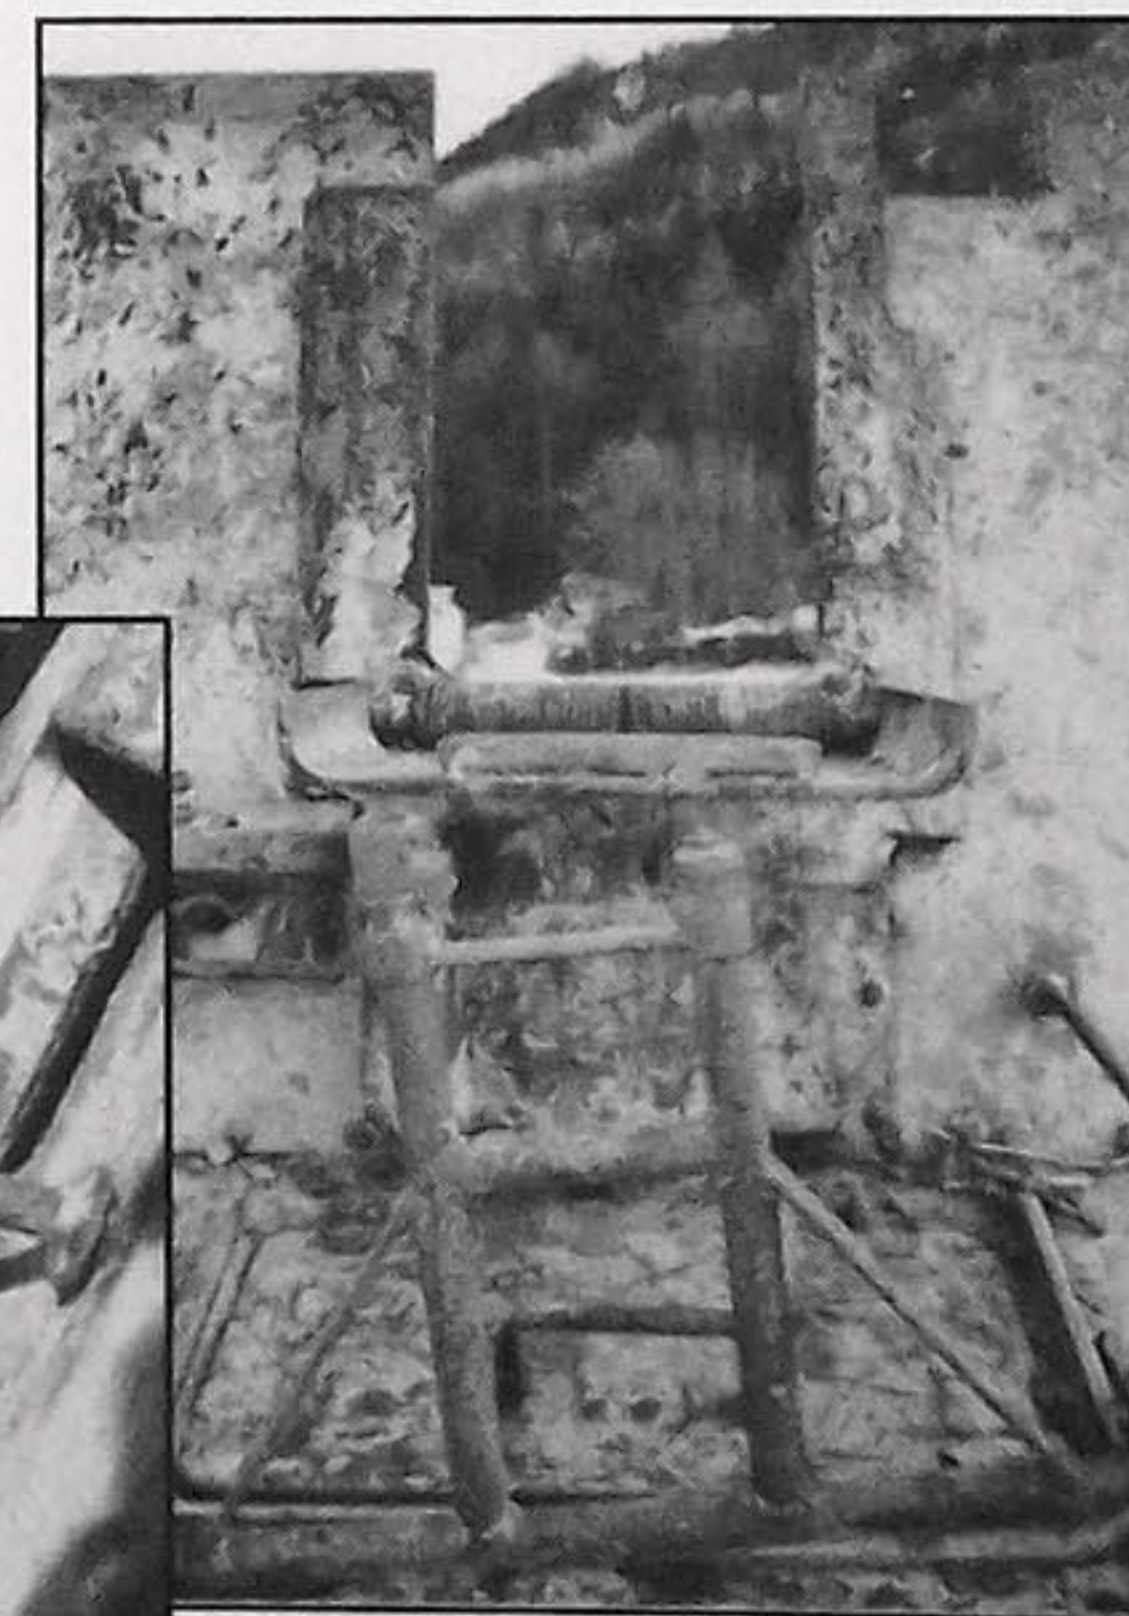
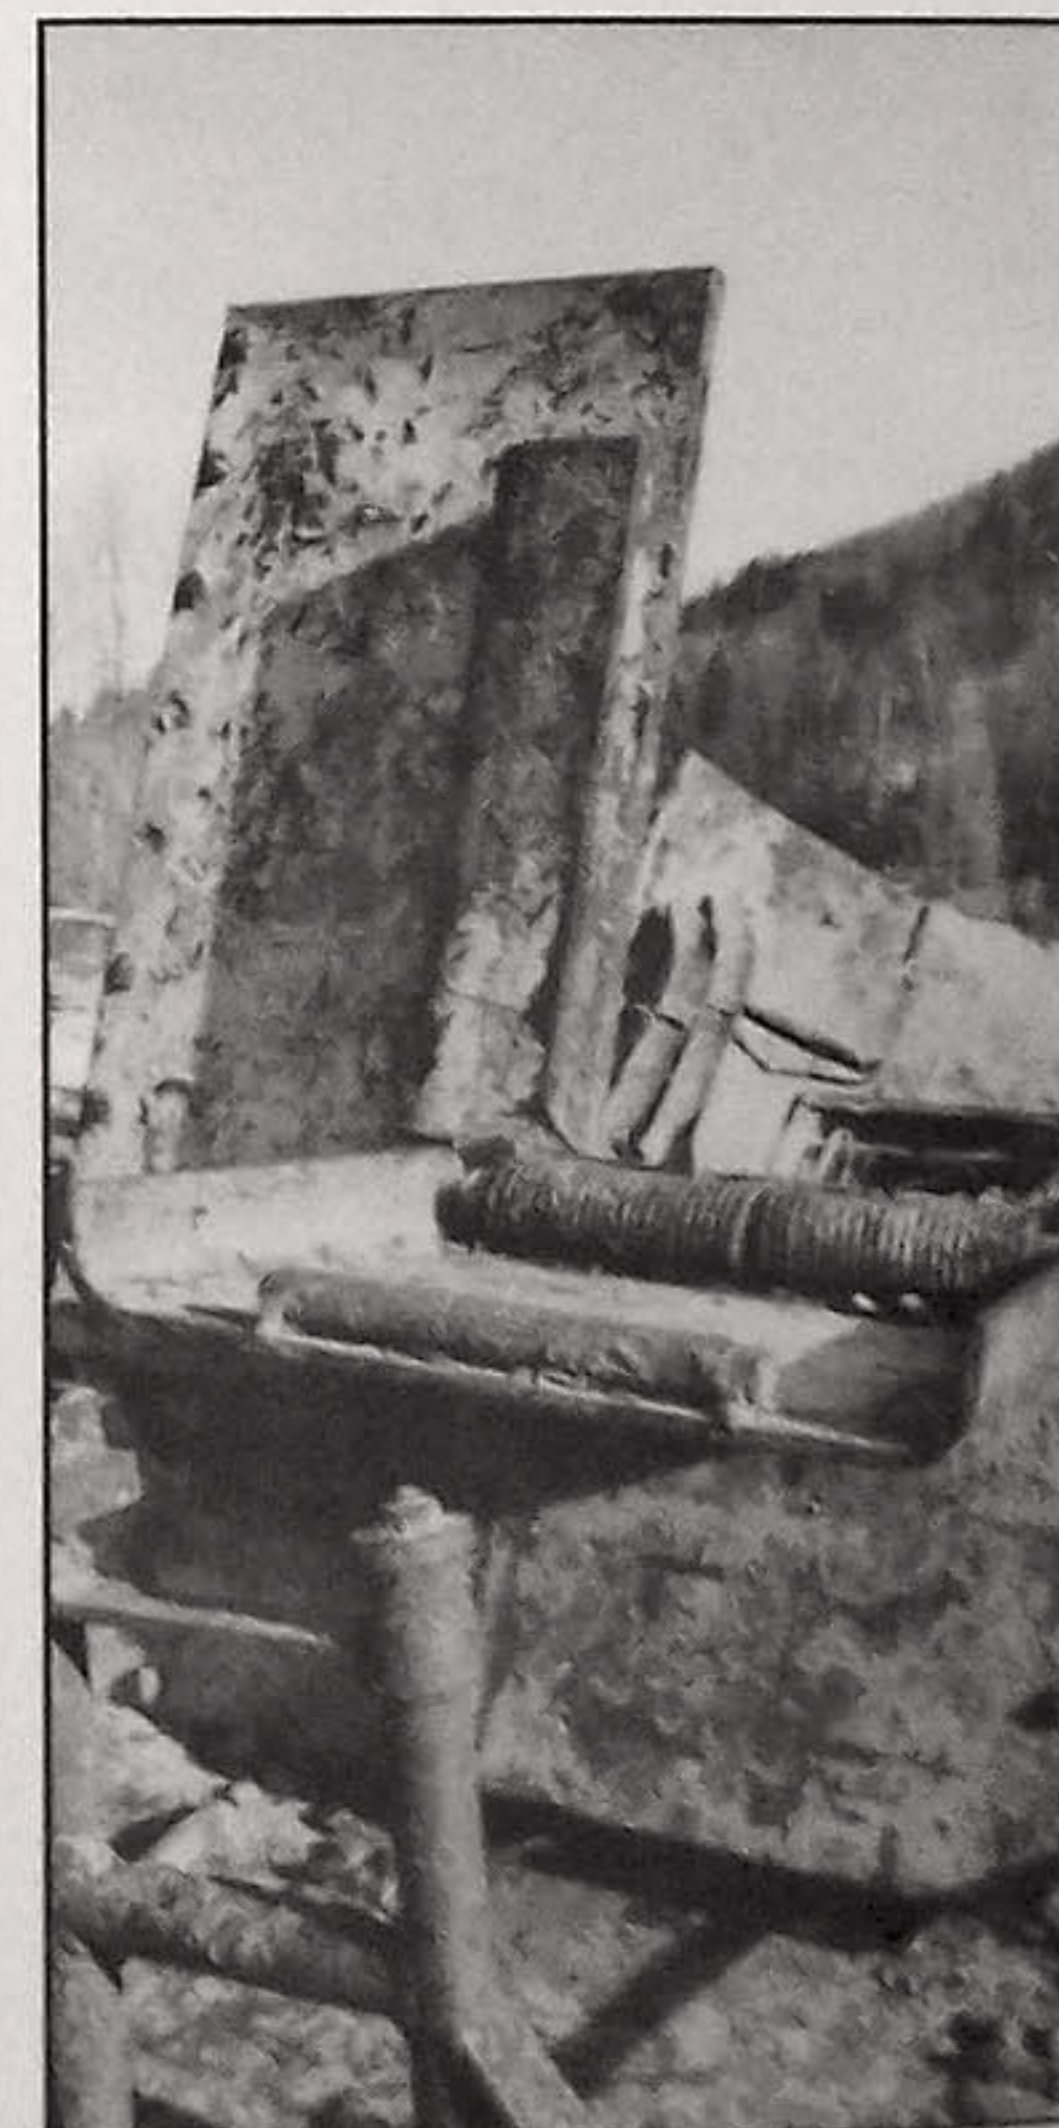
**Below:** this view shows the large spring of the gun's protection plate. The complete superstructure was bolted, a construction characteristic of the many ex-Czech vehicles used by Germany.

**Below right:** here the complete gun cradle protection is visible. When elevating the gun, the now horizontal plate would follow this movement.

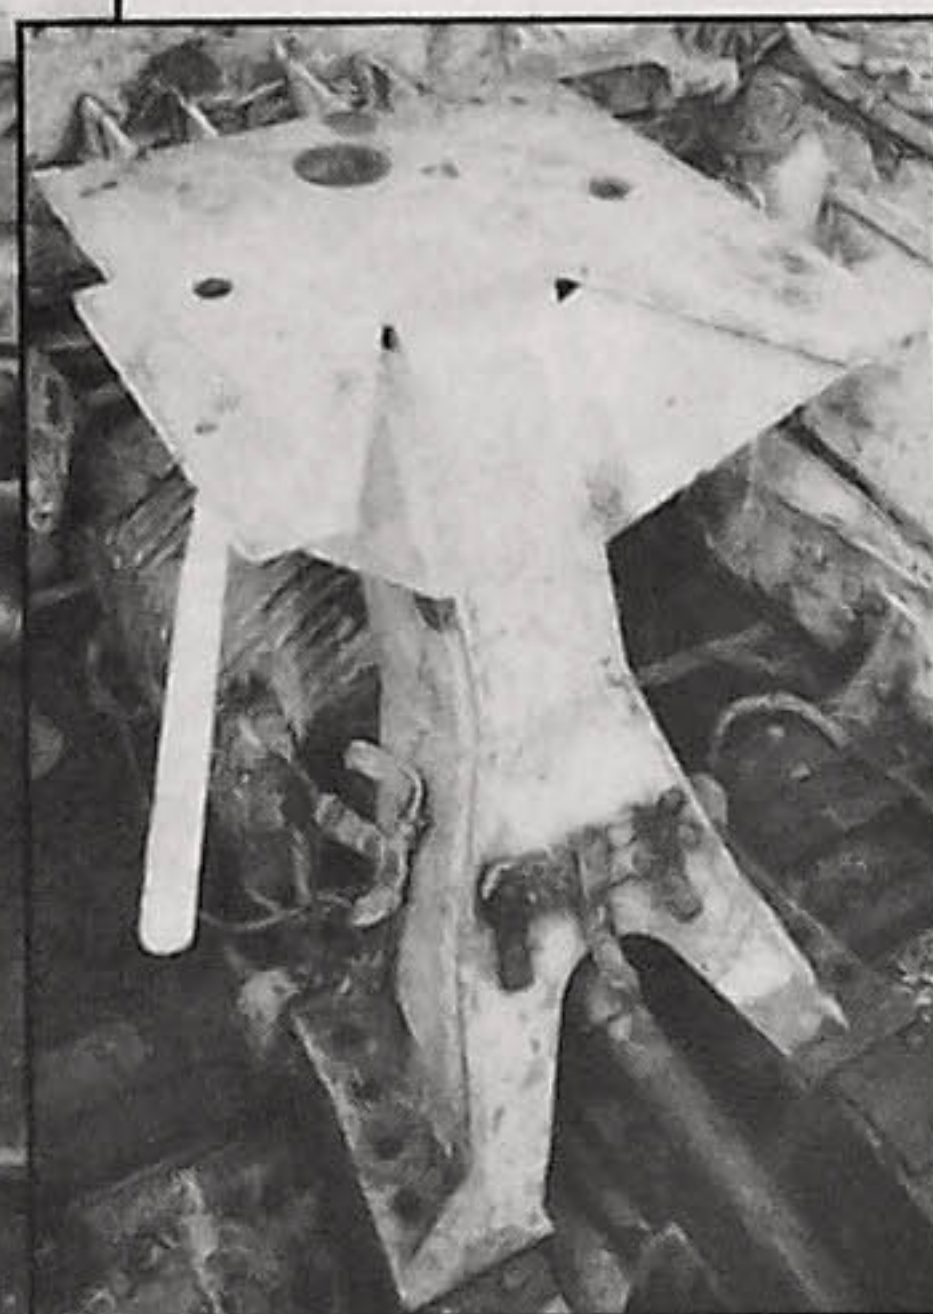
**Above left and center:** the trestle carried the SIG 33/1. This massive carrier was of welded construction. It was fixed to the bottom with eight massive bolts. Additionally, the trestle was fixed to the frontal plate as well. Brackets for two gas masks are visible. The gun mount trestle had to be open to the bottom to give way for the drive shaft. Two metal beams reinforced the trestle itself.

**Above right:** the release lever for the gun mount crank. The lever could be fixed in two positions.

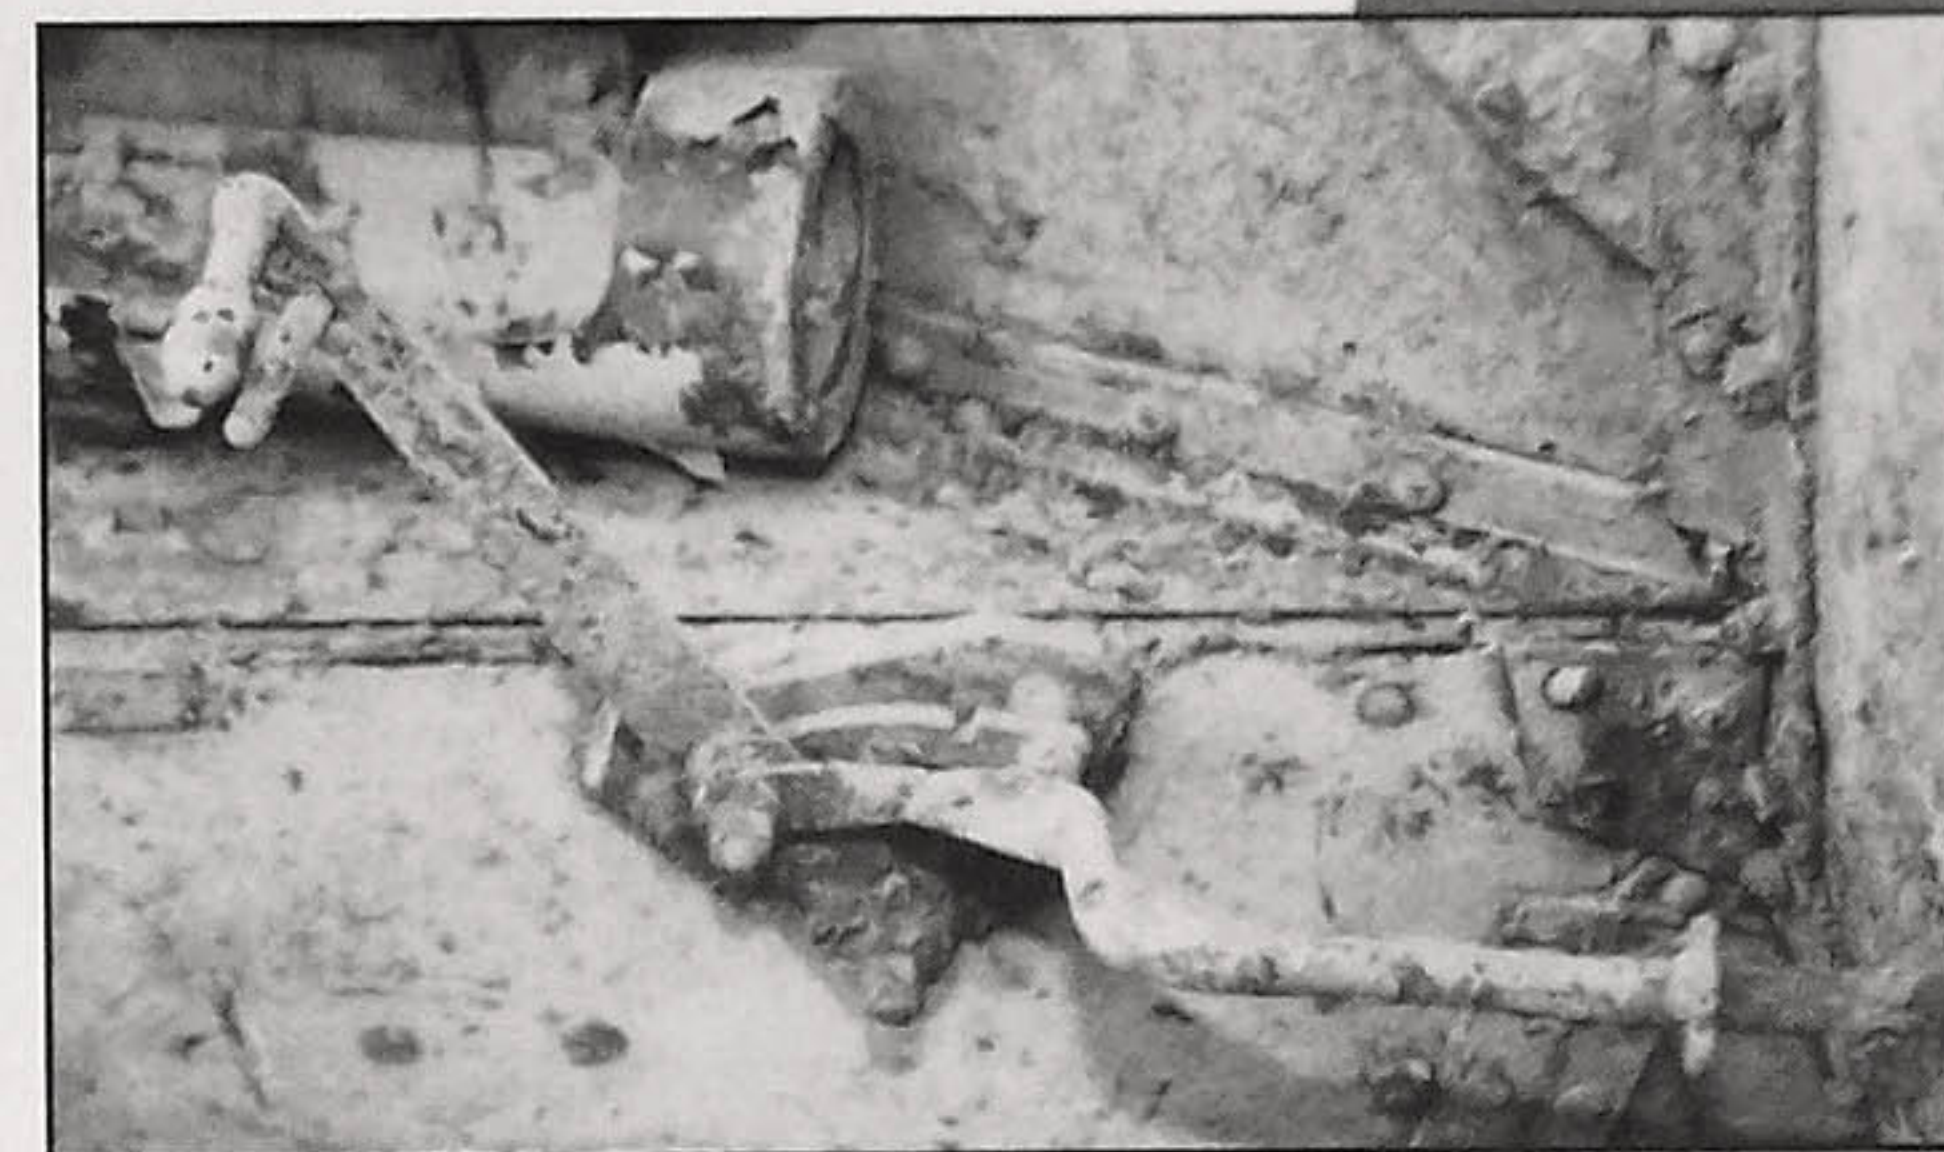
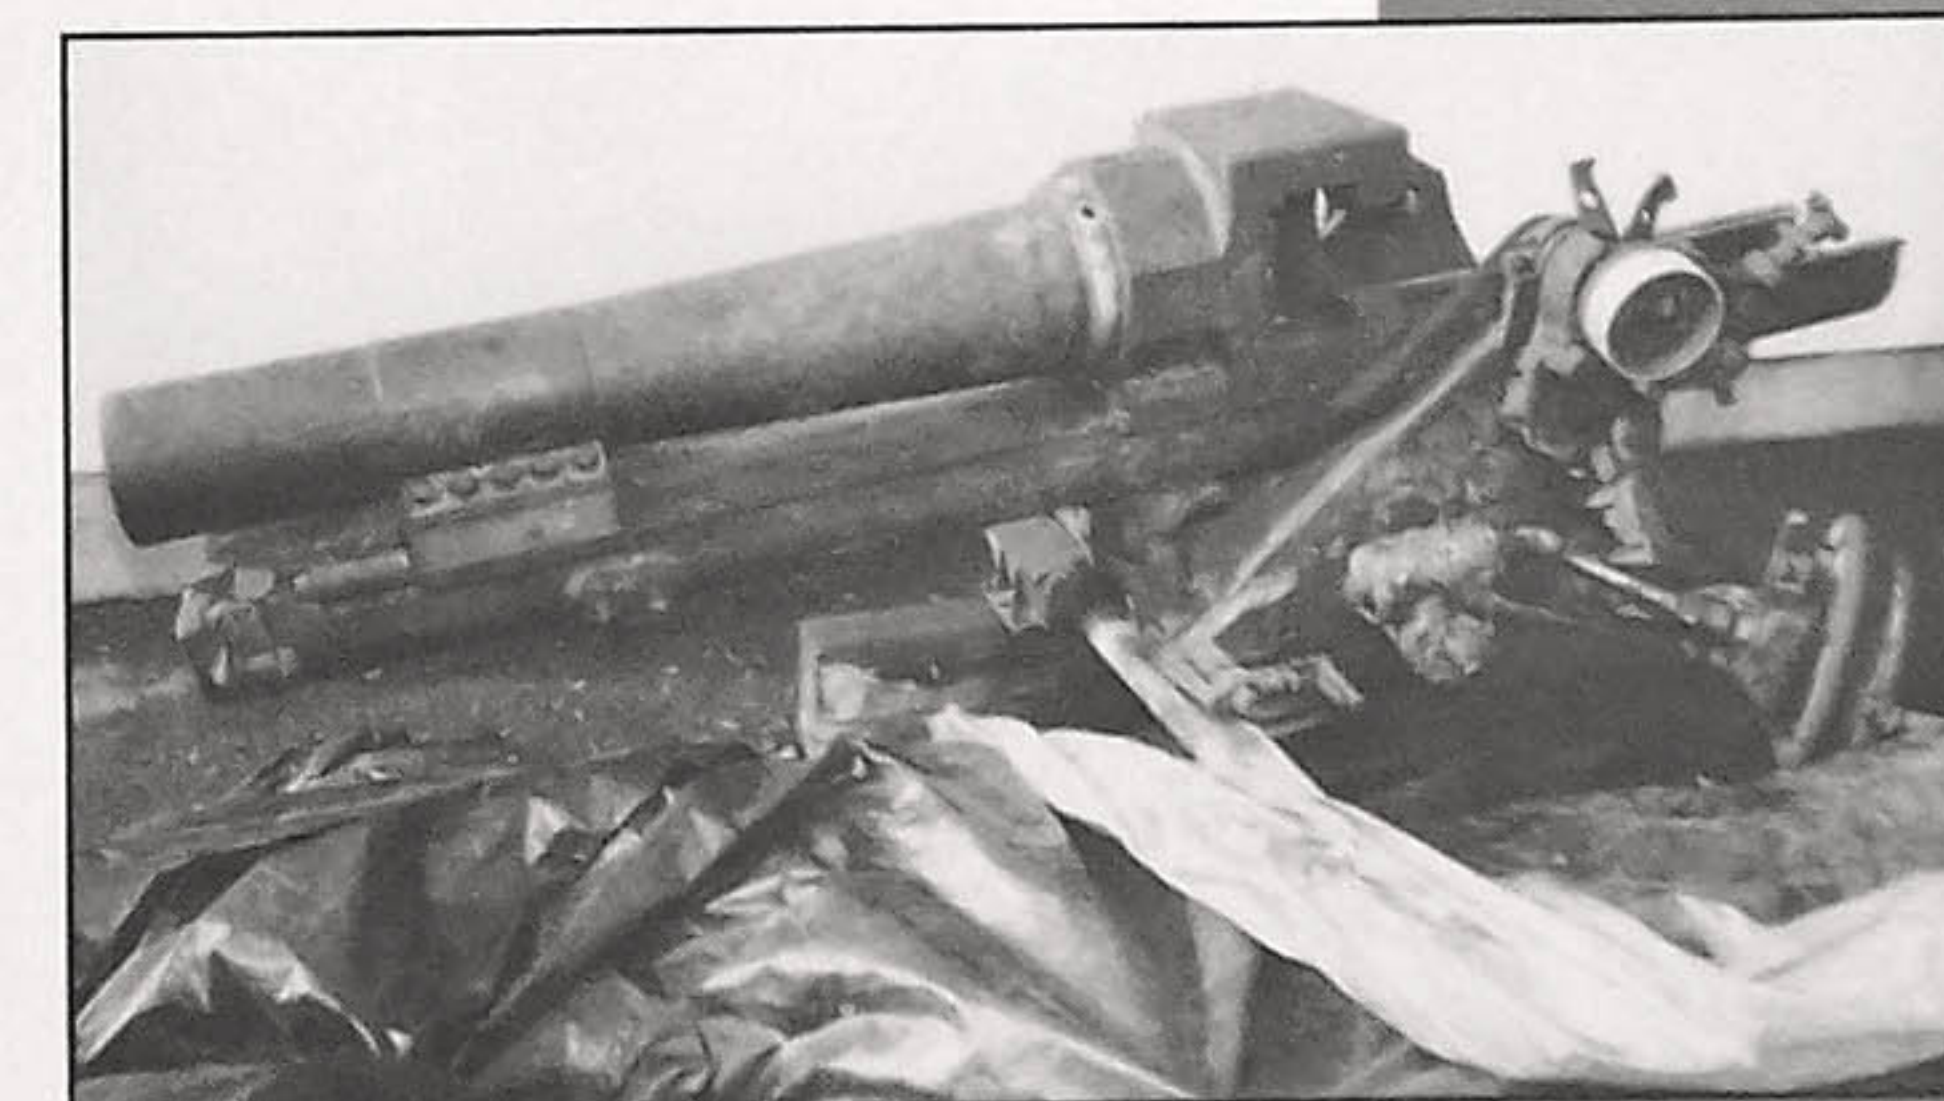
**Below:** the cradle houses the recuperator.

**Below right:** the 15 cm SIG 33/1 is stored. Again the relatively good state of the guns is astonishing.
