Early Cessna 150 Inspections, Tips, Tricks, and Hints

TCM O-200A Inspection and tips

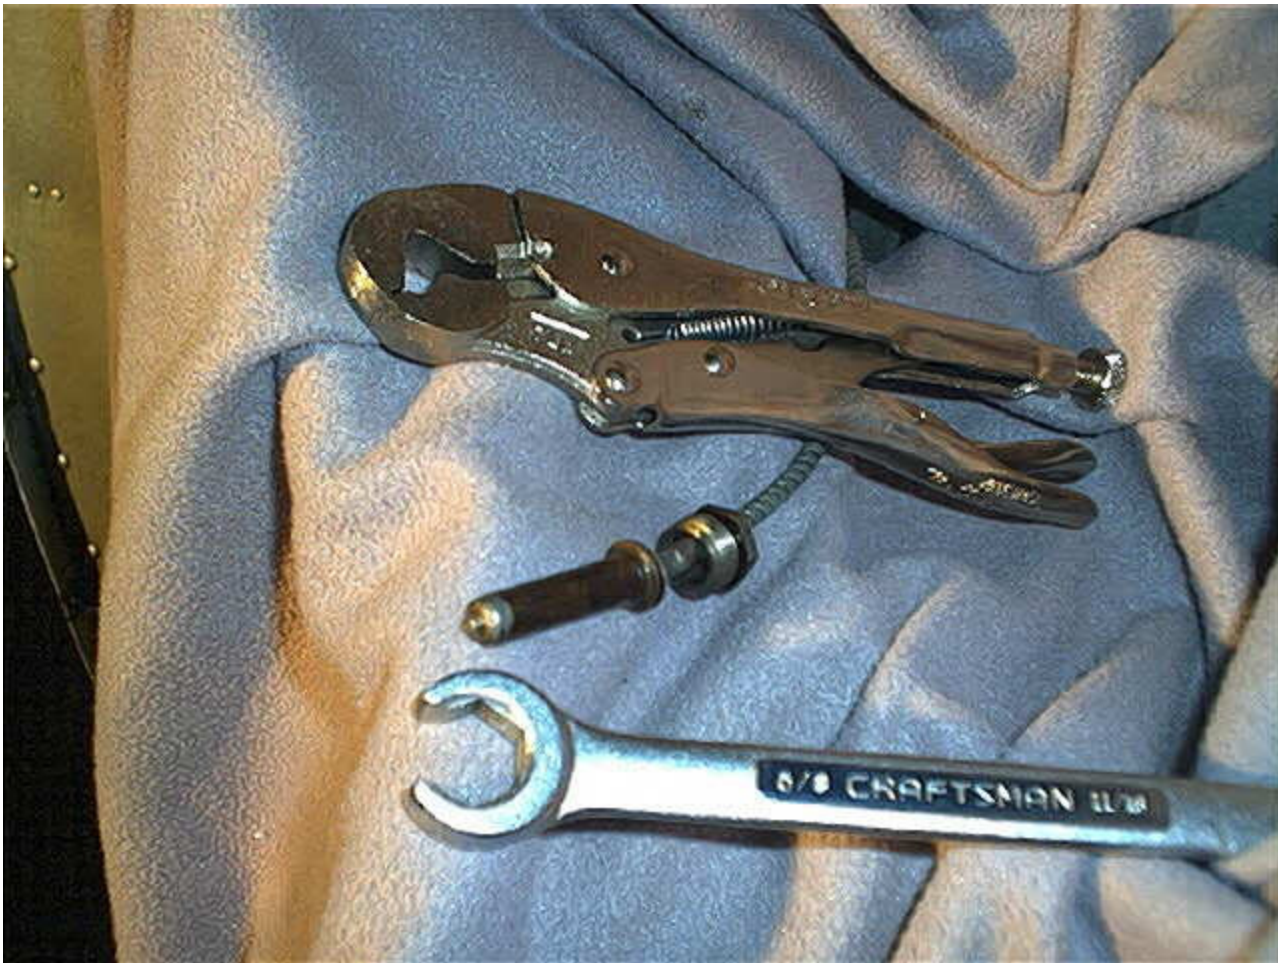
Below is a pic of the temp bulb and both of my suggested tools. The thin hex nut which I referred to is the threaded sleeve with hex that is on the tube with the temp bulb. When screwed into the adapter on the engine oil screen, you only see the thin hex and not the threads.

The biggest problem is the 5/8 hex "nut" that retains the bulb into the steel adapter, which is, in turn, screwed into the brass oil screen "nut". Removing the screen for cleaning during oil changes requires that you unscrew the 5/8 hex "nut" and pull the bulb out of the screen. You then cut the safety wire and using a one inch open end wrench, remove the brass screen "nut" to which the screen is attached, and the steel adapter fitting for the temp bulb.

This 5/8 "nut" is very thin walled, and the flats of the hex are only about 1/8 inch wide. This nut cannot be replaced as it is put on before the temp bulb is soldered to the tube and "charged "

I say all of this only to warn the unwary that the proper tools are a must for removing and installing this temp bulb repeatedly without damaging it. The best tool to use is a 5/8 inch, 6 point "line wrench", which will give the most surface contact with the thin nut without damaging it. DO NOT use an open end wrench, as the nut will be rounded off. If the nut is rounded off, the best choice of tools seems to be a special pair of vice-grip pliers with a special jaw, which can clamp down on three of the six flats of the nut. It is a p/n 7LW. Care must be exercised when using this, to not crush the nut.

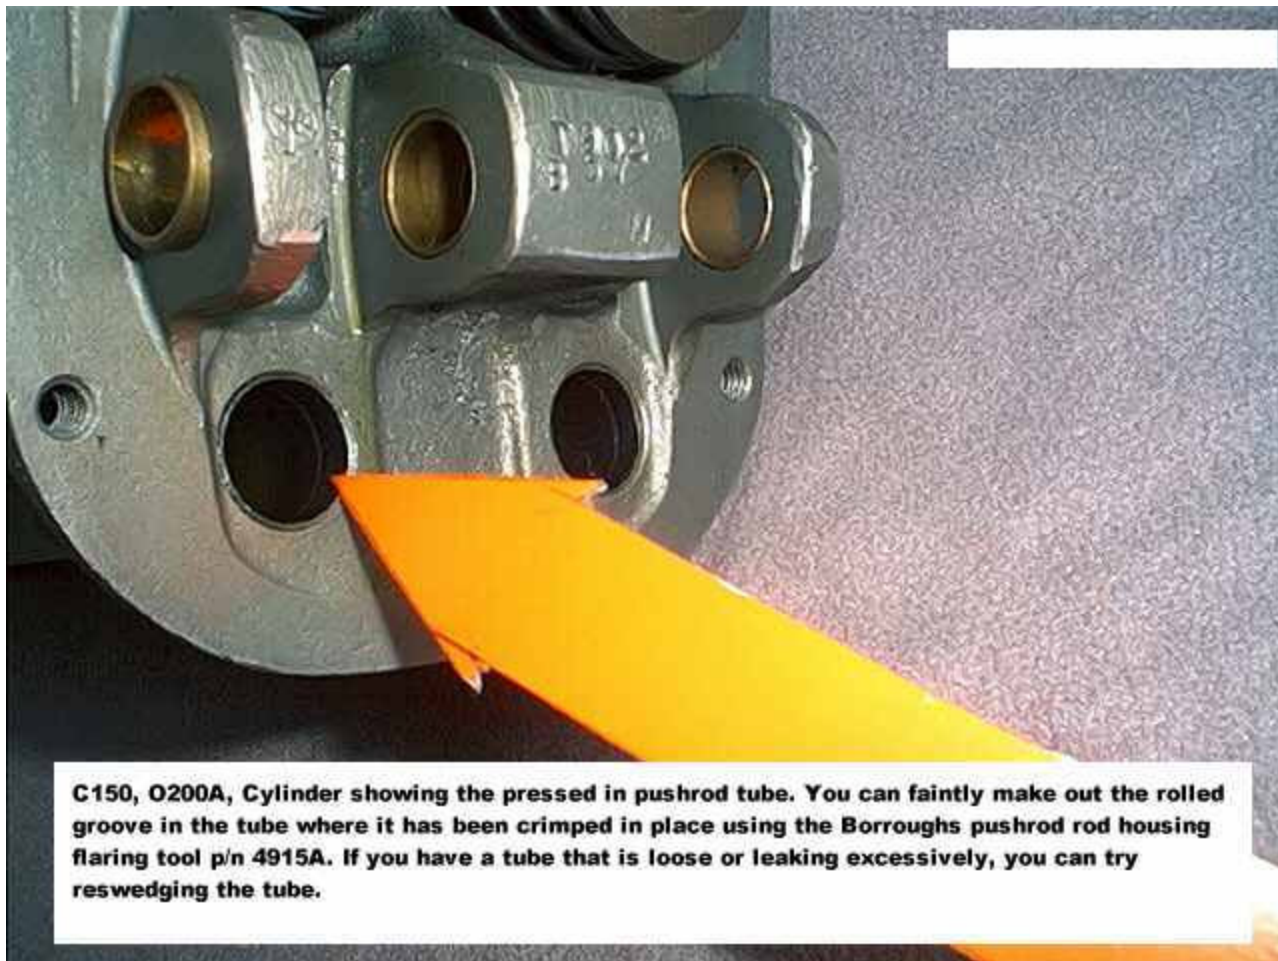
There is a tool which can be used to re-roll the pushrod tubes into the cylinder head with the cylinder installed. It is manufactured by Borroughs Tool & Equipment Corp. If your leak is in this area you may be able to stop it or slow it down by doing this.

Anyone who has ever dealt with a small A or C series Continental engine is familiar with pushrod tube oil leakage, both at the cylinder, and at the crankcase. Four or five years ago REAL Gasket Corp., P. O. Box 2048, Corvallis, OR 97339, 541-754-3622, developed a kit to install a type of pushrod tube similar to a tube used on large Continental engines. REAL Gasket has finally STC'd the removable pushrod tube kit and so it is easily installed on an O-200 and documented using a log entry and Form 337.. Continental finally realized the error in their ways and introduced a kit designed along the same line of thinking, having pushrod tubes and seals that are replaceable with the cylinder installed. It now comes standard with the cylinder as p/n 653816A3 cylinder/valve kit, which are the TCM replacements for the O-200A.

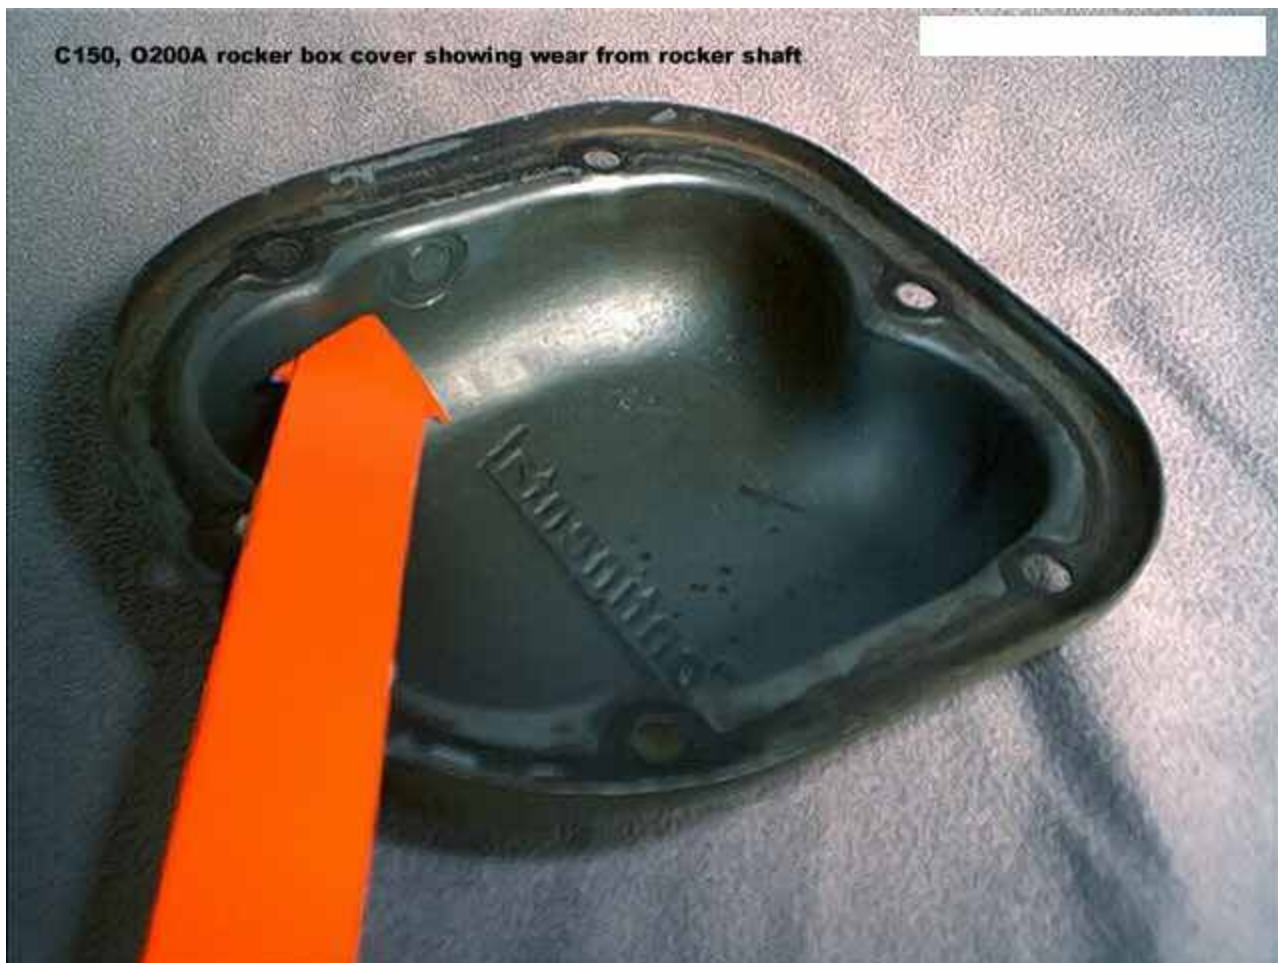
Continental designed the rocker arm shaft so that it was retained in place by the stamped steel cover. But the shaft tends to turn and usually ends up bearing hard on one side or the other of the rocker box cover. Eventually it just eats it way thru the cover. There is no fix for this, other than to be aware of it and to possibly swap covers around when they are removed so that the wear does not continue in the same spot for a prolonged period of time. Continental did fix the problem when they introduced the new p/n 653816A3 cylinder assembly. The fix was the installation of a set screw in the boss between the rockers which locks the shaft in place.

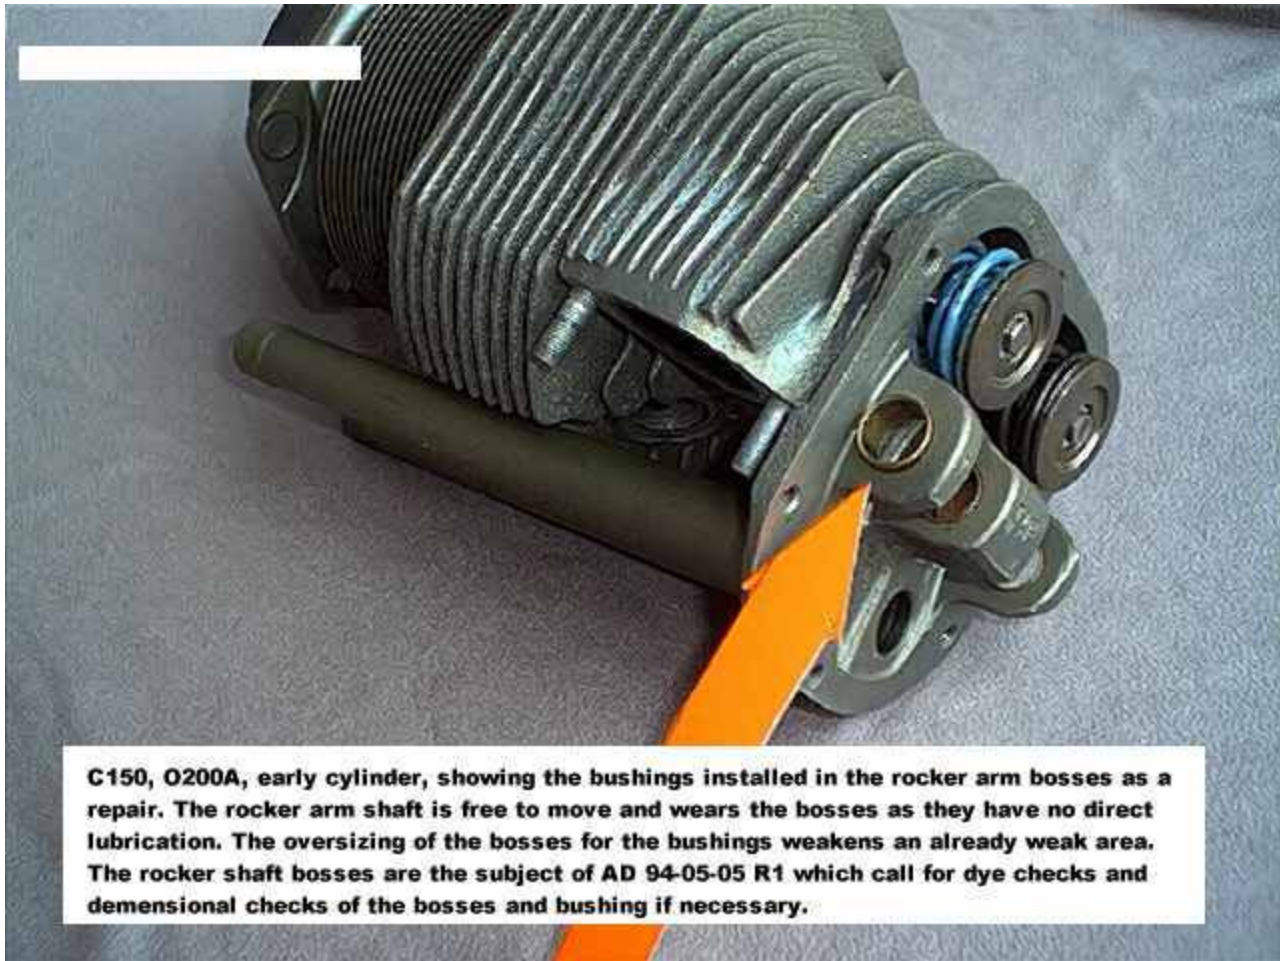
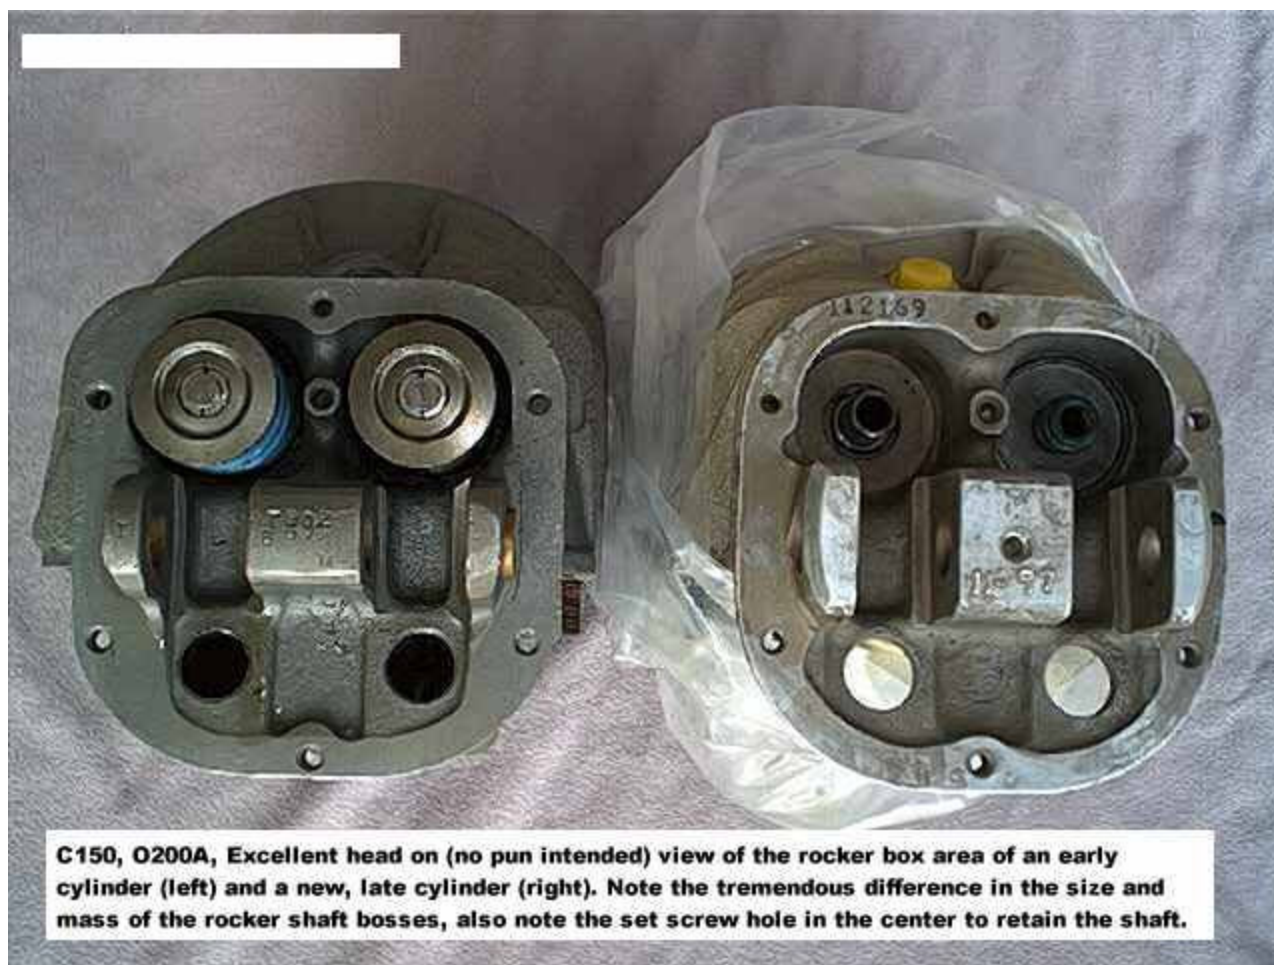
Note: The new cylinder on the right has the valves removed to comply with TCM CSB 98-1B, where Continental, during a period of time in 1997 and 1998 received some improperly hardened valves. I removed them and sent them to Continental, and they are sending me new, inspected valves to replace them. But YES, the cylinders do come complete from Continental with the valves, springs, etc. installed.

Over the years most operators of 150's have found that 500 hours was about all one could expect from the cylinders. The most common problem was a loss of compression which is caused by excessive wear of the cylinder bore at the combustion chamber end (open choke) caused by the rings reversing direction with the piston as it reaches TDC. The bore eventually becomes so worn that the rings expand out of their grooves until they jam and break, causing a loss of compression. This is much more prevalent on this engine than other models of Continental or Lycoming engines. As the total time on the cylinders accumulates, cracking and head separation became more of a problem. It is quite common to find the cylinder head cracked from valve to valve, valve to spark plug, or plug to plug. In the past it was common to have the cylinder welded up and reconditioned and reinstalled. There are so many problems with these cylinders; valve seats coming loose in the head, valve guides coming loose in the head, the cracking in the combustion chamber, valve and plug areas, and the rocker shaft bosses being cracked, plus the excessive bore wear, that it is best to install brand new cylinders.

The new Continental p/n 653816A3 cylinder kit has a cylinder assembly with a heavier head casting, has the rocker shaft retaining set screw, and has the new removeable pushrod tubes. The assembly comes complete with a piston and pin, rings, rocker shaft, pushrod tube kit, and gaskets. All you reuse is the rocker arms, the rocker box cover and pushrods, and for not much more than overhauling your old cylinders would cost.

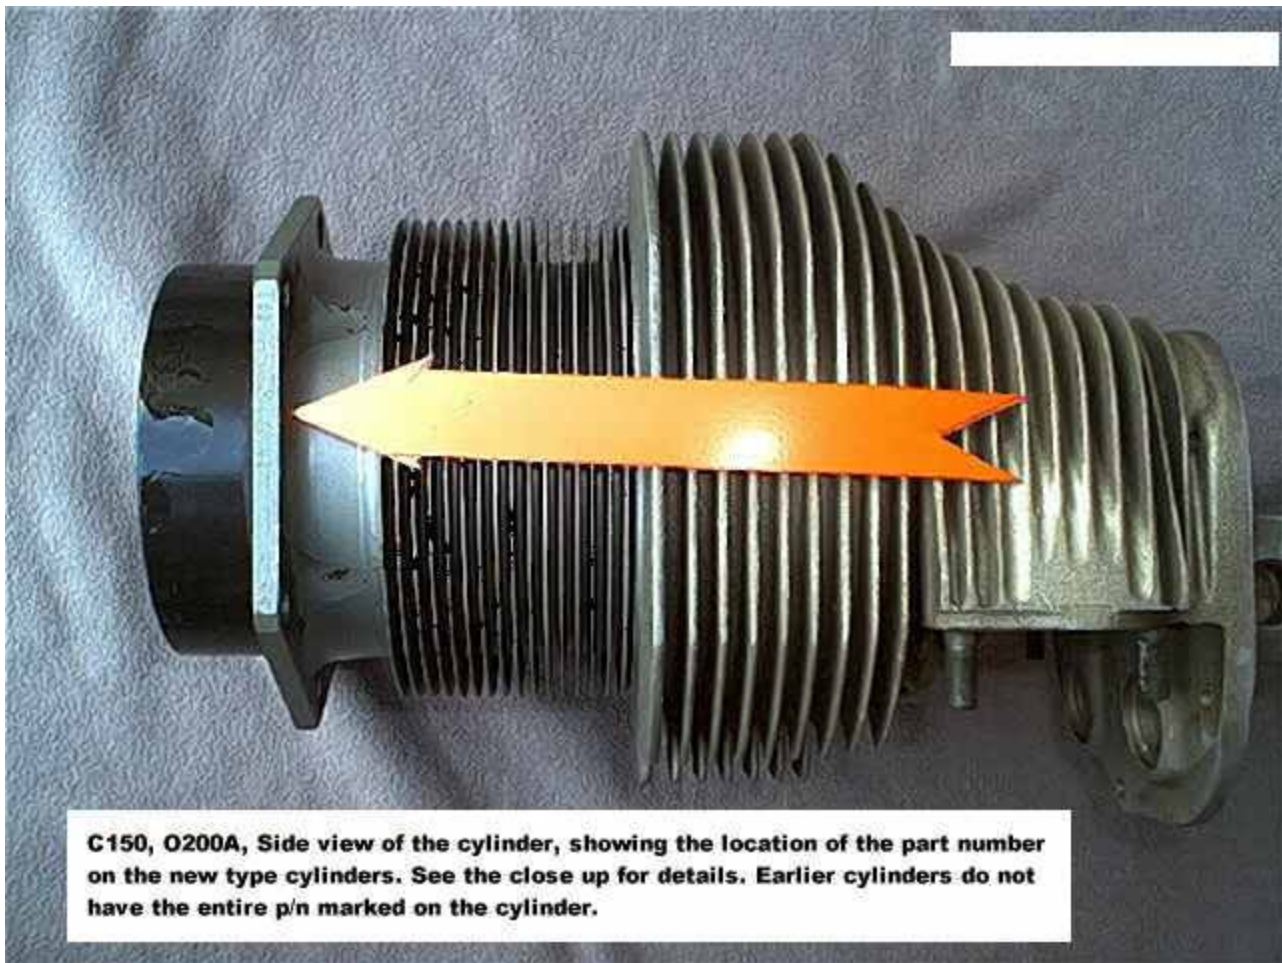
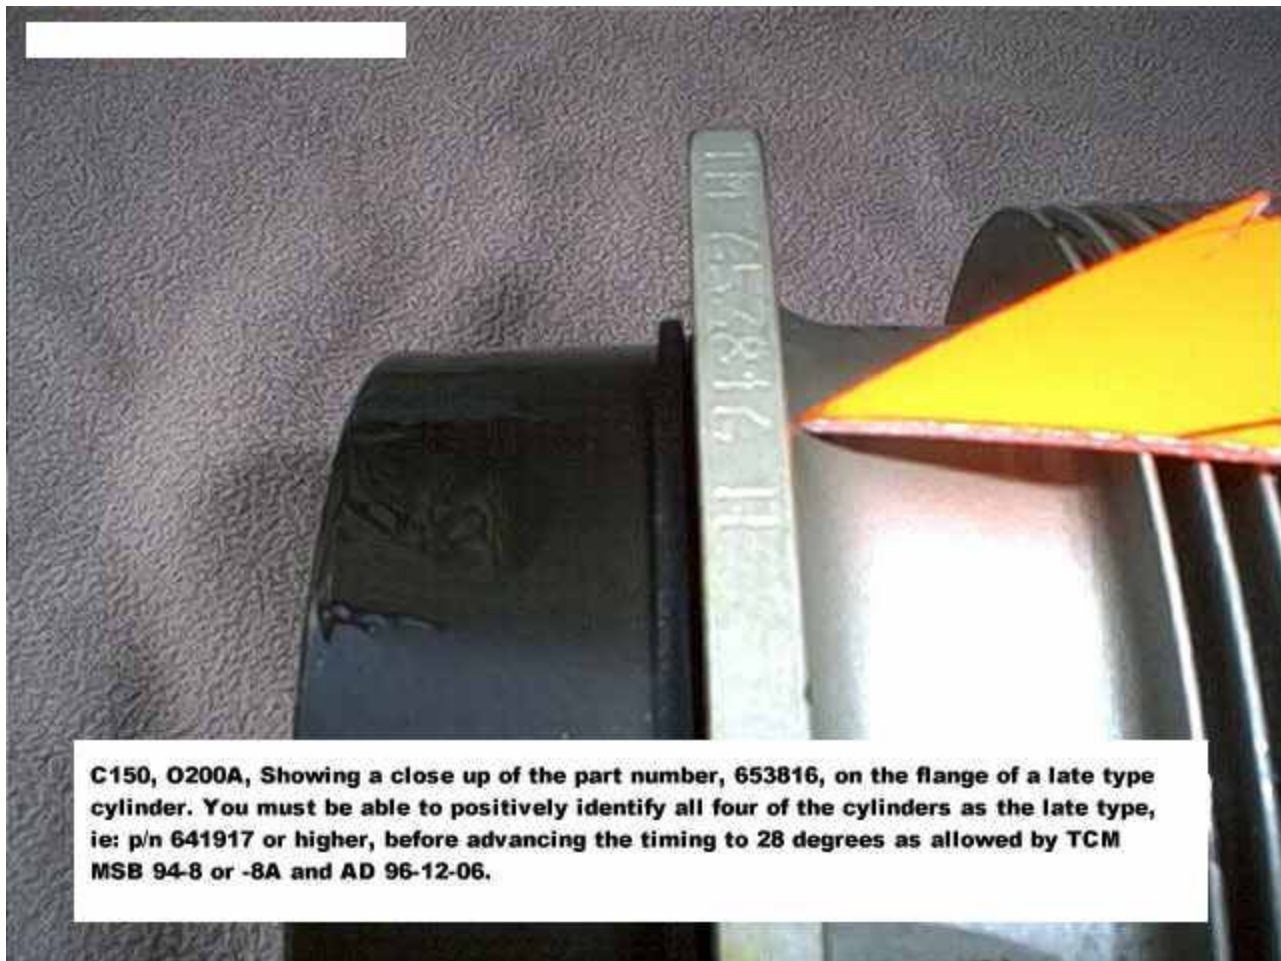
C150, O200A, Side view of the cylinder, showing the location of the part number on the new type cylinders. See the close up for details. Earlier cylinders do not have the entire p/n marked on the cylinder.

The best part of this is the relief you get from [AD 96-12-06](#). This AD supersedes a AD 77-13-03, both of which require the timing to be set to 24 degrees BTC. The engine was originally certified with the timing at 28 degrees BTC. If you install a set of four Continental cylinders of p/n 641917 or higher the timing may again be set to 28 degrees, giving a noticable increase in power. Look on the edge of the mounting flange of the cylinder for the p/n, if none is present refer to TCM MSB 94-8A (link below) for illustrations on how to identify the "improved" cylinders. **Reference TCM [Mandatory Service Bulletin 94-8A](#) dated 10/9/96 or later for information on identifying the cylinders and p/n information.**

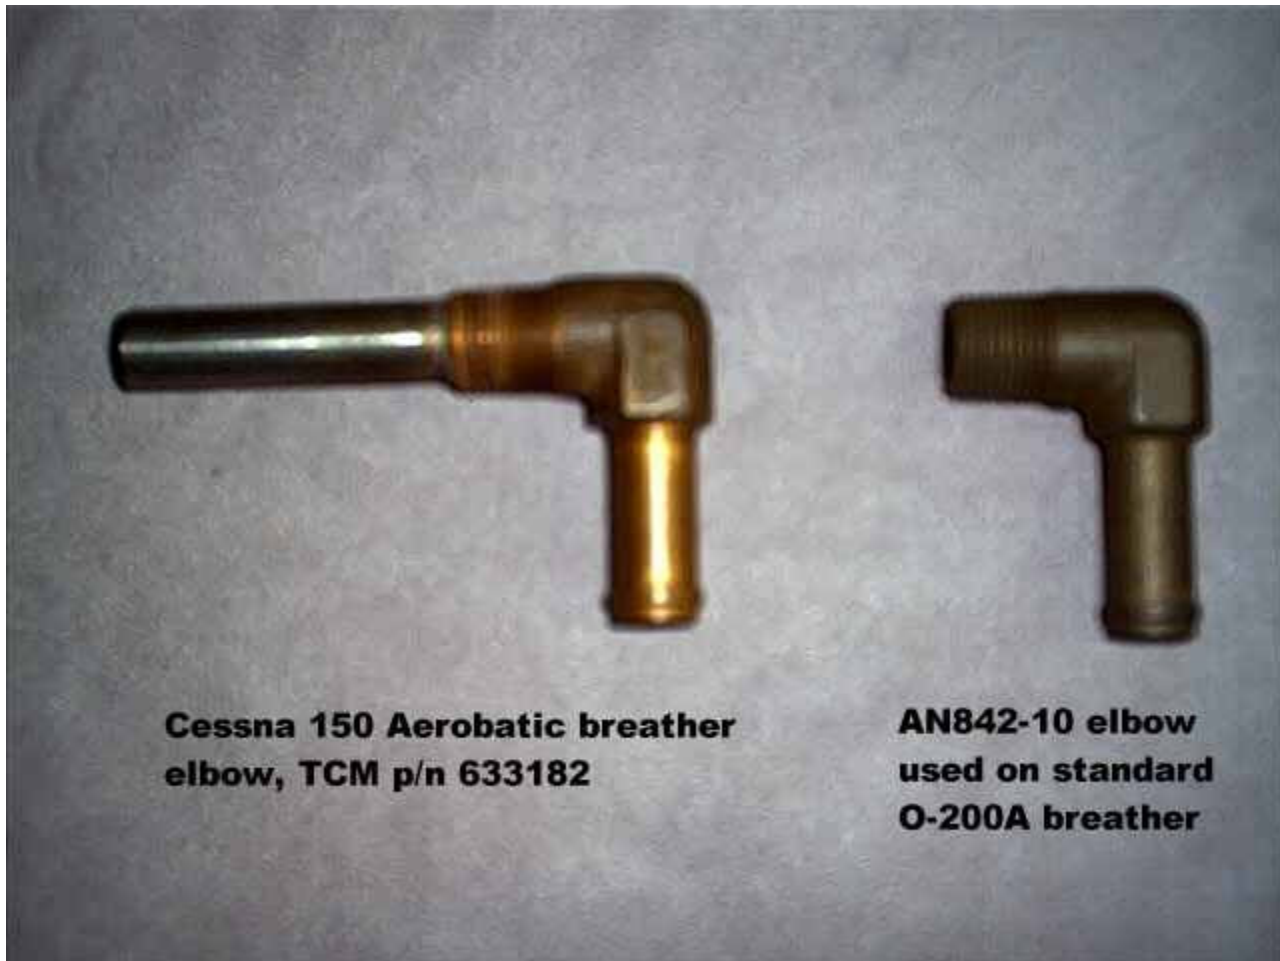
Below are three pics, the first is a comparison of the two elbows.

For those of you tired of oil on the belly and don't want to go to the hassle and expense of installing an oil/air separator (such as the M20 unit), you could install an aerobic breather elbow that was used in Cessna 150 Aerobats. Its is a standard brass elbow milled out to accept a steel tube which is then silver soldered into the elbow. The Continental part number for the aerobic elbow is **633182** and the part number for the standard elbow is **AN842-10** which is a standard part.

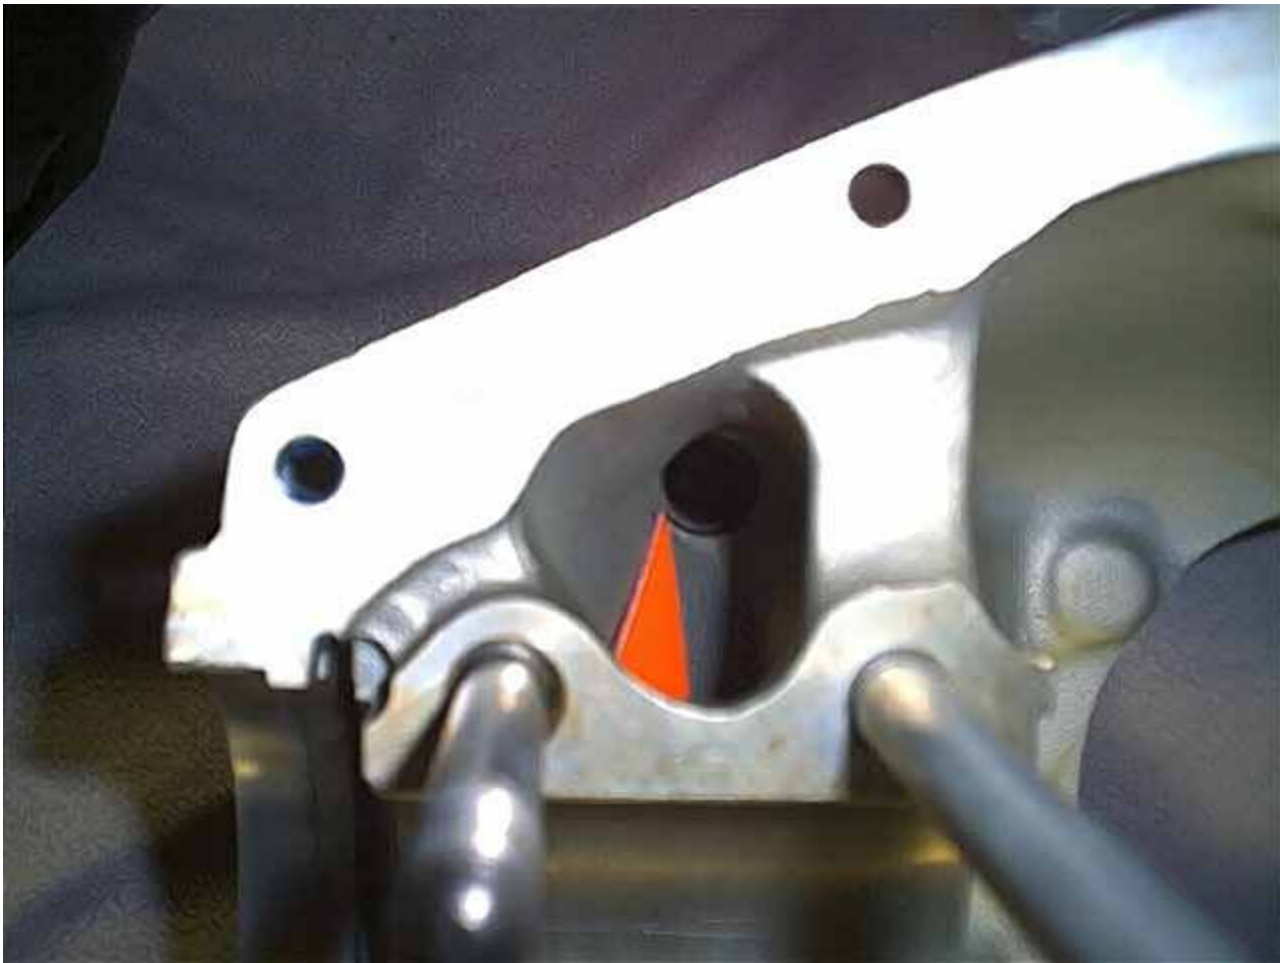
The next pic is of the inside of the Right Hand side of the O-200 engine case showing the opening where the elbow is screwed in from outside. This is a well shielded area that only gets oil spray coming off the front of the main bearing below it. (note the channel just above the LH stud in the photo, where oil coming from the front of the front main bearing is thrown by the oil slinger on the crankshaft out thru this channel and one like it below the bearing).

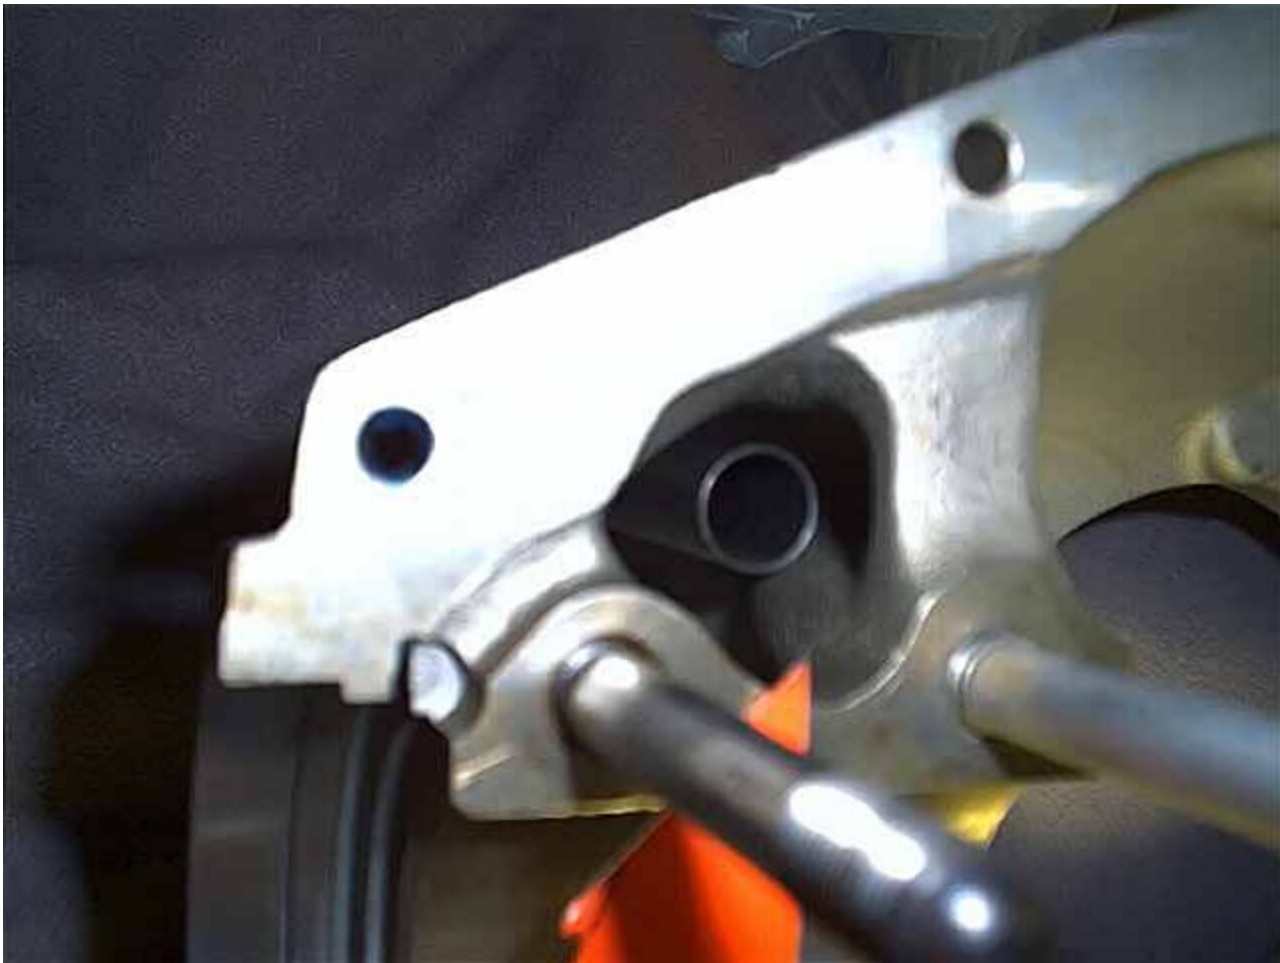
This pic shows the same view with the aerobatic elbow installed. It would be much more difficult for oil to find its way into the end of this tube suspended in mid-space than the standard elbow, where all the oil has to do is run down the top of the case till it reaches the hole and is drawn out by airflow.
