Vintage & Collector Car APPRAISALS

Make of Vehicle: 1964 Buick Skylark Convertible. **Engine:** Original Aluminum 300 cu. in. V-8 was recently rebuilt and bored out to 310 cu. in. with steel inserts installed.

Vehicle Identification Number: 3K1192047

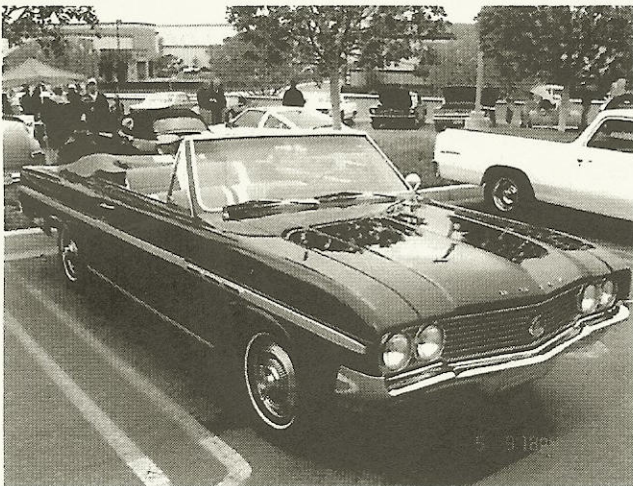
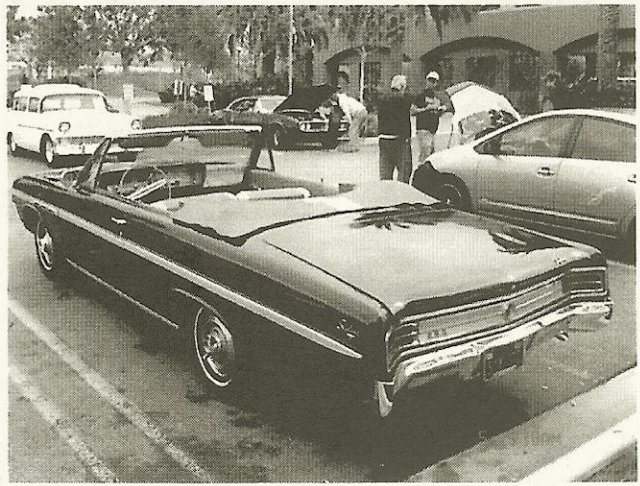
Fairly new re-paint (original color) appeared to be in excellent condition with the exception of a few scratches. See additional photos...

Consistent and regular throughout; no misalignment noticed. Both doors operated fine as well as the roll-up windows. There were no upper body dents; dings; damage; corrosion noted anywhere. There was no evidence of major collision. Most all chrome had either been re-plated or replaced during the restoration process and seemed in flawless condition; the exception was

both front fender chrome spears, which showed some wearing of the chrome plate where the spear is nearest the doors. Doors opened and closed correctly with no sagging.

Most all glass and rubber gaskets were replaced during restoration and currently in as new condition. Again the exception was the felt strips on the inward side of both doors.

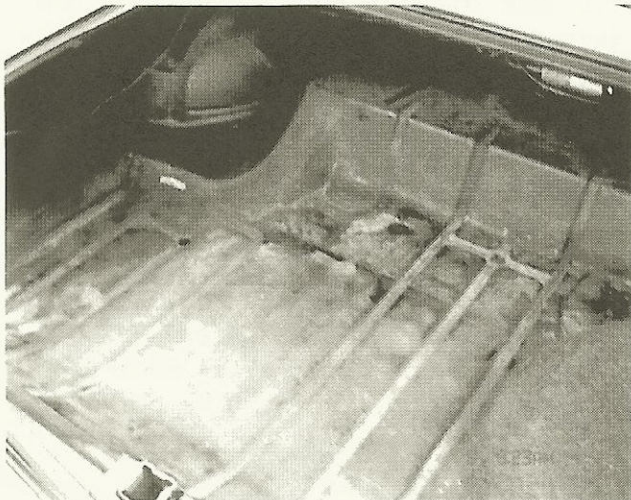
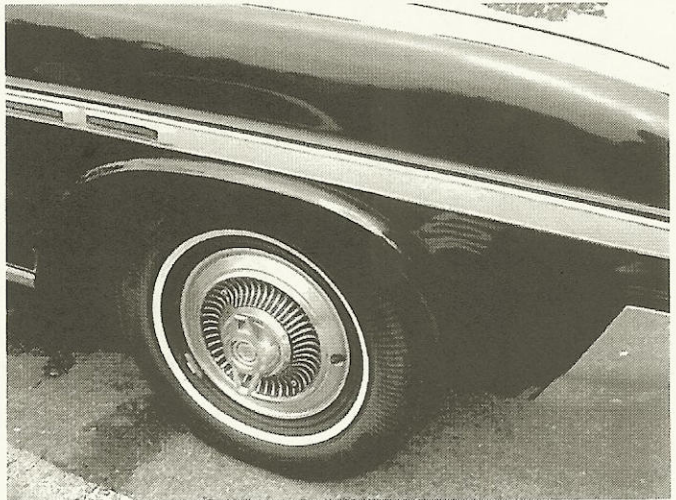
The engine started easily with no audible signs of problems. The engine idled well as typical of Buick engines. This model has only idiot lights for oil pressure, temperature, etc.

From a standstill with engine running and parking brake applied, the car was shifted through the gears starting in 'reverse', then through the ranges of 'drive'. The car jerked slightly when placed in each gear and would be considered normal.

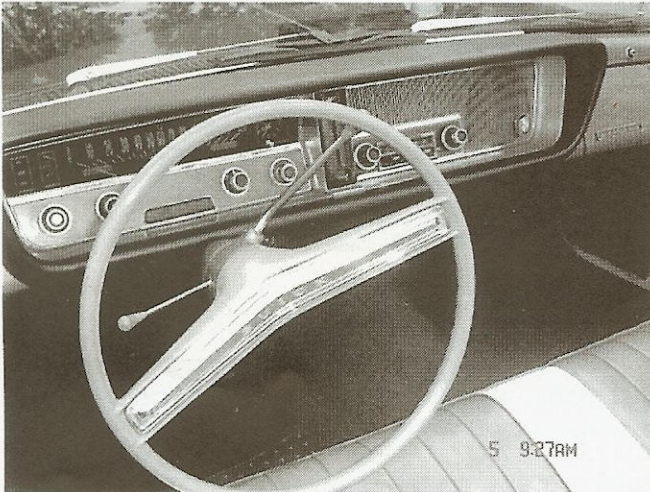
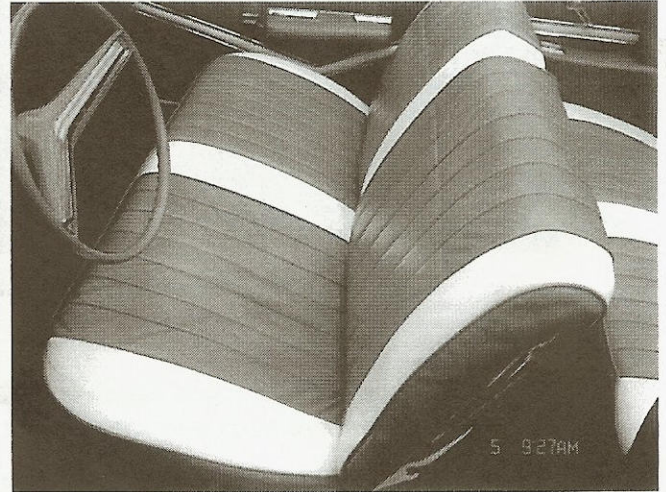
All lighting was visually verified including headlamps (bright and dim), Tail and parking lights, turn signals front and rear, back-up lights and instrument panel lamps. Owner stated that the interior lamps will require new bulbs in order to work. Other dash gauges were original and working. The 2-speed windshield wipers/washers functioned well.

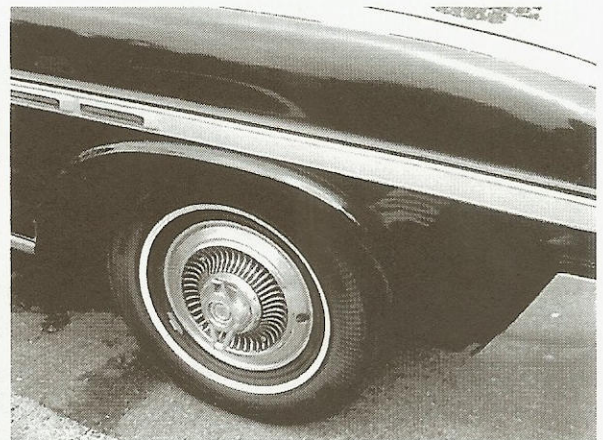
The 2-tone vinyl interior was complemented the dark blue exterior. There were no signs of rips, tears or broken stitching or dirt. Each door panel was matching and as new. The front and rear carpeting was in excellent condition. All interior chrome fittings were in excellent condition. Door locks function as required.

The radio was the original push-button AM type and according to the owner, it is currently not working. Condition of the original dash top speaker is not known.

The vehicle's wheels are the original steel type that came with the car when delivered from the dealership. The tires are size 275R-14; Good Year whitewalls and in near new condition. The spare tire matches those on the ground.

The front and rear suspension was rebuilt and holds the car level to the ground all around. There was no evidence of wear. The front and rear shocks are near new and holds the car firm and tight when testing the rebound of the shocks. The car sports the original "spinner" type wheel covers and are in very good original condition with minimal dings.

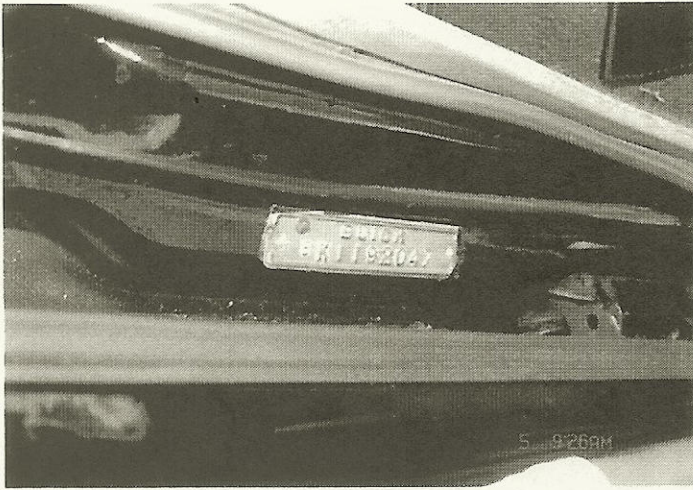
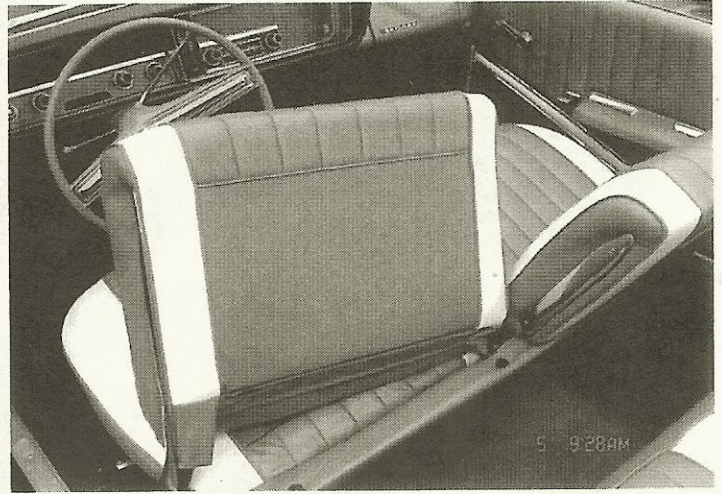
When looking under the car to inspect the undercarriage, the under body sheet metal showed evidence of undercoating but the appraiser could find no flaws other than some normal dirt gathered by normal driving. The frame showed no evidence of any damage.

The body VIN identification tag was consistent with that shown on the title to the car.
